# 72<sup>nd</sup> Highway Geology Symposium

## 2023 PROCEEDINGS

August 14-17, 2023 • Hotel Murano • Tacoma, Washington

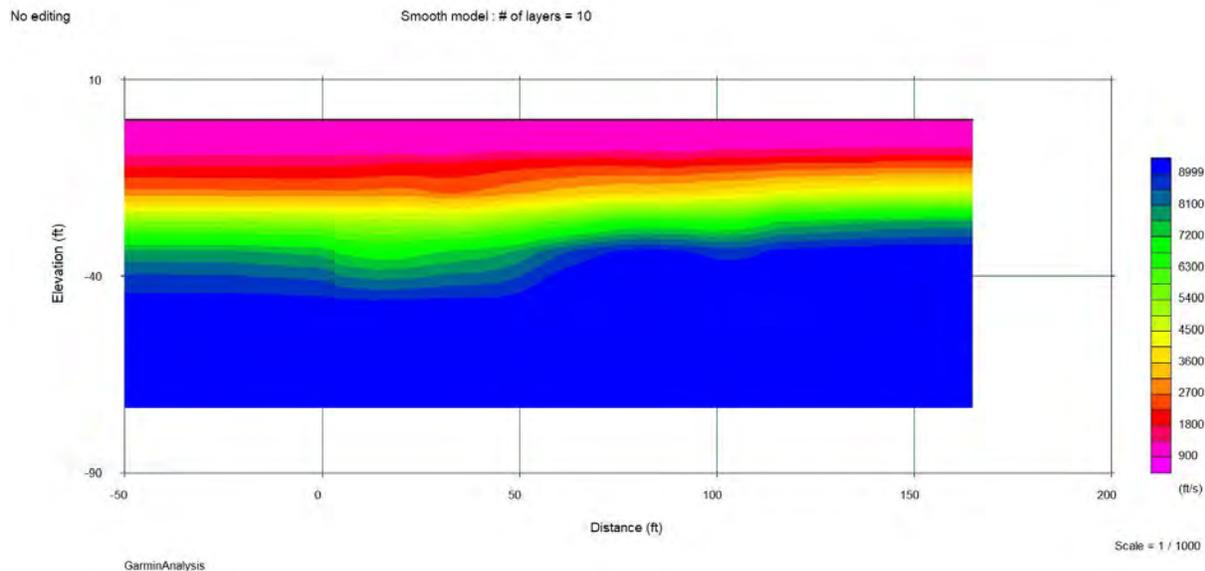
**Figure 1 – Seismic Refraction Plot Example**

Seismic refraction, a geophysical principle employed in diverse geological and engineering contexts, exploits the refractive properties of seismic waves to elucidate subsurface structures. It is frequently utilized to outline variations in ground hardness, detect subterranean cavities or profile site stratigraphy, but is seldom used for bridge site characterization. Furthermore, due to its efficient deployment by a small crew, it offers a cost-effective solution for subsurface investigations.

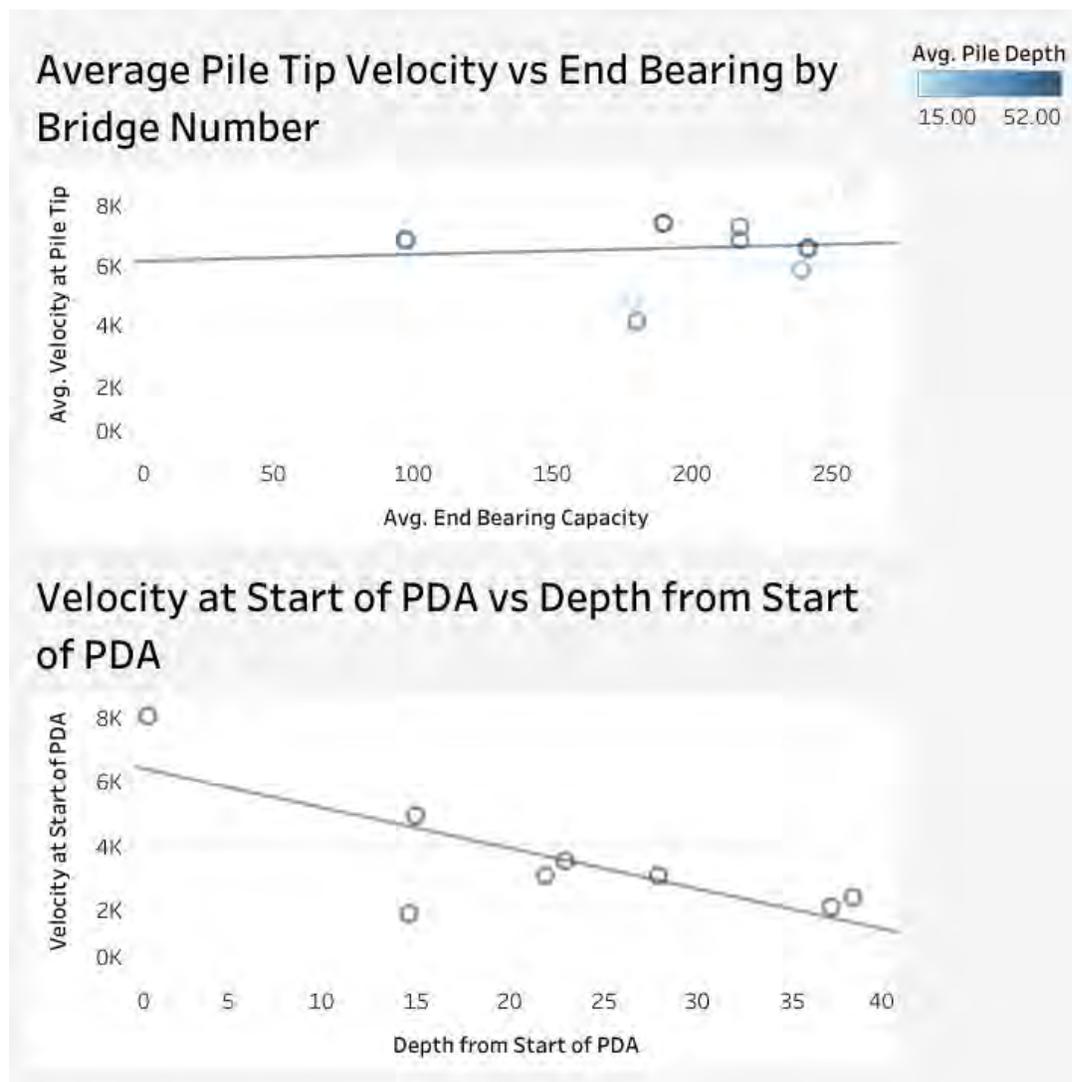
**Figure 2 – Compression Wave Velocities Visualization**

Across the span of this research, seismic refraction surveys were conducted at a total of 18 distinct sites, 8 of which were used in the data visualization in Figure 2. For brevity and focus, this paper will concentrate on examining three specific sites. These sites were chosen due to their varied geophysical properties and the unique characteristics they presented.

In the interest of providing a clear summary of the collected data, a graphical representation of the compression wave velocities will be included. This comprehensive data visualization will distill the gathered information across all surveyed sites into an easily digestible format. It allows for the comprehension of the correlation between the compression wave velocities of the soil and the pile-driving characteristics, thereby communicating the reliability and accuracy of seismic refraction for subsurface investigation.

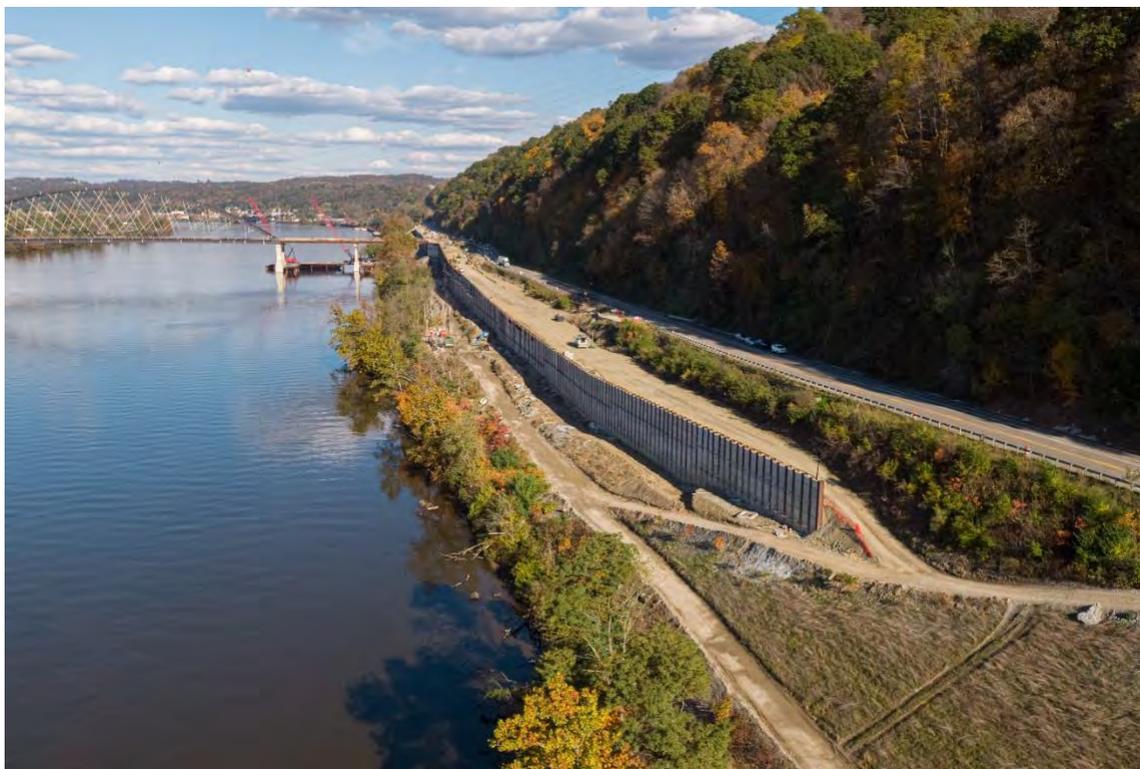
**Figure 2 - Photograph of Wall During Construction**

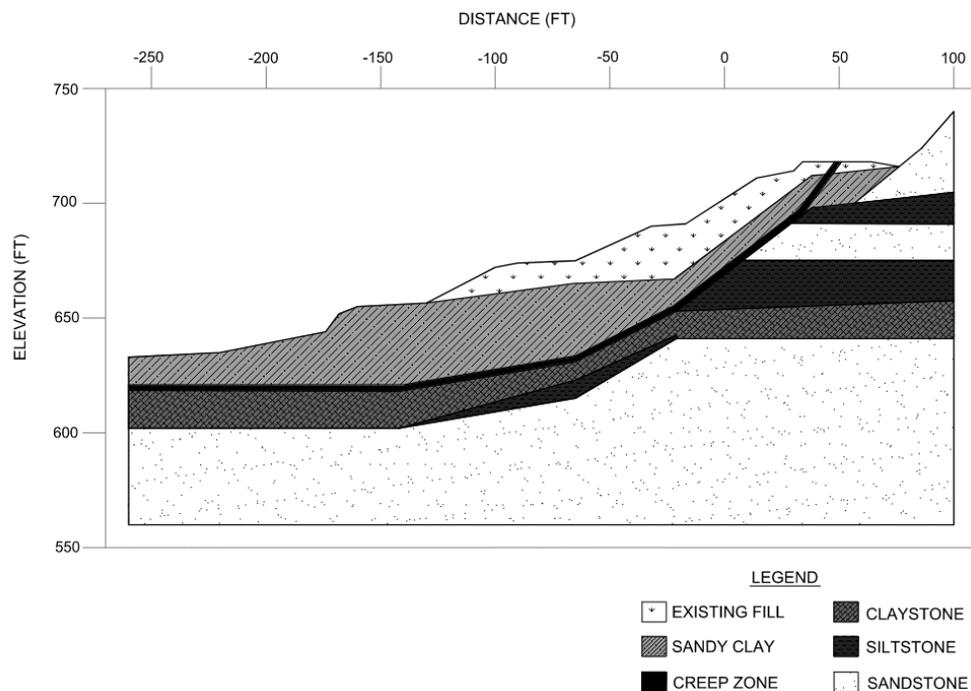
**Figure 3 - Existing Stratigraphy**

The subsurface conditions on this site consist of existing fill and colluvial soil underlain by bedrock from the Pennsylvanian-aged Conemaugh Group. The Conemaugh group is 300 million years old and was deposited at the bottom of the inland sea during a time where shorelines were shifting considerable distances (Wu 1987). The shifting of the shoreline resulted in multiple depositions of varying sediments that formed the interbedded sandstone, siltstone, claystone, and shale with coal and limestone rocks found in this formation. These rocks are generally horizontally bedded but can also slightly slope down towards the river in some locations. Figure 3 below represents a typical subsurface profile at the project site.

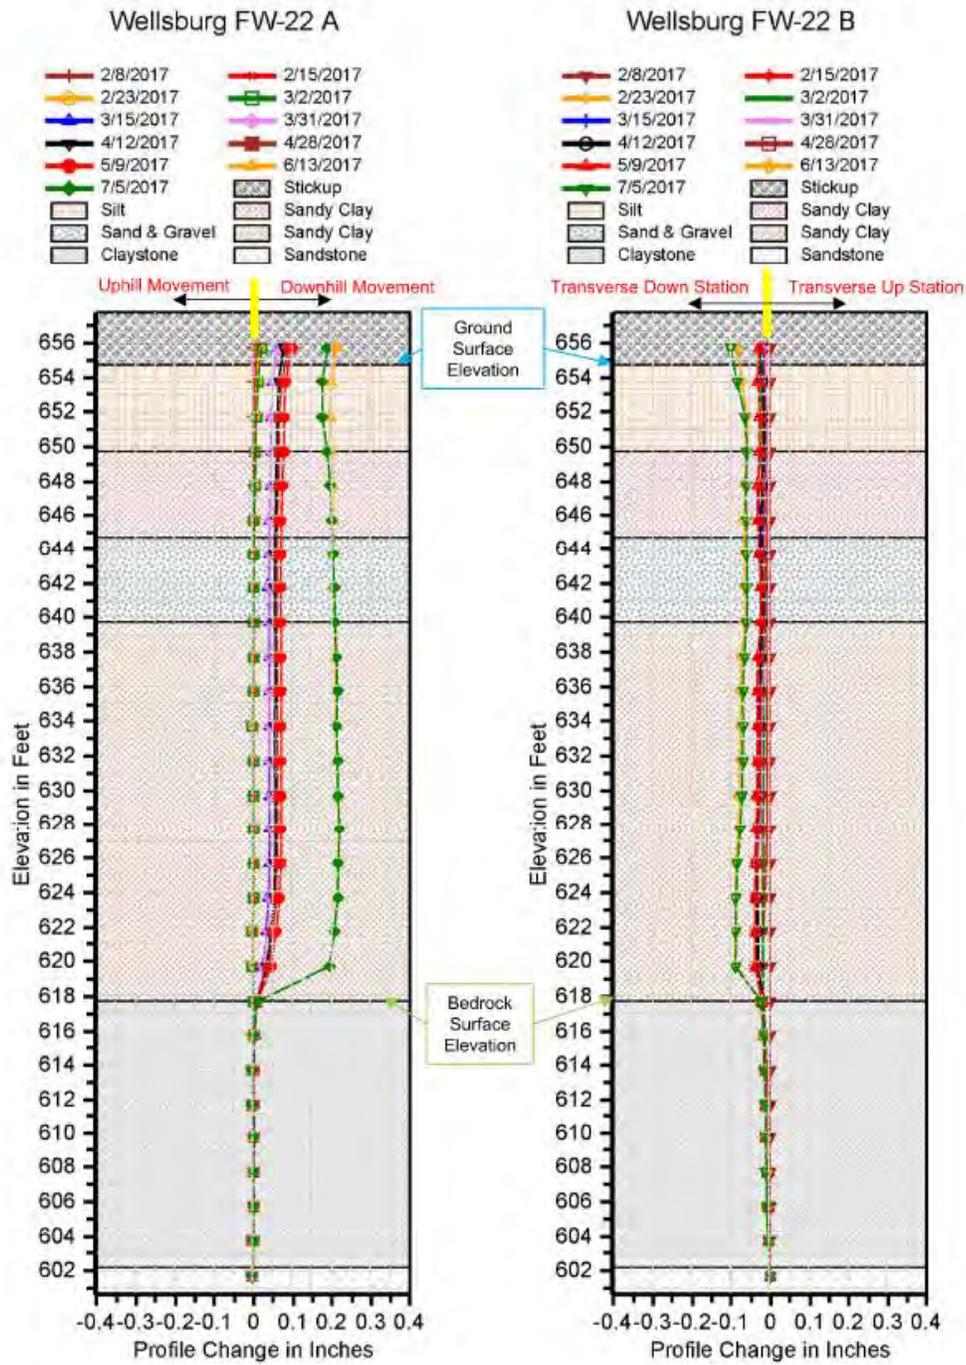
**Figure 4 - Project Inclinometer Readings**

Inclinometers were installed along the proposed retaining wall alignment and monitored for five months prior to the wall design. During that timeframe, some movement was observed in the inclinometers, as shown in Figure 4. The movement was observed at the top of the bedrock surface, within the low-strength creep zone material previously mentioned. Rigid body type movement occurred in the soil mass above the creep zone.

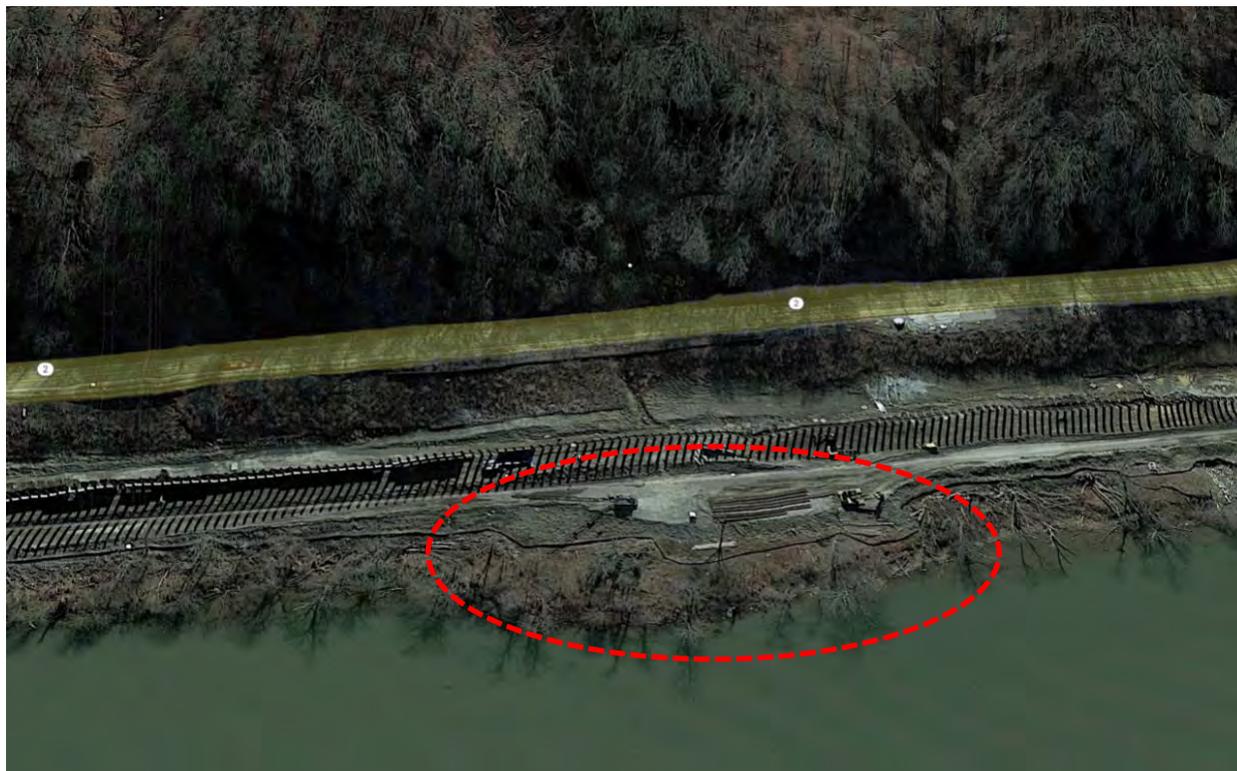
**Figure 5 - Previous Landslide Location Indicated by Toe Material**

In addition, several historic landslides were noted based on accumulation of soil along the riverbank, also referred to as slide debris, visually observed from the topographic survey of the site and from aerial photographs. An example of this soil accumulation is shown in Figure 5 below. This area of accumulated soil was utilized as a staging area of construction activities.

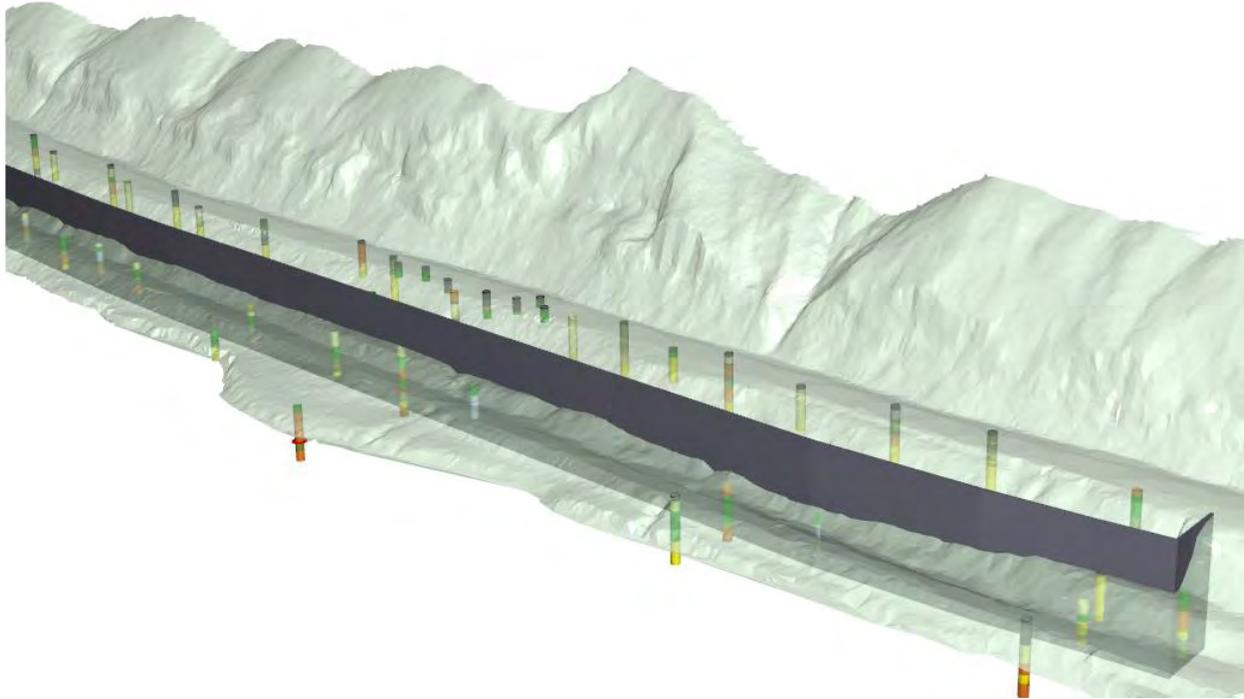
**Figure 6 - 3D model showing the wall and boring locations**

A desktop study was performed by the design team to understand the site background and the Conemaugh group. Understanding the background of the red bed material in the vicinity of the site was critical to relating the previous slope instabilities observed both by inclinometer data and topographic features. A three-dimensional model of the site was created using an in-house program engine to assist in visualization of the subsurface stratigraphy. The existing borings and topography were inserted into the program. The software was used to interpolate between the borings to generalize the limits of the soil and rock stratum. The location of the retaining wall was inserted into the model to assist with visualization. Figure 6 below represents sections of this model. The model was used to better understand the likely subsurface conditions between borings and help identify which borings should be considered to develop the design sections. Including a three-dimensional visualization tool provided a level of confidence to the design team that our design considerations were close to, or conservative compared to, the existing conditions.

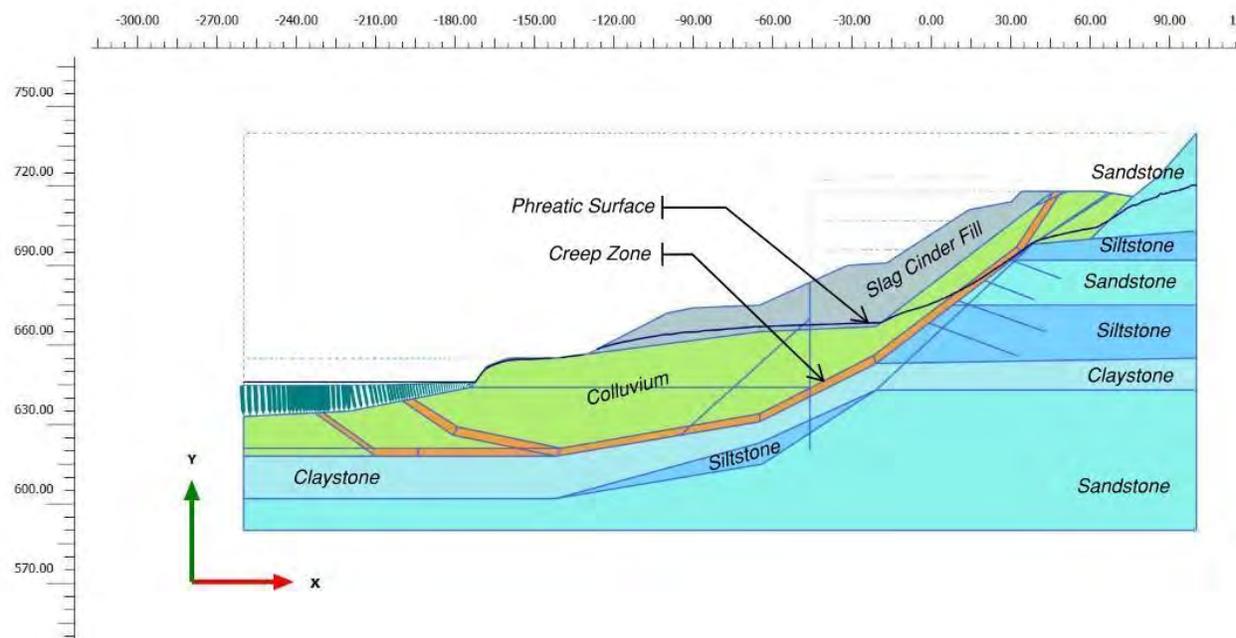
**Figure 7 - Plaxis Analysis to Develop Creep Zone Extent**

Soil parameters were back calculated using a Plaxis 2D analysis, considering the existing slope is at or close to failure (slow creep) in its current state. Limit equilibrium stability analysis in Plaxis 2D was used to interactively extend the creep zone along the high shear strain locations to develop the most likely failure condition. This was done using a combination of friction angle and cohesion for the strength of the soil. The limit equilibrium stability analysis allowed for input soil and rock strength and structural element strength to incrementally decrease until global yielding occurred, with the factor of safety equivalent to the ratio of the input and decreased strength. Visually, Plaxis 2D highlights the extent and shape of the unstable mass due to the global yielding, therefore the creep zone could be defined. The defined creep zone allowed for optimization of the design while having a prediction of the instability area due to the location of the red bed materials. The final creep zone for one of the design sections is shown in Figure 7 below. It should be noted that two likely creep zones were investigated in some design sections for steady state flow and rapid drawdown conditions.

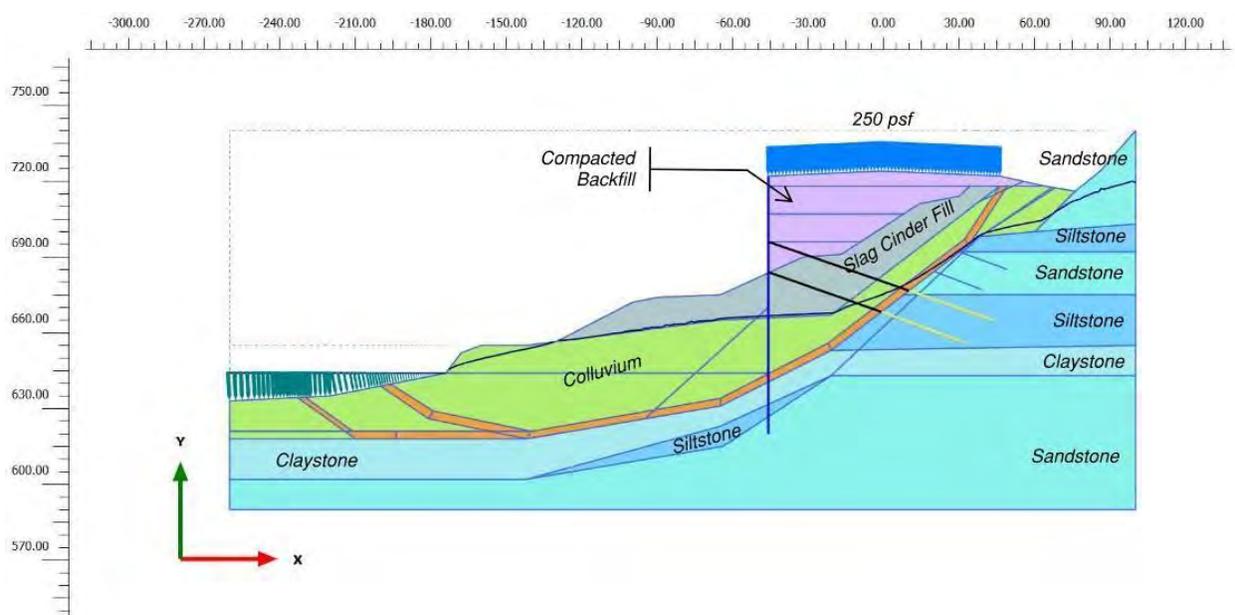
**Figure 8 - Plaxis Analysis Considering Staging**

Plaxis 2D was again used to design the retaining wall system. Staged construction was modeled in the numerical model program to evaluate the impact of construction loading, backfill placement, tieback prestressing, and traffic load application on the wall system (see Figure 8). Soldier piles and tiebacks were designed for fixity and bond, respectively, below the creep zone and into the competent rock material.

Our design considered tiebacks to be installed when 1 foot of backfill was placed above the tieback elevation. Our design considered tieback installation with the drill rig behind the wall, requiring the drill to extend between the placed soldier piles and drill through the front of the wall. A load test and tieback prestressing were to be performed at this time, as was required for stability of the retaining wall structure. Plaxis 2D analysis was able to evaluate the impact of the prestressing and compaction of material following the prestressing event on the final tieback condition. By understanding the impact of this initial load, avoidance of overloading the tiebacks due to the construction activities after lock-off was achieved. Additionally, the impact of construction activities, such as the tieback lock-off and stress from backfilling, was understood to meet the soldier pile deflection criteria provided.

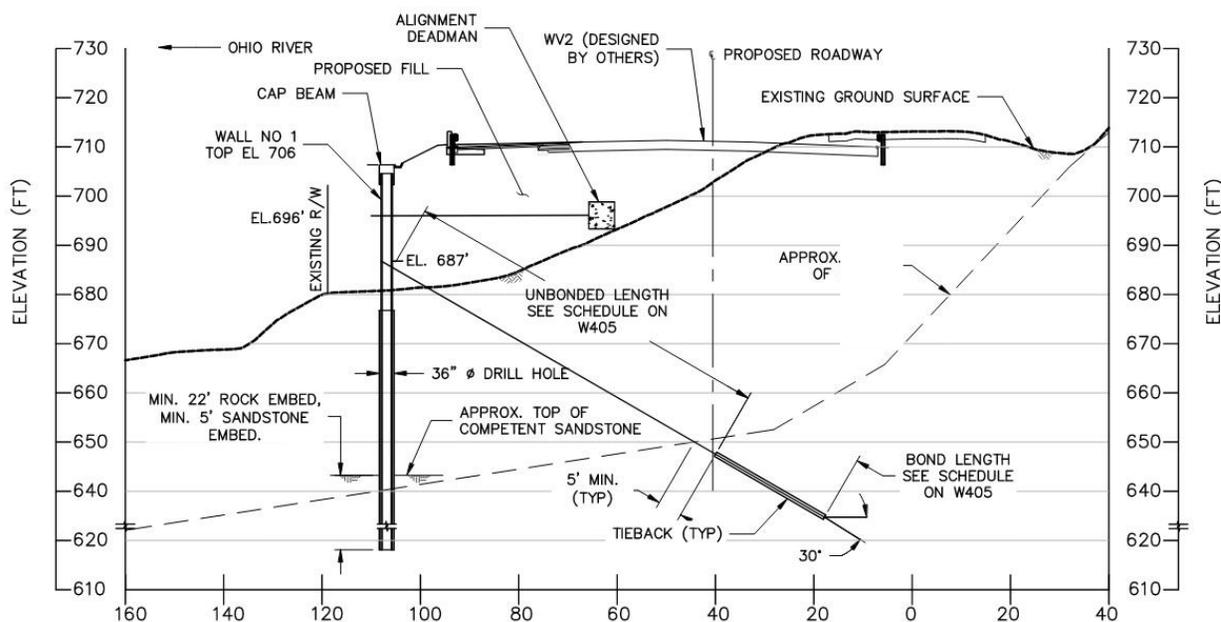
**Figure 9 - Example Section View (STA 203+50)**

The design included distances from the top tieback to the top of the soldier pile wall of up to 26 ft, which exceeds the general industry standard of 15 ft to limit deflection. A 1 in diameter, 150 ksi tierod was installed 10 ft below top of wall where the distance between the top tieback and top of soldier pile wall exceeded 15 ft. The tierods were designed to connect to concrete deadman structure 45 ft behind the back of soldier pile. This distance was calculated considering the active earth pressure failure wedge of the wall and the passive earth pressure wedge of the deadman for the tallest section of wall for simplicity of installation. Although the tierods were essentially provided to control wall deflections, their presence added stability to the retaining wall. A typical design section is found in Figure 9 below.

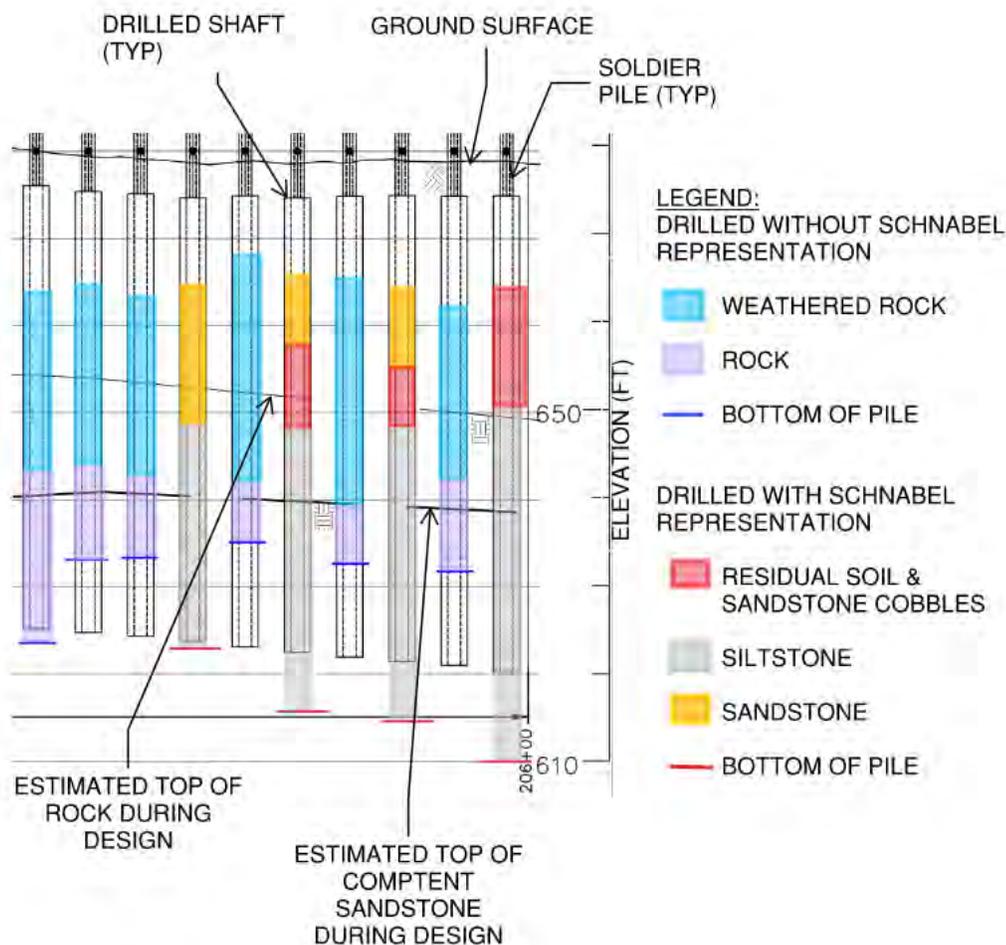
**Figure 10 - Comparison of Contractor vs. Design Engineer Material Classification**

As previously mentioned, the proper identification of the rock utilized for embedment is critical for implementation of the design. Schnabel was asked to visit the site towards the end of drilling due to concerns regarding rock classification by WVDOH's quality assurance engineers. Schnabel observed that the driller's definition of rock and competent rock varied from that of Schnabel at the beginning of the project. Schnabel observed drilling of adjacent soldier piles and compared the classifications, as can be seen in Figure 10 below. As some soldier piles were already installed without Schnabel's presence, evaluation of the as-built conditions was required to determine if additional steps were required to stabilize these soldier piles as removal would be an expensive alternative. The design section for this area was re-analyzed with the actual embedment and wall heights, which resulted in an increase in tieback loading that was handled through the existing tiebacks with no changes in design. Schnabel was retained to observe rock embedment for the remaining soldier pile structures (approximately 20% of the soldier piles installed).

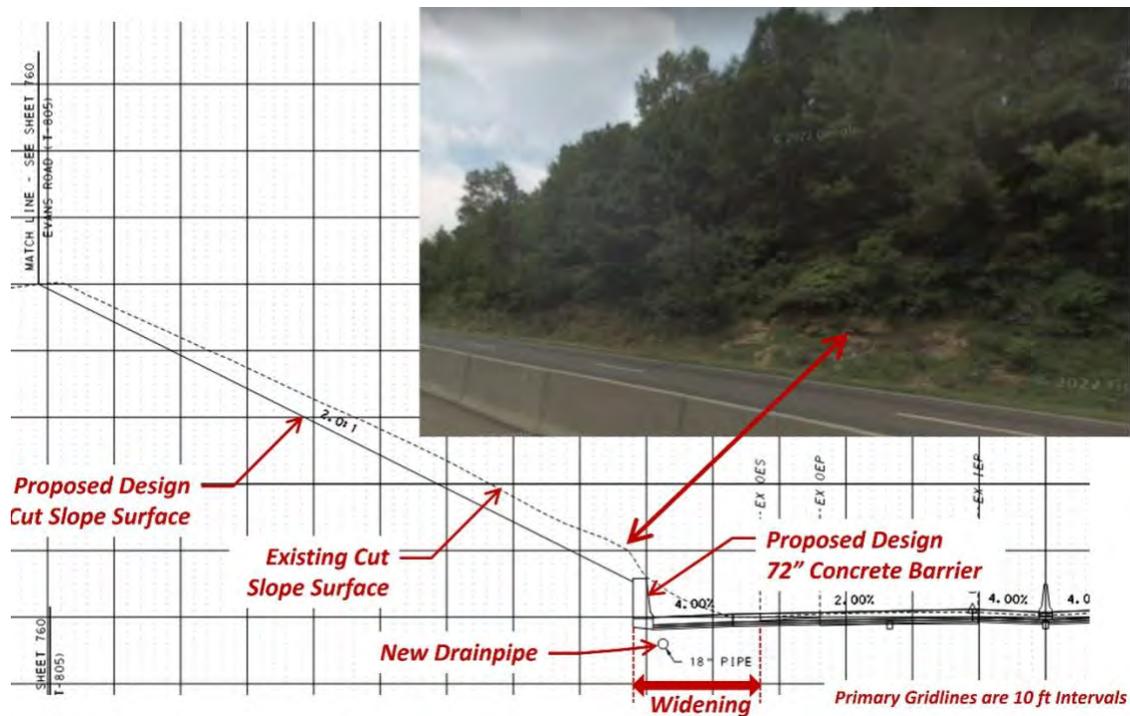
**Figure 2 – Existing and Proposed WB Cut Slope Conditions at Approx. Sta. 666+00. Modified from (7). Inset photo from 2018 Google Maps Street View.**

with a variety of young to mature trees and brush. An example existing cut slope condition is provided in Figure 2, below.

The results of the stereonet and kinematic analyses indicated that cut slopes ranging from 1H:1V to 1.25H:1V were feasible in some locations evaluated. However, to ensure consistency in the design throughout the project, a maximum slope gradient of 1.5H:1V was selected. This choice helps maintain a more consistent cut slope design throughout the project. An annotated cut slope design cross-section at Sta. 666+00 is presented in Figure 2, above.

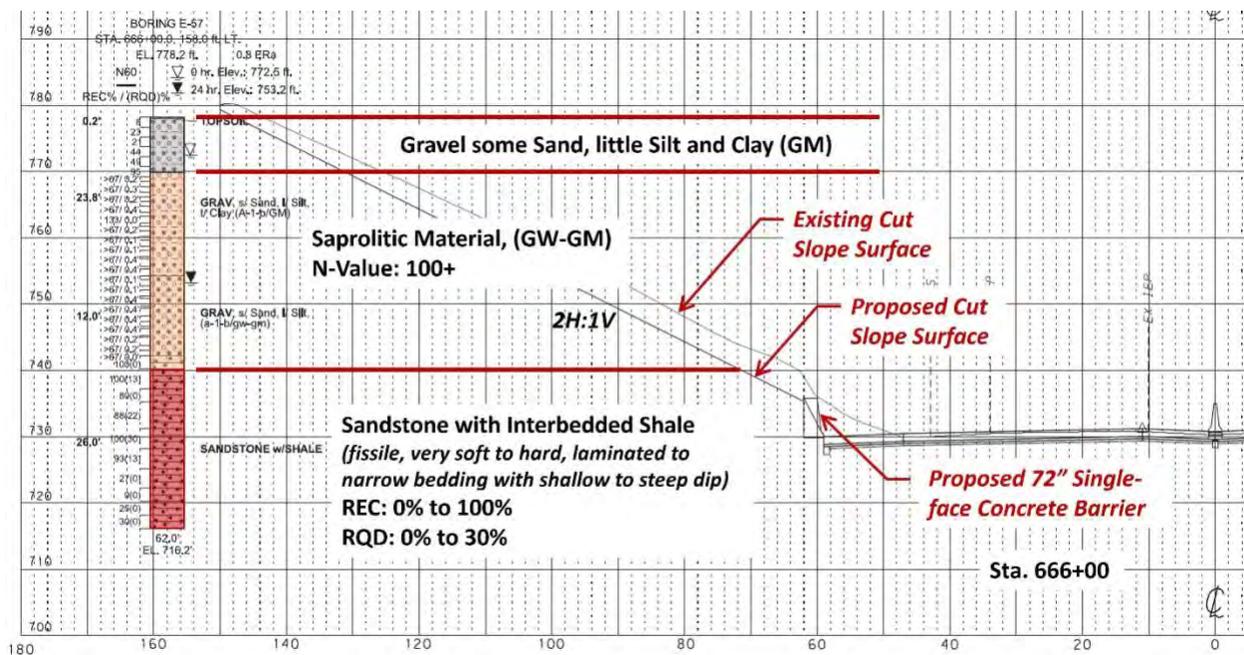
**Figure 3 – Westbound Cut Slope at Sta. 666+00 with Graphical Test Boring Data. Modified from (7).**

The distinction between the residuum soils and weathered bedrock stratum was not immediately evident in the subsurface, as the transition to coreable rock material with good recovery is gradual. Figure 3 below presents a cross-sectional view of the cut slope, including graphical representation of the test boring data at Station (Sta.) 666+003.

The modeled subsurface conditions and parameters used in the cut slope stability analysis (soil cut slopes) were derived from the test boring data as shown in Figure 3, above. The model was based on a two-layer subsurface profile consisting of a silty gravel (GM) decomposed rock material with a friction angle of  $38^\circ$  and zero cohesion, horizontally overlaying bedrock with a friction angle of  $42^\circ$  and a cohesion of 1,000 pounds per square foot (psf). The results of the stability analyses indicated that the factor of safety values ranged from 1.4 to 1.7 for potential near-surface/shallow depth failures and 1.5 to 2.2 for potential deep-seated failures for the widened 2H:1V cut slopes.

The typical geologic conditions, in cross-section along the failure area in the vicinity of Sta. 666+00 interpreted from the available boring data and observed cut slope conditions, is included in Figure 7, below (see Figure 3, above, for a comparison to original interpreted subsurface conditions). The inset image is a panoramic photo of the cut slope conditions just prior to the installation of stabilization measures.

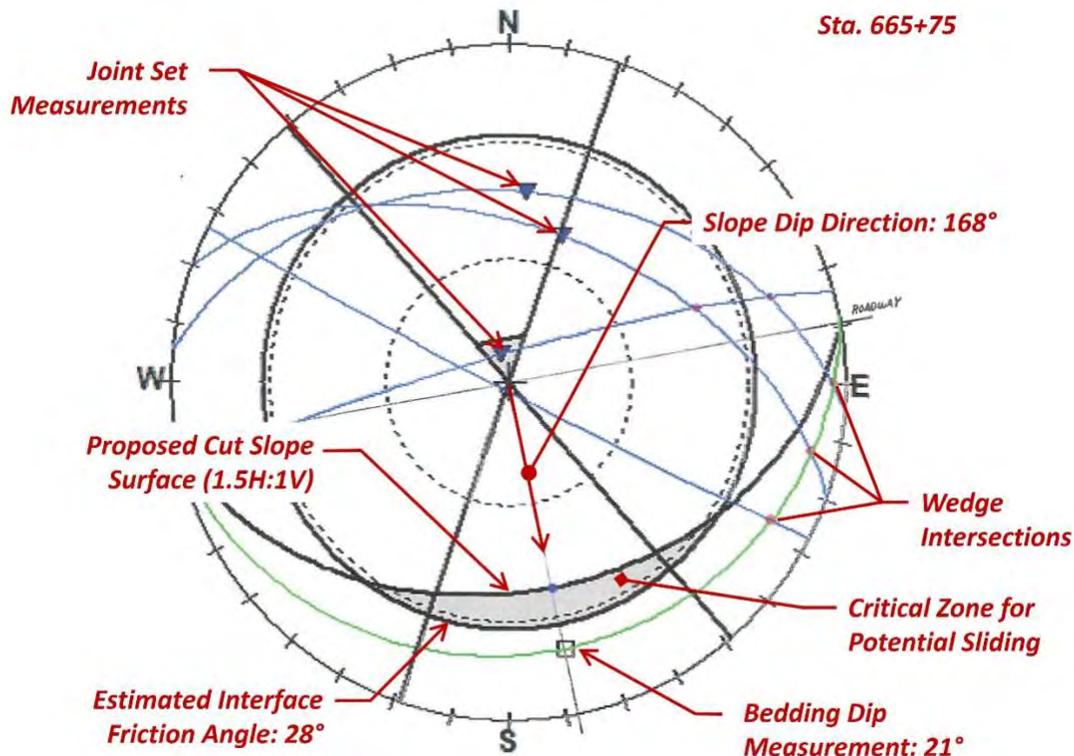
**Figure 4 – Annotated Kinematic Analysis based on Parameters Estimated During Design. Modified from project Geotechnical Engineering Report (I).**

Based on the rock type and visual discontinuity characteristics observed along the limited rock outcrop exposures, an estimated rock mass discontinuity interface friction angle of  $28^\circ$  was selected for the analyses. This angle represents the assumed resistance to sliding along the rock mass discontinuities. A kinematic analysis plot for the proposed 1.5H:1V cut slope in the vicinity of Sta. 665+75 based on estimated design phase parameters is presented in Figure 4, below.

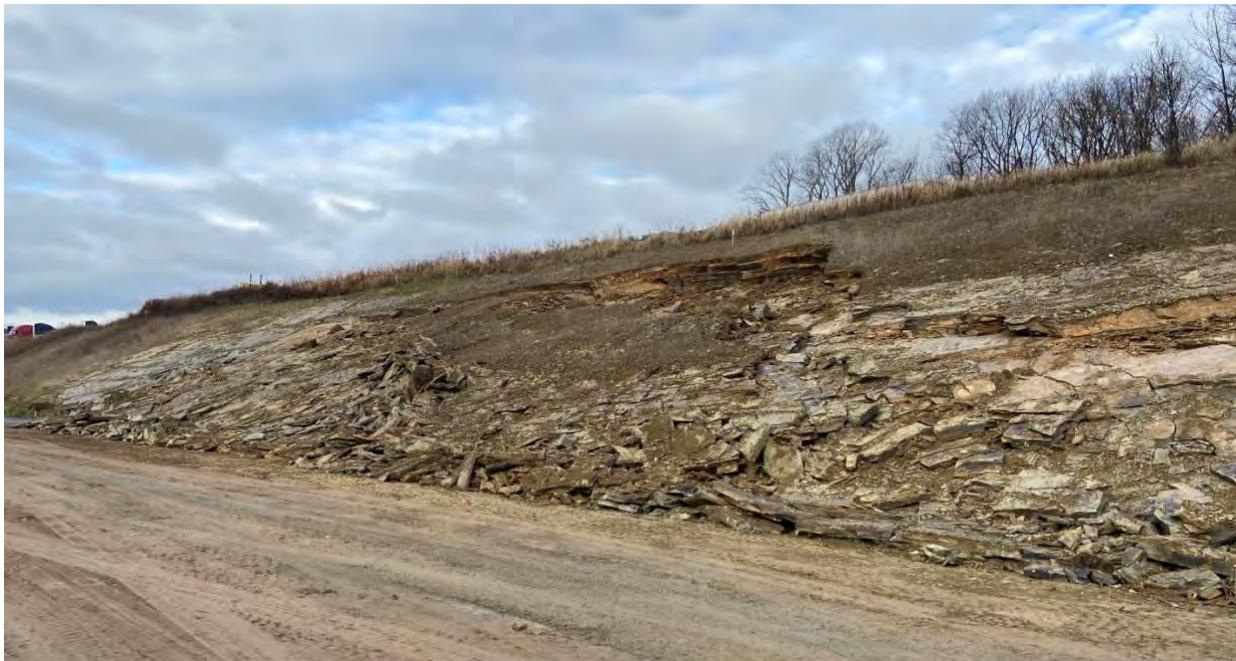
**Figure 5 – Failure resulting from contractor grading activities (< 1-foot toe cut) at previously scaled slope section (Sta. 653+00 to Sta. 659+00).**

In late December 2022, the 600-foot section of cut slope (Sta. 653+00 to Sta. 659+00), that was scaled 7 months prior, experienced another large volume planar rockslide failure, see Figure 5. This failure occurred while the contractor was performing final toe cuts (< 1-foot) in support of final roadway grading. This very small cut caused a new failure surface to daylight the slope face. This section was mechanically scaled a second time, following the same recommendations as the previous effort. The exposed slide surface was found to be only a few inches thick where it was disturbed at the toe of slope but projected as much as 5-feet under the overburden materials at higher reaches of the slope. As a result of this failure and additional scaling, approximately 3,000 cubic yards of rock debris was removed from this section. Despite the small size of the toe cut, the failure had significant consequences, highlighting the complexities of designing and constructing cut slopes through weak geologic units.

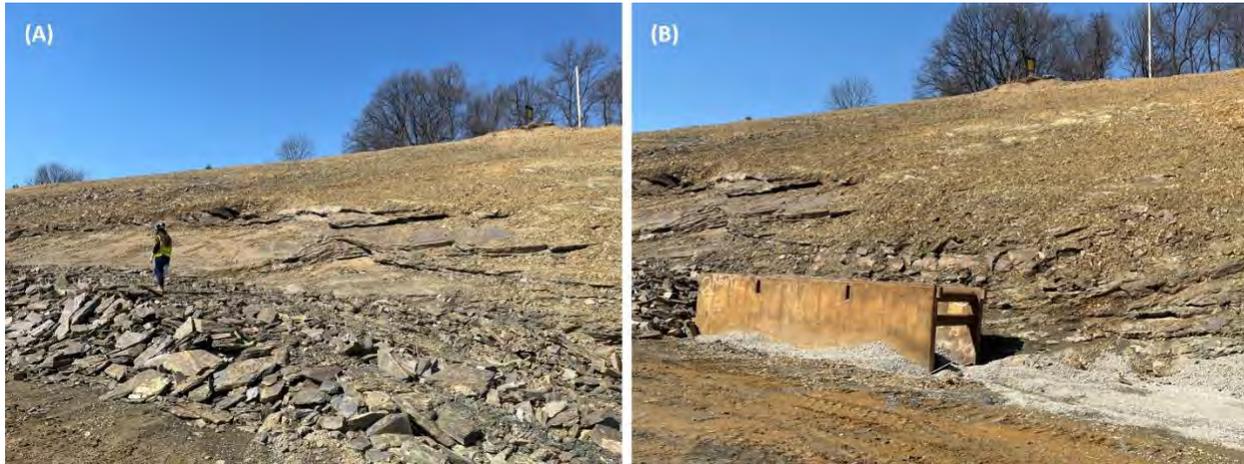
**Figure 6 – Planar Rockslide Failures, March 18, 2022. (A) Approx. Sta 665+00 to 666+00. (B) Eastern Flank of Failure at Drainpipe Trench Box, Approx Sta. 666+50.**

Cut slope grading, including the near-vertical excavation for the proposed concrete barrier had been completed for approximately one month prior to failure, while excavation for the new 18-inch drainpipe adjacent to the toe of the cut was ongoing. Photos of the slope in the vicinity of Sta. 665+00 to 666+50 shortly after failure are provided in Figure 6, below.

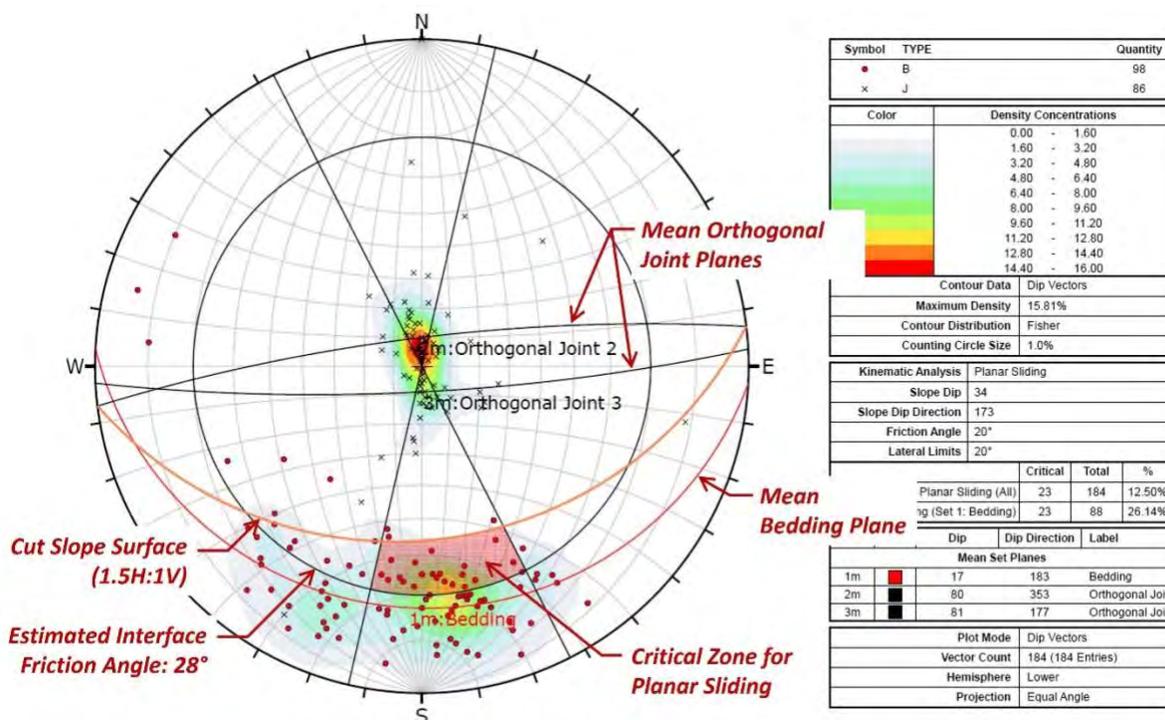
**Figure 8 – Kinematic Analysis Dip Vector Plot based on Discontinuity Measurements across Slope Section 1 (Sta. 662+00 to Sta. 669+00).**

According to the FHWA Rock Slopes Reference Manual Table 3.1 (12), the interface friction angle of “low-friction” sedimentary and meta-sedimentary rock varies considerably, typically ranging from 20° to 27°, depending on roughness of discontinuity surfaces and mineral content. Based on the smooth texture of the exposed rock units, localized clay infilling seams observed, and the results of the field tilt testing, a friction angle of 20° was estimated and used in the analyses. The kinematic analysis dip vector plot for the area of Slope Section 1 (662+00 to Sta. 669+00), is depicted in Figure 8, below. As demonstrated by the observed failure, the kinematic

analysis indicated that planar-type failures would occur for bedding surfaces with dip angles greater than interface friction angle ( $20^\circ$ ) but less than the cut slope surface angle.

This figure shows how the geologic structural discontinuity orientations and properties of the underlying weak rock exposed during construction aligned in such a way to intersect an exceedingly small envelope of potential failure.

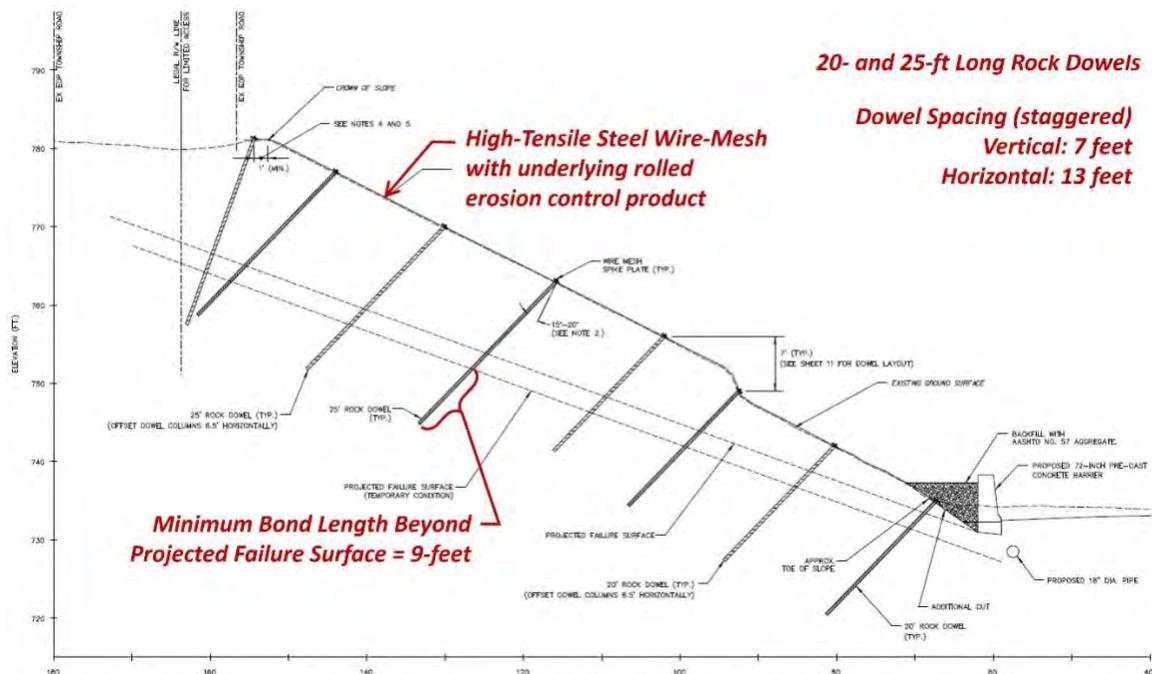
**Figure 9 – Typical Stabilization Design Section at Slope Section 1  
(Sta. 662+00 to Sta. 669+00).**

Based on the results of the existing condition results, mitigation measures in the form of passive rock dowels were added to the limit equilibrium model until the selected design factor of safety (1.3) was achieved. In order to protect the work zone from potential rockfall hazards and provide additional resistance to surficial movements, the project team decided to attach a high-tensile strength steel wire mesh system to the rock dowels. A rock dowel analysis was performed to determine the appropriate rock dowel properties and design load. The analysis involved dimensioning the steel wire mesh system using RUVOLUM® online tool by GeoBrugg and calculating the size and length of the rock dowels following FHWA guidelines. To determine the minimum required dowel bond length beyond the projected failure surface, an estimated ultimate bond stress of 120 psi was used for the interbedded shale and sandstone. A design section, showing the typical stabilization treatment layout at Slope Section 1, is depicted in Figure 9, below.

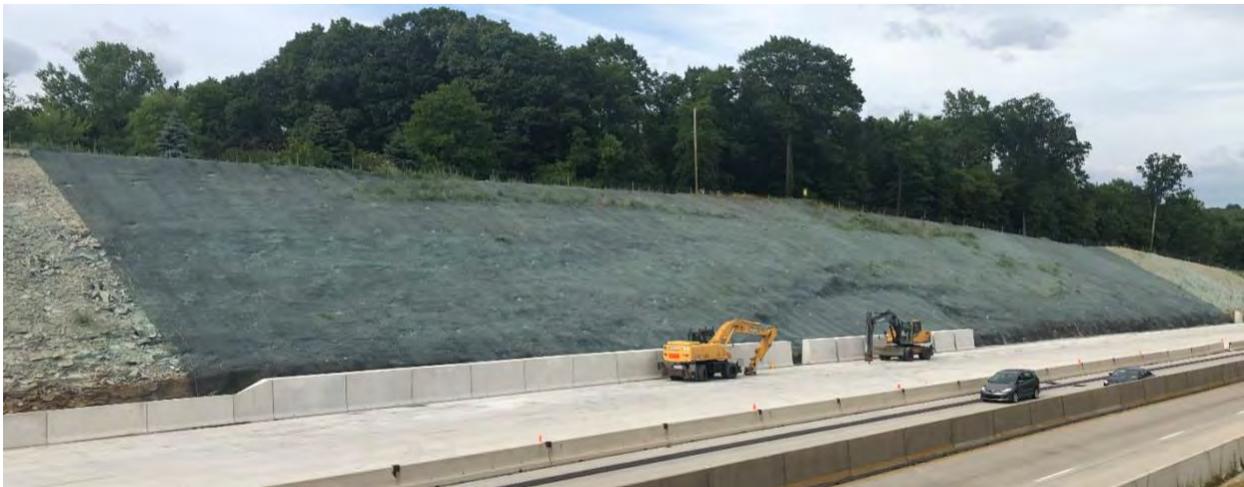
**Figure 10 – Slope at Section 1 Six-Months following Stabilization Construction.**

The drilling work was performed by H&K Structures Division, utilizing a combination of excavator-, telehandler-, and crane-mounted rock drills. To maintain the project schedule and optimize working hours, multiple operations were conducted concurrently for both stabilization sections, including drilling, rock dowel preparation and installation, grouting, and mesh installation. In total, the stabilization work was completed within a six-month period from June to November 2022. Final paving operations and construction of the barrier walls along the toe of the cut slopes are expected to be completed by the end of June 2023. An oblique photo of Slope Section 1, six-months after completion of stabilization activities, is include in Figure 10, below.

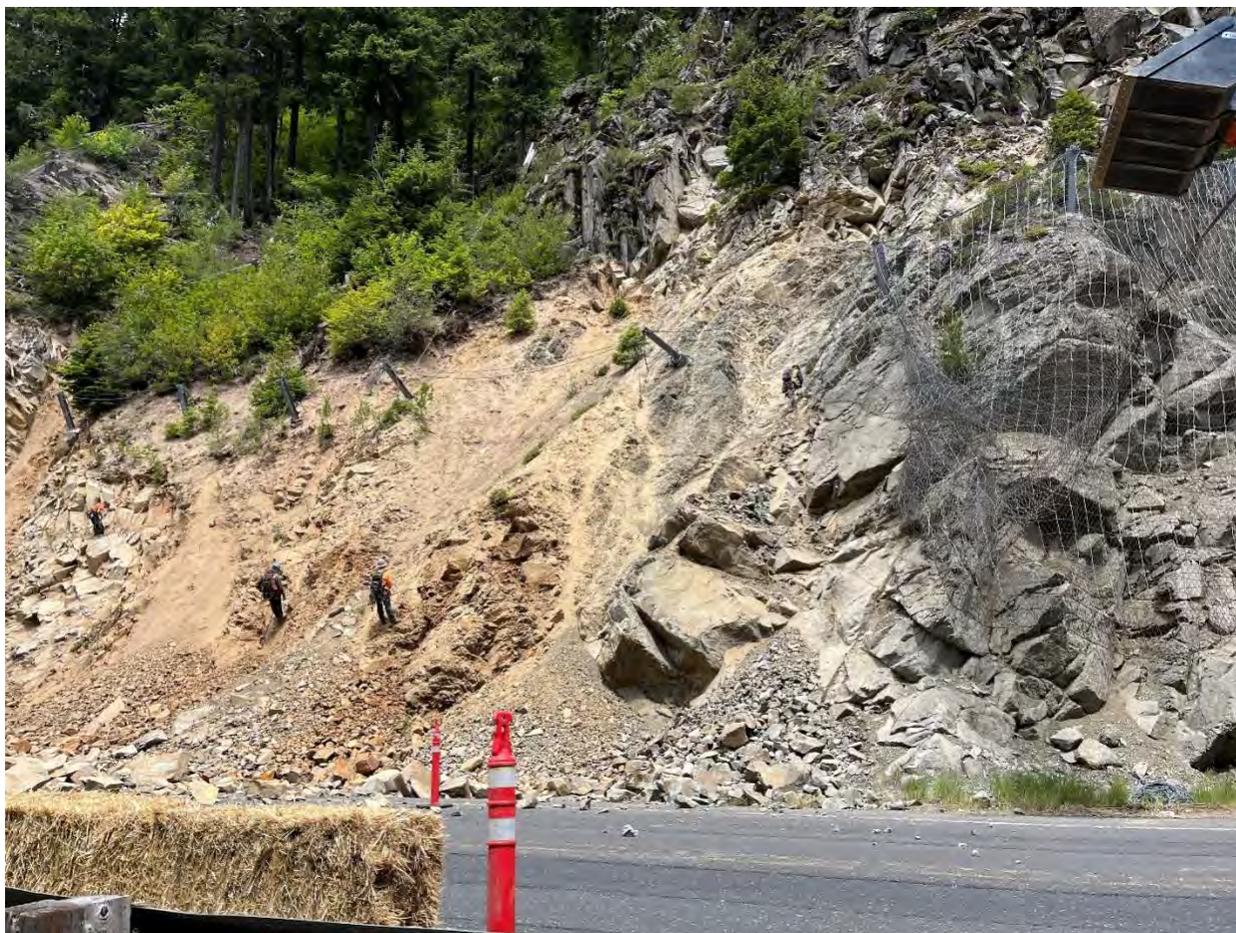
**Figure 1 – Rock Slope Scaling Crew at US 12 MP 145.75**

Debris quantities refer to the amount of loose or detached rock material that may pose a risk of falling from a slope (Figure 1). These debris materials can range in size from small rock fragments to large boulders, and their presence on a slope can significantly increase the potential for rockfall incidents. Debris quantities are influenced by various factors, including the geological characteristics of the weathering rating, rock strength, discontinuity characteristics, and overall rock type.
