# 72<sup>nd</sup> Highway Geology Symposium

## 2023 PROCEEDINGS

August 14-17, 2023 • Hotel Murano • Tacoma, Washington

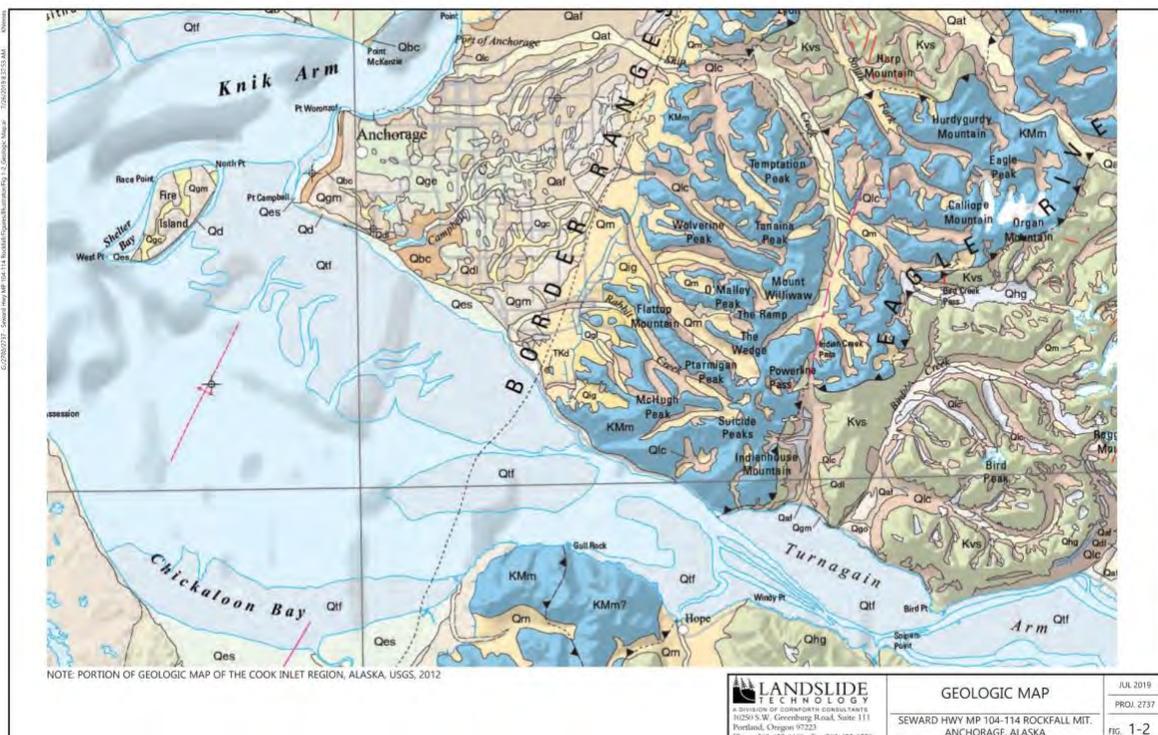
Figures 2: Geologic Map of the Cook Inlet Region, Alaska

The Undivided Metasedimentary rocks (Kvs) are described as dark-gray, thin- to thick-bedded, laumontite- to mid-greenschist facies composed of a thick sequence of rhythmically alternating, deformed metamorphosed sandstone-siltstone turbidites with beds generally ranging from a few centimeters to a few meters thick and locally, massive beds up to tens of meters thick. The metamorphosed beds are composed of moderately sorted to poorly sorted sandstone, siltstone, and mudstone flysch. The sandstone is fine- to coarse-grained and is mainly composed of plagioclase, quartz, and igneous rock fragments. A portion of the Geologic Map of the Cook Inlet Region, Alaska in relation to the project site is provided as Figure 2.

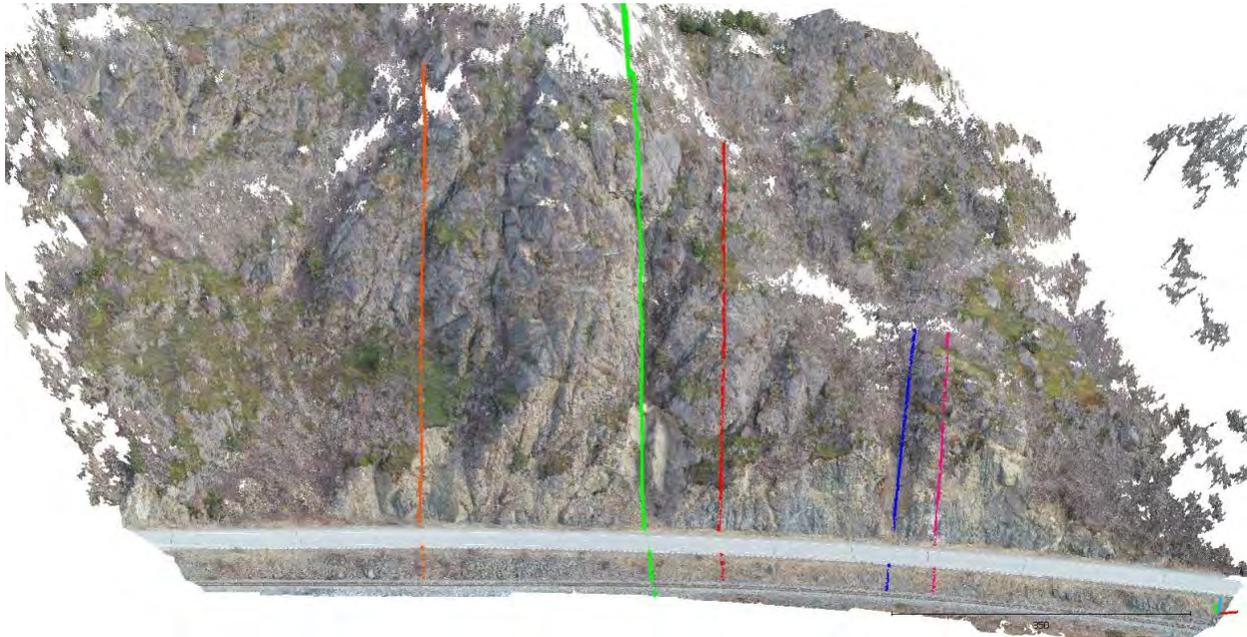
**Figure 3: Example cross-section locations identified in estimated rockfall trajectory paths.**

Several unmanned aerial vehicle (UAV) photo sets were used to conduct the site specific analyses. One set of data was gathered at various sites in mid- to late-2018 and early 2019 by DOT&PF geotechnical staff. LT's subconsultant HDL conducted two UAV surveys, one on March 4, 2019 and a second on March 29, 2019. Georeferenced point clouds were developed to analyze geologic structure of exposed rock outcrops and measure rock slope features. Using these datasets, rockfall cross sections were generated to evaluate rockfall trajectories and characteristics. An example of cross section locations generated from point cloud data used for modeling is shown in Figure 3.

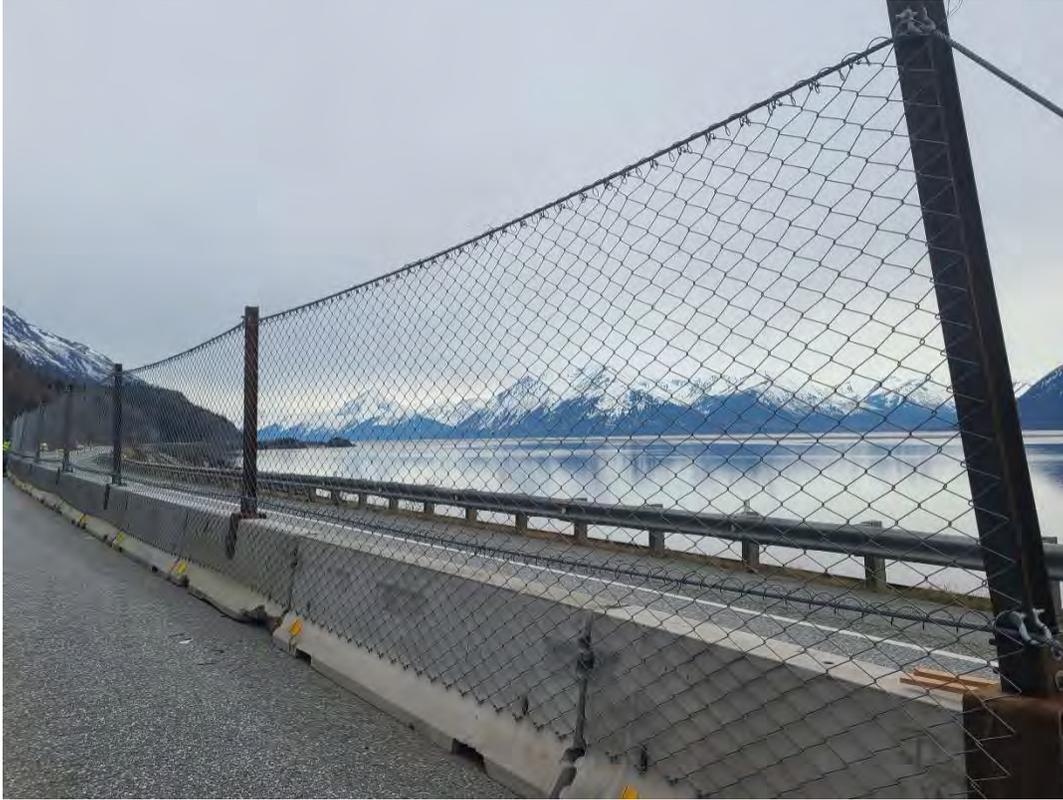
TRP for the project consisted of a concrete barrier mounted fence extension. Fencing was constructed with 6-foot-tall steel posts and high-tensile strength 4-millimeter steel wire mesh supported by ¾-inch wire ropes on the top, bottom and sides of the mesh. The posts were mounted to the top of 2.5-foot-tall standard concrete barriers, as shown in Figure 4.

**Figure 4: TRP placed along centerline on the Seward Highway.**

This system required two to three days for set up and break down depending on the length being installed. It was selected to reduce risks to highway users as a result of construction activities and limit the protection measure footprint. TRP was placed along the centerline of the roadway prior to beginning on-slope mitigation efforts and was left in place until all on-slope work at a site was completed. Debris accumulated in the work zone was removed at the end of each shift. During non-working hours, traffic was active on both sides of the barrier. Crash cushions were placed at each terminal end of concrete barrier.

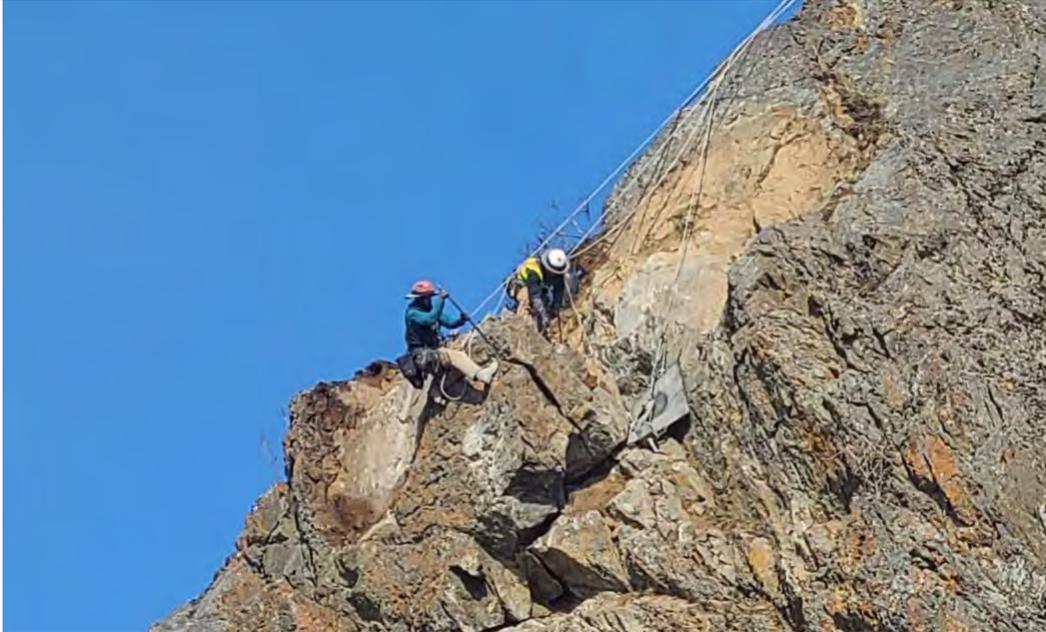
Hand scaling techniques included the use of scaling bars to remove small, loose rock and debris from the rock slopes. For heavier hand scaling efforts, pneumatic air pillows were utilized at locations where marginally stable rock blocks were identified with an adjacent fracture available for placement of the air pillow. When necessary, rock breaking techniques, such as boulder busters, were utilized to break up large rocks into smaller pieces prior to removal from the slope. Mechanical scaling was used occasionally to remove loose boulders from the slope by running a steel cable from the bucket of a loader to an identified boulder and pulling the boulder off the slope. Hand scaling techniques are shown in Figure 5.

**Figure 5: Contractor using scaling bars and air pillows to remove loose rock blocks.**

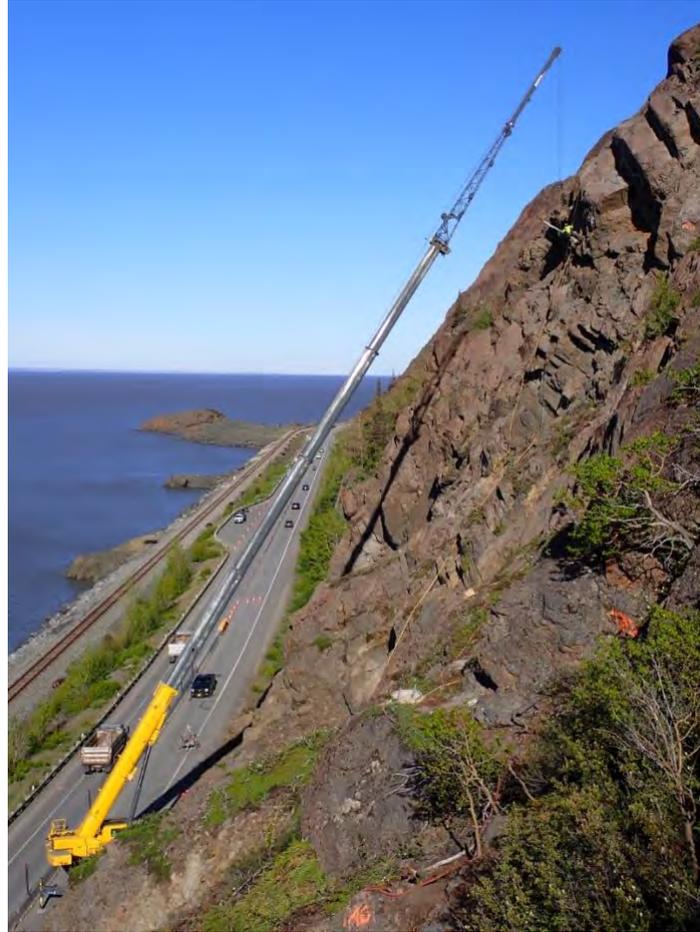
**Figure 6: Wagon drill mobilization for rock bolt installation.**

Rock bolts and rock dowels were installed at all HSIP sites and one state funded site. Rock bolts were either 40-kip or 80-kip post tensioned elements. Several drilling methods were used to install rock bolts and rock dowels including a crane-suspended pneumatic drill (“dangle drill”), a crane boom-mounted hydraulic drill, and a wagon drill. Wagon drill operation is shown in Figure 6. A total of 11,115 linear feet of rock bolts and a total of 4,800 linear feet of rock dowels were installed across the project area.

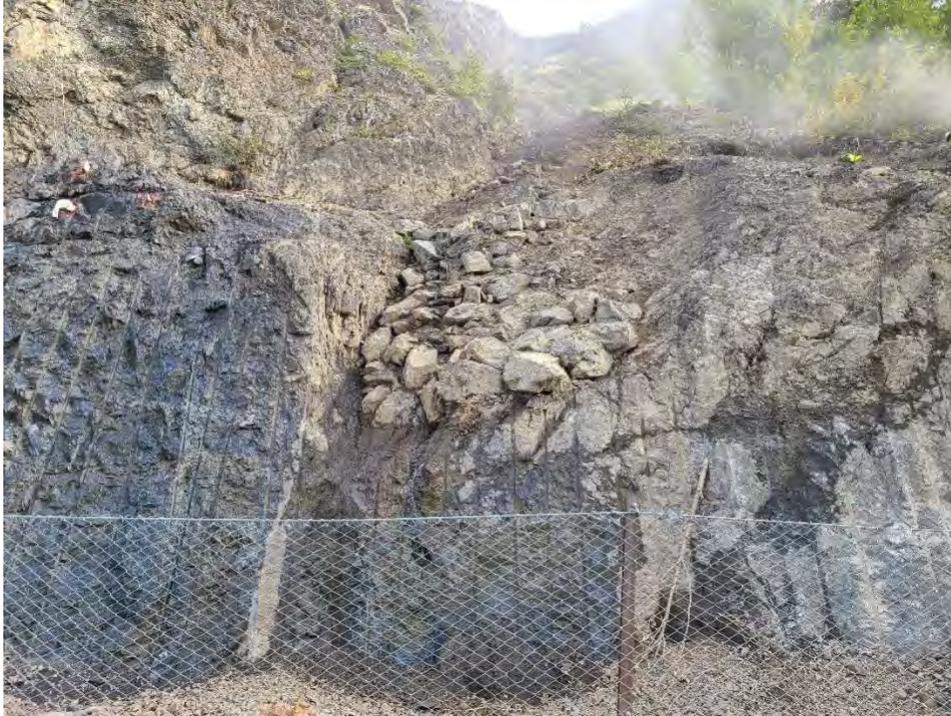
the 12-inch minus material. The boulders and 12-inch minus materials were salvaged from shot rock produced from the blasting efforts. A view of the completed buttress and expanded ditch is provided in Figure 7.

**Figure 7: Completed shot rock buttress.**

A large trough 20 feet wide by 54.5 feet deep by 53.4 feet tall was excavated to facilitate blasting workers safety. This trough was later stabilized with construction of a geogrid reinforced rock buttress. Construction of the buttress was completed by stacking 3- to 6-foot boulders on the outboard side of the trough and 12-inch minus with up to 20 percent sand to silt sized material behind or upslope of the boulders. Mirafi 5XT Geogrid was placed on approximate 2-foot lifts in

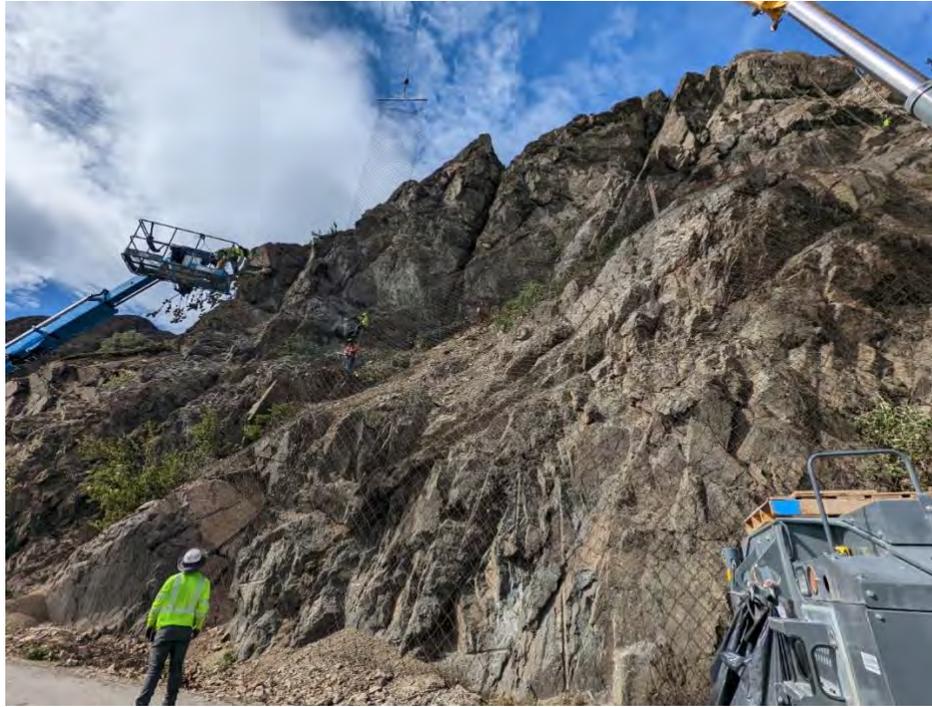
**Figure 8: Attenuator net panel installation with the assistance of a crane and rope access crews.**

Rockfall attenuators were installed at Sites 1 through 3, Site 5, and Site 7. Rockfall attenuators consist of cable net panels attached to top support cables that are suspended off of the slope by steel posts. The cable net panels consist of GeoBrugg® Rolled Cable Nets with DELTAX G80-2mm high-tensile strength wire mesh backing. All rockfall attenuators were constructed with 1-inch diameter top support rope. Top support rope lengths were limited to 160 feet with maximum 40-foot spans between posts at most locations. Top rope diameter was increased to 1-inch to accommodate spans of up to 70 feet across active debris shoots. Attenuators were constructed using either 12-foot-tall or 18-foot-tall steel posts. Attenuator net panels were hung with the assistance of a crane or by helicopter and rope access crews, as shown in Figure 8. The total area of attenuator installed across the project area exceeds 41,000 square yards.

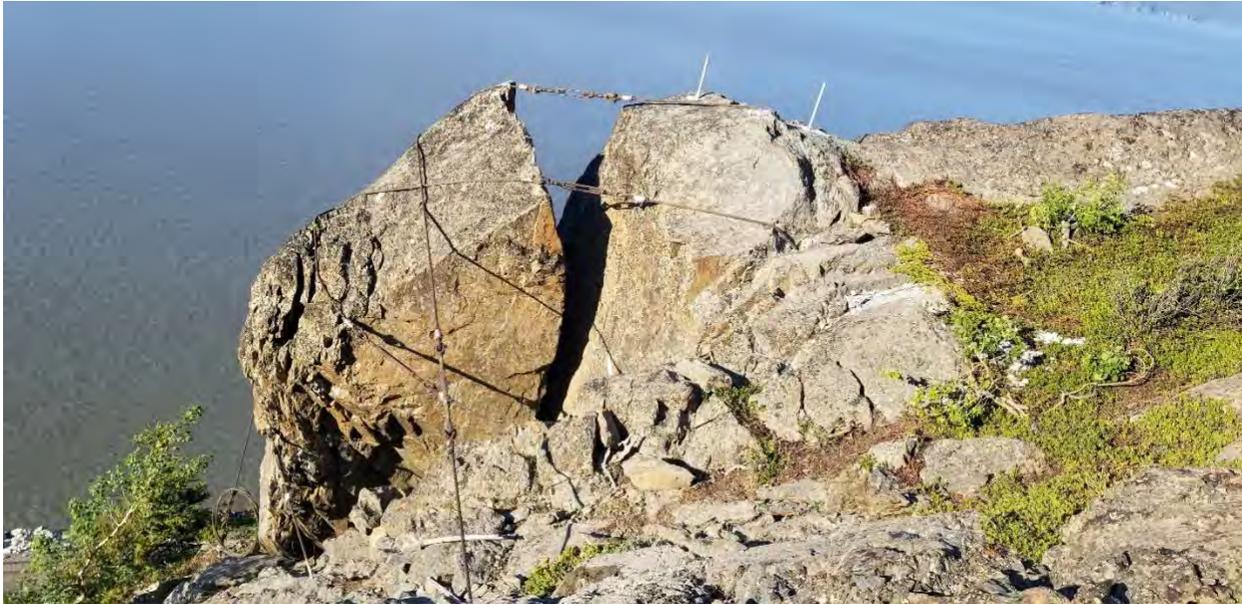
Five cable lashings were installed at Site 2 to stabilize a large rock block above the crest of the slope at the south end of the site. Cable lashings consist of two wire rope anchors connected by a section of wire rope and turnbuckle to tighten the system. Holes for the wire rope anchors were drilled by hand to depths of 6 feet in competent rock. Turnbuckles were tightened to remove slack from the system and provide tension to each cable lashing against the rock block. Completed cable lashing at Site 2 is shown in Figure 9.

**Figure 9: Cable lashings for a large rock block at Site 2, MP 109.4.**

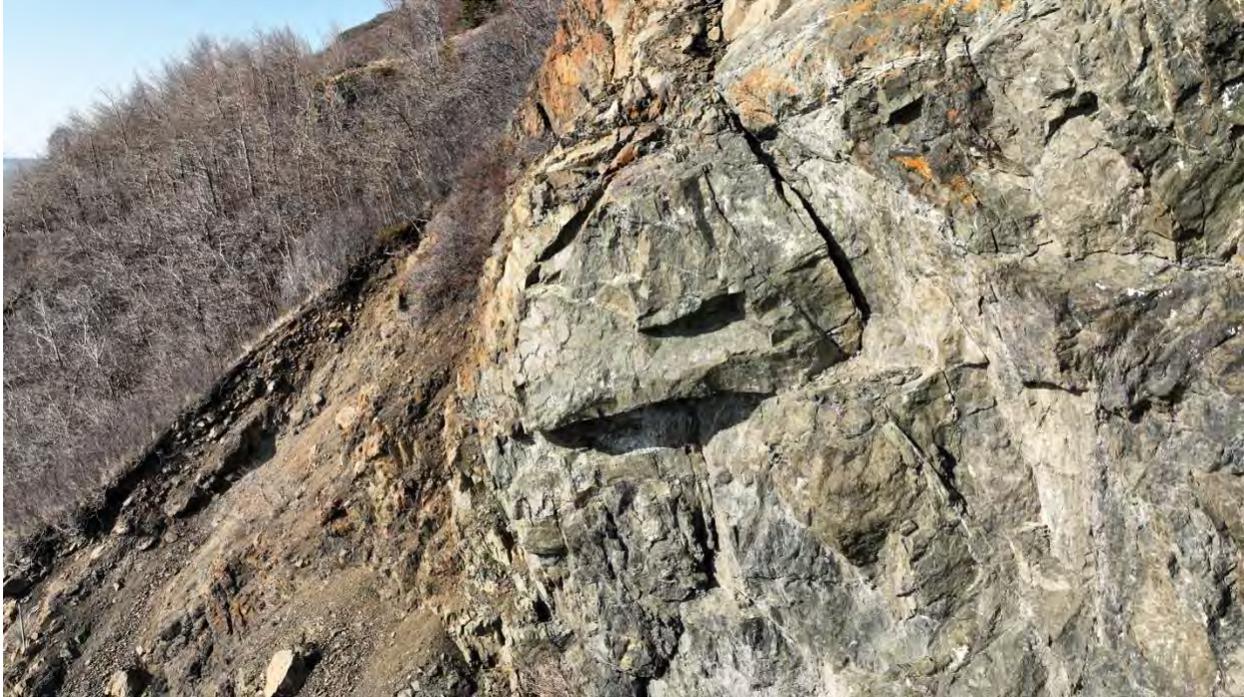
A large rock block found at Site 7 (MP 113.9) was about 25 feet by 15 feet by 16 feet in size and is shown in Figure 10. The bottom of the rock block had a prominent overhang of about 20 feet in length and up to 7 feet in depth. The rock block was bounded on the climber's right side by a continuous fracture with an aperture of up to 1-foot and climber's left side by hairline fractures. Several prominent discontinuous fractures were present within the rock block as well. This rock block was originally designated for removal (i.e., heavy scaling); however, the contractor proposed the block be considered for reinforcement.

**Figure 10: Large Rock Block at Site 7.**

LT developed a reinforcement approach based on 3D-modelling of the rock block and surrounding slopes, and multiple stability models. Designs considered static stabilization as well as during an approximate 975-year (5% in 50 years) seismic event. A sequencing work plan was developed to limit exposure of personnel to potential failure of the rock block during construction. Sequencing initially included scaling of the slopes above and surrounding the rock block. Next reinforcement three, 40-kip rock bolts were installed from the backside (i.e., climber's left) of the rock block towards the front (i.e., climber's right). Care was taken to ensure that the reinforcement holes did not daylight through the front of the block. Long-term stability of the rock block was addressed by installing eight 40-kip foundation rock bolts at the base of the block to support the weight of the rock block. Lastly, six 80-kip stabilization rock bolts were installed from the front of the rock block back into the slope. Care was taken to ensure that the reinforcement rock bolts were not impacted during drilling activities for the stabilization bolts, as based on 3D models.

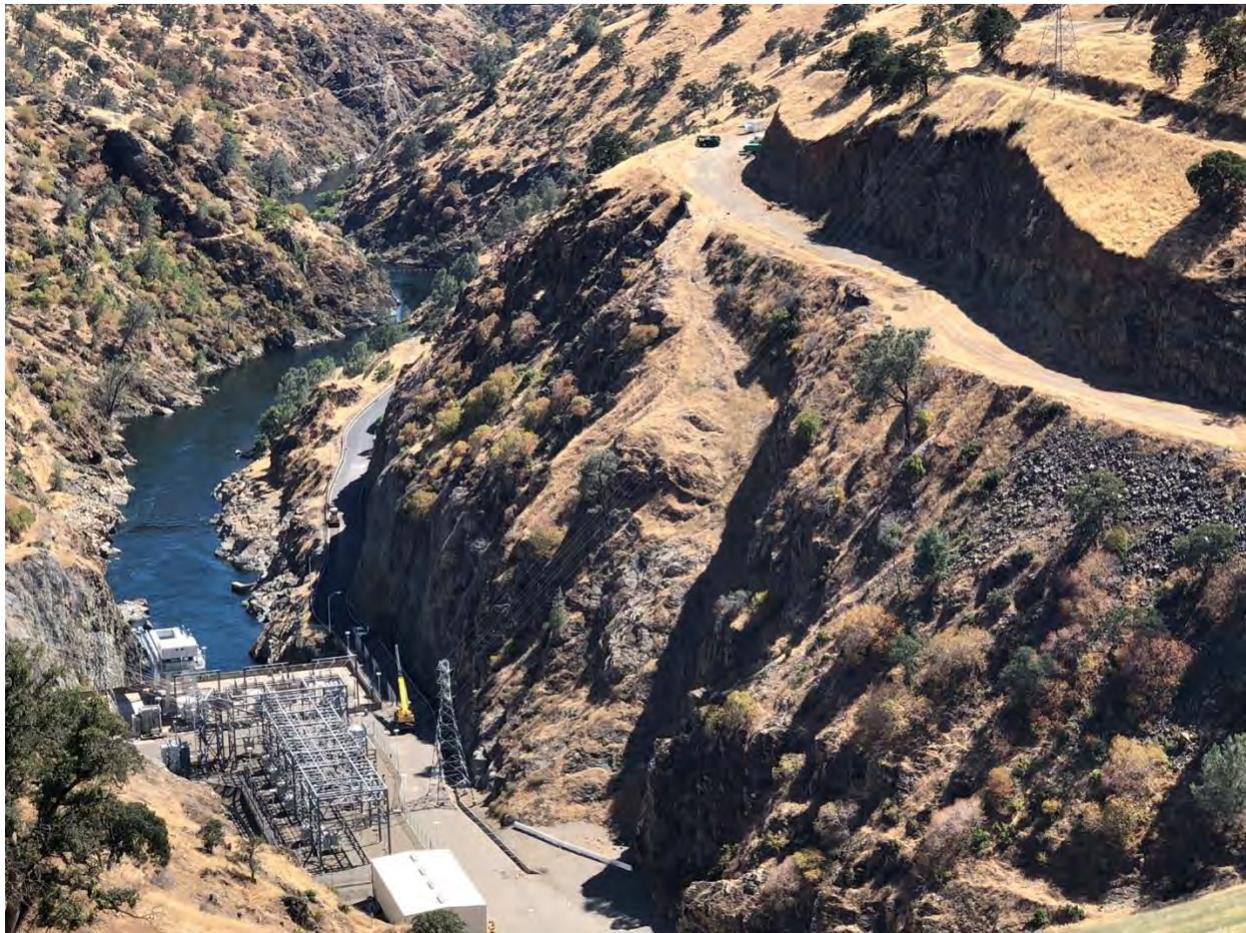
**Exhibit 1 - West Slope Above Don Pedro Powerhouse And Access Road**

Don Pedro Dam is located on the Tuolumne River in central California. Don Pedro Dam is an approximately 580-foot-tall zoned embankment dam that was completed in 1971. The dam is part of the Don Pedro Project, which is jointly owned by TID and Modesto Irrigation District (MID). A 203 MW hydroelectric facility is situated at the downstream toe of the dam and is operated by TID. The powerhouse facilities, which include a switchyard, warehouse, tunnel portal and access road, are located at the bottom of steep natural and excavated rocky slopes capable of producing significant rockfall (Exhibit 1).

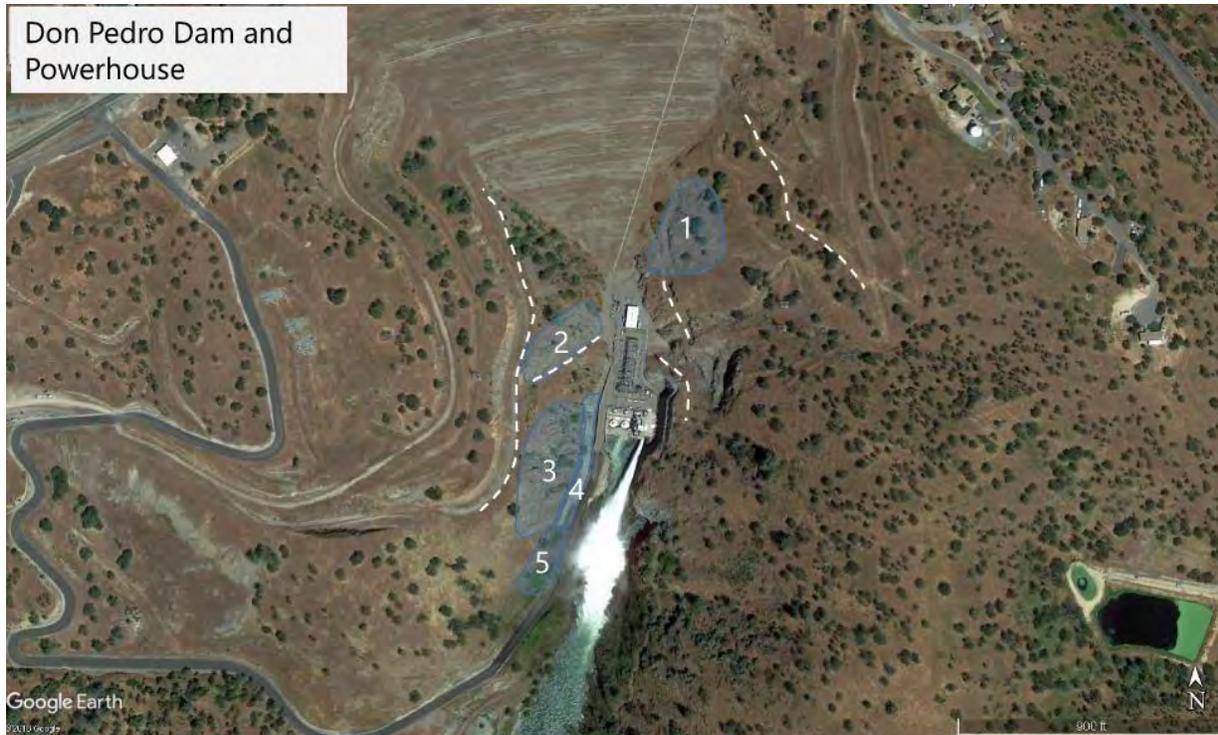
Five areas of concern were identified based on the visual assessment, which are shown in Exhibit 2 below. For each area, we qualitatively assessed the source of rockfall hazards, probability of rockfall initiation, consequences of rockfall, and potential mitigation actions and their costs.

**Exhibit 2 - Google Earth Satellite View Of The Don Pedro Powerhouse And Five Slope Areas Of Concern. Slope Breaks Are Indicated With Dashed White Lines. Imagery: Google Earth 7.0, (2018) *Don Pedro Powerhouse 37.7°N, 120.4°W, Elevation 250 Feet.* [Online] Available At [Earth.Google.Com](http://Earth.Google.Com) [Accessed 2023].**

The highest hazard area was designated as Area 3 and is located on the west canyon slope above the powerhouse and extended from the powerhouse about 500 feet downstream. Area 3 is comprised of natural slopes above the steeper, mesh-covered cut slope face, which is referred to as Area 4. The sole access road to the facility runs directly below Area 3. Numerous large blocks within Area 3 appeared at risk of destabilizing and potentially impacting the powerhouse and/or the access road.

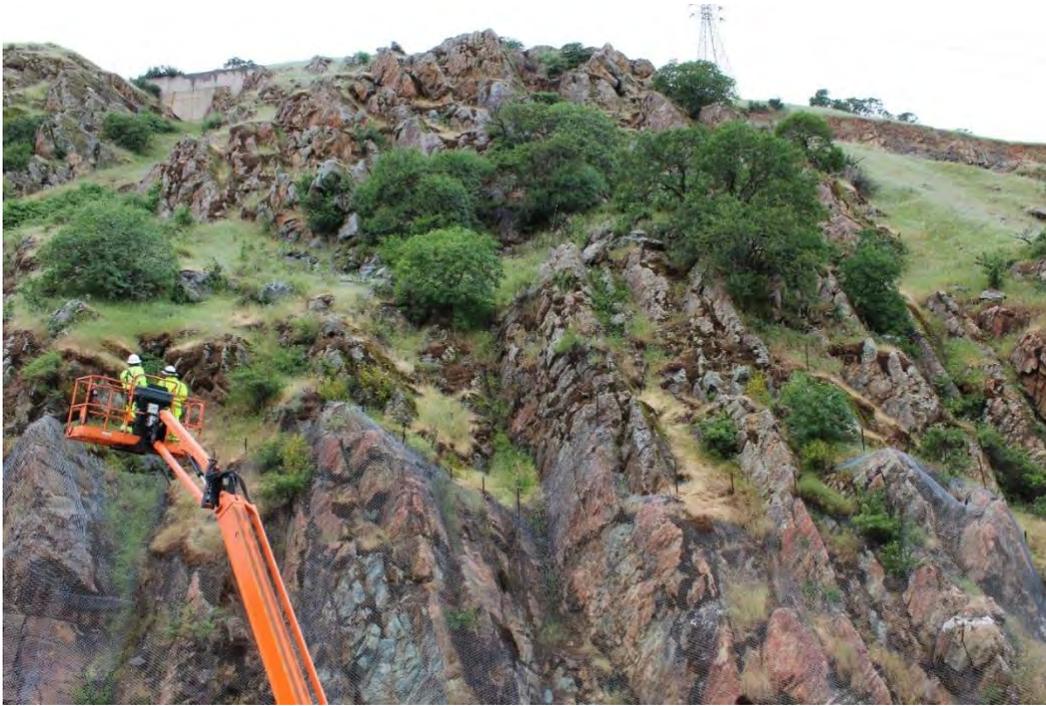
**Exhibit 3 - Area 3 Slope Reconnaissance Using Aerial Lifts**

The overall slope inclination of Area 3 is approximately 1V:1H. The slope surface is irregular, featuring numerous prominent rock outcrops and areas of colluvium and sporadic vegetation where the slope gradient is less steep. The rock outcrops are moderately (0.5 to 1.0-foot fracture spacing) to occasionally fractured (1 to 4-foot fracture spacing). Vegetation includes grasses, shrubs, and small trees. Many of the obstructions along the slope (trees, outcrops, lagging) have acted as catchments, accumulating rockfall debris (up to 6 feet in the longest dimension, although typically less than 1 foot) behind them.

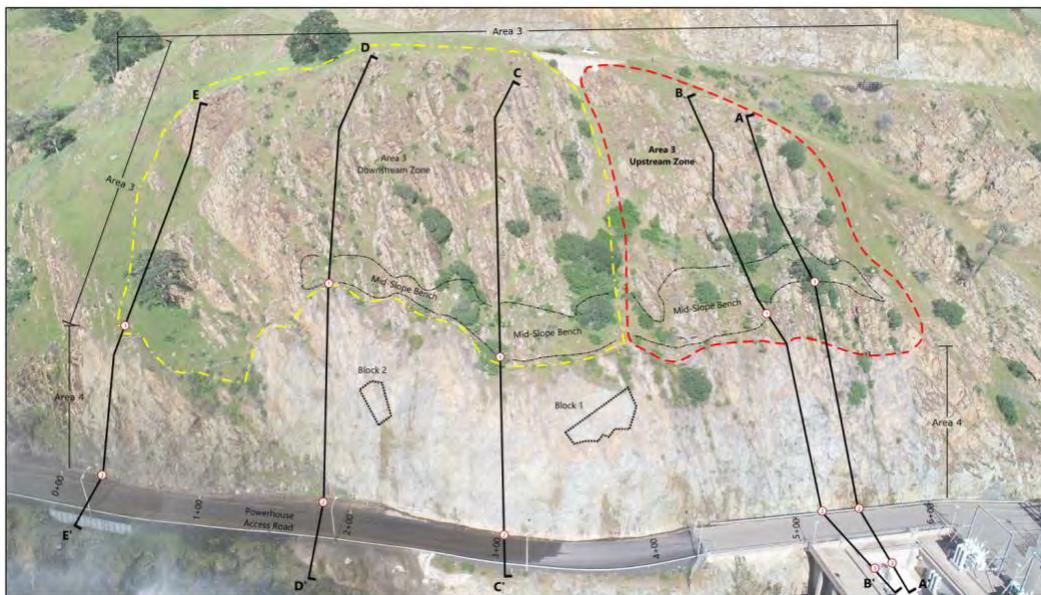
It is useful for the discussion of hazard, consequence, and mitigation alternatives to consider Area 3 as comprising an upstream zone and a downstream zone, divided by a prominent topographic swale. The Area 3 Upstream (U/S) Zone had rockfall runout paths that may have impacted the access road and powerhouse, while rockfall from the Area 3 Downstream (D/S) Zone would likely impact only the access road (as indicated on Exhibit 4).

**Exhibit 4 - Area 3 Aerial Photo With Rockfall Cross-Sections Indicated And Upstream Zone (Outlined In Red), And Downstream Zone (Outlined In Yellow)**

Area 3 encompasses the portion of the slope that begins directly above the powerhouse and extends approximately 500 feet downstream (Exhibit 4). This area is comprised of natural slopes and is vertically bounded by the prominent construction road bench above it (approximately 280 feet above the powerhouse access road) and the steeper, mesh-covered cut slope face below it (Area 4; approximately 100 feet above the powerhouse access road). There is a 75-foot-long cast-in-place concrete retaining wall near the center of Area 3 that supports the construction road bench (visible in the top left of Exhibit 3). Area 3 includes a talus-covered mid-slope bench that is approximately 30- to 40-feet wide at the upstream end (near the dam face) and narrows to 15- to 20-feet wide as it progresses downstream.

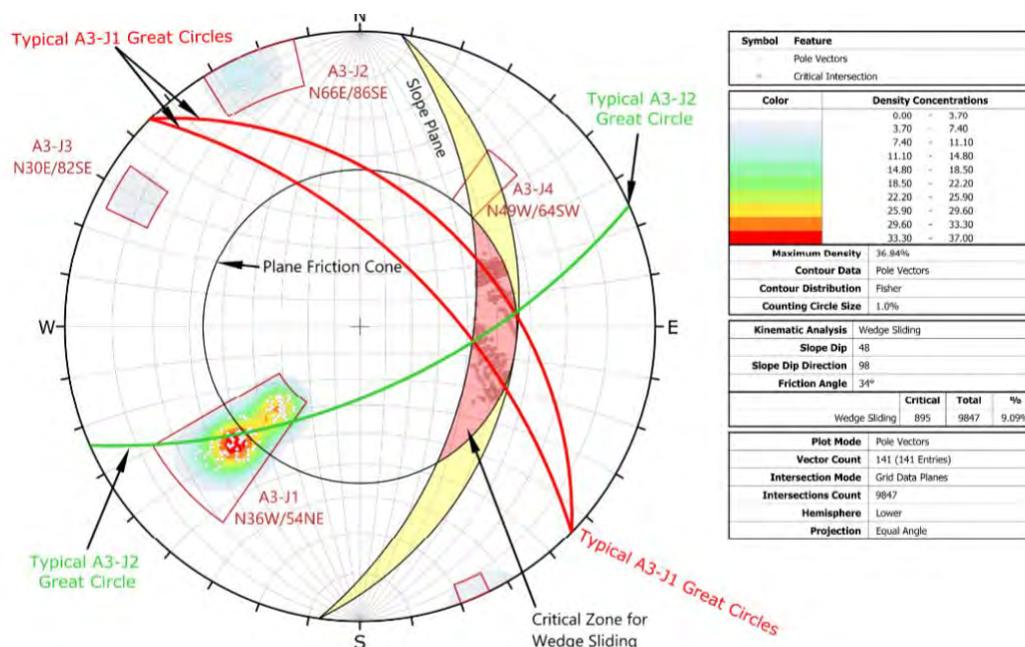
Kinematic analyses were performed to determine the susceptibility of the slope to various rockfall failure modes given the slope geometry and joint orientations. Kinematic analyses considered planar sliding with a 20° lateral limit, wedge sliding, direct toppling, and flexural toppling. Based on field observations, a friction angle of 34° was selected for evaluating planar and wedge sliding failures. The analyses indicated that the most likely rockfall failure mode was wedge sliding, which was consistent with the numerous wedge-shaped rock casts visually observed within the slope. The stereonet below (Exhibit 5) indicates that the observed joints on the slope may have interactions conducive to wedge failures.

**Exhibit 5 - Stereonet Representation Of The Kinematic Assessment For Wedge Sliding. Interactions Between Joint Sets J1 And J2 Are Capable Of Producing Wedge Failures.**

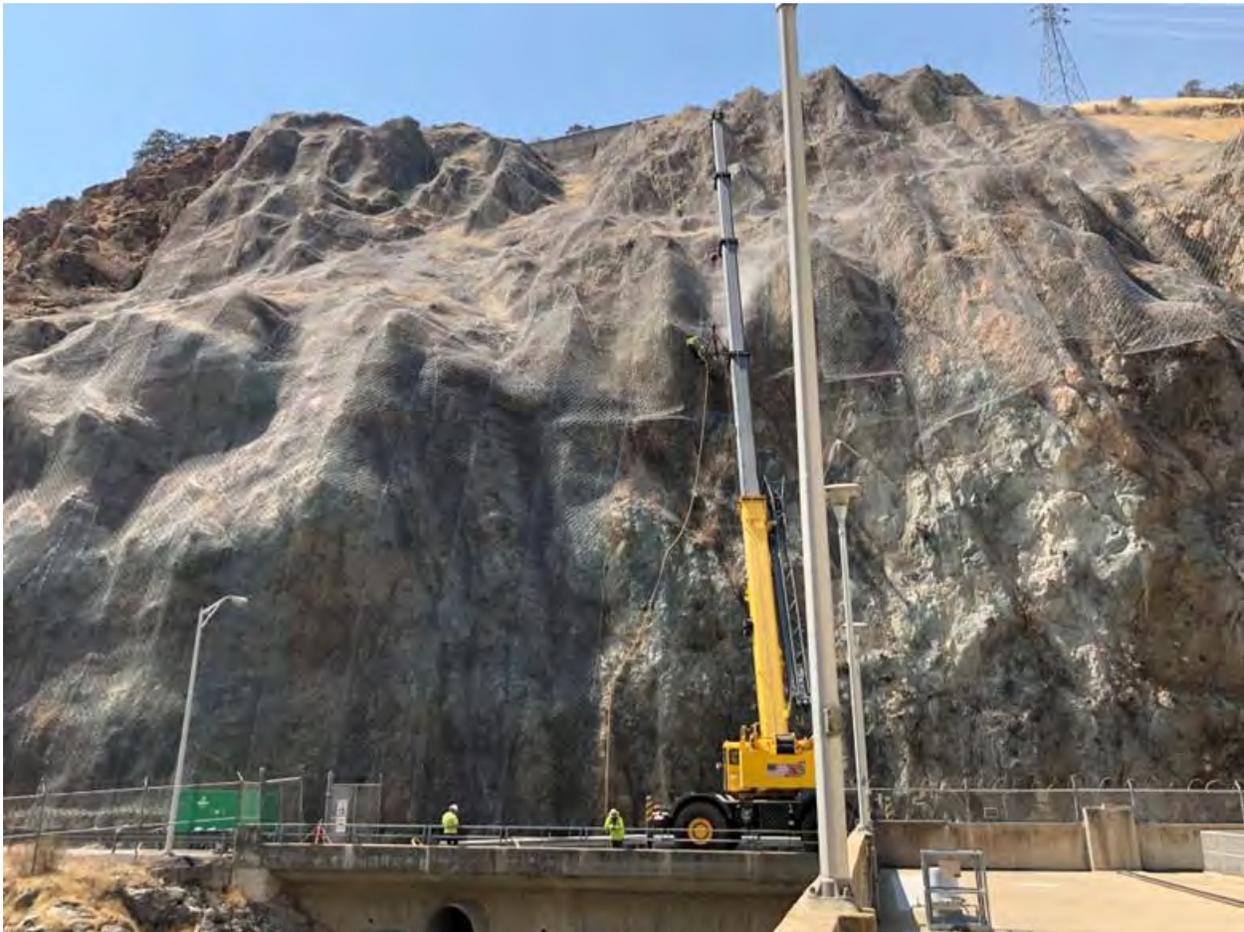
As mentioned above, TID authorized installation of additional rockfall drapery in the Area 3 Downstream Zone in order to reduce the rockfall hazard to the powerhouse from rock blocks originating from the slope downstream of the powerhouse. Gannett Fleming issued exhibits to TID and ALC depicting the layout of the downstream rockfall drapery, which continued from the terminus of the upstream drapery to approximately 200 feet downstream of the powerhouse, and vertically from the slope break below the upper access bench down to the powerhouse access road (Exhibit 6).

**Exhibit 6 - Area 3 Slope After Installation Of Rockfall Drapery**

wagon-mounted drill. Competent bedrock was generally observed at the ground surface or within 1 to 2 feet below ground surface. Grout was batched onsite and tremied into the bottom of the drill holes. The drapery panels were primarily installed by helicopter on the upper portions of the slope, and by crane at the bottom of the slope (Exhibit 6).

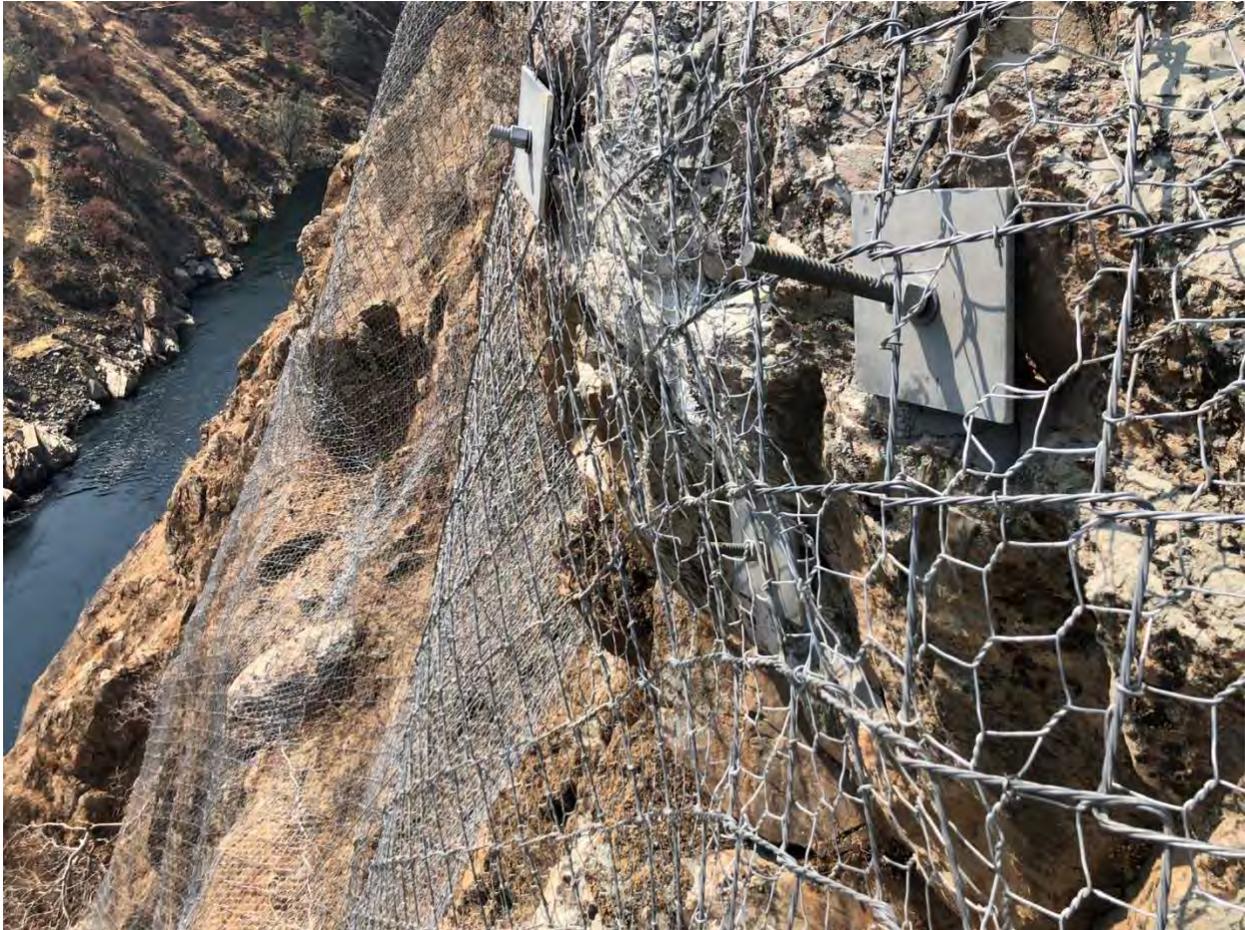
Gannett Fleming worked closely with ALC during construction in order to identify potentially unstable rock blocks that required in-place stabilization using rock anchors. Based on our observations, we identified four (4) rock blocks requiring rock anchors. We performed engineering analyses to determine the number of rock anchors required to stabilize each rock block and presented exhibits depicting the number and layout of anchors for review and approval by TID. Typical rock anchors are shown in Exhibit 8 below.

**Exhibit 8 - Rockfall Drapery Consisting Of Rolled Cable Net With Double-Twist Mesh Backing. Select Rock Blocks Were Stabilized With Rock Anchors**

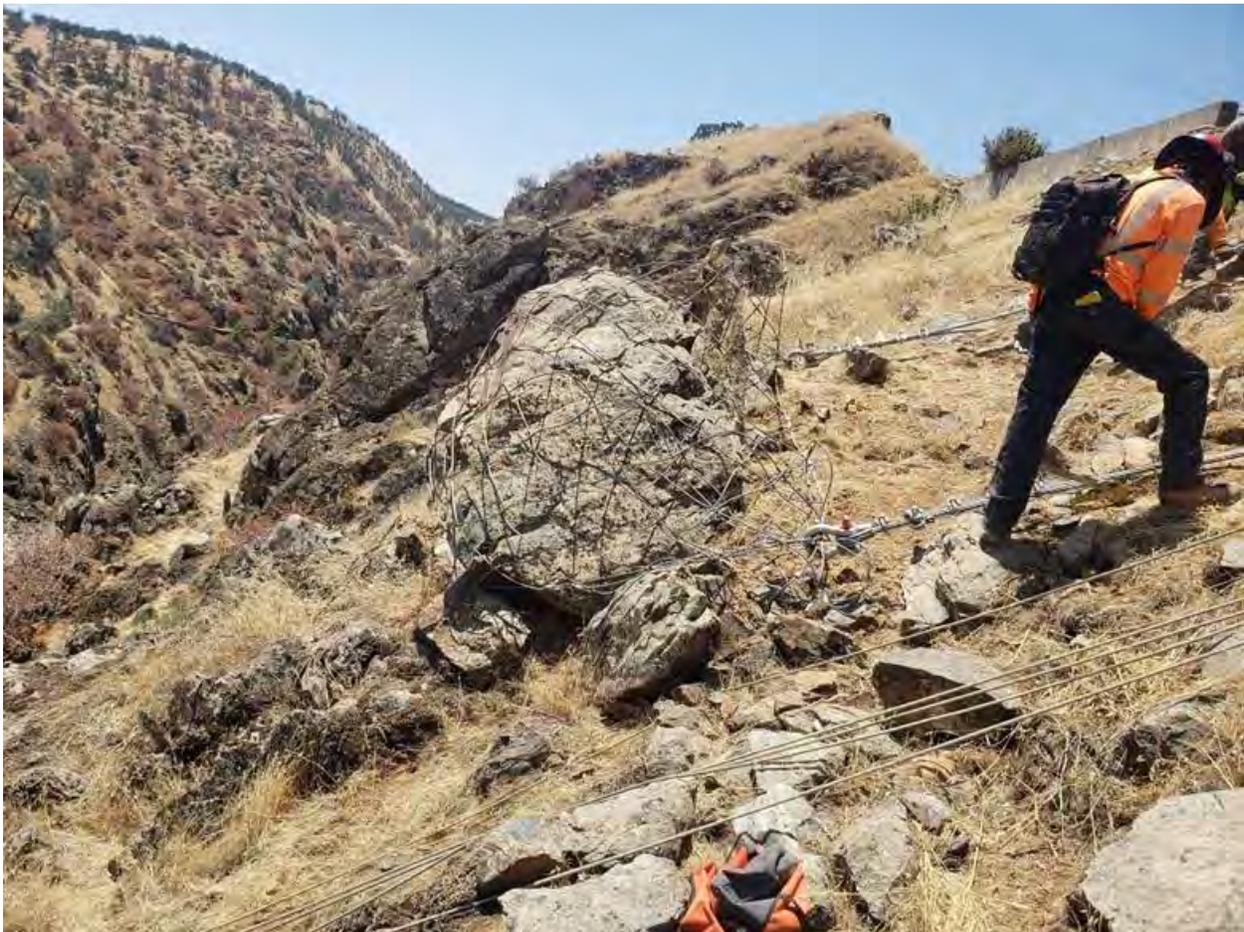
Gannett Fleming and ALC identified two large rock blocks in the Area 3 upstream zone that required in-place stabilization utilizing wire rope restraint systems. Based on their size and orientation rock anchors could not be safely installed to stabilize the rock blocks. ALC and Gannett Fleming performed layout of the six upslope wire rope anchors and two downslope anchors for each rock block, which were drilled using a 3-inch or 4-inch diameter wagon-mounted drill. Additionally, a third rock block was stabilized using a modified wire rope restraint system comprising a rockfall drapery panel supported by two upslope wire rope anchors (Exhibit 9). ALC performed proof testing of two support wire rope anchors, which performed satisfactorily.

**Exhibit 9 – A Modified Wire Rope Restraint System, Consisting Of A Rockfall Drapery Panel And Wire Rope Anchors**

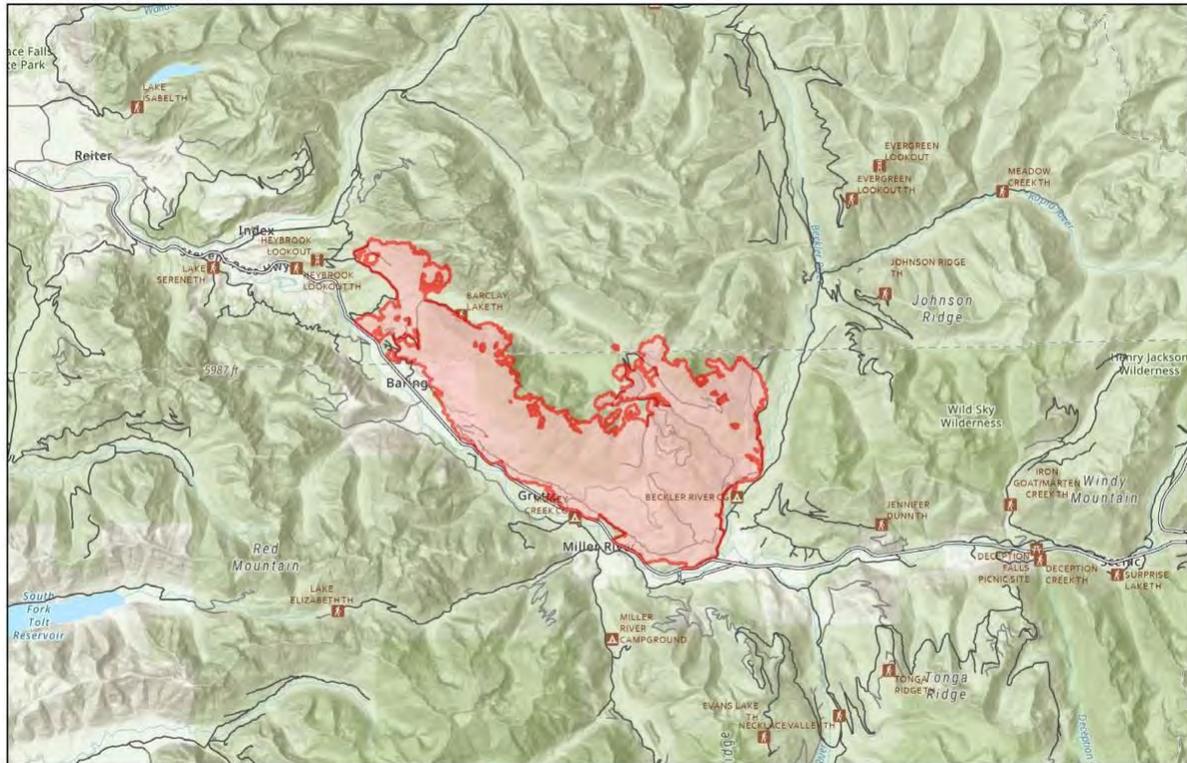
The Bolt Creek Fire began on September 10, 2022, was determined to have been caused by humans, and burned approximately 14,900 acres before it was contained in October 2022. The burned area is north of US 2 on the border of King and Snohomish Counties and burned from the highway upslope to the crest of Klinger Ridge, Baring Mountain, and Grotto Mountain (Figure 1).

**Figure 1. Map of Bolt Creek Fire burned area north of US 2 as of October 19, 2022 (1).**

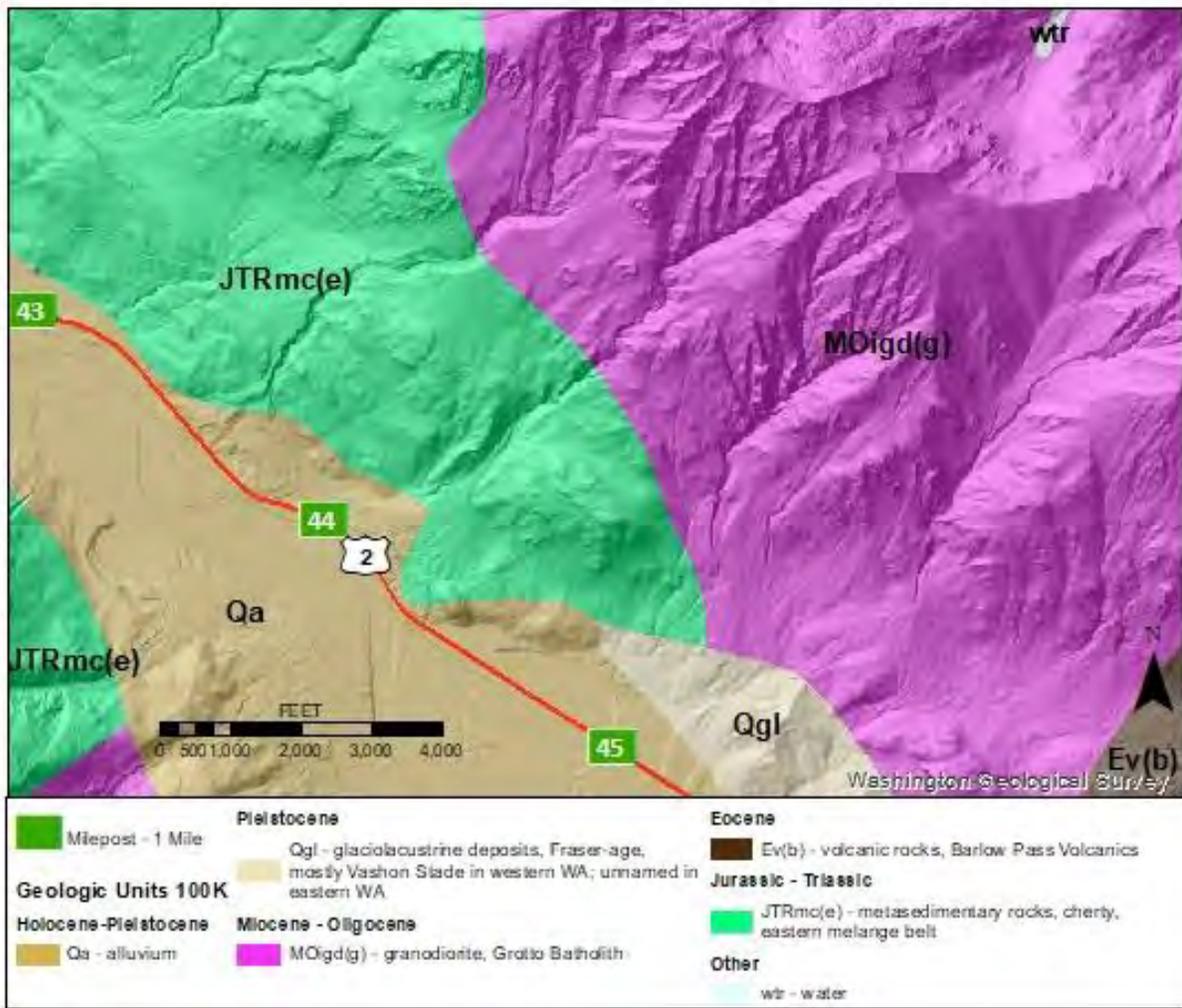
The regional geology of the central Cascades is a mix of core bedrock composed of sedimentary, metamorphic, and igneous rock, with Quaternary deposits and alluvial soils deposited over the underlying core bedrock (Figure 2).

**Figure 2. Surface geology (1) near the site vicinity of the Bolt Creek Fire on US 2 MP 43 to 45. Lidar derived from WGS (2).**

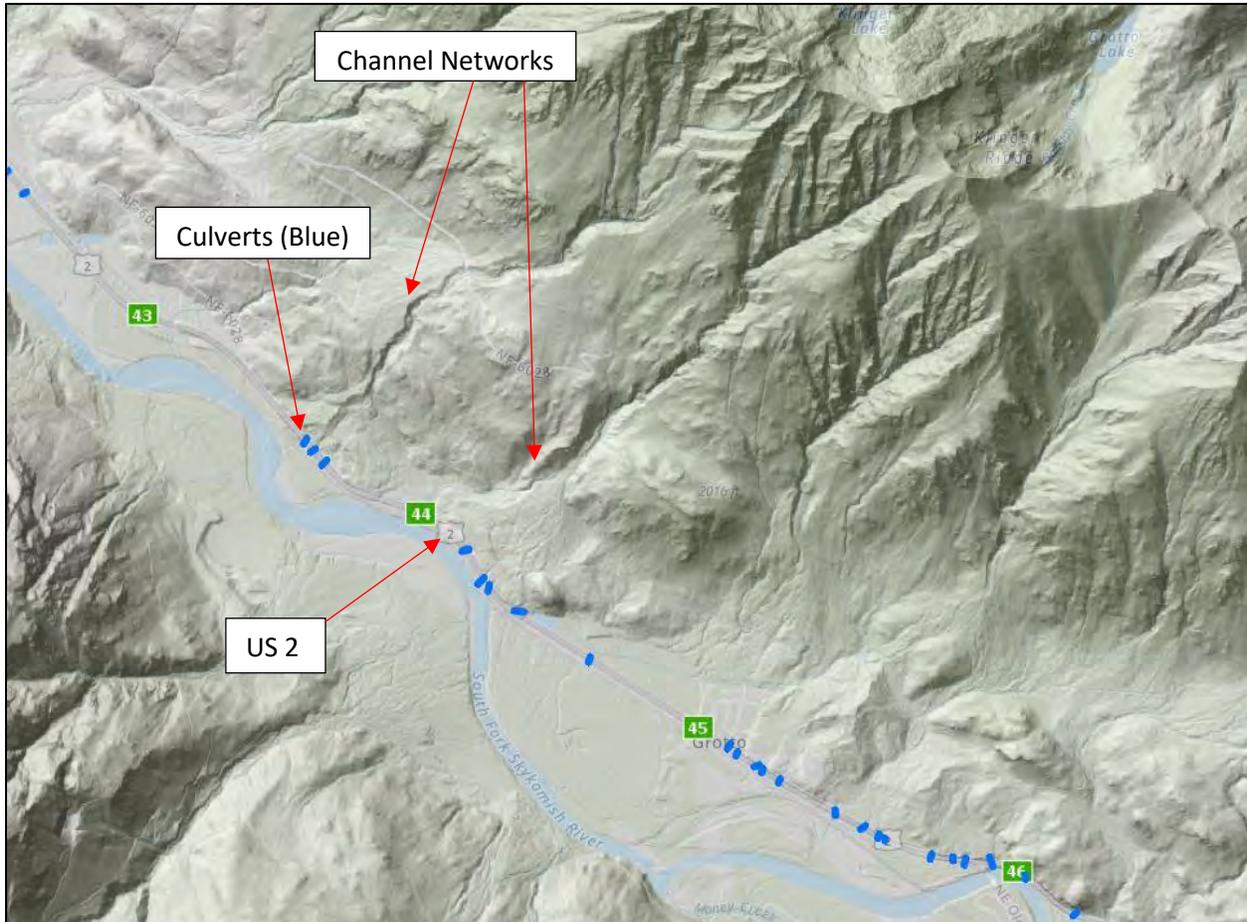
In the lower flanks of the SF Skykomish River valley, there are several series of active and apparently relict channel networks incised into alluvial soils. The incised channel networks connect to rills and gullies that appear to extend to the crest of the slopes between Baring Mountain and Grotto Mountain (Figure 3). Primary sources of water appear to be from seasonal snowmelt, and springs of groundwater that appear to produce flow both seasonally and (in some locations) throughout the year. The Bolt Creek Fire drainage network leads either directly into tributaries to the SF Skykomish River, wetlands adjacent to US 2, or directly under US 2 in culverts, eventually discharging into the SF Skykomish River. Directly adjacent and below the highway are a series of flood plains and wetlands of the SF Skykomish River that appear to provide proximal basins connecting to the channel networks. US 2 appears to be approximately 20 to 30 feet above the SF Skykomish River on average.

**Figure 3. Lidar image showing terrain, geomorphic features, and culverts in the vicinity of the site location. Lidar derived from WGS (2).**
