# 72<sup>nd</sup> Highway Geology Symposium

## 2023 PROCEEDINGS

August 14-17, 2023 • Hotel Murano • Tacoma, Washington

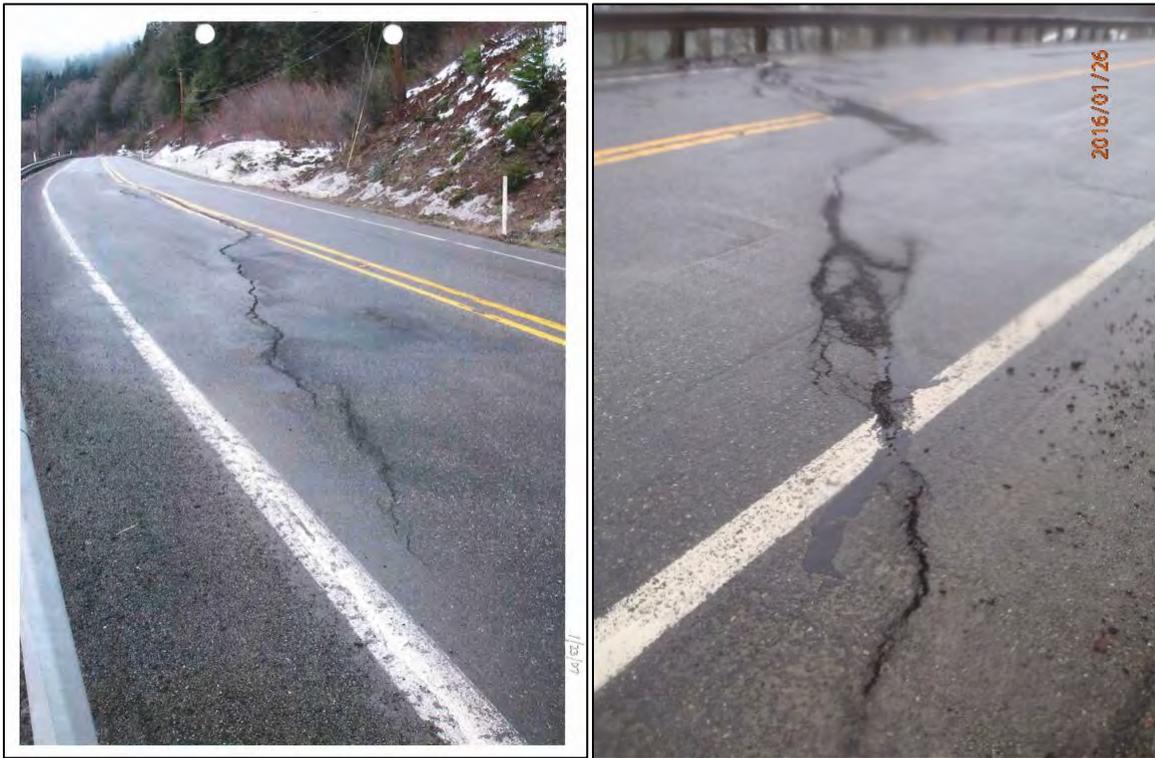
In our USMS, we found an active landslide within a primary point of interest in the Bolt Creek Fire burned area. The landslide spans from US 2 MP 44.20 to 44.31 and has been previously characterized as active, large, deep seated, and slow moving, with monitored movements up to 0.5 inches per year according to readings from our installed instrumentation. The landslide headscarp is located upslope of US 2 and the landslide has caused roadway deformation several times over the years and as recently as January of 2016 (Figure 4).

**Figure 4. Roadway deformation caused by the landslide on US 2 MP 44.2. Image on the left is from January 2007, image on the right is from January of 2016.**

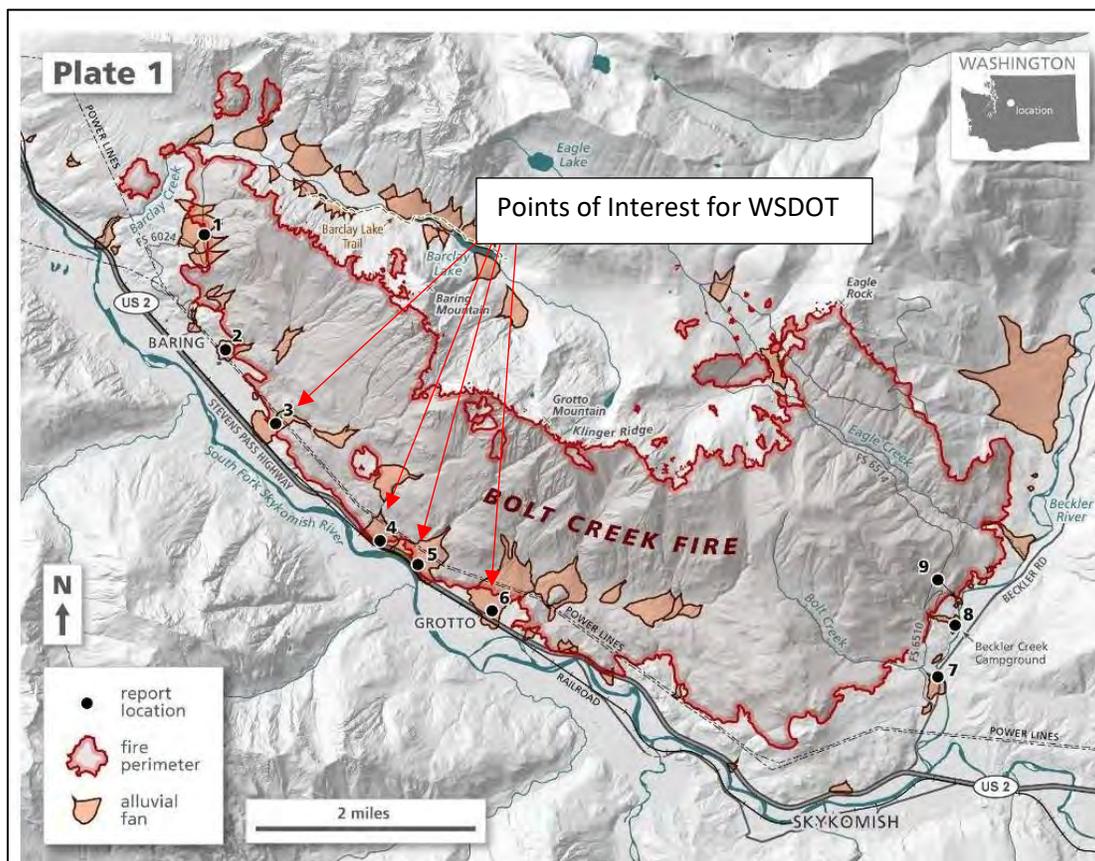
During the WGS study (2), they compiled a plate of points along the Bolt Creek Fire burned area in which they had mapped alluvial fans and provided the corresponding modeled hazard rating in the area. The WGS plate of points highlighted 9 areas within the Bolt Creek Fire burned area in which there was an elevated risk for flash flooding and debris flows. Among the 9 areas that WGS identified with an elevated risk for flash flooding, 5 of the points and mapped alluvial fans were adjacent to or directly intersected US 2 between mileposts 40 and 50 (Figure 4). After receiving the WALERT report from WGS (2), we mobilized to conduct field reconnaissance of the 5 sites along US 2 identified by the WGS. The 5 sites along US 2 that we visited coincided with points 3 through 6 from Plate 1 in the WALERT report produced by the WGS (2) (Figure 6).

**Figure 6. Points of interest for WSDOT based on WALERT report produced by the WGS (2). Imaged modified from WGS (2).**

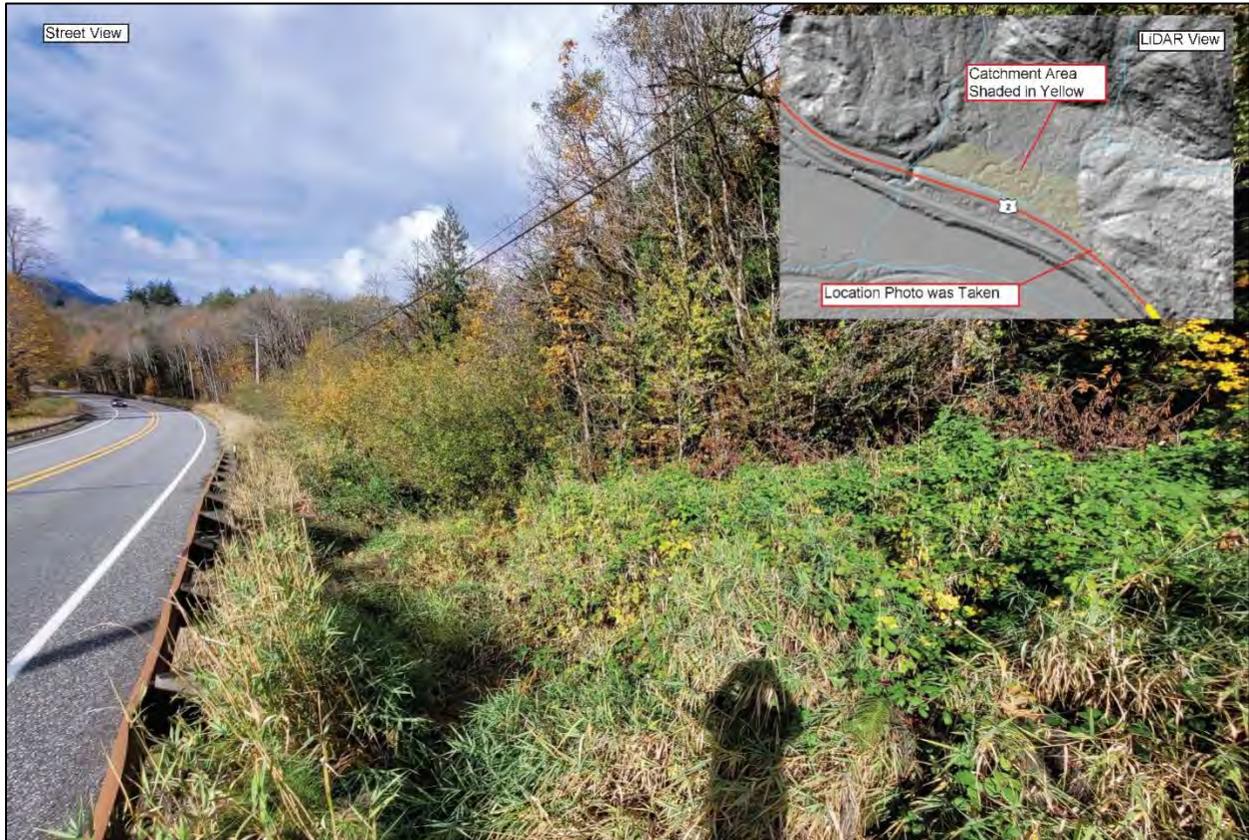
During our field reconnaissance, we walked each site, took photographs, mapped relevant geologic features using a handheld GPS unit, and took measurements of stream channels and drainage basins to characterize the catchment at each site (Figure 7).

**Figure 7. Field photo of catchment area taken during initial site reconnaissance and catchment assessment.**

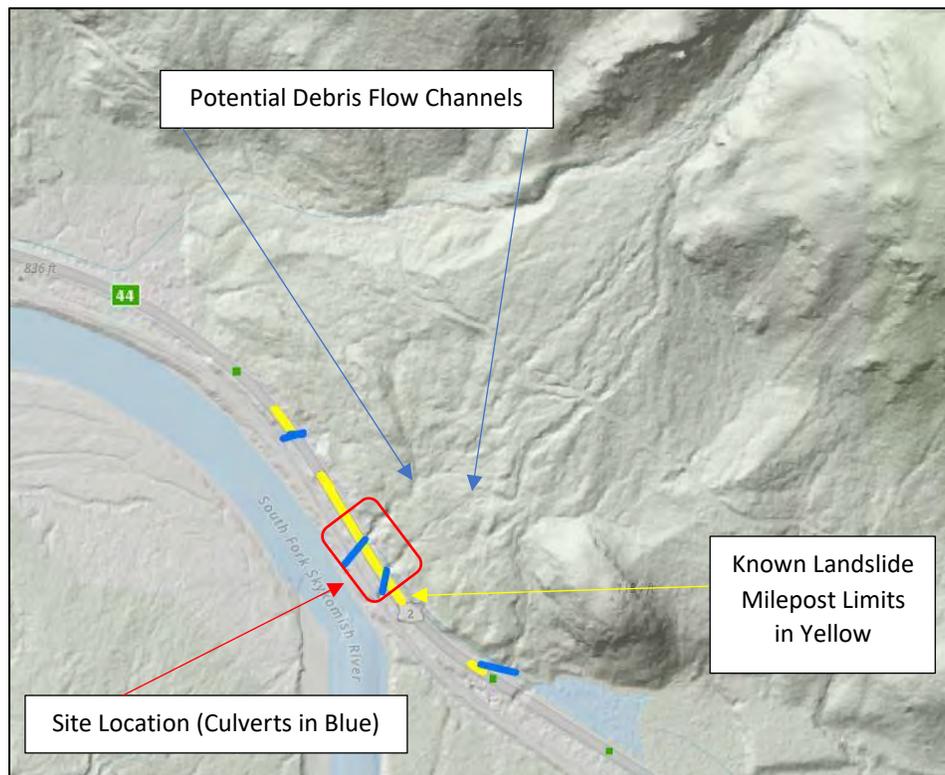
Our risk assessment determined that out of all the points identified by WGS (2) with a high debris flow risk, there was one area in which there was insufficient catchment to accommodate potential debris flows. The area with the lowest amount of catchment was identified at a location within point 5 of Plate 1 from the WGS report (2) at milepost 44.25 along US 2 (Figure 8).

**Figure 8. Location along US 2 with highest risk of debris flows reaching the roadway.**

**Lidar derived from WGS (2).**

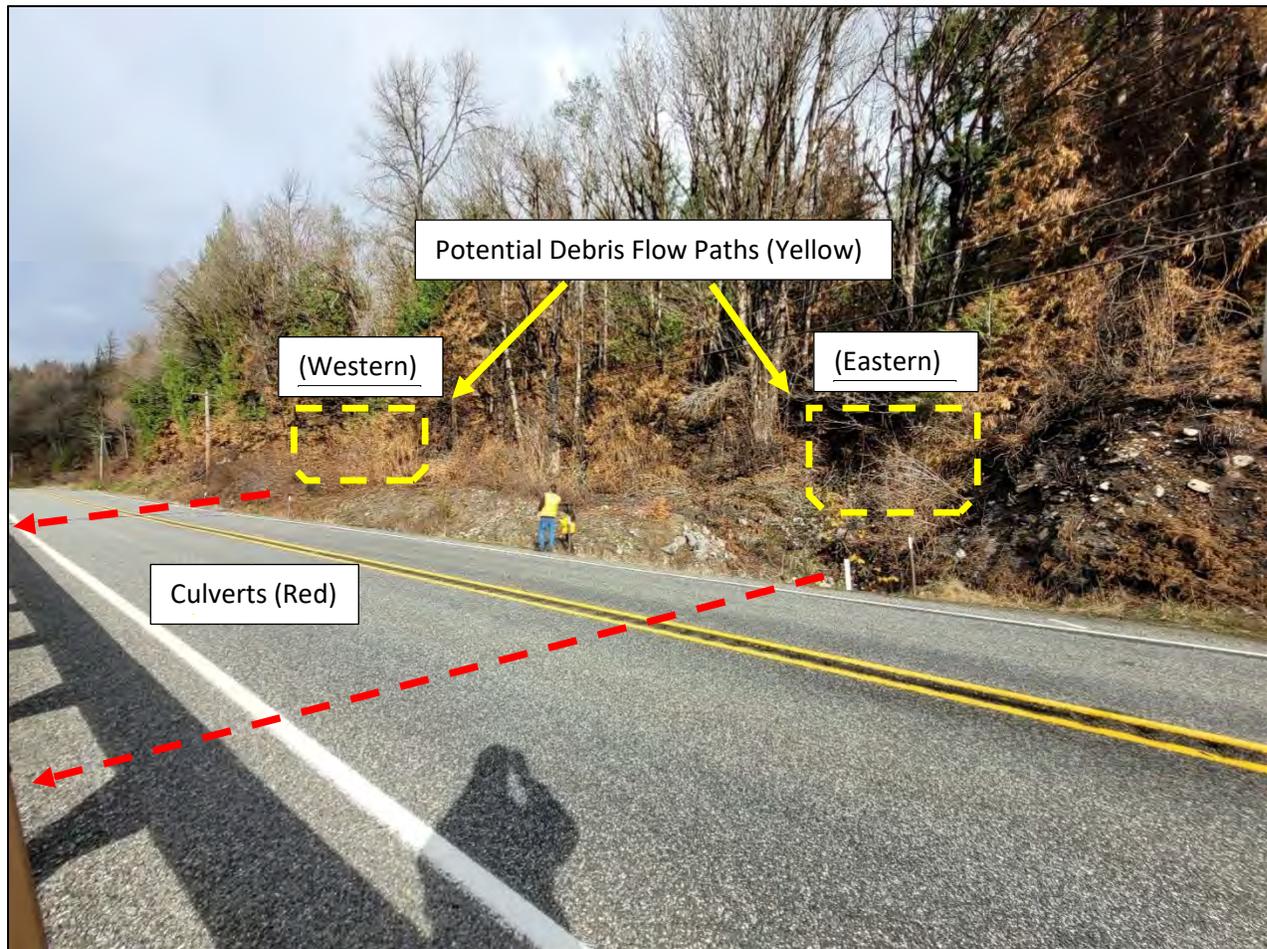
While we had not historically observed debris flows at this location, the mapped alluvial fan from WGS (2) is indicative that past debris flows at this location have occurred. We observed that should a debris flow occur at this location and follow the existing stream channel; it would likely reach a set of two culverts (Western and Eastern) that were installed underneath US 2 near milepost 44.25 (Figure 9).

**Figure 9. US 2 MP 44.25 culverts and potential debris flow path locations with the highest risk identified during our initial site reconnaissance and catchment evaluation. Red dashed arrows indicate culverts and their flow direction.**

Any significant volume of debris traveling down either the western or eastern channel at this location would likely overwhelm the culverts, and directly impact the highway. Additionally, the culverts at this location are within the limits of the landslide that has historically caused roadway deformation at MP 44.2. With the highest risk area for debris flows

After our initial site reconnaissance and geotechnical recommendations provided in November 2022, a single event occurred at the location of the previously identified eastern culvert (Figures 9, 10). According to Maintenance, on the afternoon of December 24, 2022, a debris flow occurred that blocked the culvert inlet with debris, snow, and ice, causing water to flow overtop US 2 and close the highway from MP 44 to 99, including Stevens Pass. According to WSDOT Maintenance, cleanup efforts removed approximately 70 cubic yards of material from the westbound ditch and area around the culvert inlet. WSDOT Maintenance stated that after they began removing material from the ditch, water eventually made its way back through the culvert, flushing the remaining material out before they finished cleanup operations. Considering WSDOT Maintenance did not reach out to our Geotechnical Office about the event, we received limited information, aside from anecdotes from WSDOT Maintenance and a single photo (Figure 10).

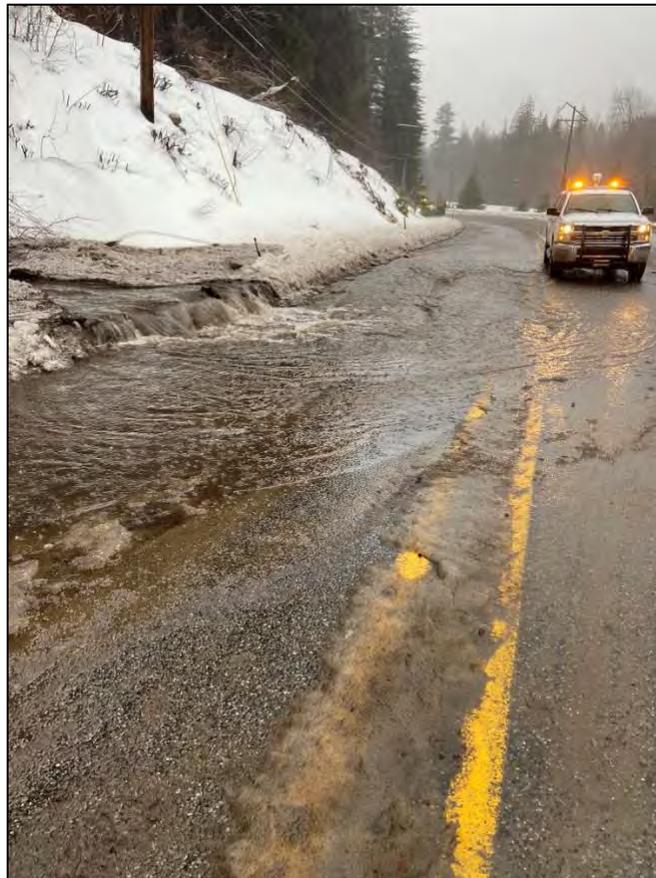
**Figure 10. December 24, 2022, debris flow along US 2 at approximate MP 44.2 that clogged the culvert inlet, causing water to flow over US 2.**

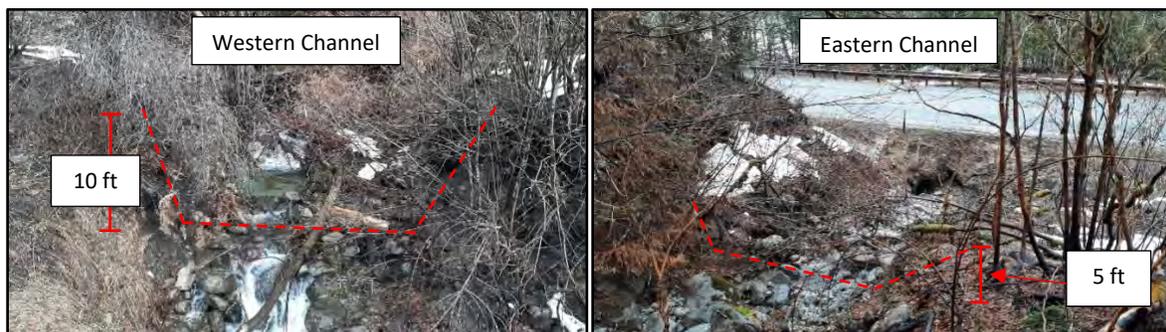
At MP 44.25, the two shallow gradient incised channels exit the slope adjacent to the westbound lane and will potentially serve as debris flow channels. These incised channels create a drainage network that connects to rills and gullies that extend up to the top of the mountain ridge to the north. The west debris flow channel is approximately 45 feet in width, approximately 10 feet in depth, and extends thousands of feet upslope. The east debris flow channel is approximately 25 feet in width, approximately 5 feet in depth, and extends thousands of feet upslope.

**Figure 11. Western and Eastern debris flow channels. Image on left is facing upstream, image on right is facing downstream.**

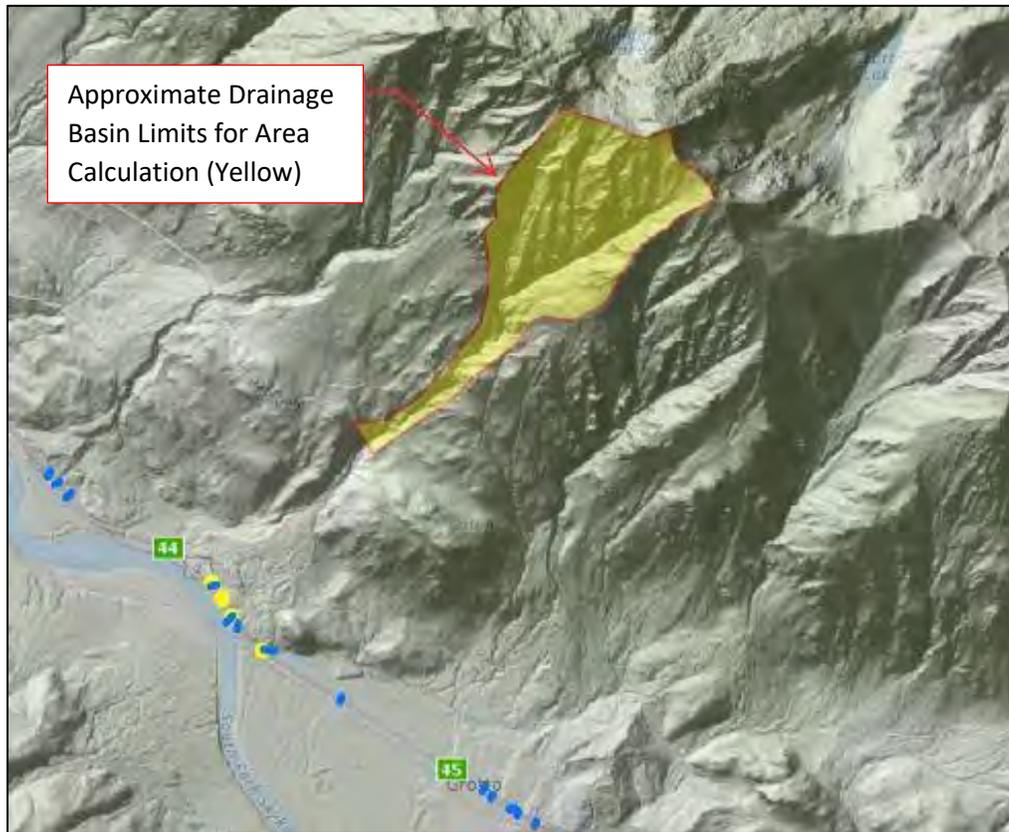
meters)). We calculated the volume based on a surface area estimate of the upstream drainage basin. The upstream drainage basin measures approximately 265 acres in surface area, measured using lidar derived from WGS (2) (Figure 12).

**Figure 12. Image of approximate drainage basin limits used in calculating potential sediment yield in the event of a debris flow. Lidar derived from WGS (2).**

Considering the estimate from the BAER report of 25 tons of sediment available per acre of surface area. This yielded a collective total of 6,625 tons of sediment available for transport through the debris flow channels at this location. Using a density of 120 pcf, we estimate that there are approximately 4,104 cubic yards (3,137 cubic meters) of potential debris flow mass available for entrainment in the upslope drainage basin. If a debris flow occurs in either of the channels at these locations, we estimate that there is less than 100 cubic yards of combined catchment from both channels where the channel meets the culverts under US 2.

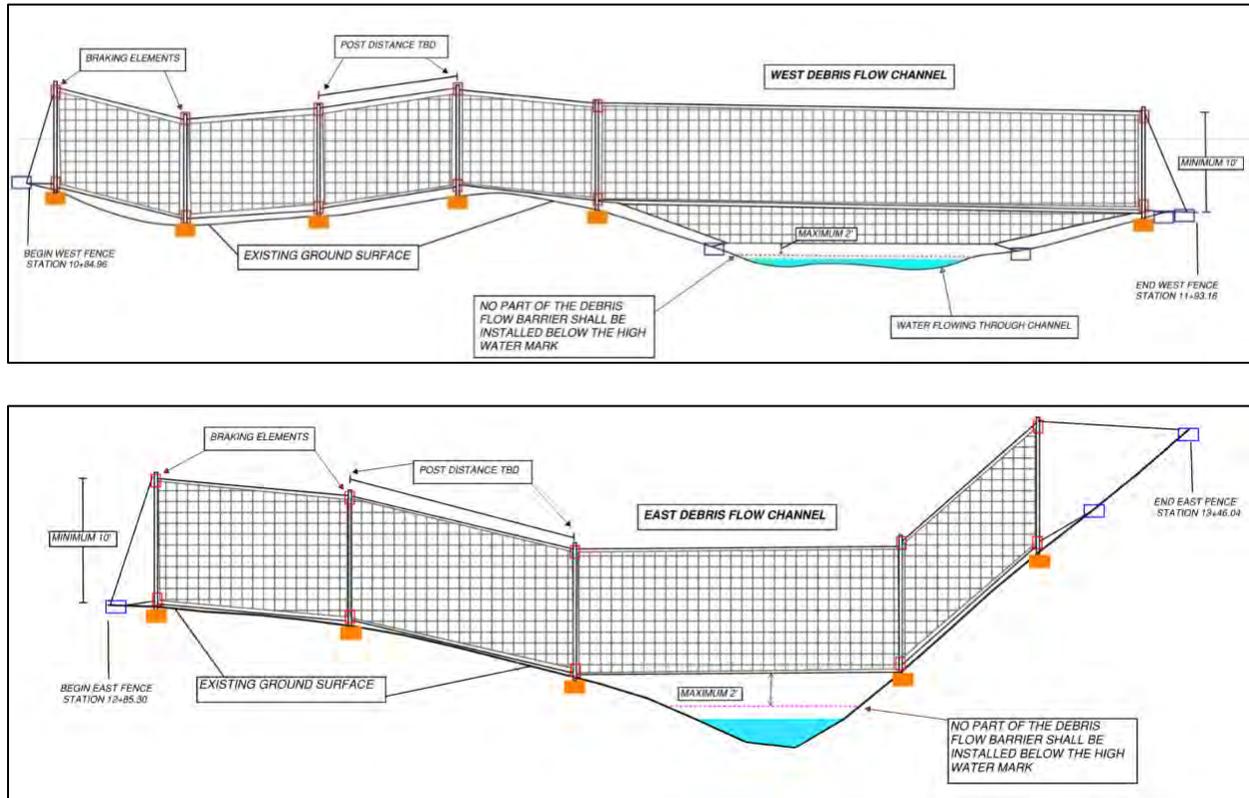
Using the outputs from our analysis, we recommended that post-supported debris flow or shallow landslide barrier systems be installed at the previously identified western and eastern channels at US 2 MP 44.25. We recommended the barriers be installed approximately 50 feet upslope from the US 2 centerline in order to keep the barriers and components within WSDOT right of way. We recommended that each barrier system be able to withstand repeated impact loads of 522 psf ( $25\frac{kN}{m^2}$ ), and static loads up to 1,570 psf ( $75\frac{kN}{m^2}$ ). We recommended a minimum barrier height of 10 feet, a minimum total length of 110 feet for the western barrier system, and a minimum total length of 60 feet for the eastern barrier system. We chose a 10-foot minimum height based on the 10-foot depth of the deeper (western) channel. Based on the potential for debris to spill out of the sides of the channels, we chose barrier lengths that extend well beyond the limits of each channel. Rather than having a single system span the length of both channels, we chose to recommend leaving a space between the barrier systems. We considered having space between the systems essential so that machinery would have access to reach behind the barrier systems for debris removal and maintenance. Approximate layout and dimensions of each barrier system are shown in Figure 13.

We recommended each barrier be constructed of typical flexible debris flow barrier components such as, posts, post foundations, wire rope, ring net or cable, wire mesh, braking elements, and ground anchors. Additionally, we recommended the bottom of the system be within 2 feet of the ordinary high-water mark of the streams at both channels. Due to environmental constraints, no components of the system would be able to be installed within the limits of the ordinary high-water mark of the stream. This included ground anchors and post foundations. In order to accommodate the western channel, we recommended an extension of the barrier system further down into the western channel to within 2 feet of the ordinary high-water mark. Due to the channel depth and geometry, a system spanning overtop of the stream channel would likely miss debris in the event of a debris flow, because the gap below the fence would be too large, allowing debris to pass beneath the barrier. We anticipated not having the same issue in the eastern channel because it is only 5 feet deep.

**Figure 13. West and east debris flow barrier layout as recommended. Note these are recommended as proprietary systems and were designed to be installed according to manufacturer’s specifications.**

We recommended that proprietary systems be installed at each location and chose only to specify the minimum barrier system height, lengths, and impact loads that the systems would need to be capable of withstanding. Recommendations for proprietary systems opened the project to multiple different debris flow barrier manufacturers, which we believed would ultimately yield competitive pricing when the project is advertised. Additionally, recommendations for a proprietary system shortened our internal design time required to provide geotechnical recommendations.

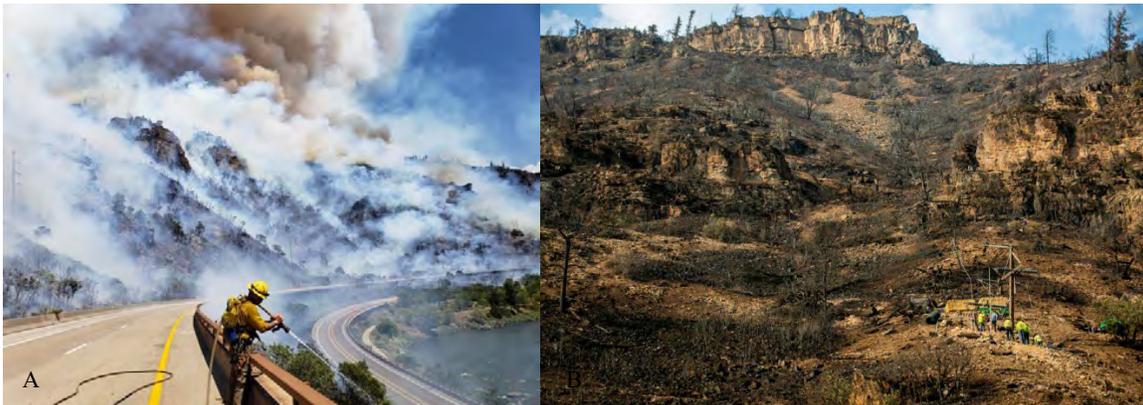
**Figure 1: Photos taken during (a) and after (b) the Grizzly Creek Fire. Photos taken from [www.wildfiretoday.com](http://www.wildfiretoday.com) and [www.cpr.com/news](http://www.cpr.com/news)**

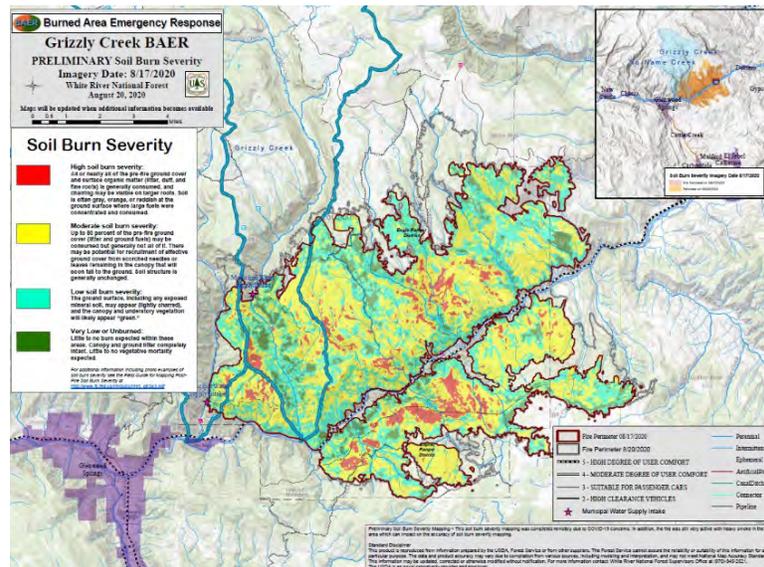
**Figure 2: Burn Severity and Extents of the Grizzley Creek Fire (3)**

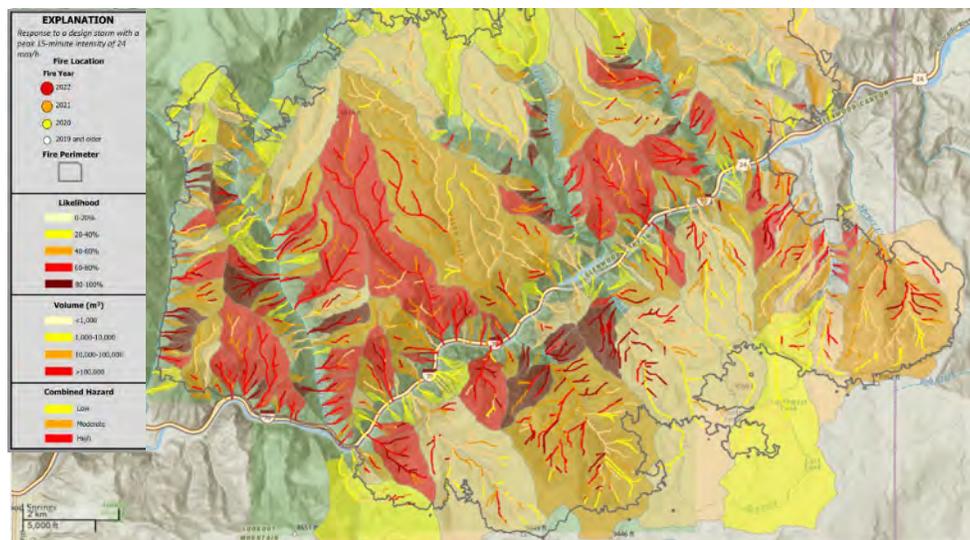
**Figure 3: USGS Post Wildfire Debris Flow Hazard Assessment Model (1)**

Dozens of burned watersheds intersect I-70 within the 13-mile-long canyon. Using the USGS post-fire debris hazard models (1) (Figure 3) and estimates of event probability, debris/water volumes, and other factors, Golder conducted a corridor level debris flow study to prioritize CDOT mitigation efforts. Approximately 82 basins outlet directly to the I-70 corridor. Watersheds were sorted to prioritize highest risk areas that may impact I-70.

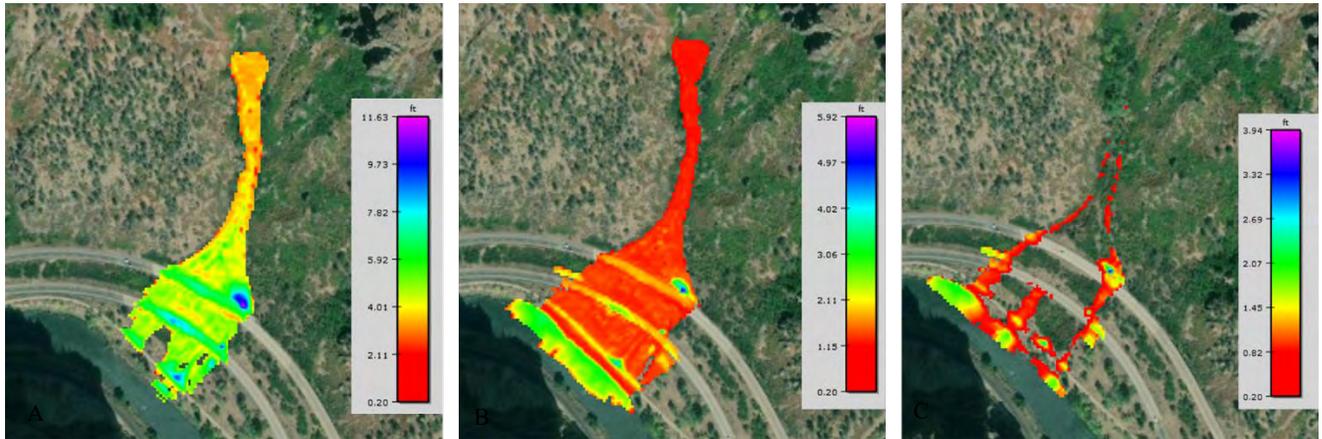
**Figure 4: Final Floodplain Depths After 48 Hours for Three Hydrographs Used in the Sensitivity Study. (A) Shows 55% Solids by Volume (B) Shows 45% Solids by Volume, and (C) Shows a Varying Sediment Concentration**

The three hydrographs produce the same total volume of debris flow while changing the water and sediment volumes. In the variable sediment concentration case, when concentrations of sediment by volume are low, most of the fluid flows over I-70 and into the Colorado River. In contrast, the base case model (constant 55% sediment concentration by volume) results in most of the fluid cessation occurring around the shallow and moderate slopes on the road or near the basin outlet.

The results of the sensitivity analysis (Figure 4) show that the model is sensitive to the sediment concentrations assumed and distribution of sediment within the hydrograph. Based on the results of the analysis, the 45% sediment concentration by volume case was selected for predicting the potential impacts from the post-fire debris flows in the Glenwood Canyon.

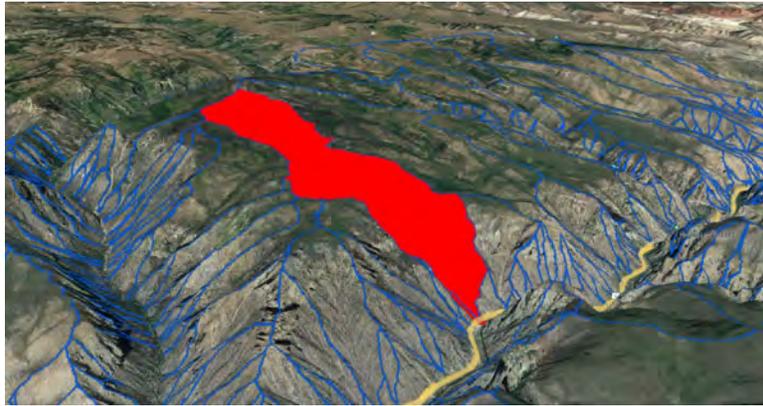
**Figure 5: Extents of MP 123.4, identified as a high-priority basin. Taken from Google Earth**

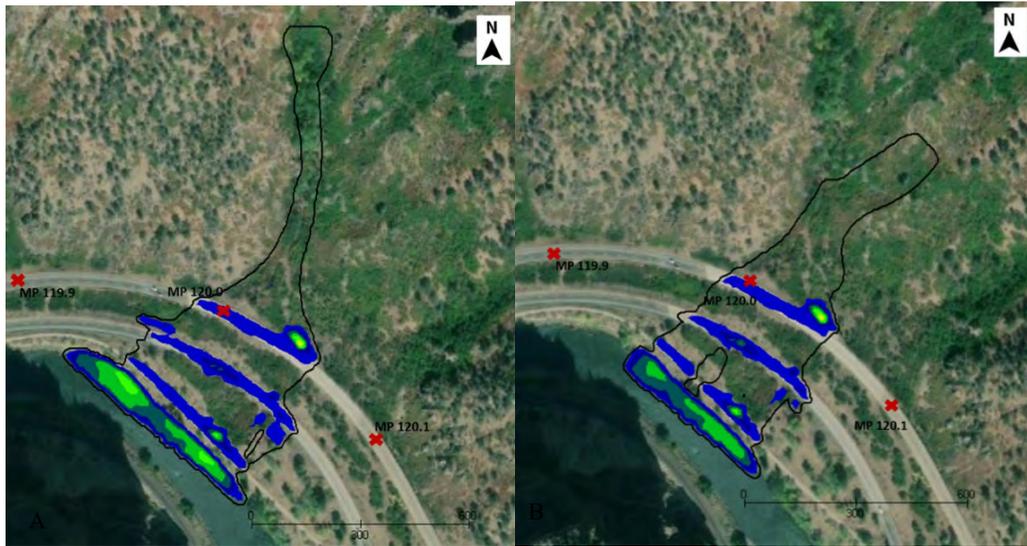
**Figure 6: Final Flow Depth After 48 Hours for Watershed 6472 (A) And 6468 (B).**

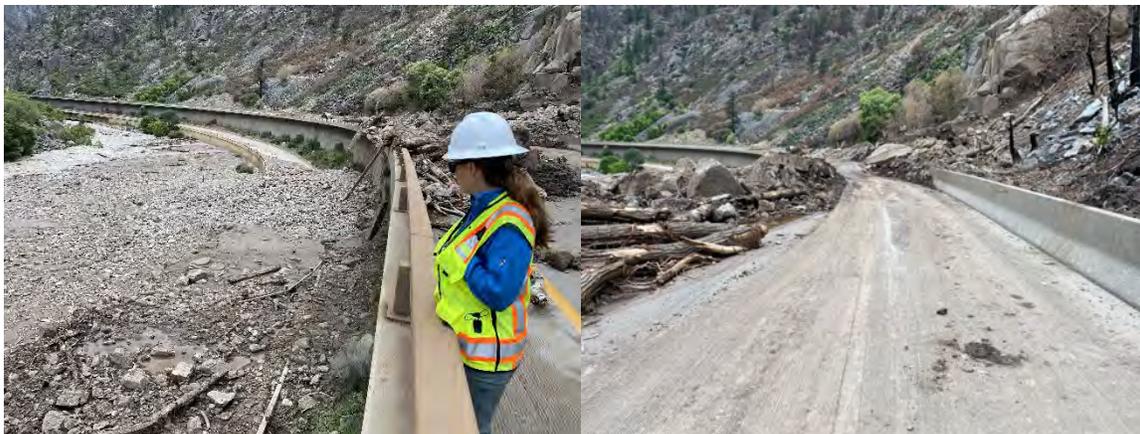
**Figure 7: Example of debris flow material at MP 123.4 deposited on I-70**

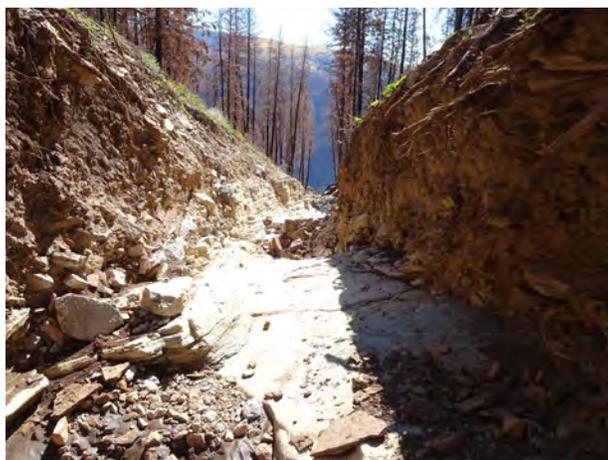
**Figure 8: Example of the extent of scouring from a debris flow event**

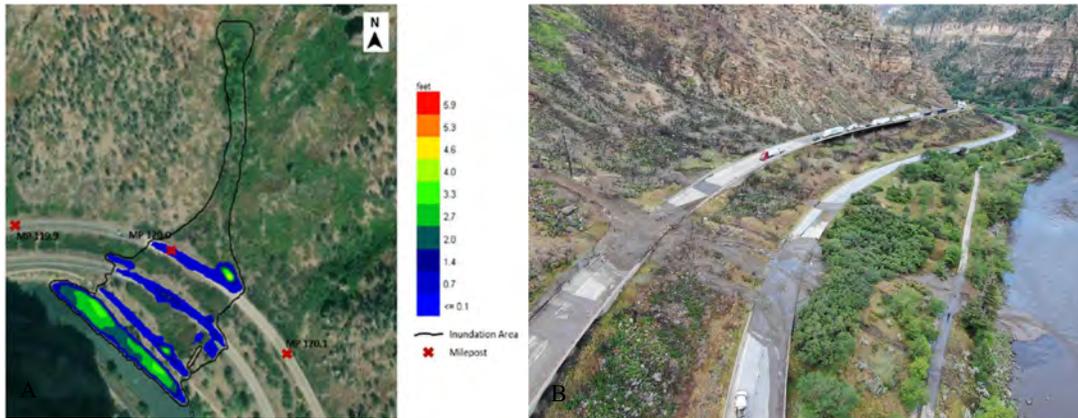
**Figure 9: Predicted (A) and Actual (B) Final Debris Flow Deposition Area**

Golder compared the predicted debris flow events (13) and two observed events for MP 120.23 and MP 120.0 to refine estimates and to calibrate future models. Table 4 presents a comparison between the predicted versus actual debris flow events. A comparison of the model results from MP 120.0 and a photo from the actual flow event is shown in Figure 9 and Figure 10.

In general, there is good agreement between the model results and the actual debris flow event. Total flow volume is omitted from the comparison due to the uncertainty of the actual flow volume. Debris that is deposited up channel or into the Colorado River would not be accounted for during estimate of the flow event. The following observations were made during the comparison:

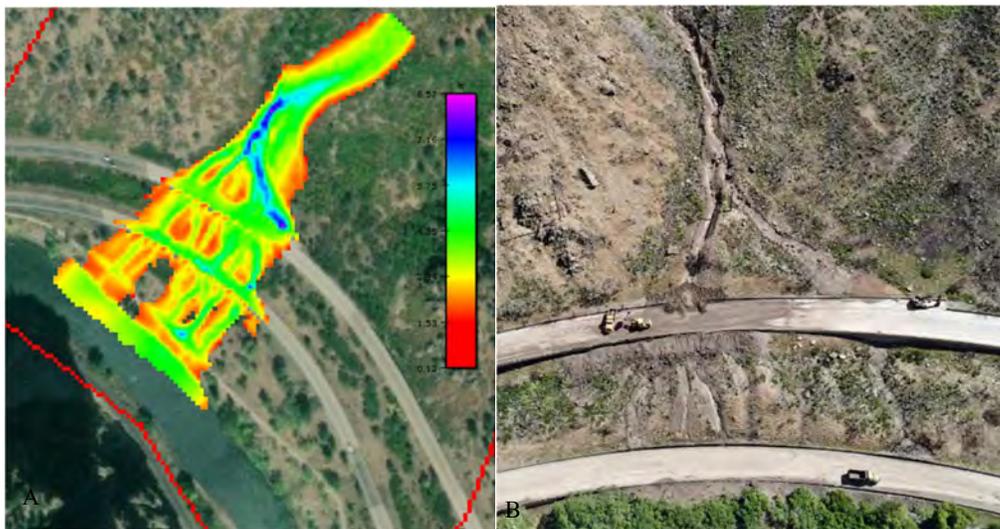
**Figure 10: Predicted (A) and Actual (B) Debris Flow Paths**

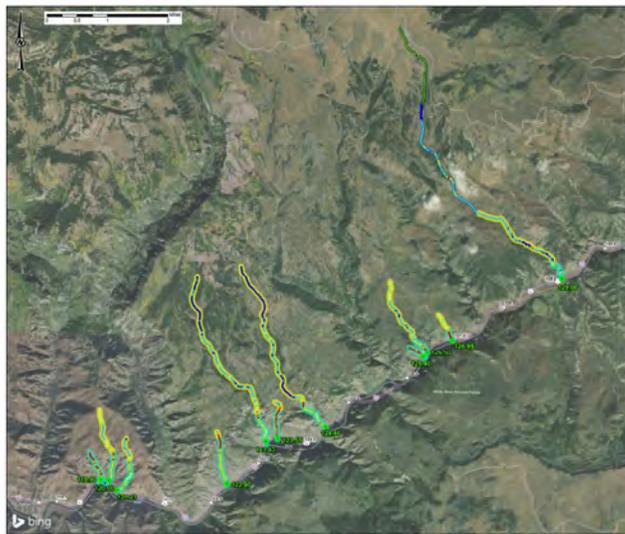
**Figure 11: Location of Priority Channels for Debris Flow Mitigation Design (14)**

After the summer 2021 debris flow events, Golder used the results of the corridor level debris flow study conducted in 2020 to prioritize CDOT mitigation efforts. The basins selected in 2020 were compared to 2021 debris flow event data and screened to determine which watersheds would be feasible to mitigate (i.e. shallower terrain, clear channel, storage area at outlet, existing culvert, etc.). This was done using available topography, aerial imagery, site inspections, and Google Earth. Twenty-five basins were identified where mitigation may be feasible. Sites were prioritized based on frequency of debris flows in the basin, the debris flow deposition volumes seen during the 2021 events, and maintenance impacts seen during the 2021 events. Conceptual level debris flow mitigation was designed for eleven sites as shown in Figure 11 (14).

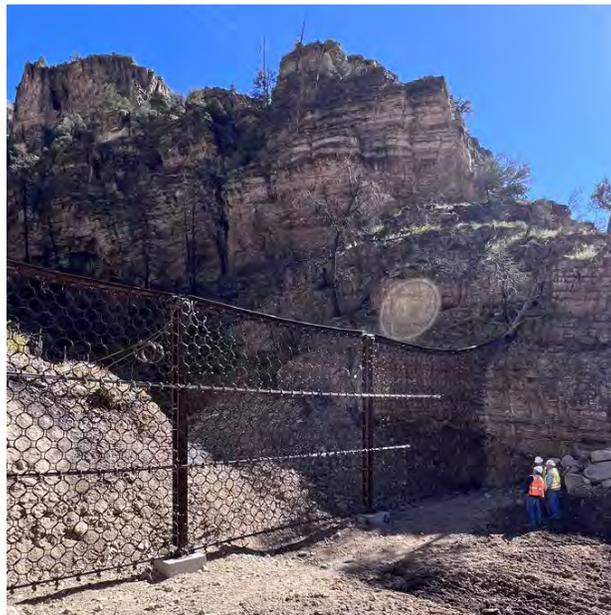
**Figure 12: Finished construction of the barrier installed at MP 120.23**

120.23	One flexible debris flow barrier	53%
122.4	No mitigation selected due to steep topography and costs-benefit analysis	
123.4	Two flexible debris flow barriers installed in series	6%
123.55	No mitigation selected due to ROW constrictions	
124.4	Increase debris flow storage with mass excavation and gabion structure	8%
126.4	No mitigation selected due to ROW constrictions and steep topography	
126.5	No mitigation selected due to ROW constrictions and steep topography	
126.95	Increase debris flow storage and gabion structure	69%
127.86 <sup>1</sup>	Increase debris flow storage with mass excavation and gabion structure	-
129.06	Increase debris flow storage with mass excavation	100%
129.25 <sup>1</sup>	Increase debris flow storage gabion structure Protect existing culvert	-

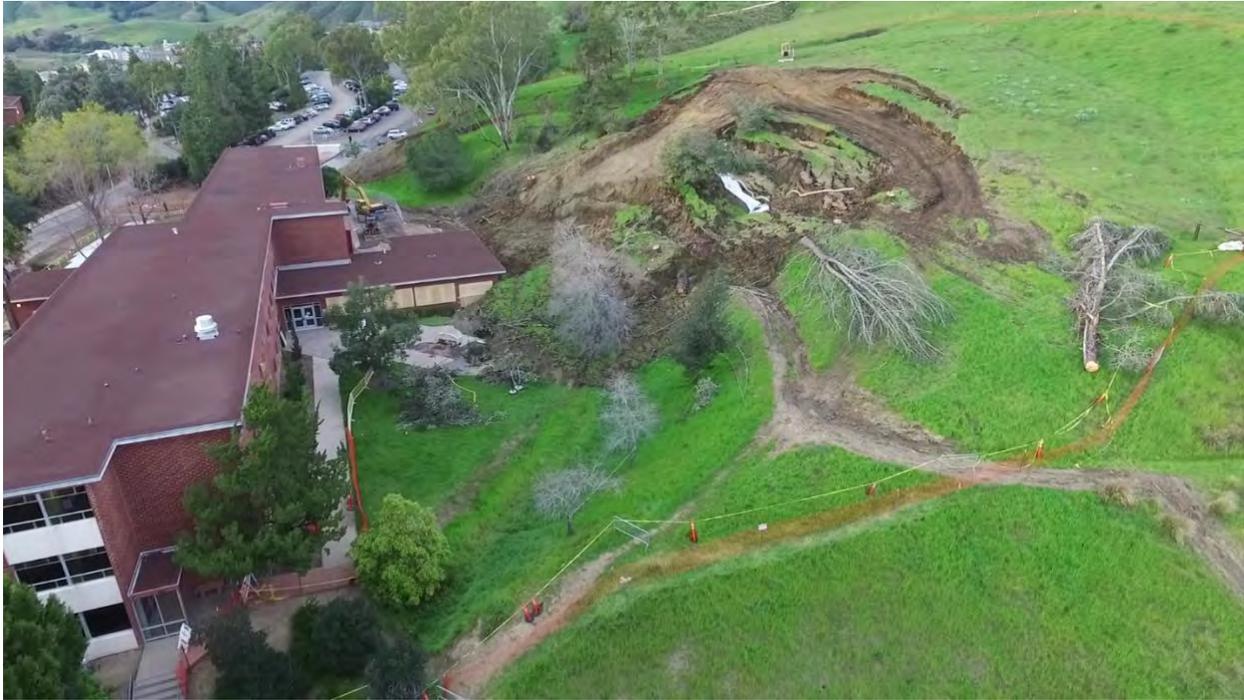
**Figure 2: 2017 Fremont Hillside Landslide**

drainage and surficial erosion of the slope. This included a 20- to 25-foot-tall cut slope within the landslide toe that was regraded to 1.5:1 (horizontal to vertical).

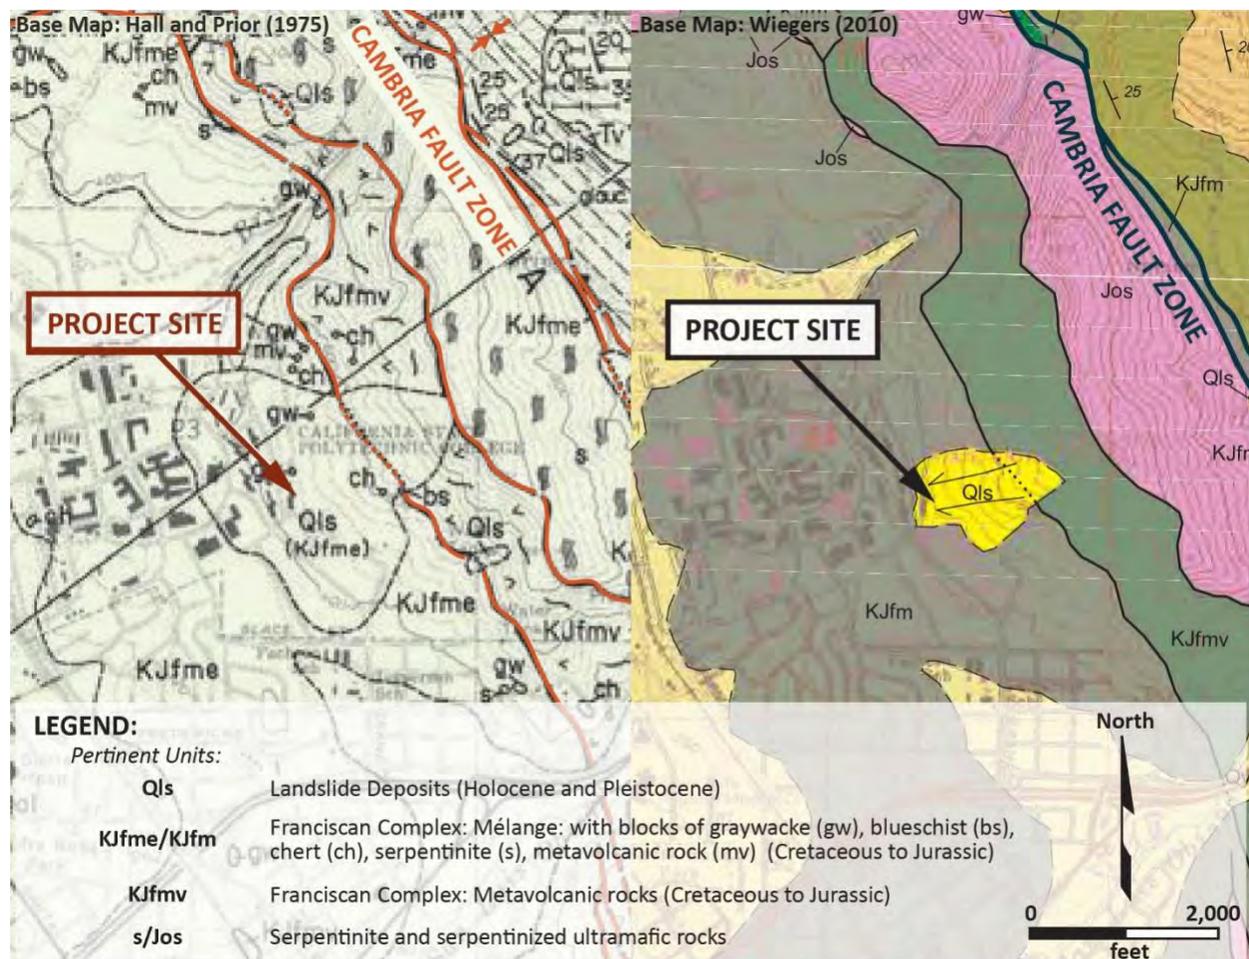
**Figure 3: Geologic Maps by Hall and Prior (1) and Wieggers (3) Showing Published Landslides**

The published geologic maps reviewed by Yeh noted an existing Holocene to Pleistocene-age landslide at the project site (see Figure 3). These mapped landslides led the University's concern of the potential for a deep-seated landslide at the site. Previous reports and documents for the existing reservoirs also noted landslide activity and the presence of landslide debris at the reservoir location upslope of Fremont Hall and within the mapped limits shown on the published maps. Landslide debris or the presence of landslides were not noted in the explorations downslope and adjacent to Fremont Hall.

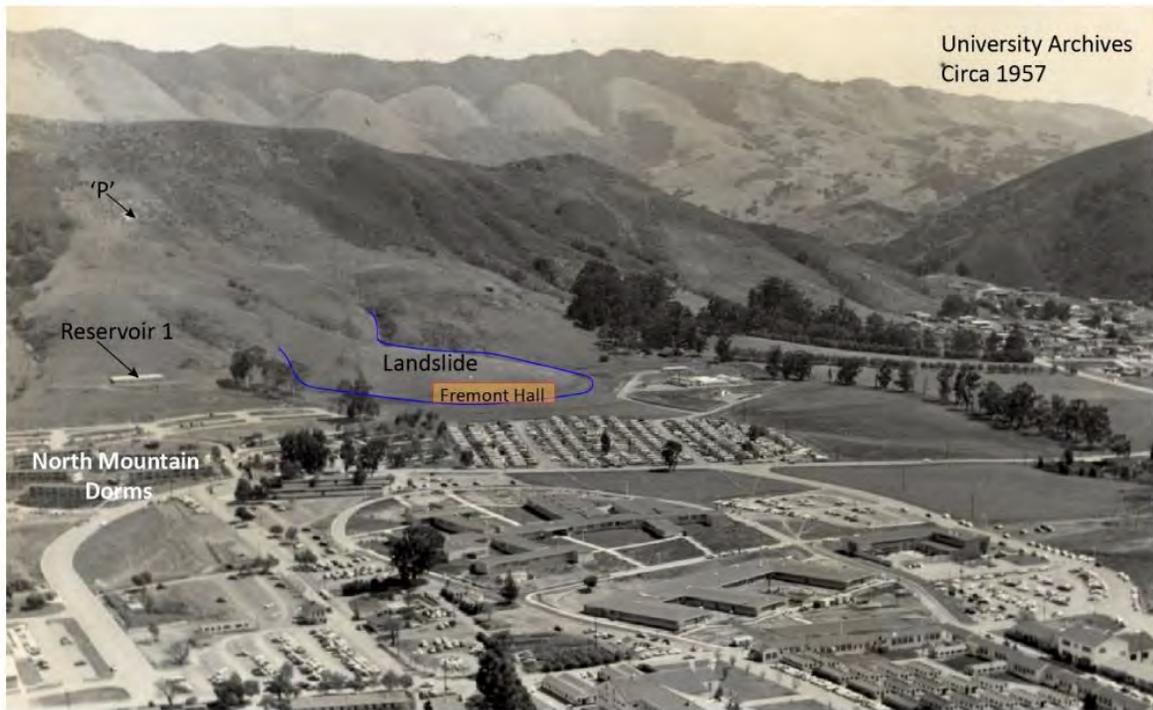
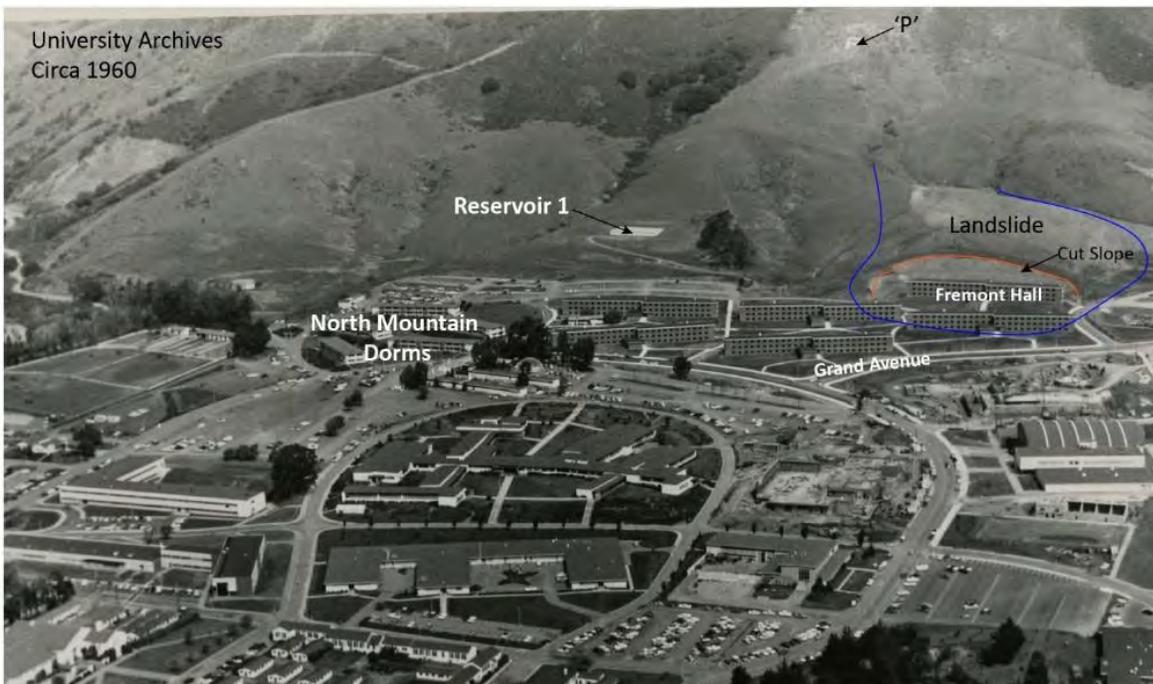
**Figure 4: Oblique Historical Photos – Fremont Hall Area**

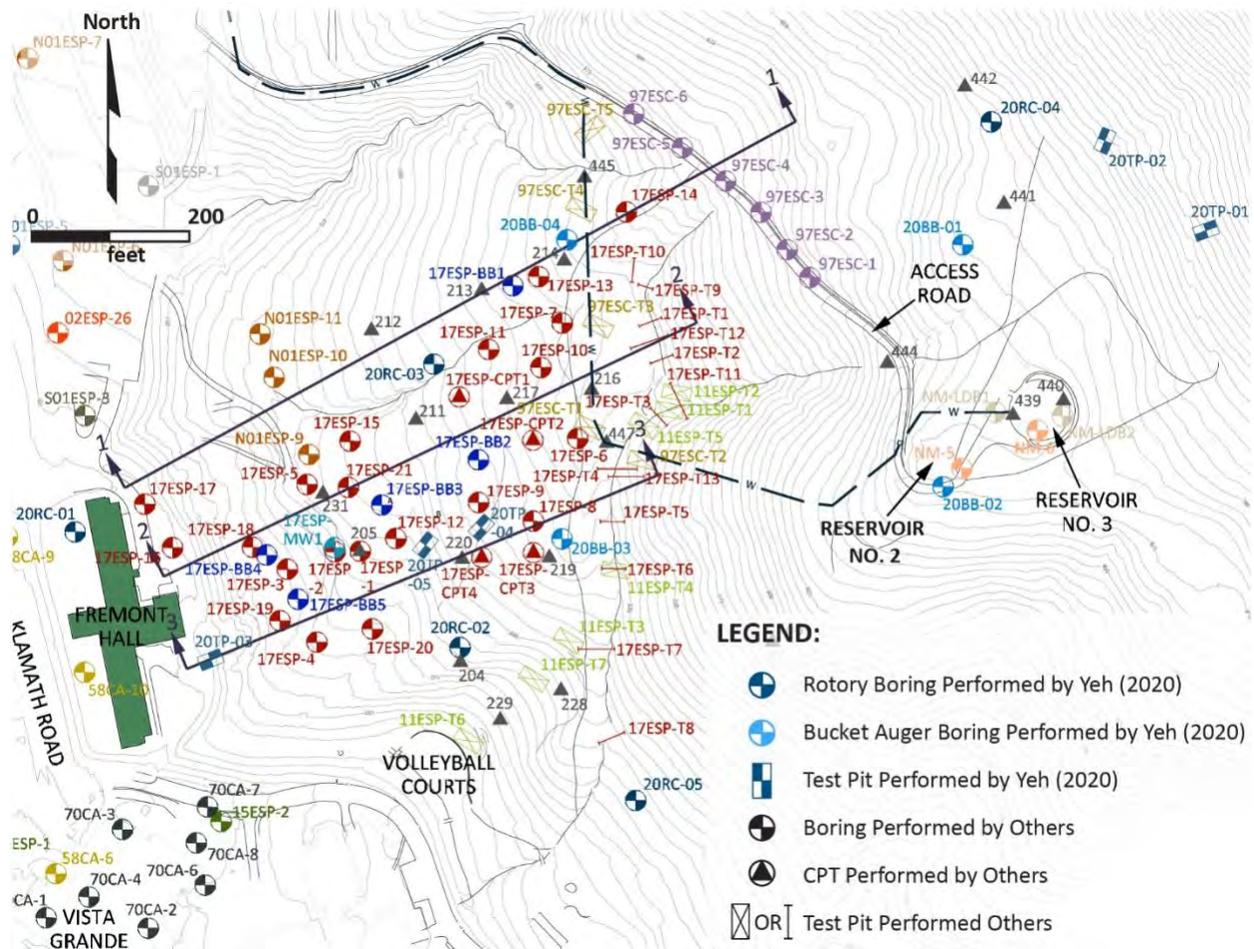
**Figure 5: Previous Study and Current Study Explorations Near Fremont Hall**

Existing and current study data at and adjacent to Fremont Hall (for the 2017 landslide stabilization geotechnical characterization), as well as existing data for the east side of the University campus (for the assessment of deep-seated landslide potential) were reviewed and compiled. A reduced version of the exploration location map including both current study and previous study explorations near Fremont Hall are shown in Figure 5.
