# 72<sup>nd</sup> Highway Geology Symposium

## 2023 PROCEEDINGS

August 14-17, 2023 • Hotel Murano • Tacoma, Washington

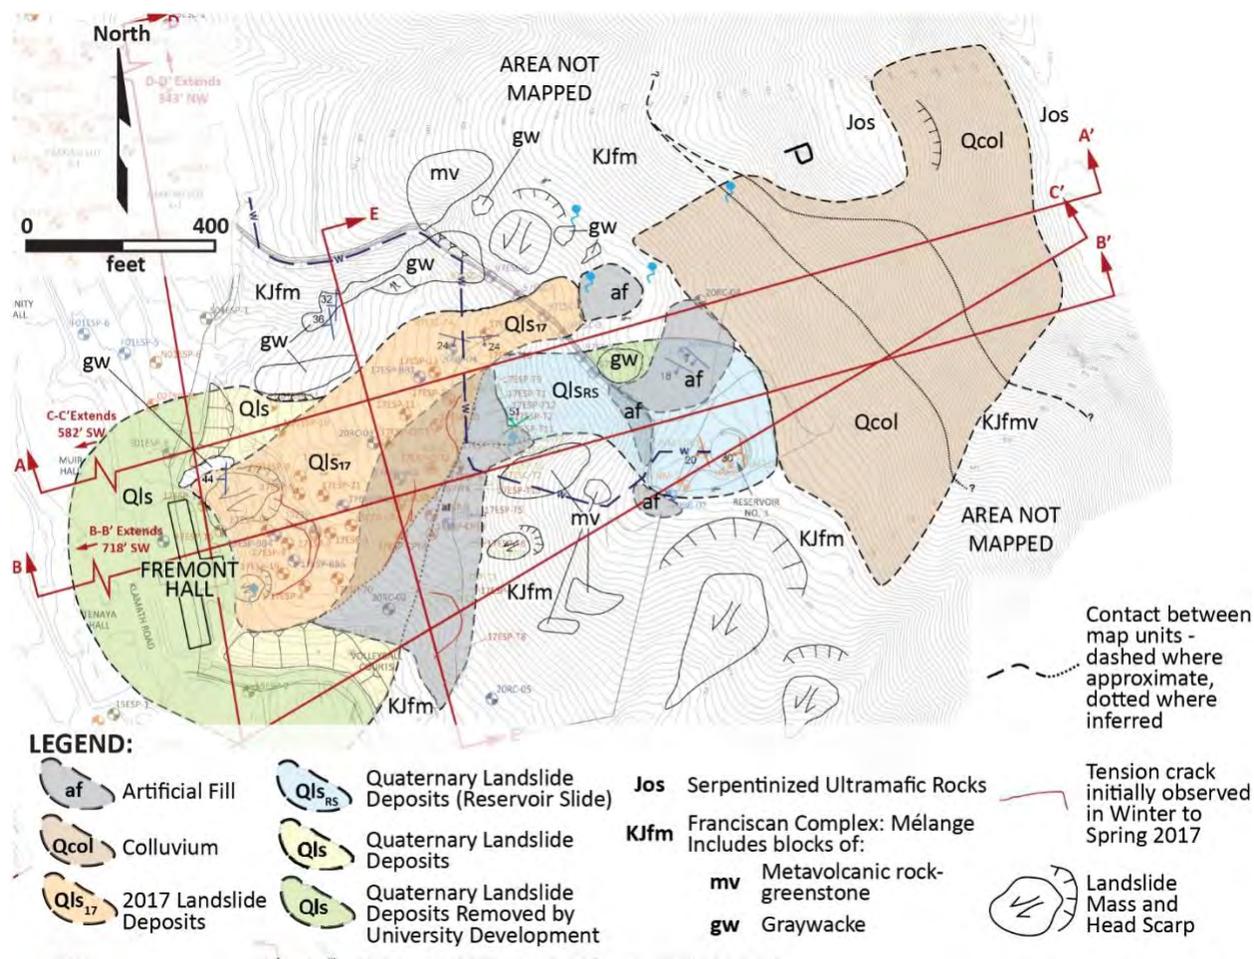
**Figure 6: Site Geology**

Hall and Prior (1) mapped four different bedrock units at the project site: Jurassic age serpentinite (s), Cretaceous to Jurassic age metavolcanics (KJfmv), mélangé (KJfm) of the Franciscan Complex, and a large landslide (Qls). Dibblee and Minch (2) and Wieggers (3) mapped similar geology with modified contacts and descriptions. Yeh's interpretation of the site geology based on previous data as well as mapping and exploration performed for the project and previous studies is shown in Figure 6 and described below.

Yeh mapped the limits of the Quaternary landslide deposits as shown in Figure 6. The landslide mapped upslope of the 2017 Landslide (termed the "Reservoir Slide") was mapped based on the basal rupture surface encountered in a bucket boring performed by Yeh and the rupture surfaces reported previous studies. The orientations of the rupture surfaces were interpreted to be associated with landslide movement towards the downslope west-flowing drainage. The landslide was mapped as underlying Reservoir Nos. 2 and 3, and portions of the roadway and pipelines within the roadway that connect those facilities to campus. Evidence of active movement of the landslide was not reported by previous studies and surficial distress to the reservoir structures typically associated with slope movement was not observed. Therefore, the Reservoir Landslide was interpreted to be inactive and separate from the active 2017 landslide.

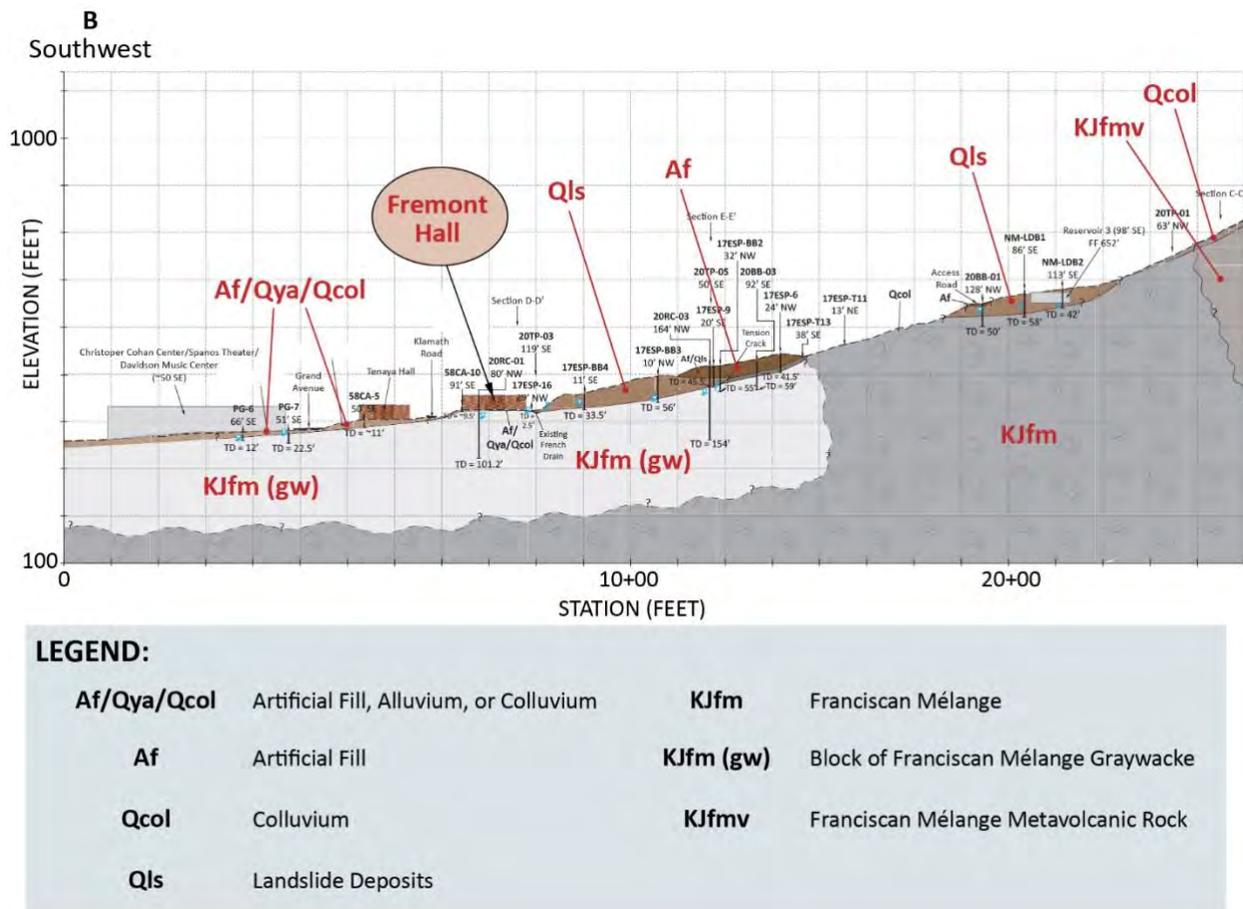
**Figure 7: Portion of Cross Section B-B'**

The landslide was mapped on the published maps from a regional perspective, and the depth of the landslide deposits shown on published maps was not assessed without site-specific exploration. Borings were drilled to depths of approximately 109 to 112 feet below the interpreted rupture surface of the 2017 Landslide to help evaluate whether rupture surfaces were present that could be associated with a deep-seated landslide. Evidence of a deep-seated landslide rupture surface was not observed. Fremont Hall, Reservoir Nos.2 and 3, and other structures are located within the landslide limits shown on published geologic maps. The University had not reported historical distress to those structures that could be attributed to landslides, with the exception of the 2017 Landslide that impacted Fremont Hall. The results of Yeh's Fremont Hall floor level survey and condition assessment did not find evidence of movement, cracking or distress that would be associated with landslide movement other than the previously mentioned cracked exterior east wall resulting from the 2017 Landslide.

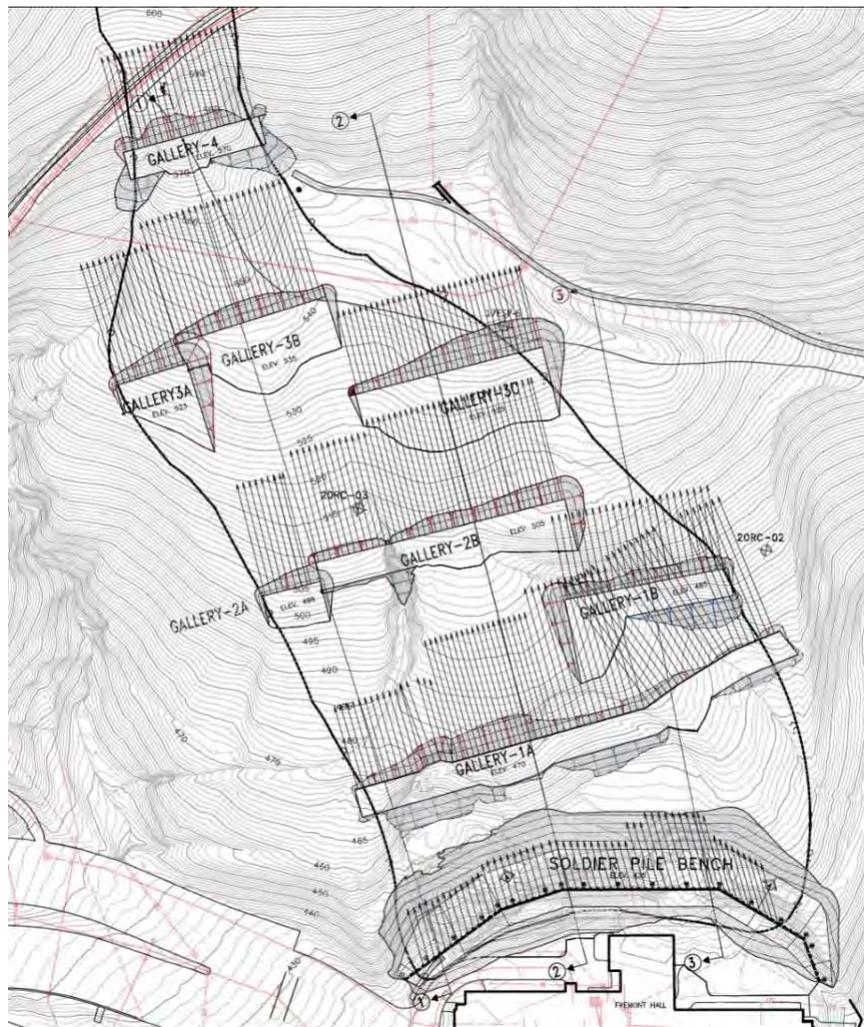
**Figure 8: Stabilization Design Layout**

The analyses were performed to calculate slope stability factors of safety under static and seismic loading conditions, estimate structural loads per foot for the anchors, and estimate slope displacement under the design seismic loading. The location of ground anchor galleries along the design sections was varied to optimize the support resistance and provide stability to the overall slope. Support locations were based upon design and analyses iterations and collaboration with Schnabel. The final design layout is shown in Figure 8.

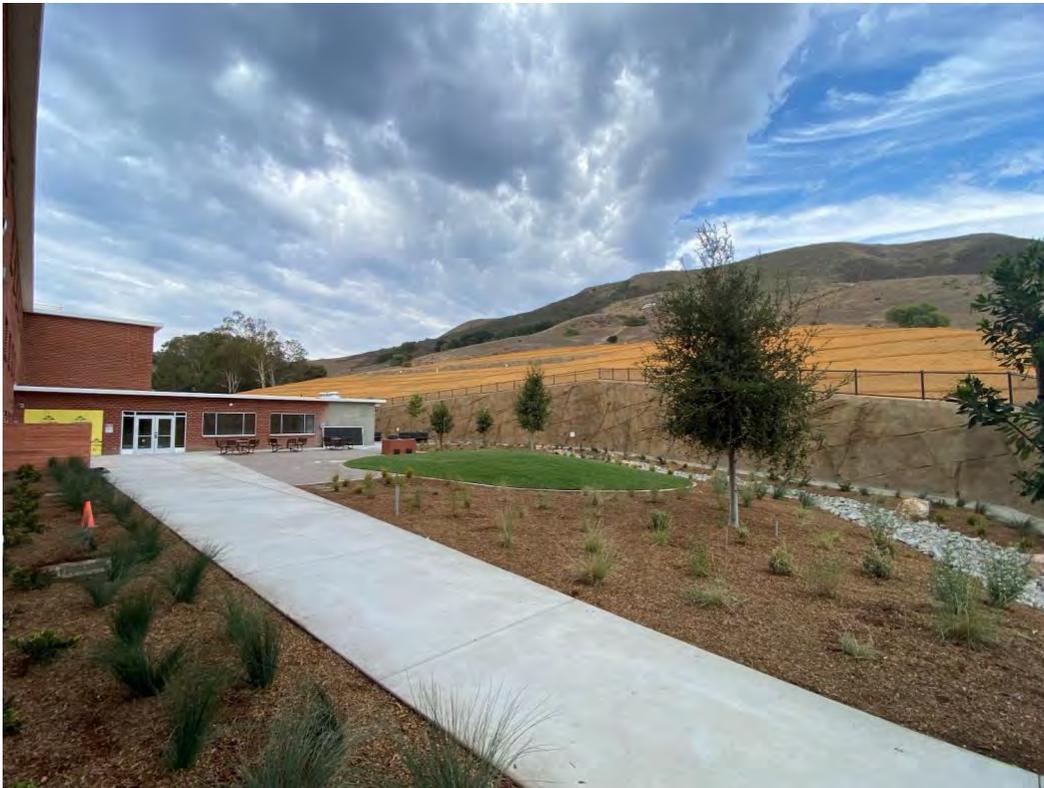
**Figure 9: Completed Project - September 2022**

The stabilization consisted of a series of ground anchor galleries within the landslide mass and an anchored soldier pile wall at the toe of the stabilized slope (see Figure 9). Horizontal drains and subdrains were installed within the landslide mass to collect and maintain design groundwater elevations. The project was successfully completed in July 2022 and students have since reoccupied the dormitory. A photo of the completed project is shown in Figure 9. Yeh is contracted to continue to monitor the existing twelve inclinometers, fifteen vibrating wire piezometers (VWPs), and fourteen instrumented anchors on a monthly basis. An “atmospheric river” event impacted the region in January 2023 which caused bridge failures, levee failures, and multiple landslides in the surrounding area. A rise in groundwater elevation of approximately 16 feet was recorded in the VWPs at the site and water was observed actively flowing from the horizontal drains. However, the data recorded from the inclinometers and anchors did not show evidence of slide mobilization. Besides surficial erosion of the newly-hydroseeded slopes, the slope stabilization performed well during the “atmospheric river” event and for the remainder of the above average precipitation that occurred in in the region during the Winter of 2023.

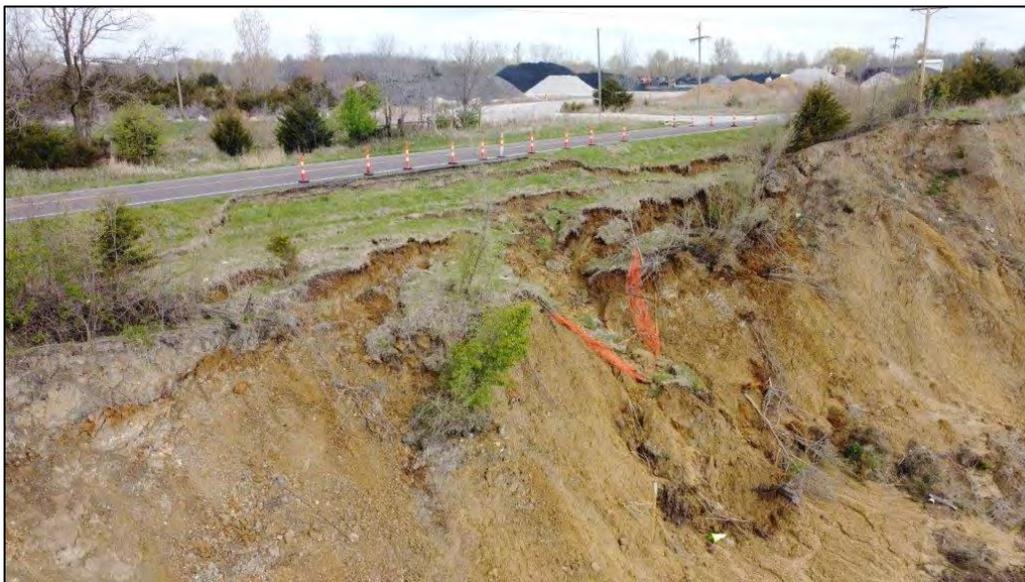
**SLOPE FAILURE FROM EAST PIT – FIGURE 3**

The slope failure occurred in the non-engineered berm and underlying glacial till – lean clay overburden. In its existing position, the scarp of the failure is at the east edge of the pavement with the slump extending to the top of the quarry highwall. Slumped material has also fallen over the highwall and down to the quarry floor (Figures 3 and 4). Small tension cracks have been noted in the roadway parallel to the landslide scarp.

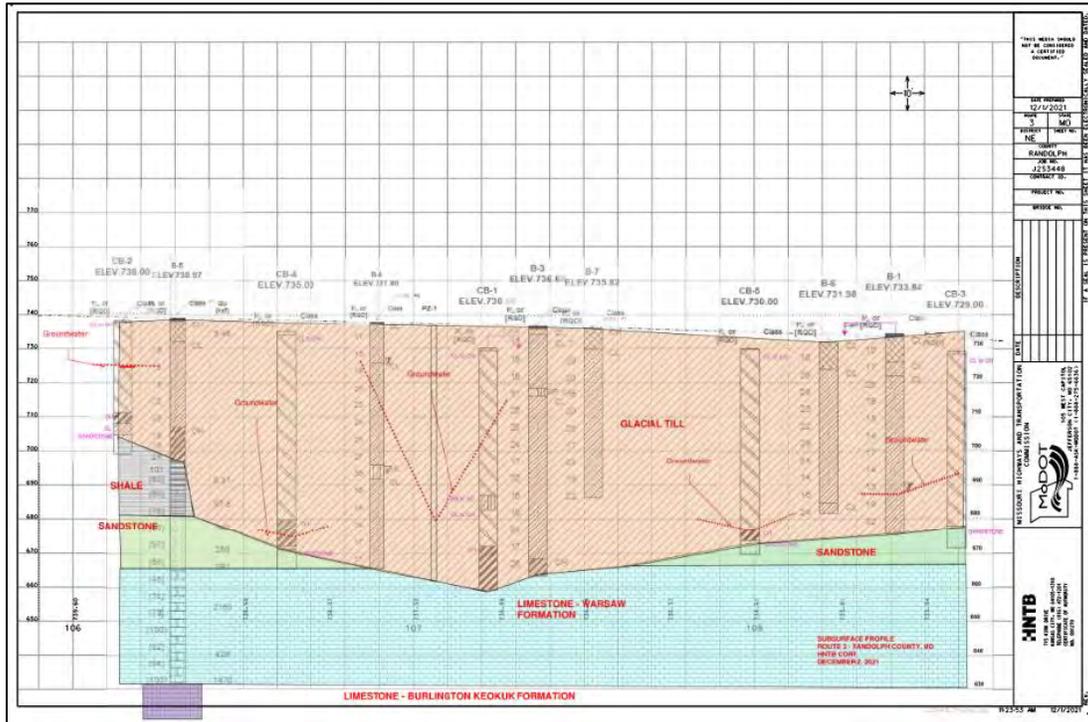
**SUBSURFACE PROFILE – FIGURE 11**

The subsurface can be generally characterized as glacial till over lower Pennsylvanian Channel sandstone (Weldon River, Warrensburg, Moberly) cut into and flanked by other Pennsylvanian shale and sandstone (Cherokee and Marmaton), all underlain by the Mississippian limestones (quarried material) of the Warsaw and Burlington – Keokuk Formations (Figure 10). The glacial till is described as mostly lean over-consolidated clay. Sand and gravel particles are interspersed within the clay matrix, characteristic of Northern Missouri glacial till. The glacial till

contains irregular lenses, layers and pockets of silt, sand, and gravel. Fat clay occurs above the top of rock, most likely derived from very weathered shale (Figure 11).

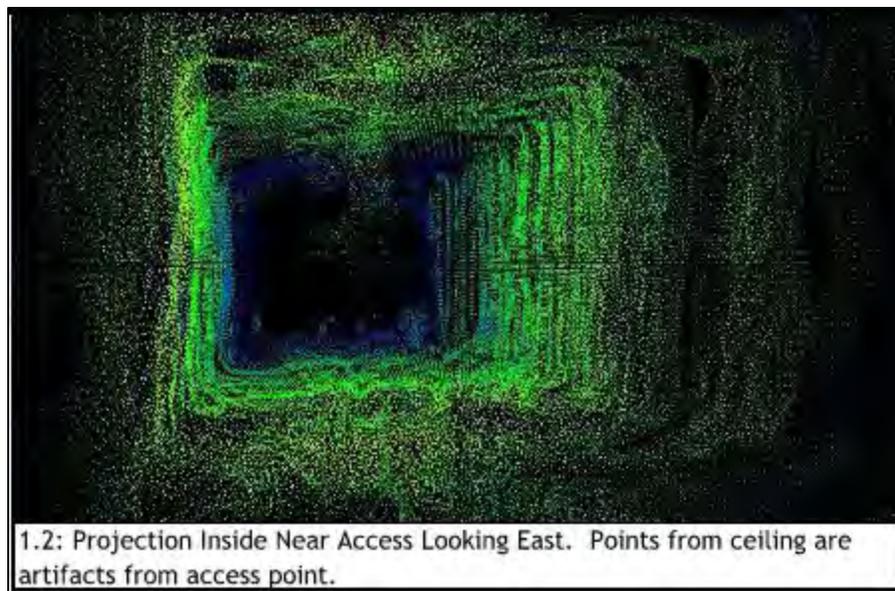
**DOWNHOLE LIDAR IMAGE OF THE TUNNEL - FIGURE 12**

HNTB subcontracted with COLOG, of Lakewood, CO, to perform a downhole laser survey of the mine tunnel directly beneath Route 3. A boring (B-5) was drilled from the roadway surface and penetrated the roof of the mine at a depth of 107 feet. The 3.25” ID hollow stem augers were left in the boring after drilling to keep it open and provide access for the geophysical laser scanning tool and camera (Figure 12).

The purpose of the laser scan was to view the general condition of the mine walls, floor, and ceiling, identify debris, as well as determine the size of the opening. In summary, the COLOG survey did not identify rock debris on the mine floor, and it appears the mine ceiling, floors and columns are intact. The logging operator reported water flowing down hole during the scanning procedure.

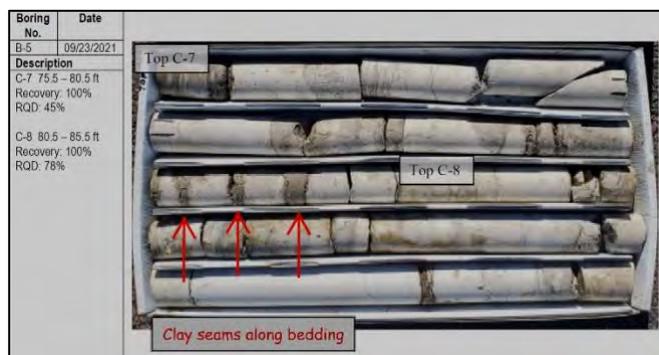
Figure 13

For each selected section, two models were developed: the first assuming no structural control of the failure surface (i.e. analogous to a circular material failure in soil slopes), and the second assuming partial structural control along horizontal bedding planes. The latter model conservatively assumed that clay-filled bedding planes as identified in borehole B-5 could occur anywhere within the limestone sequence (see margin photo). These planes were further assumed to be sufficiently thick to prevent rock-on-rock contact during shearing and to have shear strength parameters nominally equivalent to the glacial till. It was acknowledged that the collective assumptions relative to this model with partial structural control are improbable and represent a worst-case scenario, albeit instructive with respect to the evaluation of Route 3 longevity.

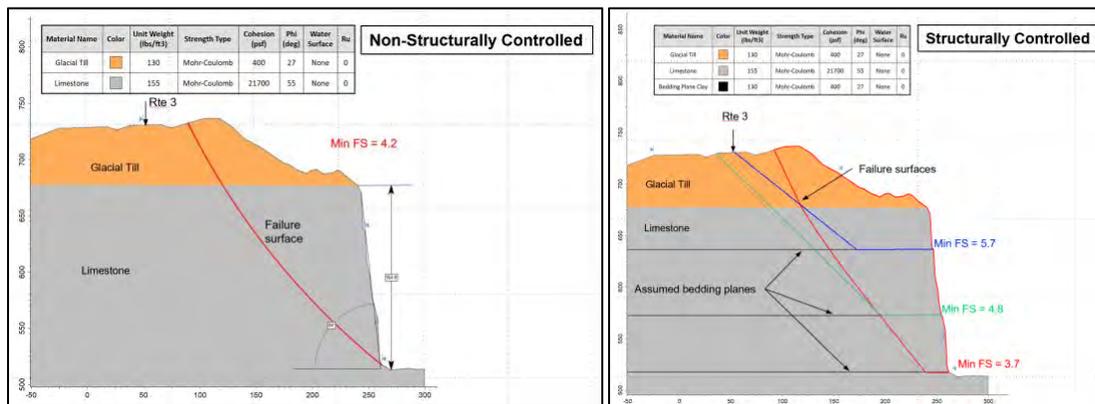
**Examples of Quarry Wall Stability Analyses – FIGURE 14**

Limit equilibrium stability analyses employing Rocscience software Slide (ver, 6.039) with Spencer’s method (1967), yielded stability margins expressed as the Factor of Safety, FS. For permanent slopes adjacent to this public highway corridor, a minimum FS value of 2.0 is suggested for the quarry walls. For context, the typical acceptance criterion for a critical overall mine slope would be FS = 1.5 (Read and Stacey, 2009, Wyllie, 2018). The figures below summarize Spencer’s Method for the analyses and report minimum FS values for non-structurally controlled failures and structurally controlled failures of 4.0 and 3.7, respectively, assuming fully drained conditions. Given the conservatism incorporated in the geotechnical models coupled with the very favorable condition of the walls evident in the UAV video footage, these stability results are consistent with the expectation that long term overall stability of the nominal 160-foot high limestone quarry walls should not pose a risk to Route 3.

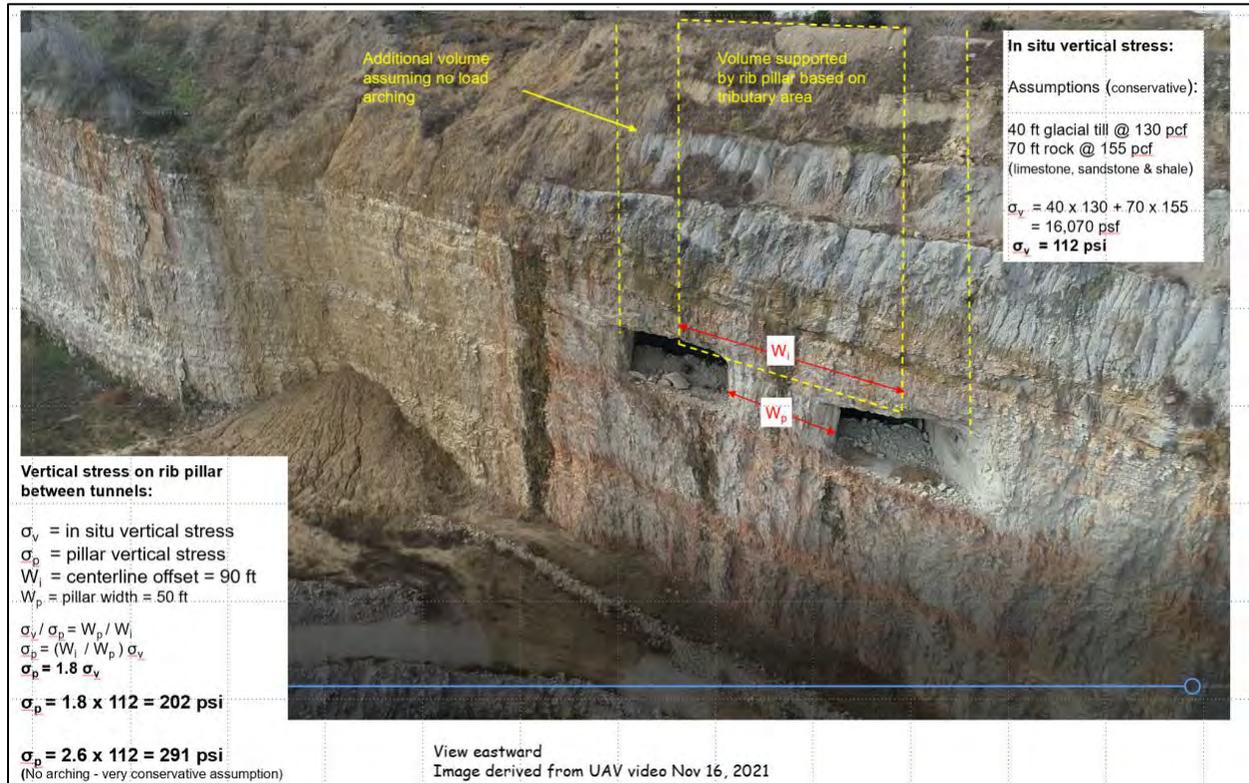
**Rib Pillar Vertical Stress- FIGURE 15**

The trailing figure 15, summarizes the estimated vertical stress acting in the pillar with the assumption that the entire rock and soil volume above the tunnels is supported by the rib pillar. As shown, this yields an estimated vertical stress in the rib pillar,  $\sigma_p$ , between 200 and 300 psi, depending on the assumption for rock volume carried by the pillar (i.e. degree of load arching onto the abutting rock).

The ratio of pillar strength (1864 psi) to vertical stress,  $\sigma_p$ , indicates a **Factor of Safety > 6** consistent with the shallow cover over the tunnels and the strength of the limestone. It is concluded that the rib pillar has adequate long-term stability. As collateral evidence to the foregoing analysis, two pillar configurations in the historic underground mine with differing extraction ratios (ER) were analyzed:

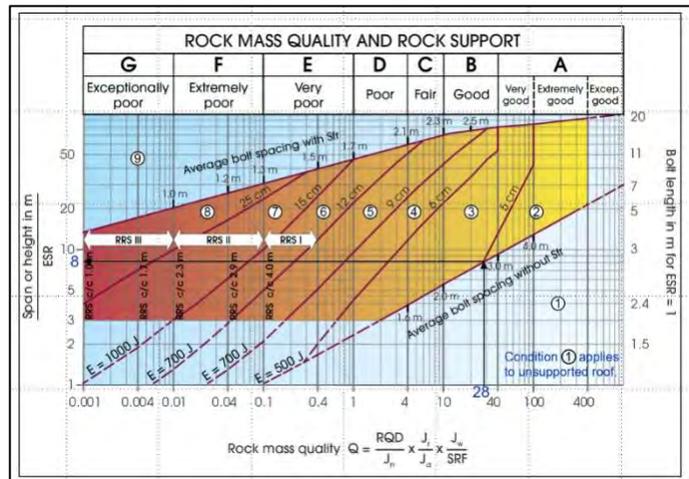
Figure 16

methodology dating from the early 1970's. The second was the closed-form theoretical formula to calculate the stability of a bedrock roof beam with horizontal strata. The margin figure below shows the relationship between rock mass quality (i.e. expressed as "Q" value) and roof span (metric presentation) after NGI (2015). For the limestone penetrated by the tunnels beneath Route 3, the estimated Q value is 28. If one were designing the span for an unsupported roof, Figure A-8 shows the corresponding ratio of Span/ESR = 8. The Excavation Support Ratio (ESR) is a factor that takes account of the performance risk for a given type of underground facility. For permanent mine openings, water supply tunnels, hydro power tunnels, the recommended value for ESR is 1.6. This is judged equivalent to the project case with a public highway passing over a tunnel. Using this value, the computed unsupported span is:

$$\text{Allowable Span} = \text{ESR} \times 8 = 1.6 \times 8\text{m} \times 3.28 = 42 \text{ ft.}$$

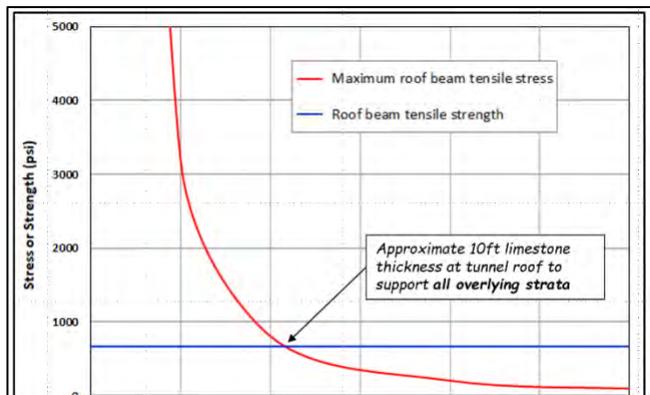
Figure 17

The maximum possible limestone beam thickness is 31-ft. if it acts as a monolithic unit. Bedding plane partings (shale, clay etc.) within the Warsaw Formation could reduce this beam thickness. For demonstration purposes, it was assumed the beam thickness could vary from 2-ft to 31-ft and for each value would have to support the limestone, sandstone, shale and glacial till above. The vertical stress at the tunnel crown was calculated at 100 psi (14,475 psf). Utilizing the intact tensile strength of the limestone at 667 psi, the relationship between beam thickness and maximum roof stress was

plotted (Figure 17). This demonstrates that for the worst-case assumption in which **all overlying strata** must be supported by the roof beam, a minimum thickness of slightly more than 10-ft is required. In actuality, the limestone above such a beam would also be self-supporting and only the glacial till and possibly channel deposits (shale/sandstone if present) would require support. Furthermore, there is no evidence in borehole B-5 of a persistent bedding plane parting that could potentially define a roof beam within 10-feet of the tunnel crown (see photo below).

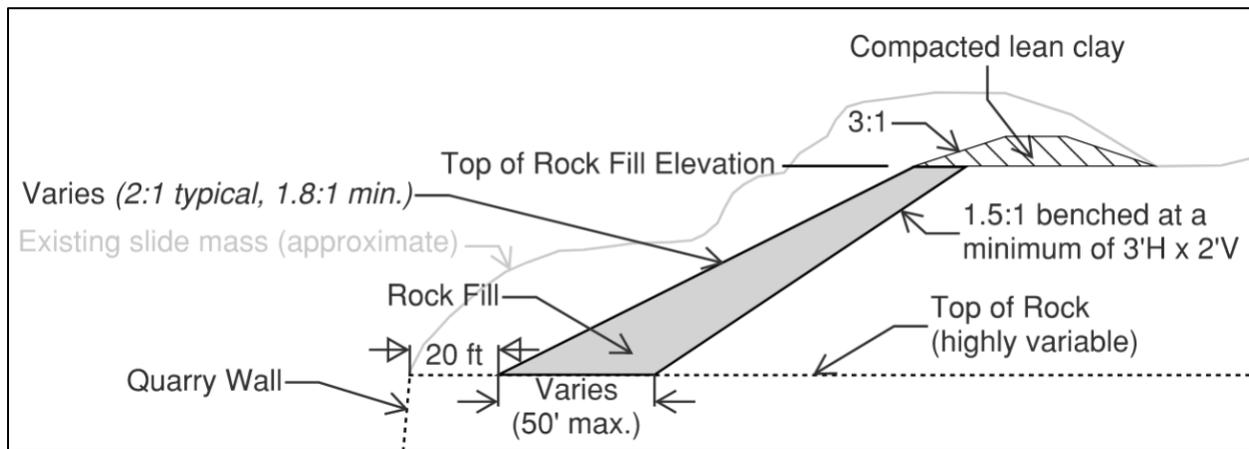
The top of rock surface is highly variable throughout the site. Based on available borings and other geologic information, an interpreted top of rock surface was developed, and the rock fill landslide repair applied that met the required factors of safety. A schematic of the final landslide repair is shown below. Figure ???

**Schematic of Final Landslide Repair – FIGURE 18**

The overall three-dimensional shape of the rock fill repair is estimated to be concave relative to the new roadway alignment, similar to an amphitheater, due to the variable bedrock surface. This concavity is most nearly tangent to the roadway alignment where bedrock is deepest, at approximately Sta. 107+50, which is also the estimated center of the original slide mass. Both upstation and downstation of Sta. 107+50, the rock fill sections gradually taper out to match existing grading. The rock fill repair was applied until the existing grading achieved a satisfactory FS with respect to overall slope stability. Based on the stability analyses, the transitions from rock fill to existing grading are at Sta. 105+50 to the north and Sta. 109+50 to the south.

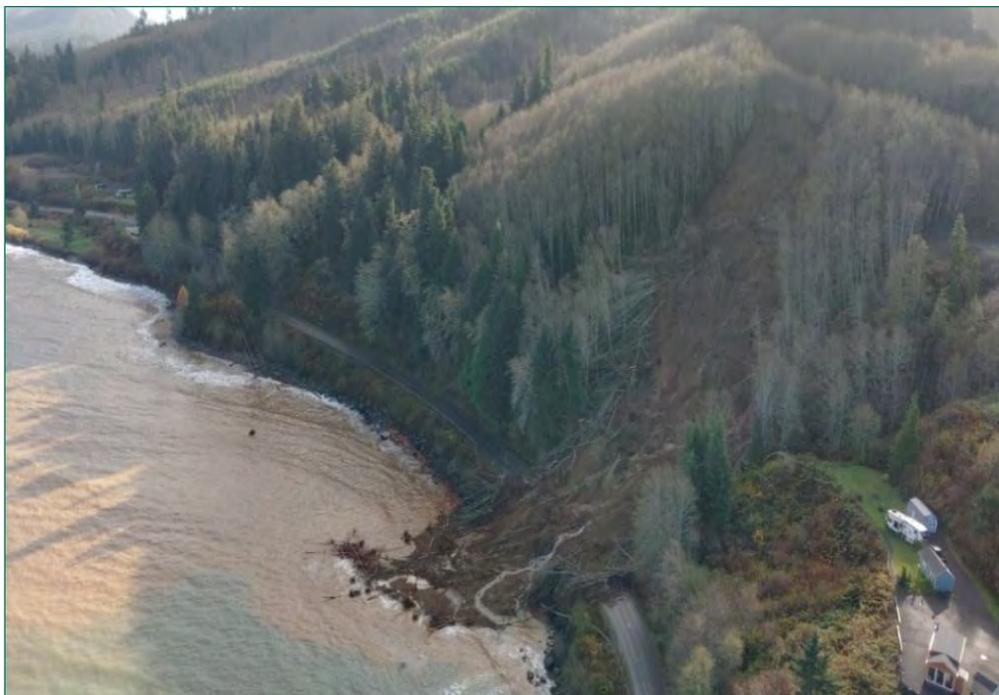
**Figure 1: Photograph of the debris slide taken from a helicopter on November 16, 2021**

We estimate that the debris slide mobilized tens of thousands of cubic yards of side cast material that had been dumped below the gravel road, as well as weak native soils present along the lateral margins and toe of the landslide. We estimate that approximately one hundred thousand cubic yards of debris mobilized in the event. The landslide buried SR 112 in nearly 20 feet of debris and extended several hundred feet north into the Strait of Juan de Fuca (Figure 2). The debris slide was approximately 340 feet high, 800 feet long and up to 400 feet wide.

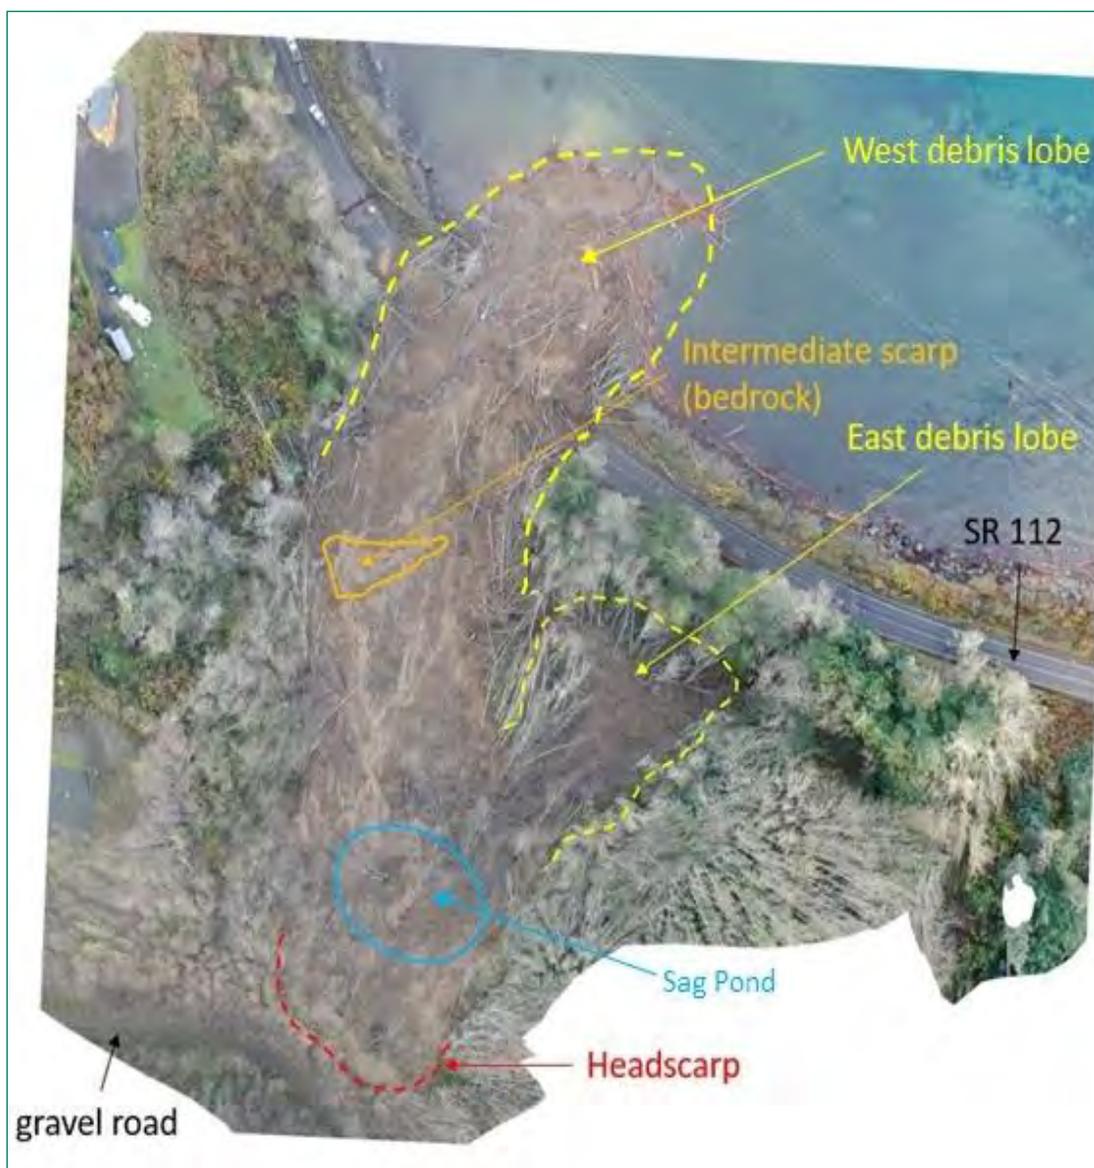
**Figure 2: Orthomosaic photo from 11/21/2021 UAV flight, annotated with major debris slide features**

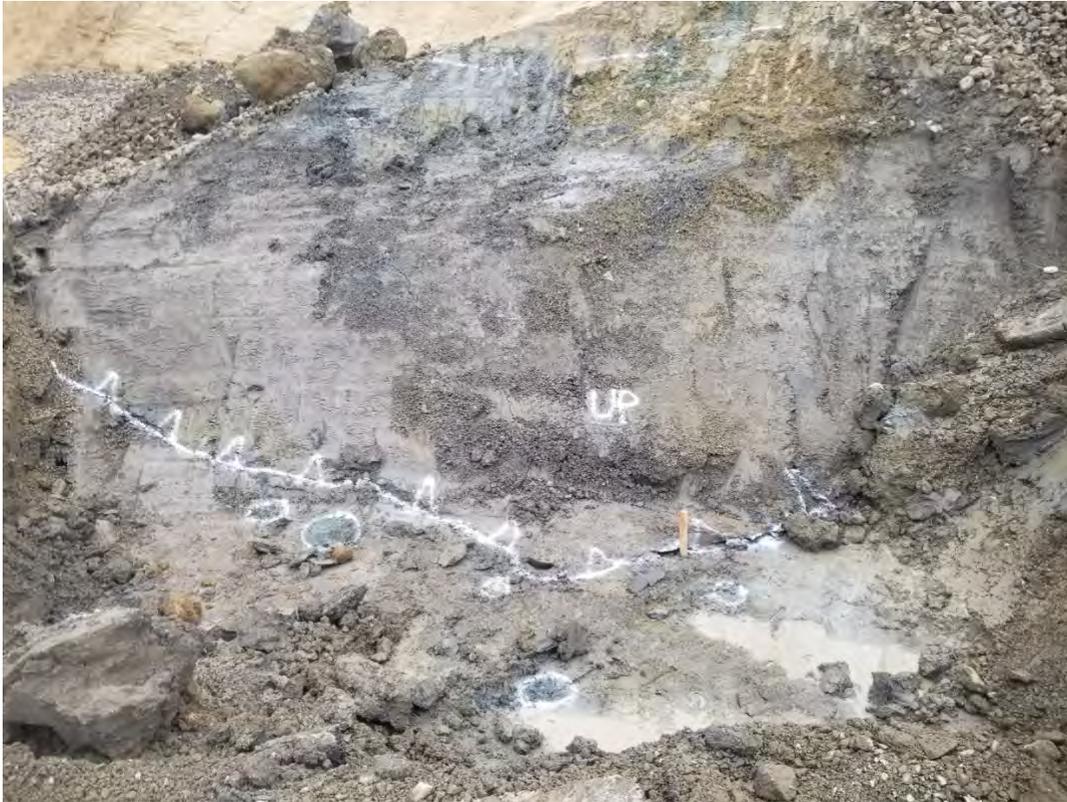
During our March 18 site visit, we excavated a test pit (TP-1-22) in the heave area of the highway to a depth of approximately 6 feet below the highway elevation. The landslide failure plane was exhibited in the test pit as a fracture seeping water that deformed visibly over the period of approximately 30 minutes that the test pit was left open. The floor of the test pit was found to consist of a very dense deposit of granular material that we interpreted at the time as weathered bedrock.

**Figure 3: Test pit excavated into the ‘heave’ area with paint marks denoting the failure plane**

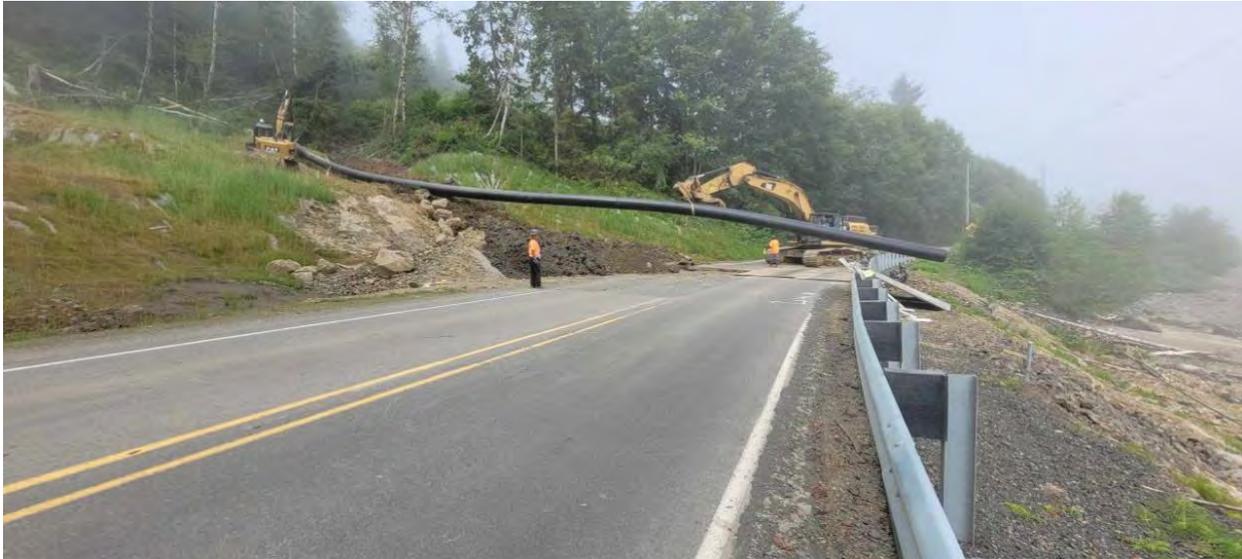
**Figure 3: July 2022 installation of tightline to capture water draining from adjacent property**

Based on our findings, and our expectation that the emergency shear key and tightline were not adequate to permanently stabilize the landslide, we initiated a second phase of investigation and mitigation design.

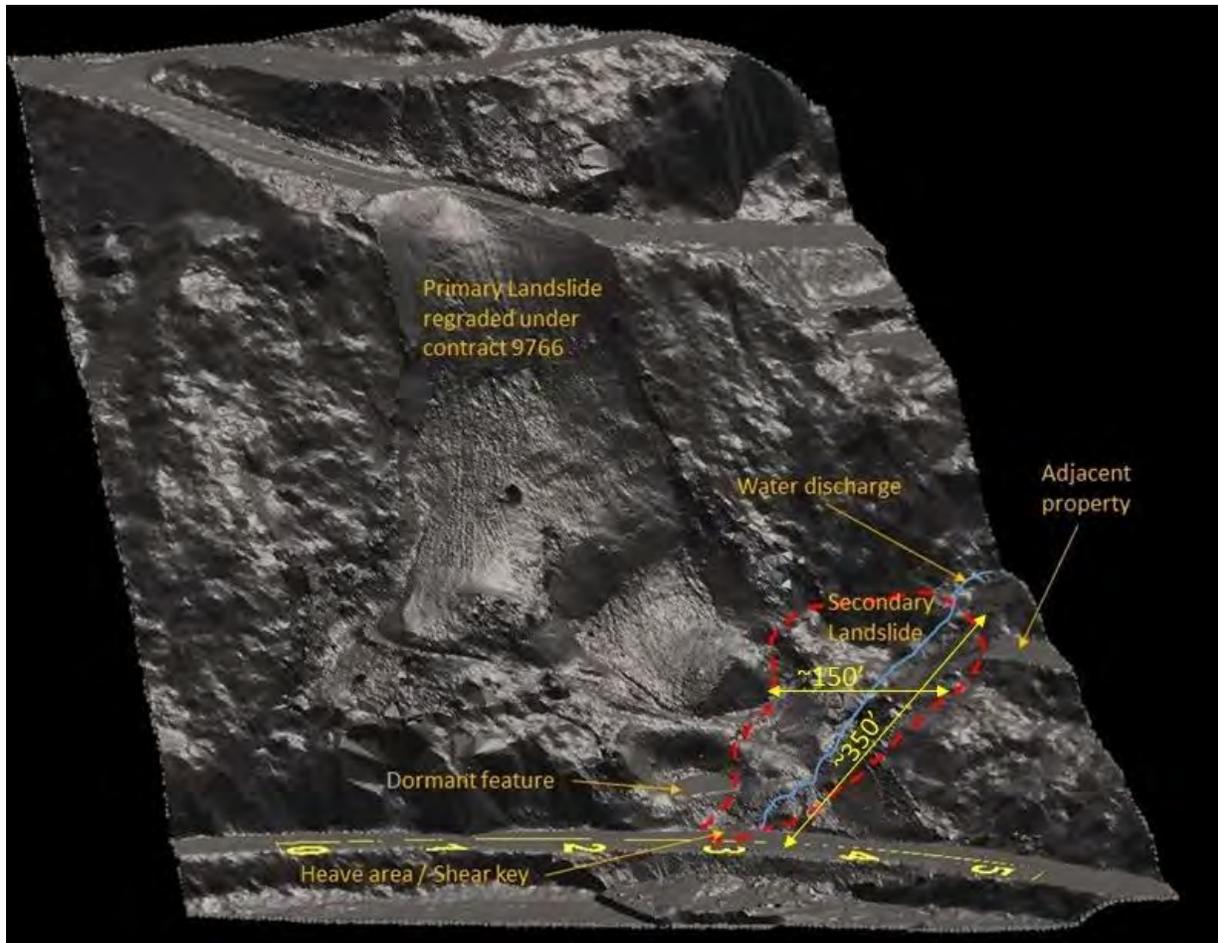
WSDOT collected terrestrial lidar data of the area on March 23, 2022, following the stabilization work for the debris slide. This lidar-generated surface was used for additional change analysis and for design of the permanent stabilization of the 'secondary landslide'.

**Figure 4: Annotated terrestrial lidar hillshade showing the approximate limits of the 2006 'secondary landslide' with a red dashed line.**

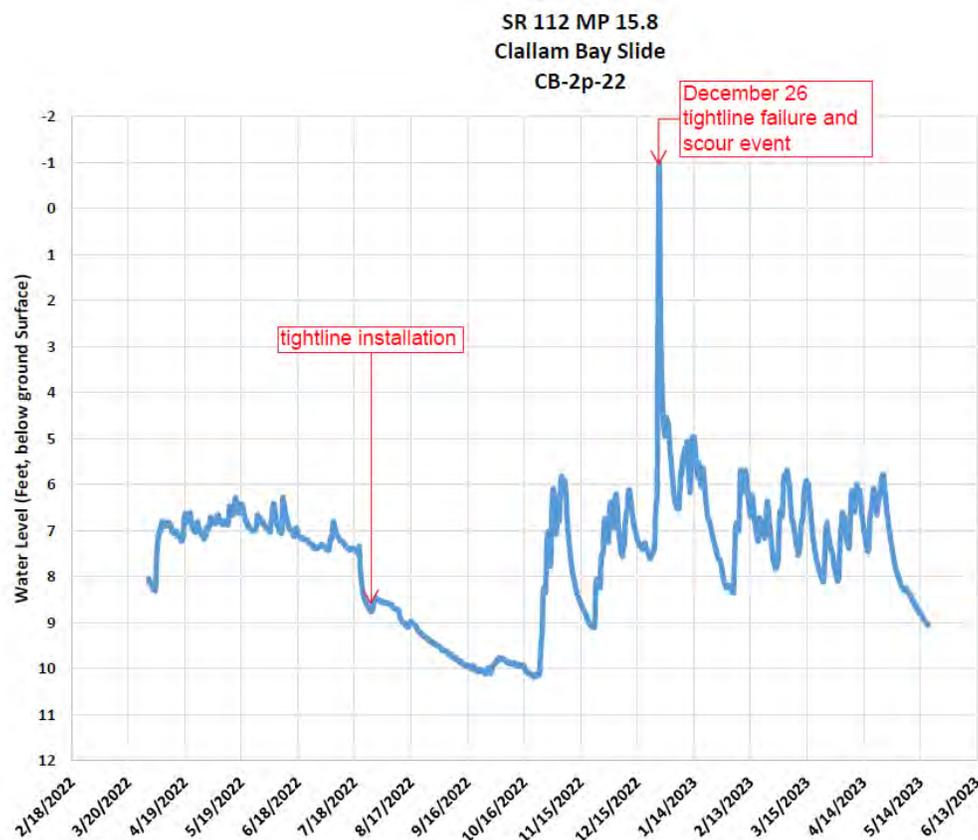
Figure 5: CB-2p-22 groundwater monitoring data

A piezometer was installed in test boring CB-2p-22 to obtain groundwater measurements. A pressure transducer was installed in the piezometer and connected to a datalogger to collect and store measurements at 6-hour intervals. The piezometer indicated that groundwater is present at a depth of approximately seven to eight feet below ground surface at the location of CB-2p-22.

Monitoring of piezometer CB-2p-22 is ongoing. The piezometer indicates that groundwater elevation was lowered by approximately 2 feet, shortly after the tightline was installed in July 2022 (Figure 5). Based on groundwater monitoring data through the following year, the tightline does not appear to adequately lower groundwater during the winter, and the reduction in groundwater we observed after the installation of the tightline may be a function of the dry season, rather than our efforts to eliminate water from infiltrating into the landslide with the tightline.

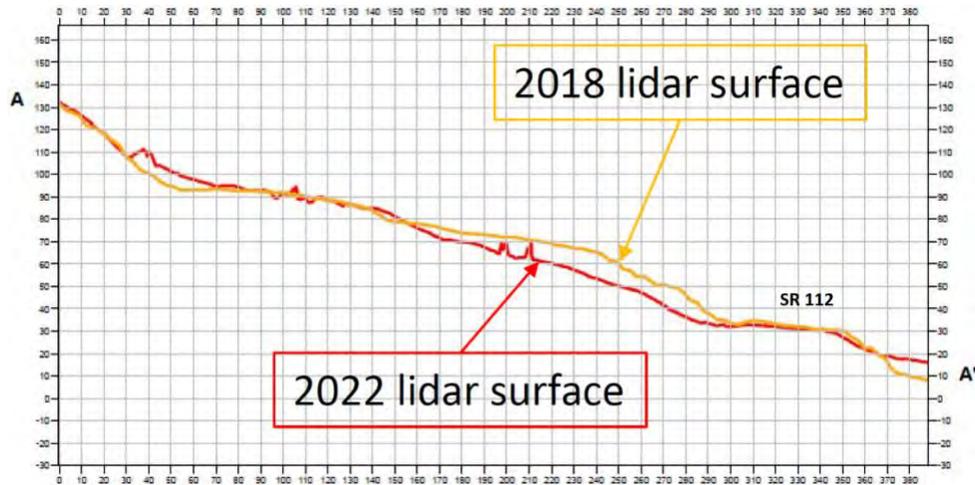
**Figure 6: A comparison of the ground surface along a longitudinal cross-section of the secondary landslide showing that material had been removed from the landslide toe during grading work.**

Using the pre-landslide aerial lidar (2018) and post-stabilization terrestrial lidar (2022), we developed and compared cross-sections longitudinal to the secondary landslide. We confirmed that the stabilization work had removed material from the toe of the 2006 secondary landslide.

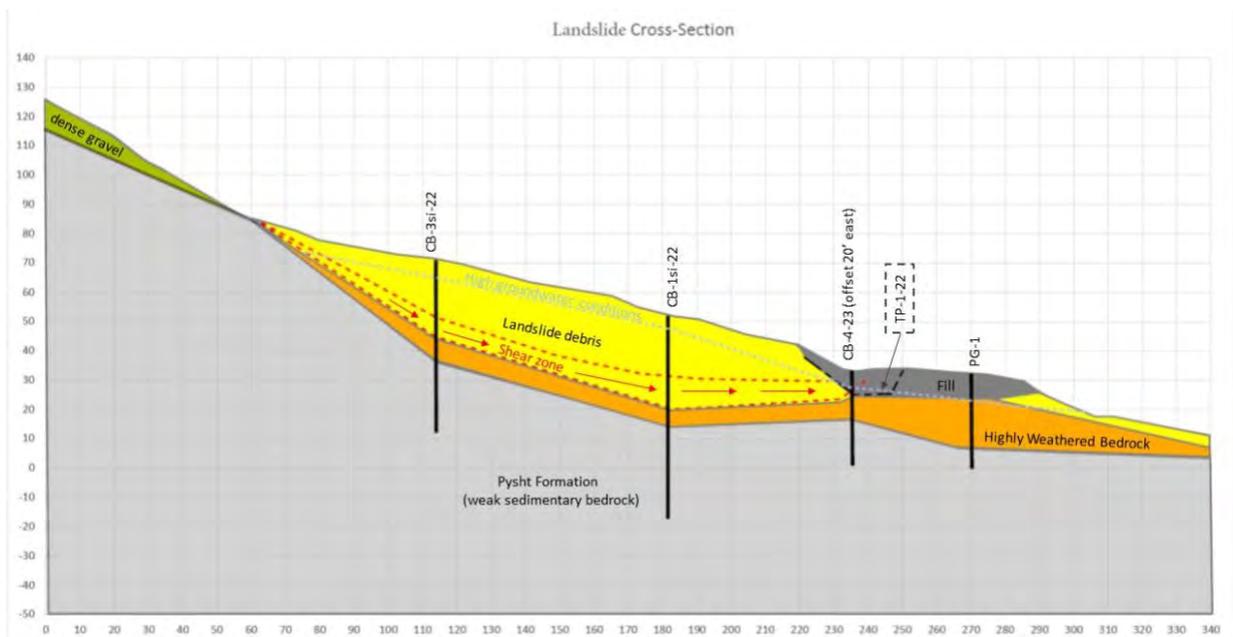
Based on the information collected from the geotechnical investigation, we developed a subsurface interpretation along the longitudinal cross-section of the landslide developed from the 2022 terrestrial lidar data (Figure 5).

**Figure 5: Landslide subsurface interpretation**

This subsurface interpretation was input into Rocscience SLIDE2, a limit-equilibrium slope stability analysis program. Engineering properties for subsurface materials were selected with guidance from laboratory index testing of samples retained from drilling in conjunction with

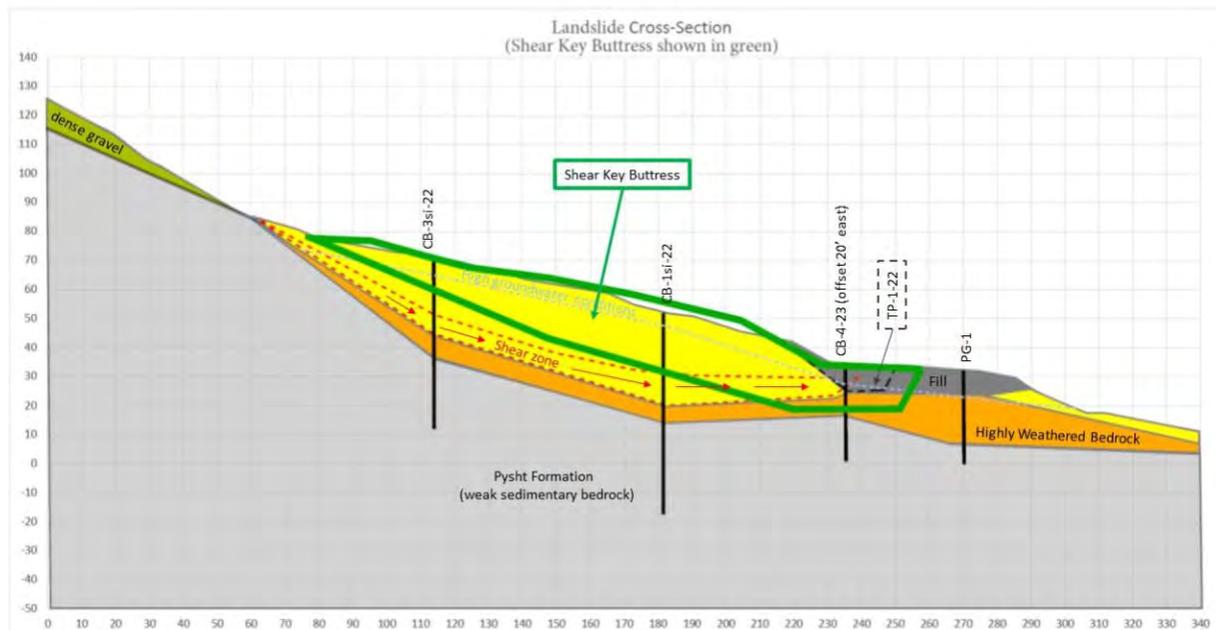
The shear key rock buttress was designed to meet or exceed a minimum Factor of Safety (FS) of 1.25 during high groundwater conditions (Figure 7). Our analysis indicates that the rock buttress requires a wide shear key to resist the landslide failure plane at the highway elevation and must extend upslope approximately 140 feet to prevent overtopping failures from above the buttress. The rock buttress will be 150 feet wide, along SR 112, to mitigate the entire landslide area.

**Figure 7: Landslide subsurface interpretation with the approximate limits of the proposed shear key rock buttress overlain with a bold green line.**

In addition to reinforcing the toe of the landslide, the buttress will have the added benefit of being constructed from well drained rock material and will lower the groundwater elevation within the landslide mass.

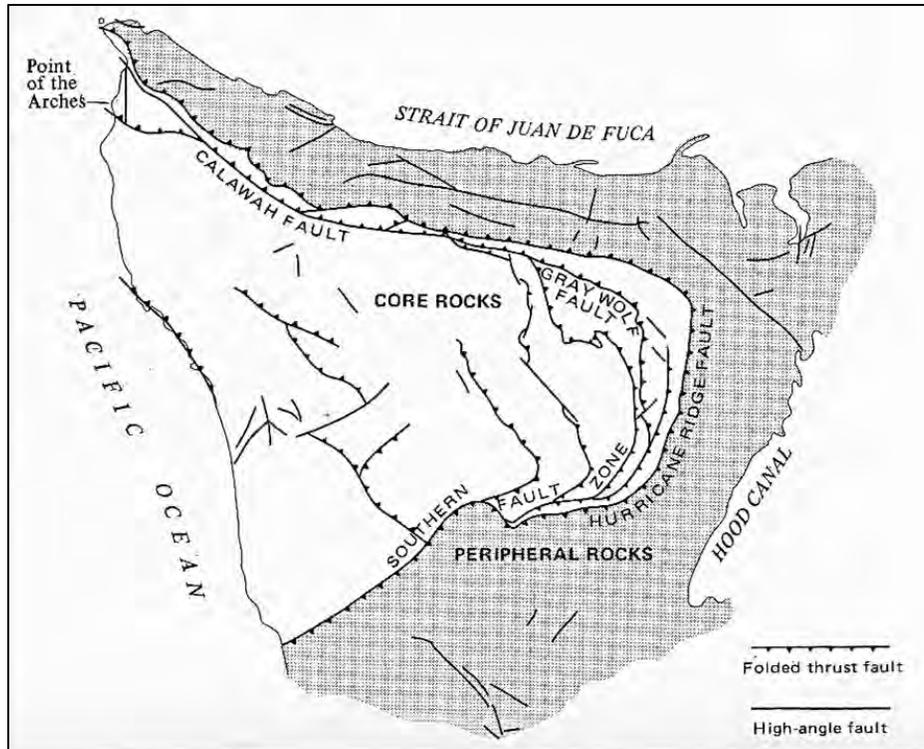
**FIGURE 1: GEOLOGIC ASSEMBLAGES OF THE PENINSULA (FROM 3)**

The formation of the Olympic Peninsula began around 50 Ma with the collision of a thickened slab of oceanic volcanic rocks, namely the Crescent Basalts, onto the North American tectonic plate. Development of an active subduction zone to the west and accretion of primarily marine sediments onto this Crescent Terrane followed. This assemblage of Crescent Basalt and deformed marine sedimentary rocks form the core of the Peninsula and Olympic Mountains. Post-collisional basins formed around the perimeter of this accreted terrane, which filled with sediment shed from the eroding continental margin (2). Continued convergence of the oceanic Pacific Plate with the North American continental plate along the Cascadia Subduction Zone has led to uplift of the Peninsula and tilting and folding of these peripheral sediments. These sedimentary rocks are referred to as the peripheral assemblage, and they form a horseshoe configuration (open to the west) around the core rocks (3) (Figure 2). Along the north side of the Peninsula in the vicinity of the highway, this peripheral assemblage of sedimentary rocks is tilted steeply (30° to 50°) toward the Straits. The lower northern flank of the Peninsula was extensively modified by Pleistocene-age continental glaciers that advanced into the Puget Lowlands and westward out the Strait.
