# 72<sup>nd</sup> Highway Geology Symposium

## 2023 PROCEEDINGS

August 14-17, 2023 • Hotel Murano • Tacoma, Washington

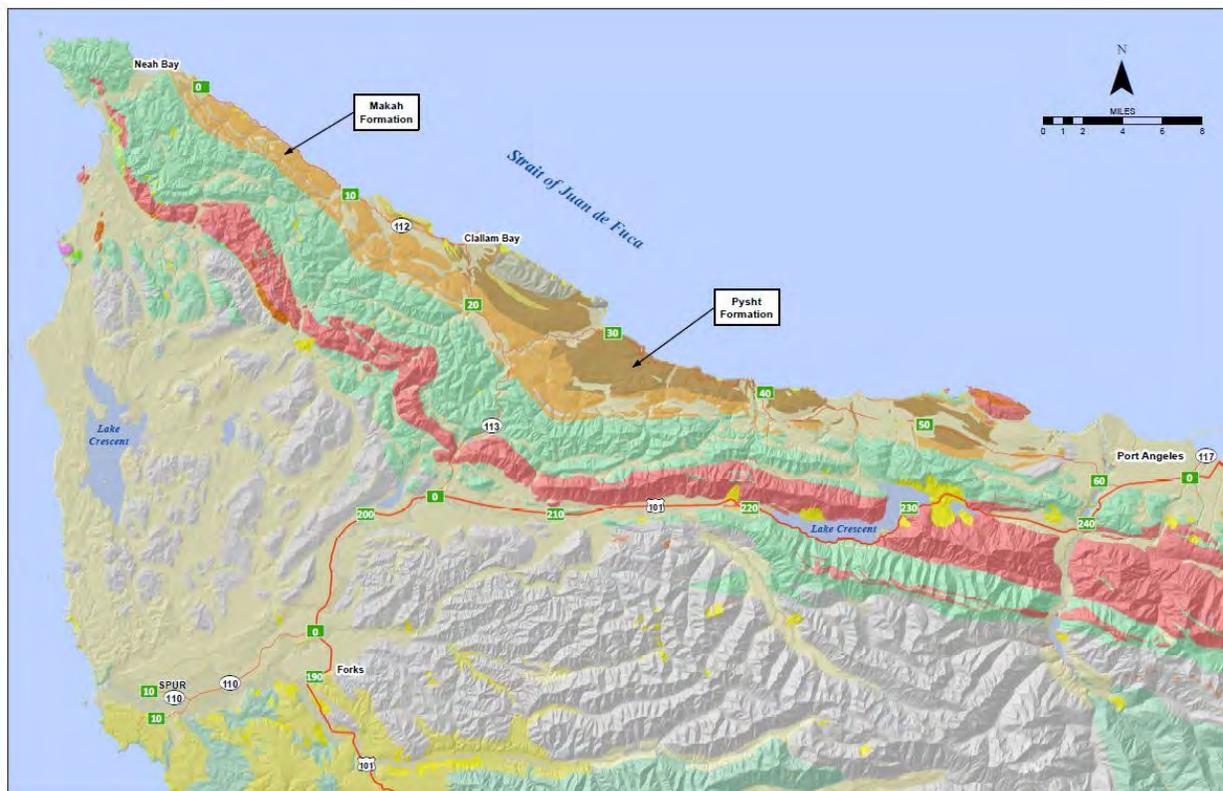
**FIGURE 2: GEOLOGIC MAP (MODIFIED FROM 4)**

Relevant to the abundance of landslides along the highway corridor between Neah Bay and Joyce are two of the younger sedimentary units of the peripheral assemblage, the Makah and Pysht Formations. These appear as E-W-trending bands of rock on the geologic map, with the Makah present from the reservation boundary to Clallam Bay, and the Pysht rocks present for the segment between the Pysht and West Twin Rivers (Figure 3) (modified from 4). The Makah Formation consists of interbedded sandstone and mudstone, and the Pysht Formation consists of primarily siltstone and mudstone. The weak nature of these fine-grained bedded rocks, weathering susceptibility, and adverse inclination are the primary geologic contributors to the contiguity of deep-seated landslides for tens of miles along the Strait (5).

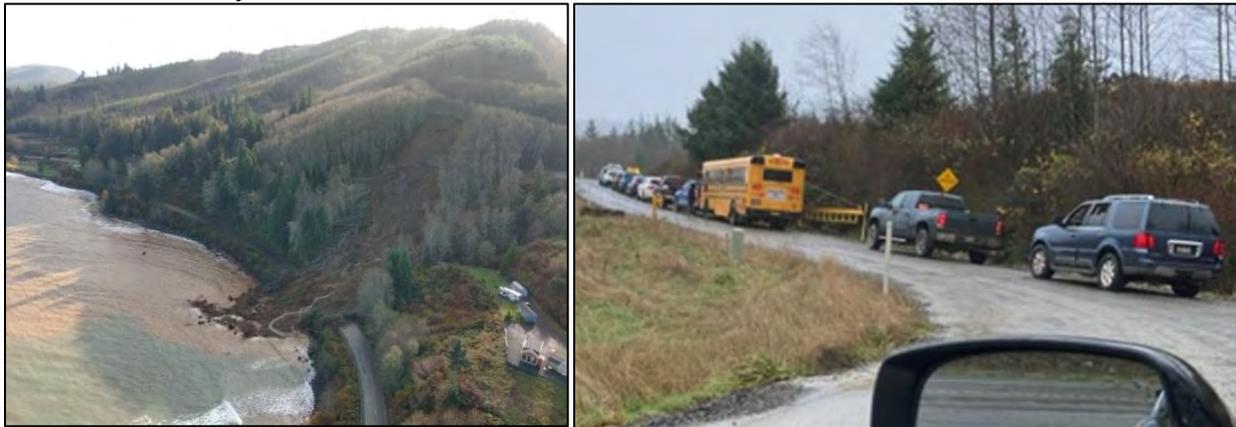
**FIGURE 4 AND 5: CLALLAM BAY LANDSLIDE AND RELATED TRAFFIC CONGESTION ON DETOUR**

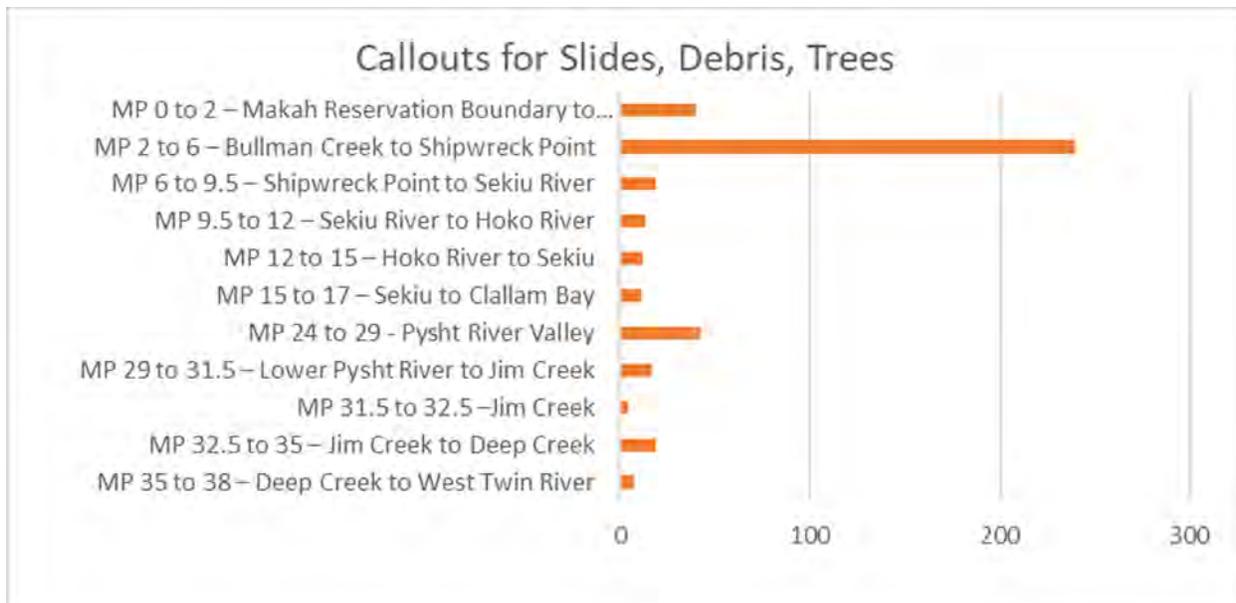
**FIGURE 6 – MAINTENANCE CALLOUTS FOR SLIDES, DEBRIS, TREES ON ROADWAY 2008-2022**

To better characterize the locations and nature of service disruptions, several WSDOT data sources were queried. An example frequency plot of callouts for Maintenance callouts by subsegment is depicted in Figure 6.

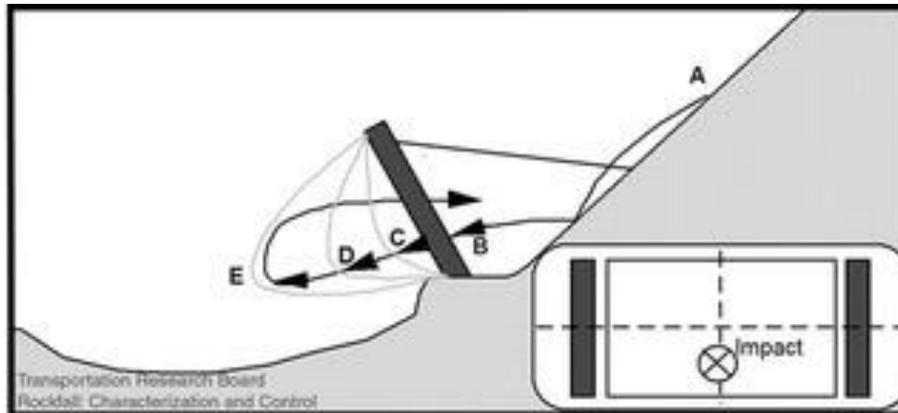
**Figure 1: Fully flexing fence (Duffy, Badger 2012).**

Beginning in the 1980s, research and development of flexible rockfall fence systems began and continues today resulting in a wide variety of systems developed to protect facilities from falling rocks. These systems were basically a fence with a wire mesh supported by an infrastructure of cables and posts and specifically designed to be flexible. The flexibility of these systems increased the time for the impacting rock to stop and thus reduced the forces on the system (Figure 1) with versatile and economical materials that have proven to be reliable for mitigating rockfall.

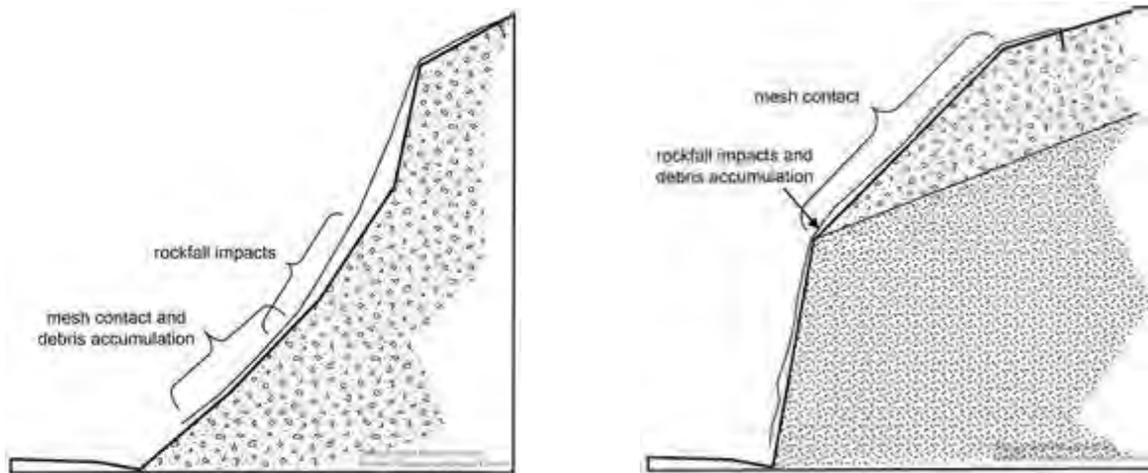
**Figure 2: Typical schematic of unsecured drapery (Badger, Duffy 2012).**

Long before the development of these new flexible rockfall fences, unsecured wire mesh draperies were commonly being hung on slopes for rockfall protection. The early unsecured drapery design was a single or double twist wire mesh laid on the slope and supported at the top of a slope with simple ground anchor system (Figure 2). The unsecured drapery covered the slope to mitigate only rockfall covered by that system and did not address rockfall generated from the slopes above. The drapery allowed rocks beneath it to move downslope in a slow and controlled trajectory and be deposited into a catchment area at the base of the slope where the rocks could be more easily removed by maintenance forces. This design approach remained relatively unchanged for years.

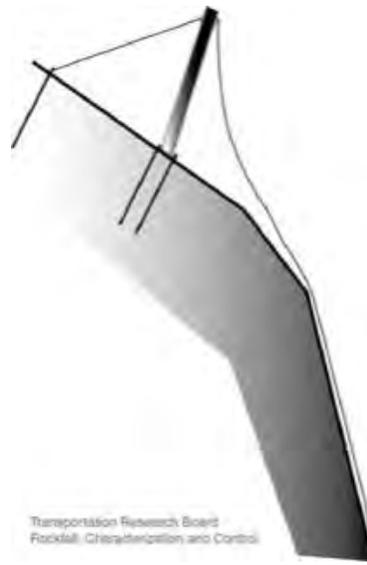
**Figure 3. Schematic of a typical flexible rockfall fence and an unsecured drapery combined (Badger, Duffy, 2012).**

An initial modification was to raise the top of an unsecured drapery to help capture rock fall generated from the slope above. A series of draperies installed in combination with flexible rockfall fences could be installed on long slopes whereby the rock is stopped by a fence and the rock can migrate under the draperies to the base of the slope. These modifications were initially referred to as Hybrid systems. A hybrid being made by combining the two different elements to achieve the benefits of both. In this case a flexible rockfall fence was combined with unsecured drapery (Figure 3).

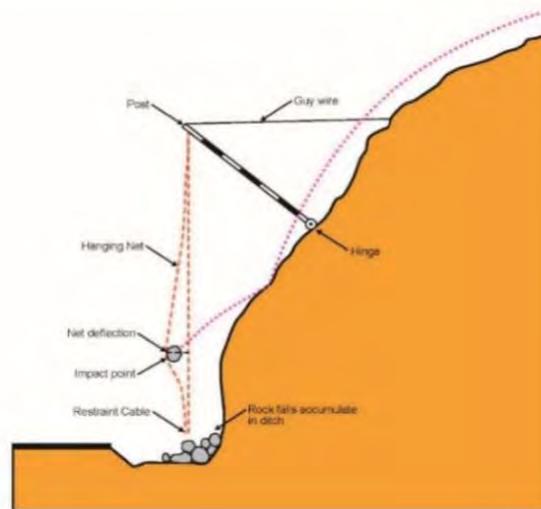
**Figure 4. Schematic of a typical design where the rock immediately falls into a suitable containment area at the bottom of the mesh and stops (Wyllie et. al., 2017).**

Combining key elements of a flexible rockfall fence and an unsecured drapery create a hybrid design whose purpose is to attenuate rockfall energy and trajectory. Is it a hybrid: yes. Is it an attenuator: yes. In either case there seems to be two general designs evolving. Both designs intercept rockfalls by elevating the upper part of the design off the surface exposing the upper portion of the design to impacts orthogonal to the plane of the mesh where rockfall is then channeled under the design and its trajectory confined within the plane of the mesh. But in one design, the rock immediately falls into a suitable containment area at the bottom of the mesh and stops (Figure 4).

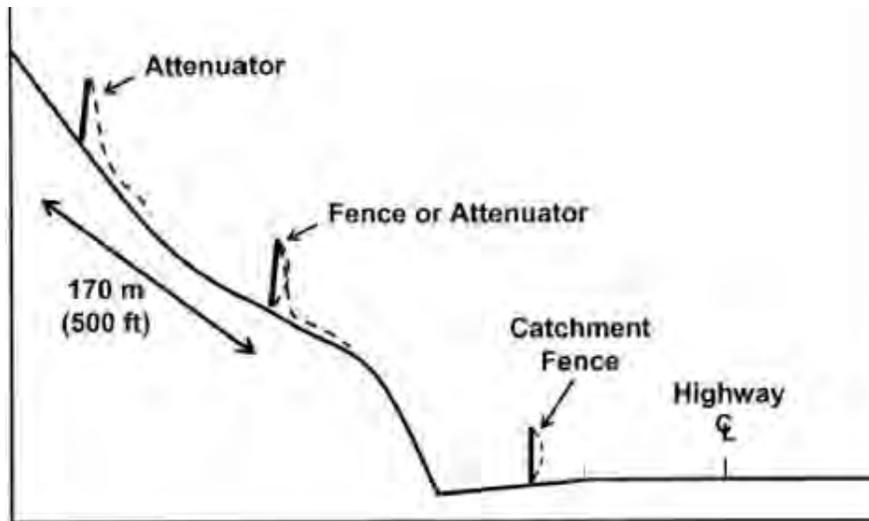
**Figure 5. Schematic of a typical design allows the rock blocks to continue down the slope essentially restarting the descent from a very low velocity (Arndt et. al. 2009).**

The other design allows the rocks to continue down the slope essentially restarting the descent from a very low velocity. The rock blocks can then continue downslope at a much-reduced speed and trajectory into a suitable containment at the base of the slope or into a series

of similar systems to control the rock blocks trajectory down a long slope eventually guided into a suitable containment area at the base of the slope (Figure 5).

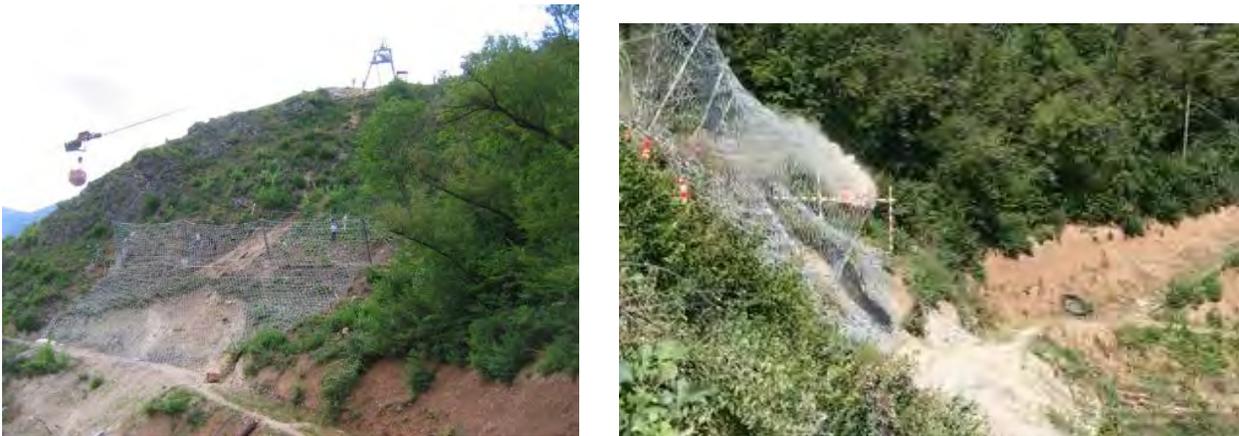
**Figure 6. 2007 IGOR Parimmissi Italy First Hybrid/Attenuator tests (Badger et. al., 2008)**

Seventeen years later the use of hybrid/attenuators was in full swing. In 2007 the first flexible hybrid attenuator system full scale test was performed in Italy by the company IGOR Parimmissi (Badger et. al., 2008). Four manufactured concrete rocks were rolled on a natural slope, and impact energies and rock trajectories were measured. The test design was 20 meters (65 feet) wide with three ring mesh panels supported by 4-meter (13 feet) high posts. The drapery section below the fence was 12 meters (39 feet) long ending at the at-grade bench. The mesh was a ring net. The system, referred to as a hybrid system, was placed at the edge of a break in a slope above a small cut slope with an open natural slope above (Figure 6). There were three flexible rockfall fence panels supported by four posts. The bottom was not fixed. At the base of the posts the drapery was connected to the bottom of the fence panels extending downslope in contact with the ground to a bench. This single design and wire mesh were tested. The design intent was to catch the rock, attenuate the energy, and guide the rock into a flat catchment area at the base of the slope. The maximum kinetic energy measured during the tests was 500 kJ (185 foot-tons). The system performed as intended with no maintenance required between tests.

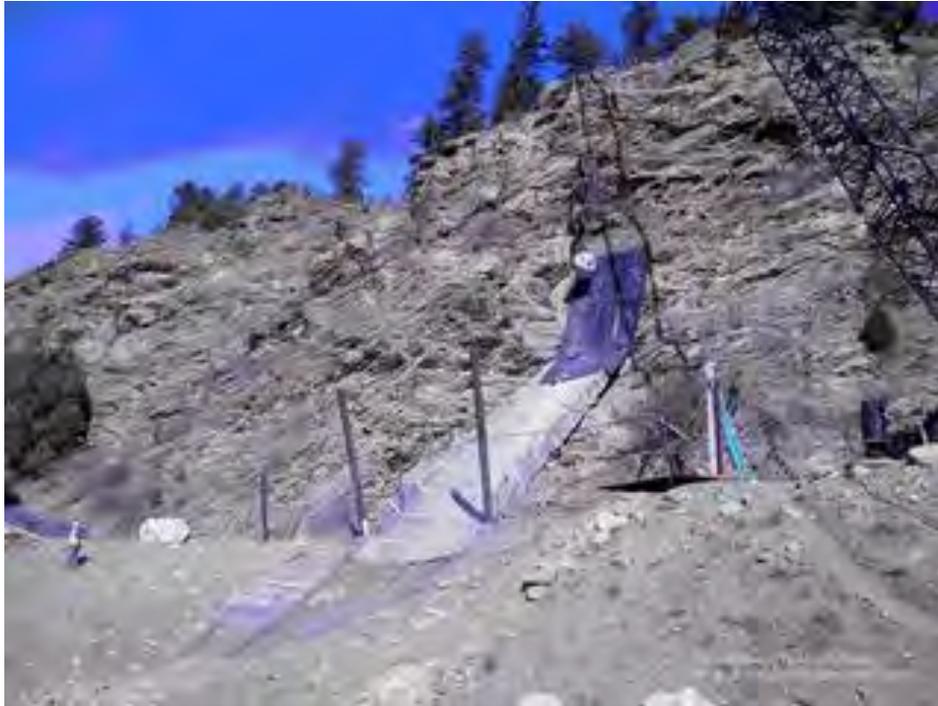
**Figure 7. Hidden Valley attenuator full scale test site (Arndt et. al., 2008).**

Two years later in 2009 the Colorado Department of Transportation published the results of their comprehensive study for what they referred to as an attenuator (Arndt, et. al., 2009). In these full-scale tests two infrastructure designs were used one was a single panel width of 6 meters (20 feet) and the other was a three-panel width of 18 meters (69 feet) (Figure 7). Eleven different mesh panel materials and two different post configurations were evaluated. Like the Italian tests this testing used a near vertical flexible rockfall fence that were 3 and 6 meters high (10 and 20 feet), not connected at the base but instead a drapery was attached below the fence varying in length from 1.5 to 9 meters (5 to 30 feet). One hundred and twenty-five rock-rolling tests were performed by dropping concrete and rocks onto a ramp (unnatural slope) and into the

system. Six sizes of concrete test rocks were used weighing up to 3,800 kg (8,360 pounds). The maximum total kinetic energy measured during the testing was 500 kJ (185 foot-tons). The design approach was to test each design to failure and evaluate their ability to attenuate (reduce) rockfall energy, the amount of deformation, the maintenance required, the amount of tail (drape length) required to adequately attenuate the rockfall energies, the durability of the post-to-foundation connections, and the amount of fly-up of the drapery tail that occurred upon rock impact (Arndt et. al., 2008).

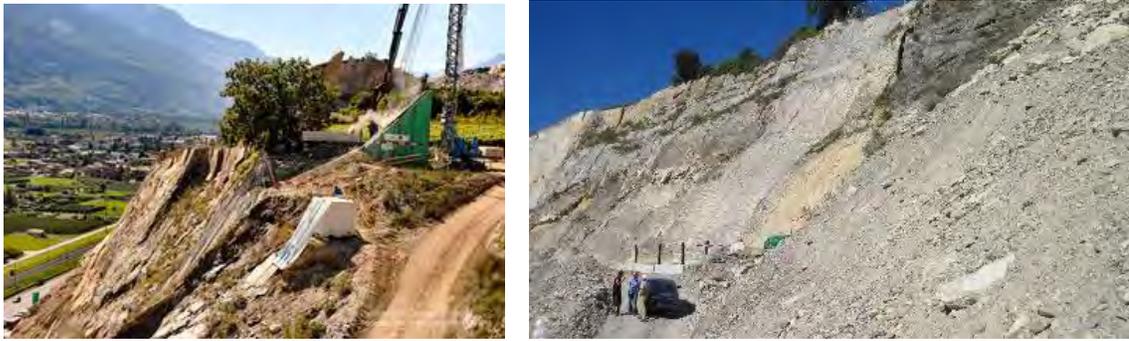
**Figure 8. Saint Leonard Attenuator and Hybrid Design full scale test site (Glover et. al., 2010) (Badger, Duffy, 2012)**

In 2010 the Swiss Federal Institute for Forest, Snow, and Landscape Research (WSL) in collaboration with Geobruugg performed full scale field testing examining the attenuation properties of a hybrid system (Figure 8) (Glover et. al., 2010). The tests were performed for a single system that consisted of a near vertical flexible rockfall fence that was 3 meters tall and 8 meters wide creating a 6-meter-long impact zone. A drapery was attached to the base of the fence that extended 40 meters along the slope below the fence. The mesh was a high tensile spiral wire rope net. At the base of the slope was a ditch created and a 3-meter (10 feet) high flexible rockfall fence. Seven rocks were rolled by dropping natural rocks onto a ramp, onto a natural slope, and down into the system. The natural rock weights ranged between 300 to 1,200 kg (660 to 2600 pounds). This test focused on reduction in kinetic energy, bounce height, impact energy, and exit velocity. The system performed as intended with no maintenance required between tests.

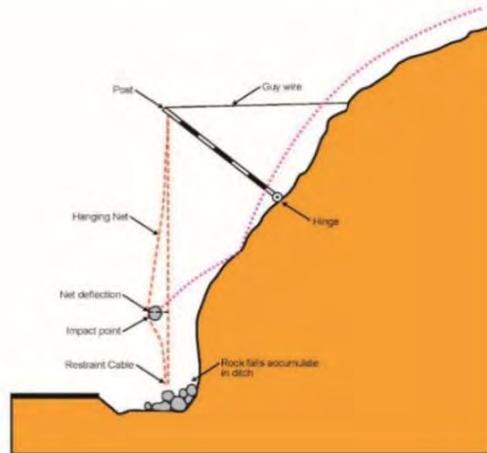
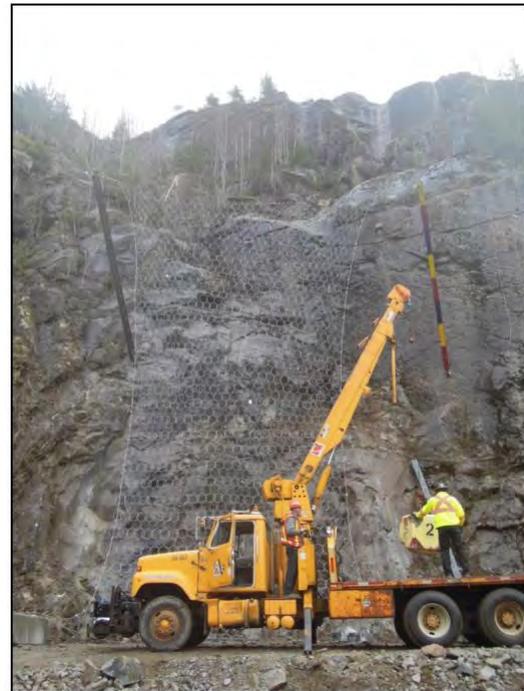
**Figure 9. Nicolum Test site and schematic of attenuator configuration tested (Wyllie, et. al., 2017).**

In 2016 full scale testing continued at the Nicolum Site. An attenuator similar to the 2015 design underwent full scale testing, with the mesh hanging vertically from the top of the posts to the ground within the catchment area (Figure 9). The principle of this attenuator design is that rocks were deflected by the net into the ground such that the net structure only absorbed a portion of the impact energy, and the major portion of the energy was absorbed by the ground (Wyllie et. al., 2017). Rocks, natural and concrete, as large as 950 kg (2200 lbs.) were used in the tests.

In 2015 and 2016, a total of 46 tests were performed at the Nicolum test site. Rocks were rolled on natural ground and analysis provided dynamic measurements of rockfalls and attenuator interaction. Translational velocity, and where necessary the rotational speed of the blocks, were measured from the time just before impact with the net, to time of impact with the ground. In these tests, the impact of rockfalls with the attenuator net system were analyzed using the conservation of momentum principle. During the time the block is in contact with the net the loss of momentum of the test blocks was equal to the gain in momentum in the net. This full-scale testing for attenuators was carried out to evaluate the detailed mechanics of their behavior during impact with respect to such factors as net impact, load transfer into the support cables, and net deflection (Wyllie et. al., 2017).

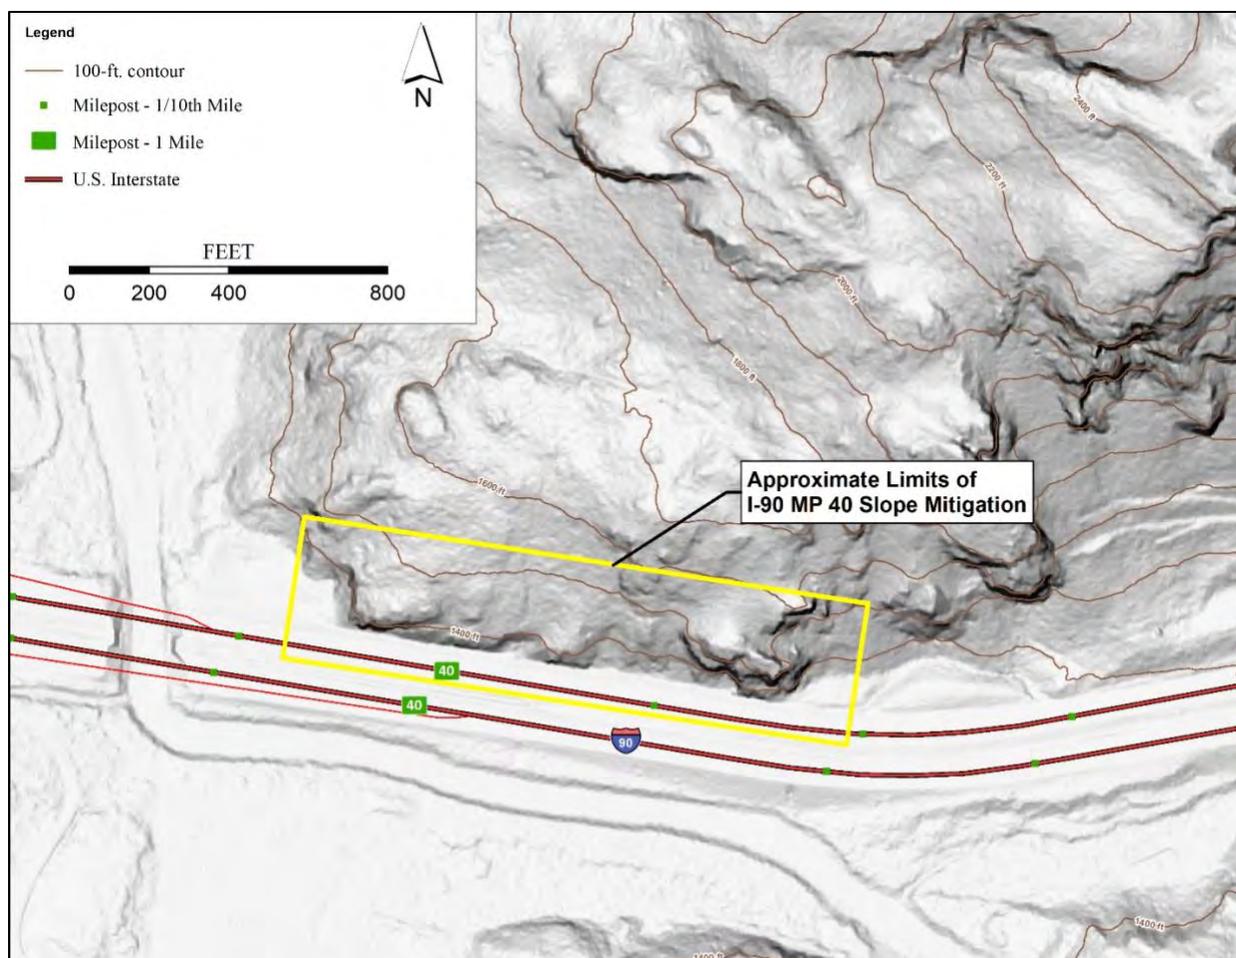
**Figure 2 – Lidar Hillshade Map of the I-90, MP 40 Site Vicinity.**

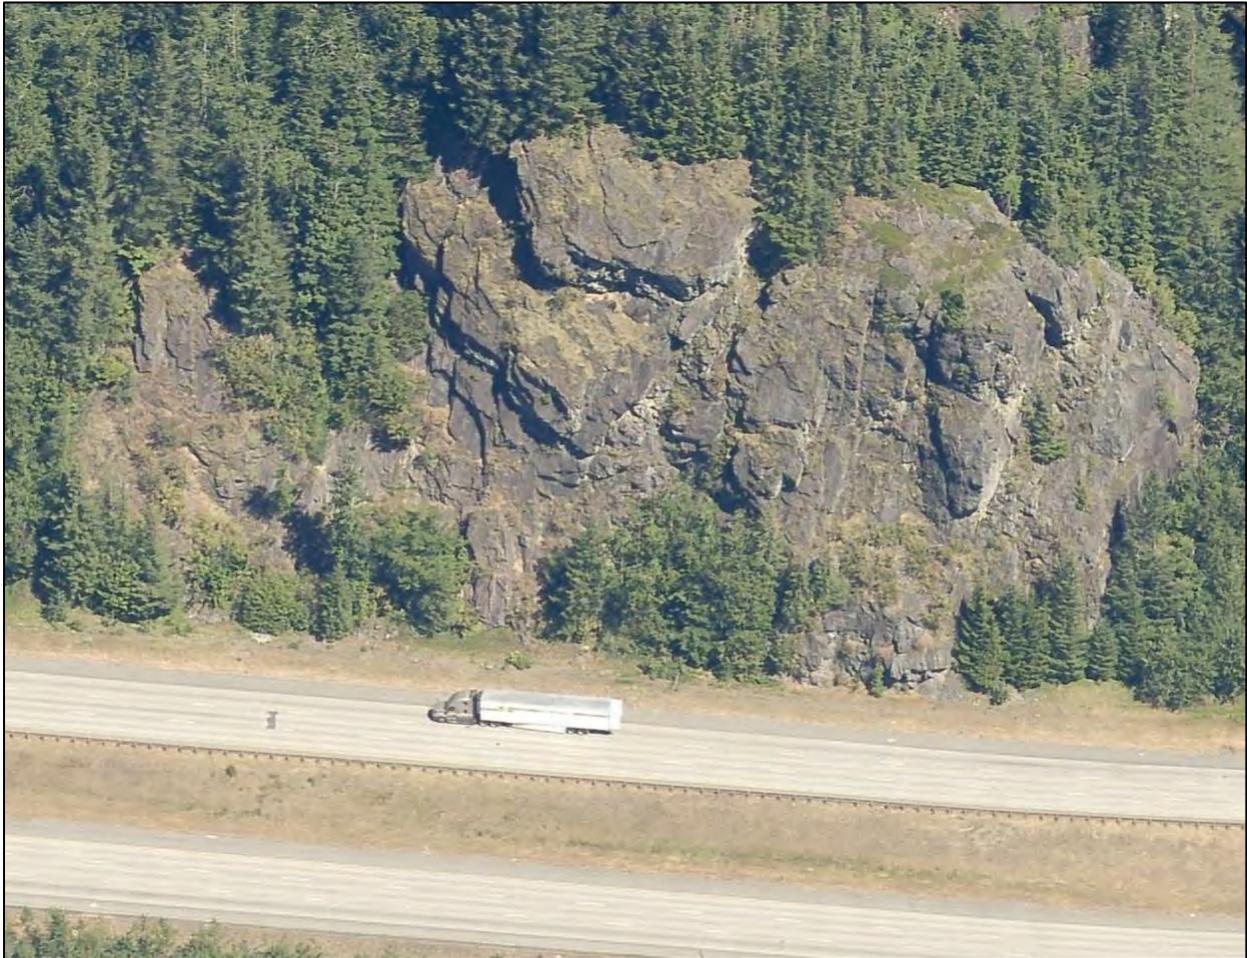
**Figure 3 – Oblique Aerial Photograph Showing Some of the Highway-Dipping Rock Slabs Perched Above WB I-90 at MP 40 in Washington State.**

Despite the lack of documented historical instability on the slope, the large rock slabs resting on highway-dipping fractures present hazards to I-90 that necessitate geotechnical slope mitigation measures (Figure 3).

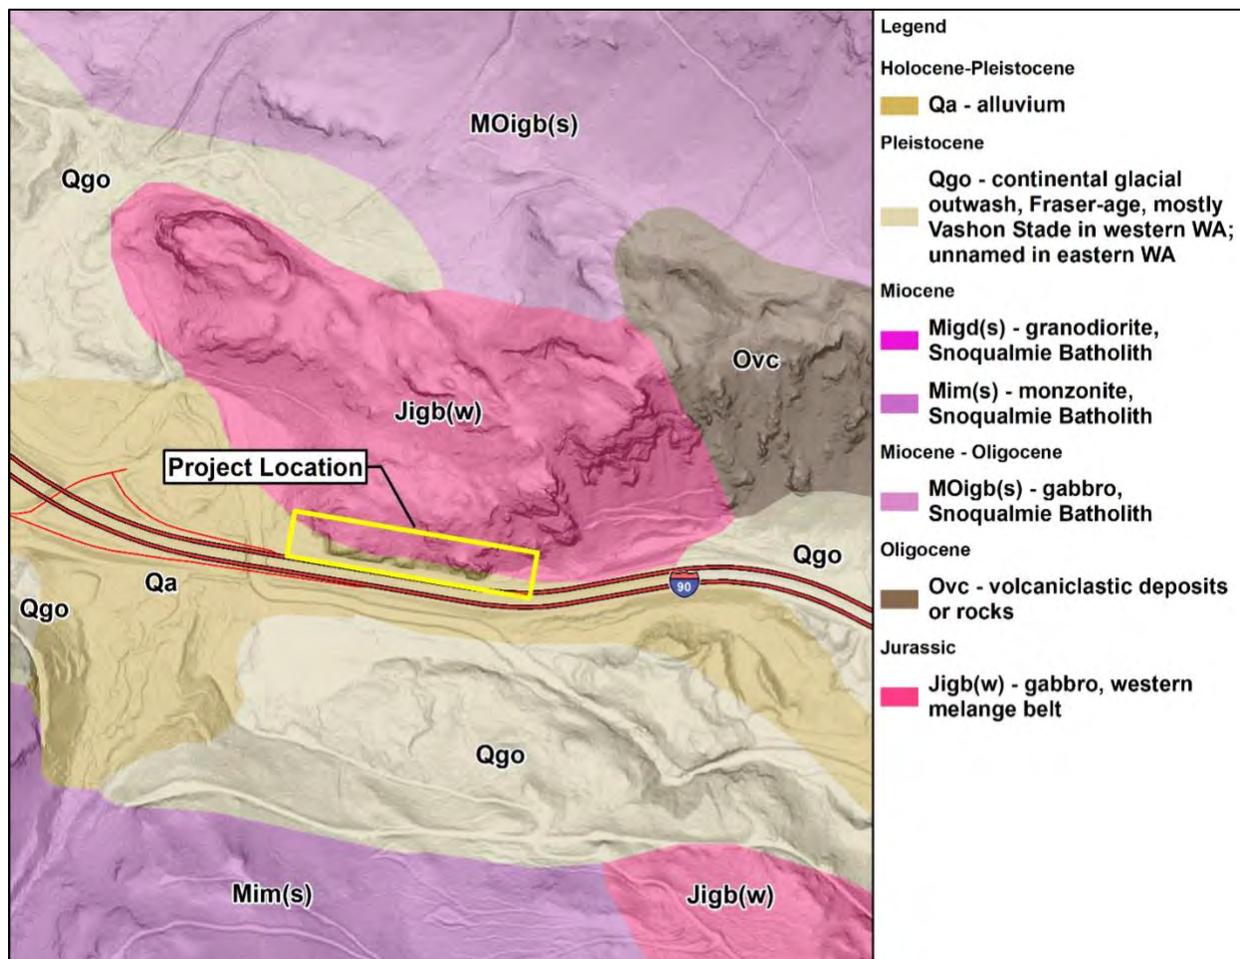
Figure 4 – Excerpt of 1:100,000-Scale Geologic Map in the Vicinity of I-90, MP 40 (4).

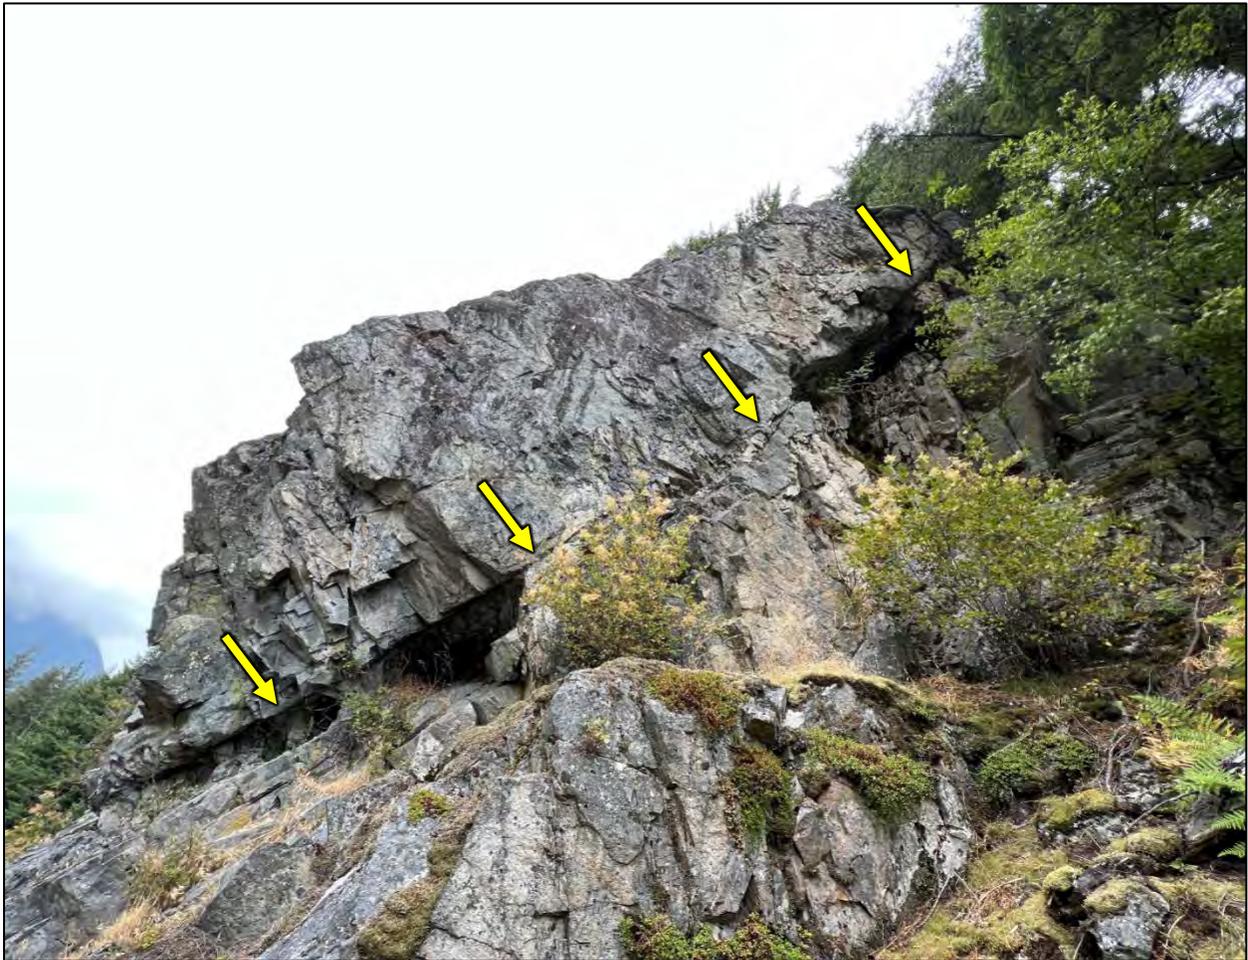
**Figure 5 – 2022 Field Photograph of the Primary Highway-Dipping, High-Persistence Joint Set (Yellow Arrows). The I-90 Travel Lanes are Out of Frame, Downslope to the Left.**

The rock mass on the slope is moderately to highly fractured (jointed) and exhibits at least one prominent discontinuity set that dips toward the I-90 travel lanes, with dip directions ranging between 170° and 220°, and dip angles ranging between approximately 40° and 75° from horizontal (Figure 5). In at least three locations, basalt sills were observed that were coplanar with the highway-dipping discontinuity set (Figure 6). This set commonly exhibits high to very high persistence and very wide to extremely wide spacing, in some cases defining very large, adversely dipping slabs 10s of feet thick and 100 or more feet in extent.

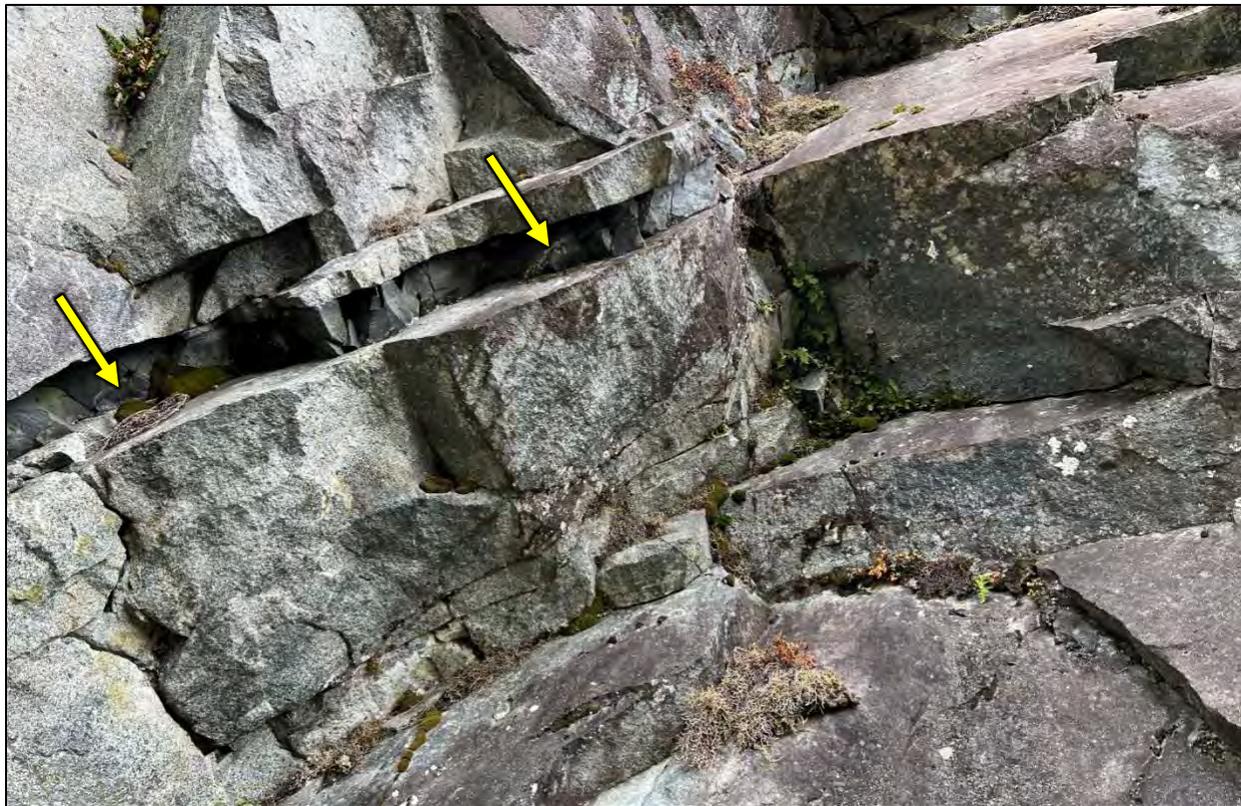
**Figure 6 – 2022 Field Photograph of a Basalt Sill (Yellow Arrows) Parallel to the Highway-Dipping, High-Persistence Joint Set. The Sill Shown Here is Approximately 0.5 Feet Thick.**

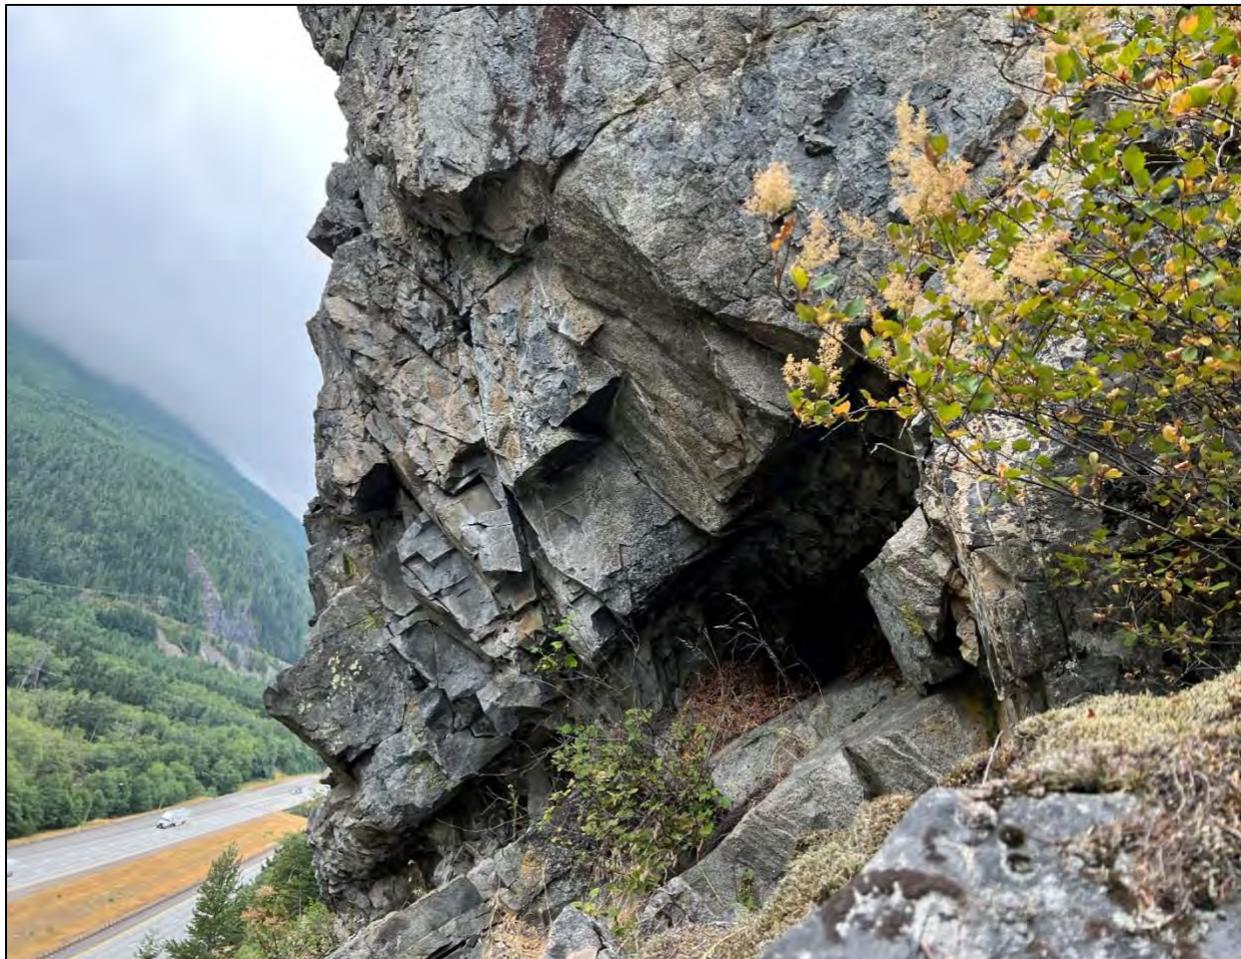
**Figure 7 – 2022 Field Photograph of a Large Void Caused by Preferential Weathering of a Basalt Sill Along the Base of a Highway-Dipping Rock Slab. I-90 is Visible at Lower Left.**

Several large, conspicuous voids are present along the bases of two of the largest highway-dipping rock blocks on the slope (Figure 7). These voids are apparently the result of preferential weathering of hackly-fractured basalt sills that are present along the base of these two blocks.

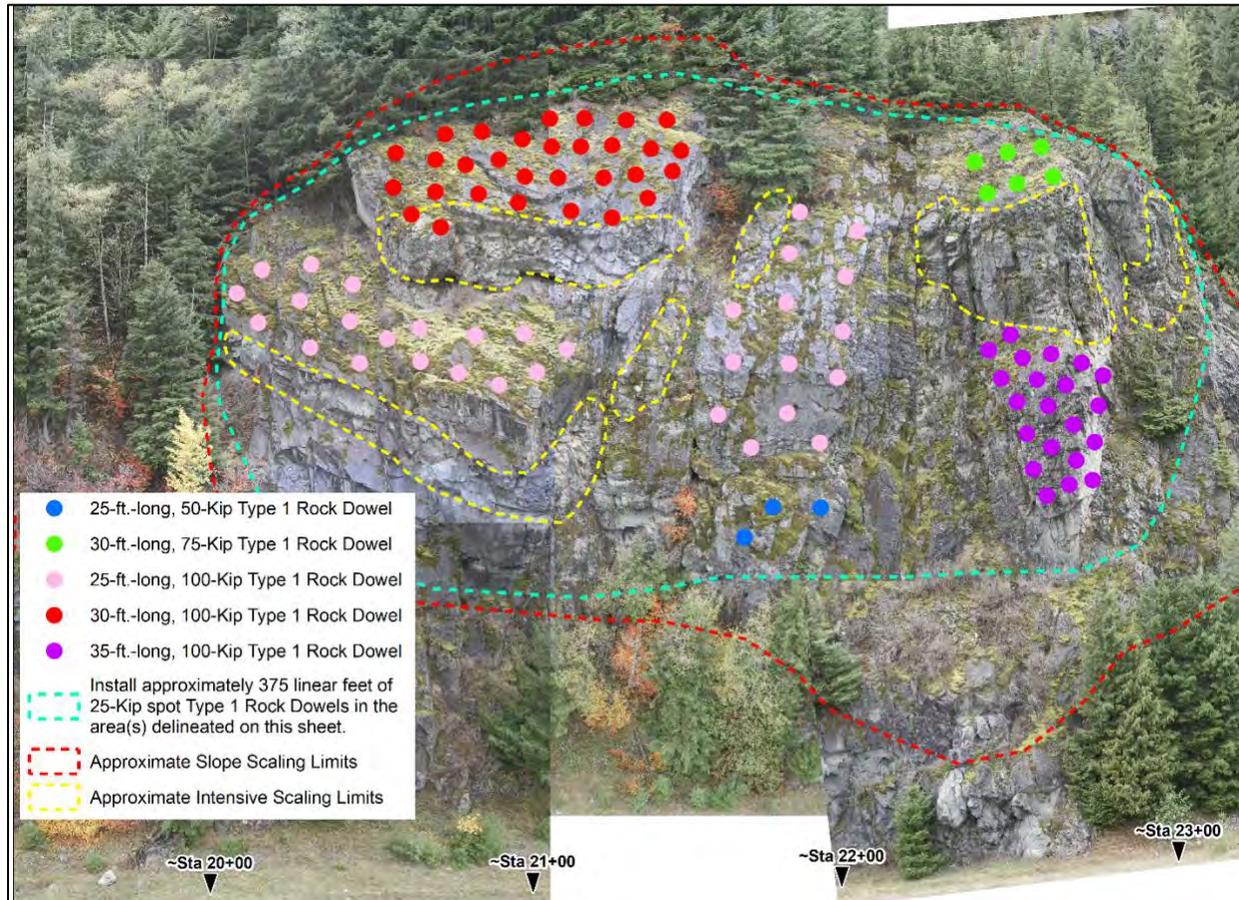
**Figure 8 – Selected Excerpt of Proposed Slope Mitigation Plans, Showing Preliminary Layout of Slope Scaling and Rock Dowel Installations.**

Based on the reinforcement quantities modeled in RocPlane, WSDOT recommended installing approximately 3700 linear feet of untensioned rock dowels in the slope, with capacities ranging from 25,000 lbs (25 kips) to 100 kips (Figure 8). Post-tensioned rock bolts were not considered for this project, due to the increased time required during installation and testing of

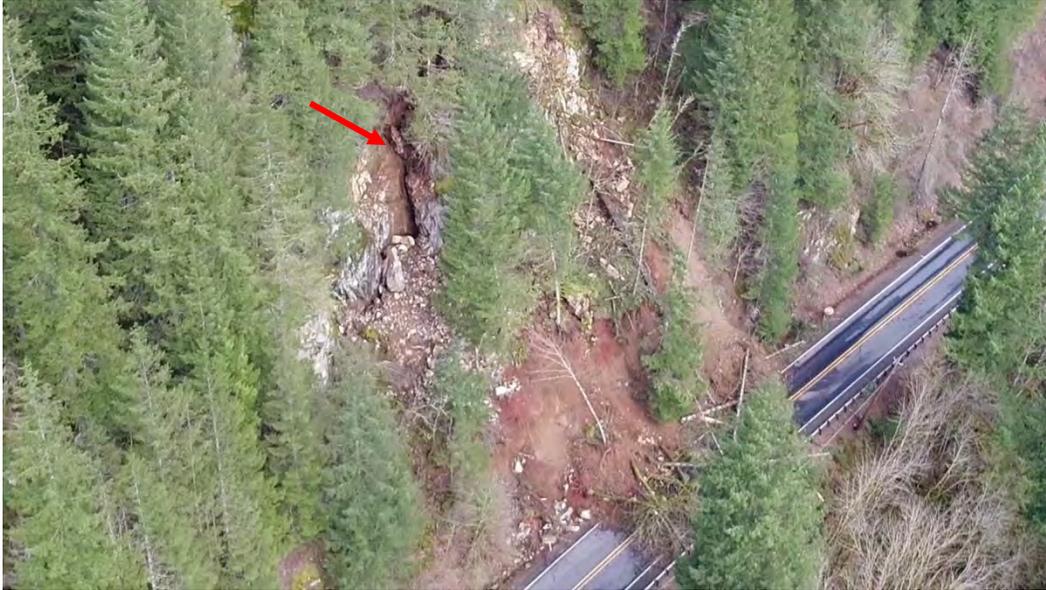
**Figure 2. Oblique aerial view of debris on highway at vicinity MP 34.34 and exposed western edge of subvertical decoupled rock slab (red arrow) above the highway (image taken 3/16/17).**

rockfall, trees and debris on the highway, a large subvertical rock slab had decoupled from the cliff face north of the highway and had come to rest in a precarious subvertical orientation on a highway-sloping bench (Figure 2). Further investigation revealed that adjacent rock slabs were also at risk of decoupling and falling in a similar manner. A fast-tracked response, development of partial mitigation recommendations, safety monitoring of the slope, initial partial mitigation (discussed in more detail below), and partial reopening of the highway followed. Concurrent with the above activities, a follow-on bid contract was developed to address a longer-term mitigation. The bulk of the Phase 2 mitigation was completed in January 2018. The repaving portion of the mitigation was completed in late March 2018. This paper outlines the Geotechnical Office's response, investigation, and recommendations, as well as the completion of the recommended mitigation under the emergency and Phase 2 contracts.

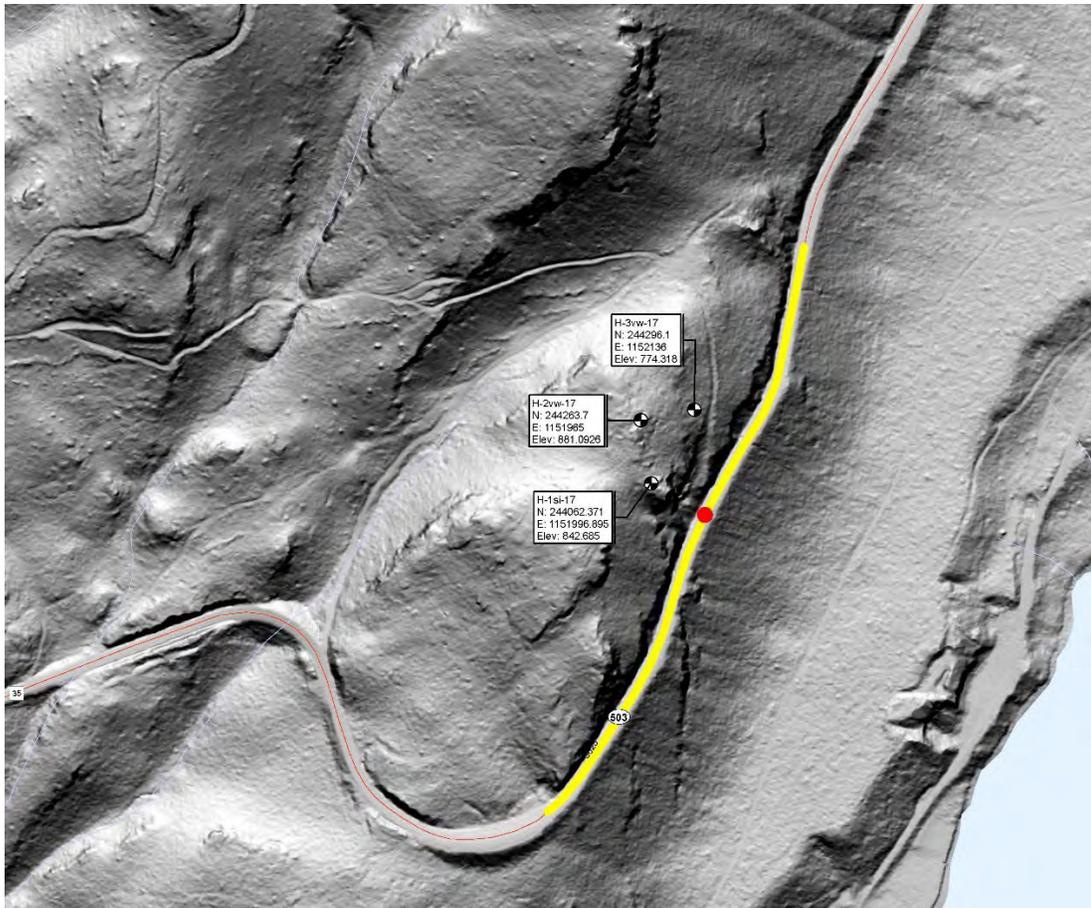
**Figure 3. LiDAR map showing test boring locations (red dot is centered on the subject failure area).**

As an aid to kinematic and slope stability analysis of the bedrock in the failure area, two of the test borings (H-1si-17 and H-2vw-17) were selected for down-hole instrumented logging,

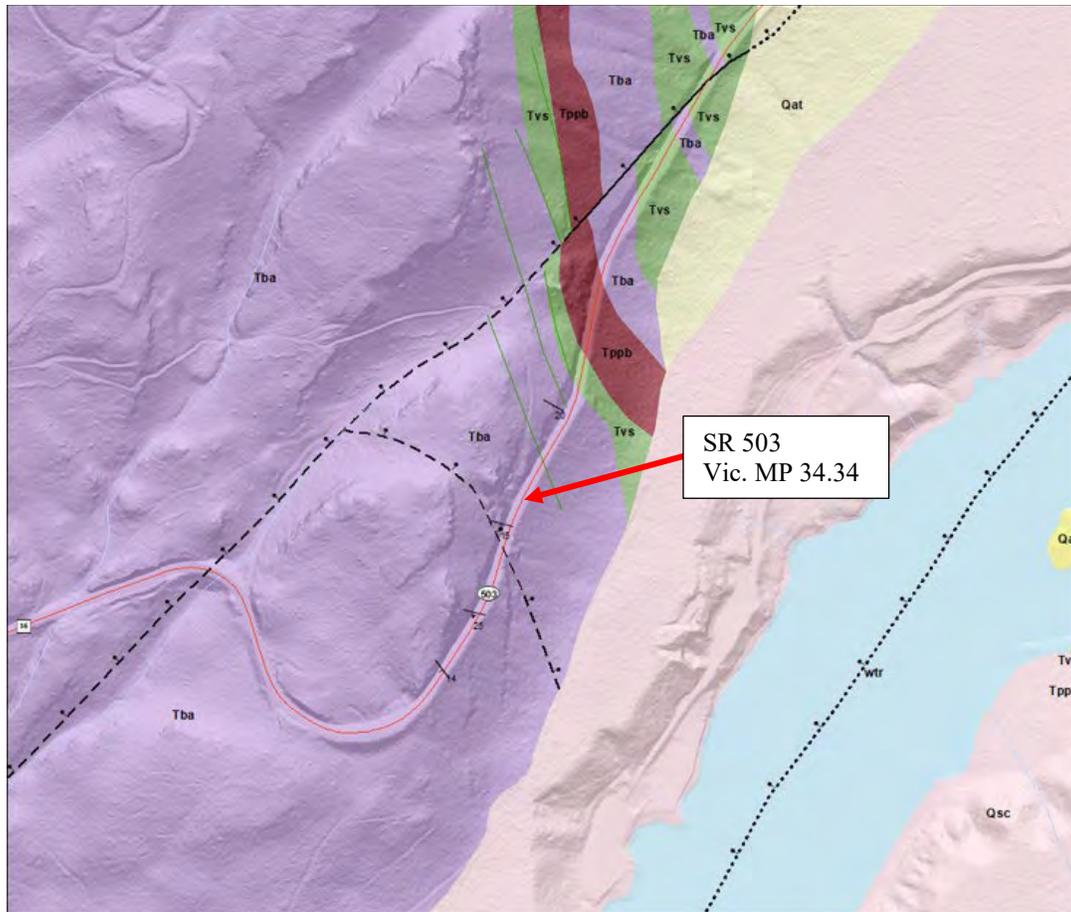
**Figure 4. Site geologic map (adapted from Evarts, 2005)**

Field observations and data from test borings were found to be consistent with this description. Regional tectonism has resulted in southwestward tilting of the once subhorizontal layers (Figure 4).

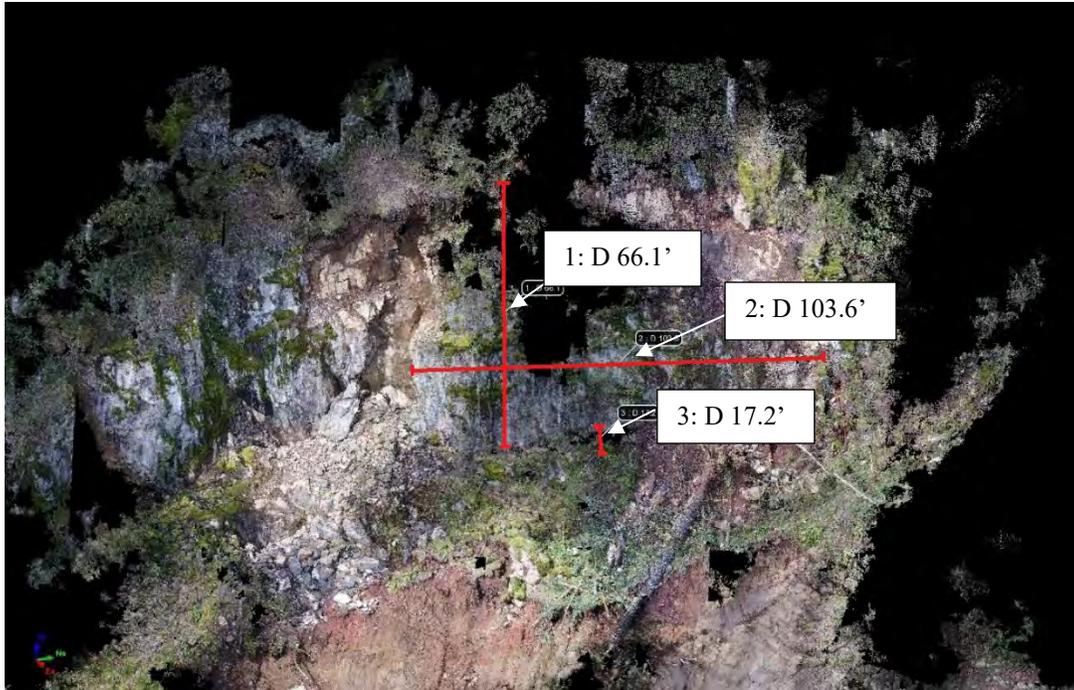
**Figure 5. Oblique view, north, toward failed rock slab, in point cloud derived from UAV data and pulled into point cloud processing software by the GeoMetrix Office. Approximate exposed dimensions of the failed rock slab are shown (in feet).**

Based on a preliminary point cloud derived from the UAV data (via structure from motion software), the original failed rock slab measured approximately 60 to 65 feet tall, 100 to 105 feet wide and 10 to 20 feet thick (Figure 5). Using the average measured unit weight of the in-situ rock (174 lbs./ft.<sup>3</sup>) and the dimensions shown in Figure 5 (excluding any embedment in the duff or vegetation cover), the slab constituted approximately 4,360 cubic yards of material and weighed approximately 20.5 million pounds or approximately 10,250 tons.
