# 72<sup>nd</sup> Highway Geology Symposium

## 2023 PROCEEDINGS

August 14-17, 2023 • Hotel Murano • Tacoma, Washington

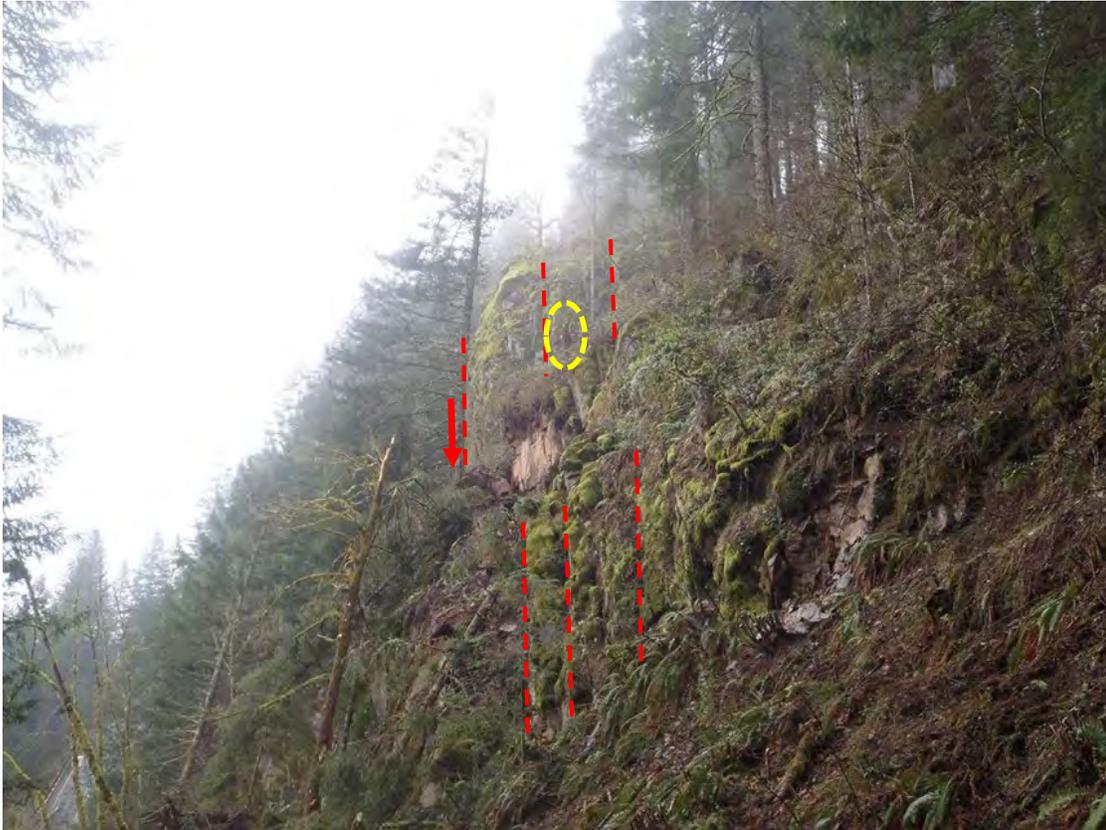
**Figure 6. View west, toward top of subject detached rock slab (red arrow). Also visible is an end-on view of the dominant subvertical discontinuity set (highlighted by red dashed lines) that tends to act as release surfaces for failures and to allow infiltration of rainwater. A scaler standing in the photo (yellow circle) provides scale. SR 503 is visible at lower left corner. (Region photo, dated 4-1-17).**

in the cut slopes and cliffs at and above the highway in this area. Where exposed on steep slopes, it tends to form steep cliffs, subparallel to its dominant southwesterly-striking discontinuity set (Figure 6). Uniaxial compression tests of samples within this rock sequence (sampled primarily from the relatively unweathered volcanoclastic rock) yielded strengths ranging between 1,125 psi and 4,989 psi.

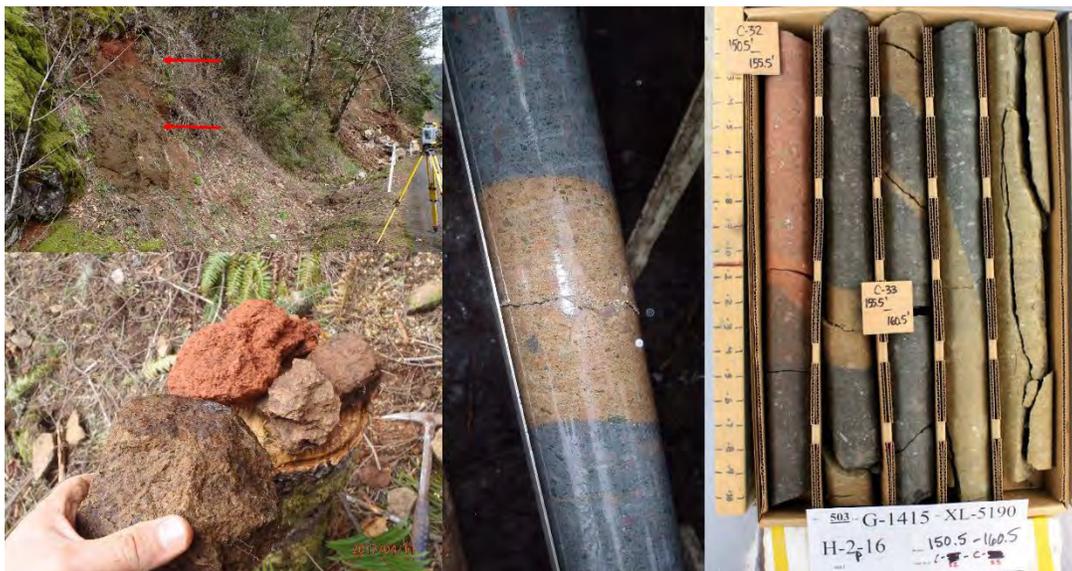
**Figure 7. Photos showing locations where ESU 2 was encountered: lower left, in float; upper left, in outcrop west of the failure; and at right, in the drill core. The center photo illustrates weathering in ESU2 at an existing discontinuity.**

ESU 2 is a persistent southwesterly-dipping volcanoclastic rock unit that underlies the subject failure area. In exposures, it is generally olive brown in color and capped by an approximately 1-to-3-foot-thick reddish brown layer (Figure 7), interpreted to be a “baked zone” (thermally oxidized portion of the top of the volcanoclastic rock). This unit was initially encountered in “float” (disaggregated surface rocks) below the failure site, in an outcrop immediately west of the failure site, in two of the three test borings, and in later exposures during construction. Uniaxial compression tests of grab samples (from the failure area) of this highly weathered form of the volcanoclastic unit yielded strengths ranging between 86.1 psi and 231 psi. These low strengths are in stark contrast with the in-situ strengths of this unit, as encountered in

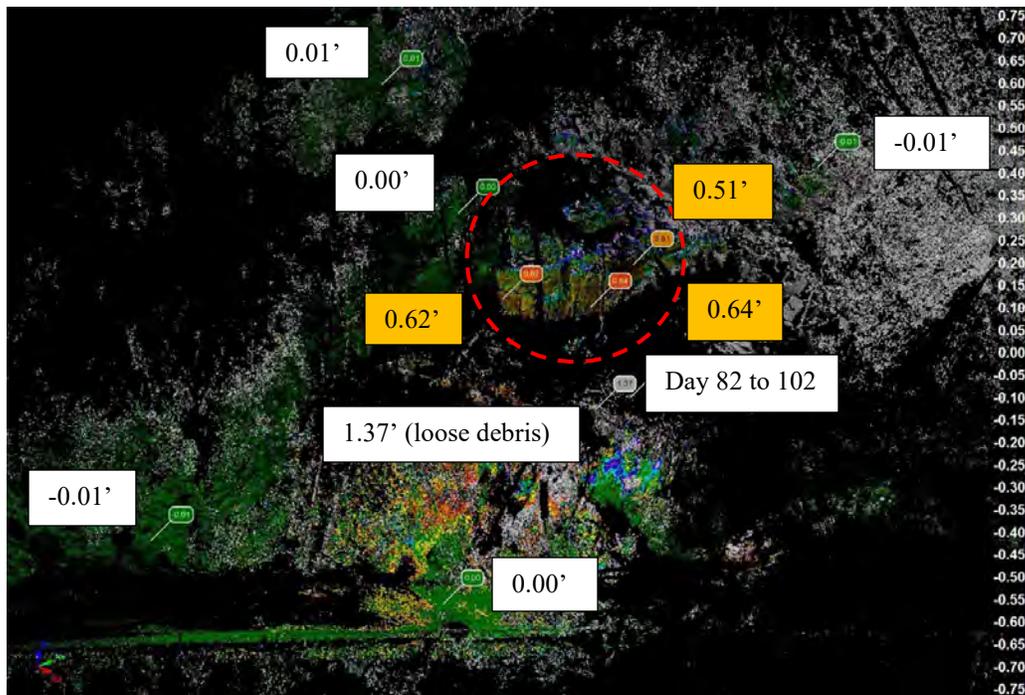
**Figure 8. Terrestrial LiDAR change analysis, in feet (day 82 to 102, 2017), showing that the detached rock slab (circled area) had moved outboard approximately 7-½ inches in 20 days. The above movement predates the first trim blast of the top of the rock slab that occurred on 4-13-2017.**

The subject decoupled rock slab consisted of a single very large block or slab of ESU 1 that failed within the upper few feet of ESU 2, while one of several subparallel highly persistent subvertical discontinuities served as a release surface. Through the GeoMetrix Office, we conducted safety monitoring of this decoupled slab (via baseline and follow-on terrestrial LiDAR scans) in the days and weeks following the initial failure, and during the emergency contract period. These scans confirmed the precarious nature of the rock slab's configuration, as the lower edge of the slab was found to be creeping slowly in the downhill direction (Figure 8).

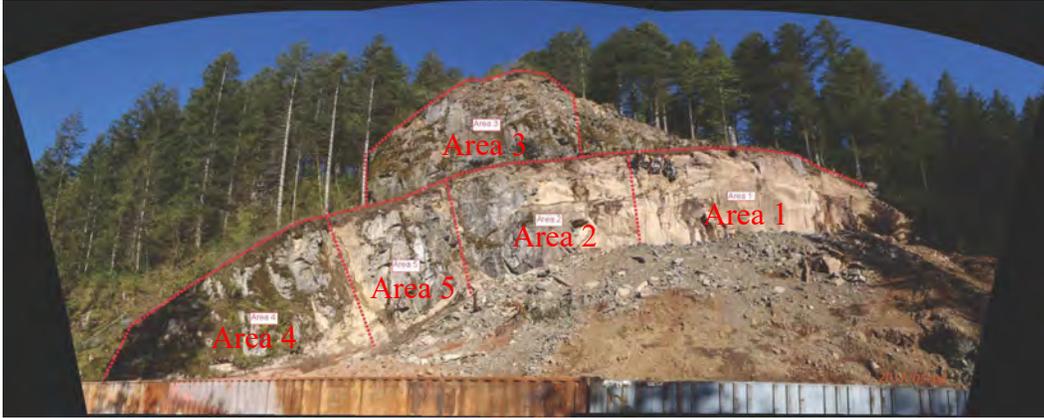
**Figure 9. View, north, toward the site from the vantage of the highway, following the majority of the emergency contract work, and showing the selected areas for Phase 2 mitigation design. Most of the original failed rock slab had been trim-blasted (in front of Area 1), and the remainder of the slab is at this point largely surrounded by blasted and scaled rock debris. A conex rockfall barrier is visible in the foreground.**

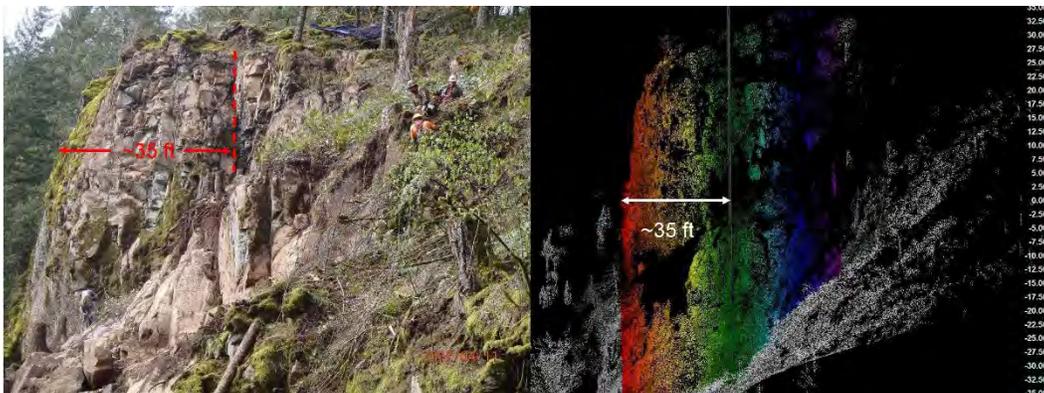
**Figure 10. Photo (left) and LiDAR isopach (right), both facing west, showing the thickness of the Area 3 reinforcement area and the targeted highly persistent and dilated subvertical discontinuity and potential release surface, beyond which reinforcement would be embedded.**

Area 3 represents the outboard (highway-facing) rock face of the high bluff above and west of the failed rock slab area, the outboard face of which is bounded by a dilated subvertical discontinuity. The crest of this bluff is approximately 200 to 210 feet above the elevation of the highway. Using the terrestrial LiDAR data and the point-cloud processing software Polyworks (by InnovMetric), it was determined that this highly persistent and dilated discontinuity projected behind Areas 1 and 2 as well and, based on corroborating field observations, became the design target plane behind which to anchor proposed reinforcement in Areas 1, 2 and 3 (Figure 10).

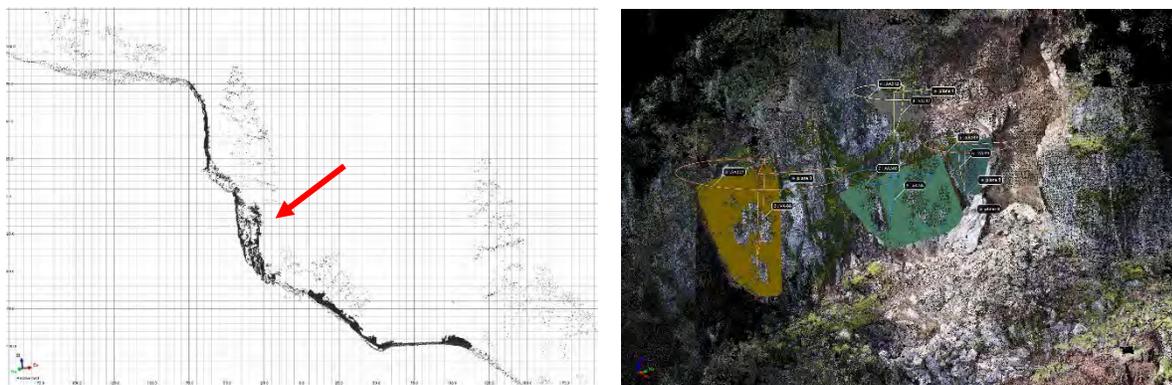
**Figure 11. A) An example of a cross section cut directly from a terrestrial LiDAR point cloud. The arrow points to the western edge of the failed rock slab. B) A screen capture of some of the discontinuity orientations mapped on the terrestrial LiDAR.**

Using the field data gathered and the terrestrial LiDAR data provided (including cross sections, discontinuity orientations and block sizes) by the GeoMetrix Office (Figure 11), we performed limit-equilibrium slope stability analyses using the analysis program RocPlane (v. 2.045) by Rocscience for the above-described domains or areas.

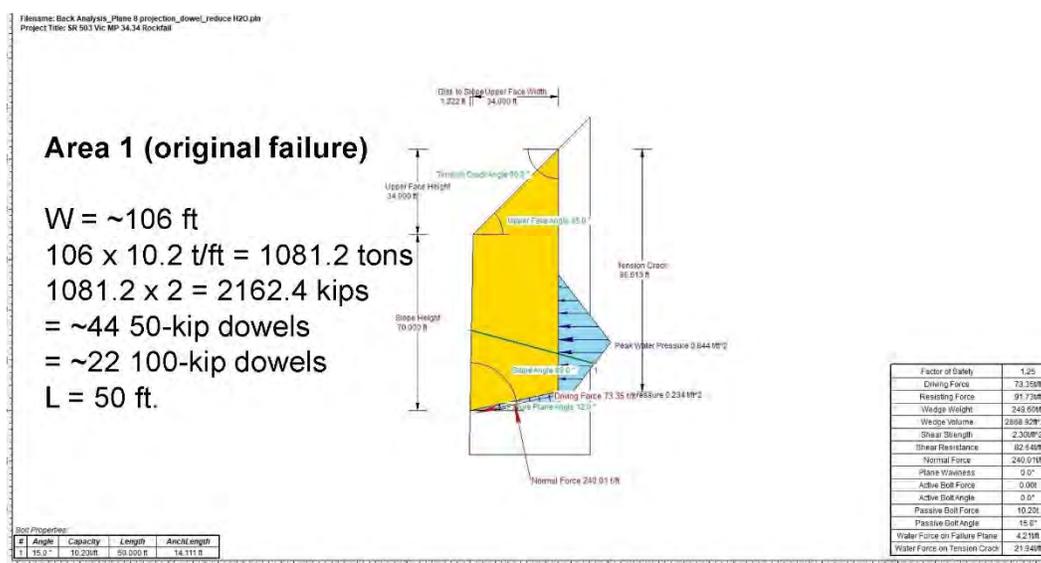
**Figure 12. Typical limit-equilibrium analysis using RocPlane by Rocscience.**

through 5 (that were measured via the terrestrial LiDAR data in Polyworks) to estimate the required reinforcement capacities (Figure 12).

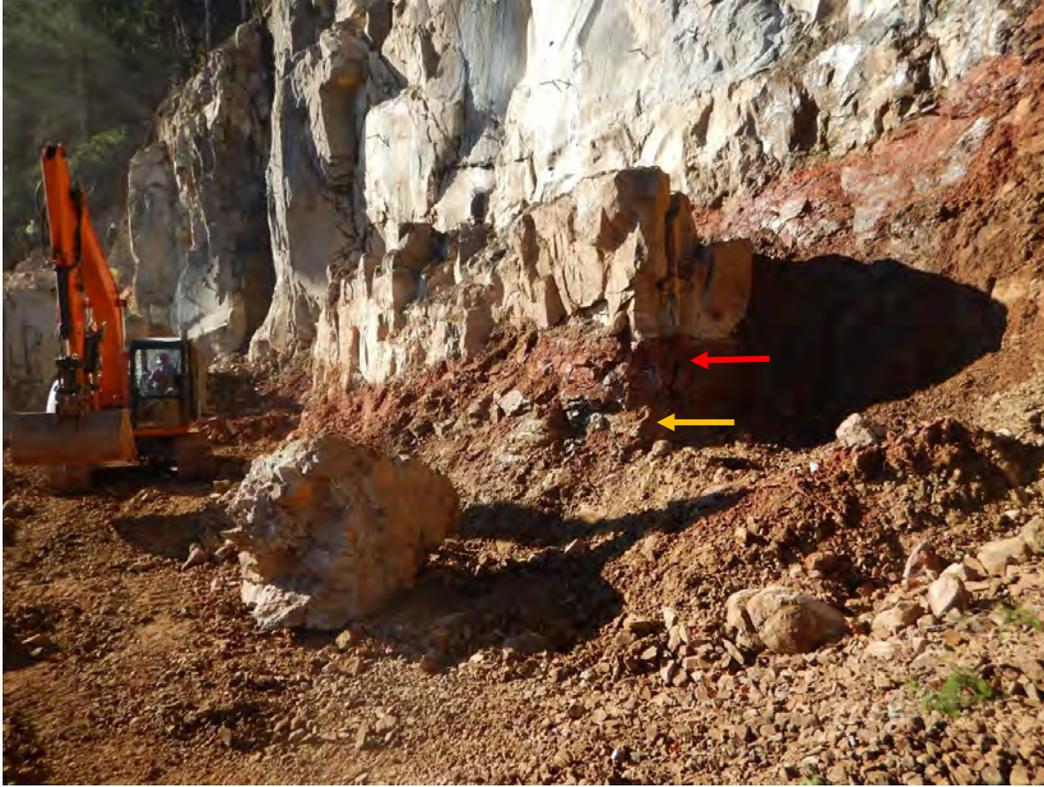
**Figure 13. View, west, toward exhumed bottom remnant of the original failed rock slab, showing the overlying basaltic andesite still in contact with a remnant of the reddish “baked zone” (red arrow) and a remnant of the olive brown weathered volcaniclastic unit (orange arrow). Note the in-situ contact above and to the right, indicating the failed slab had dropped about 15 feet.**

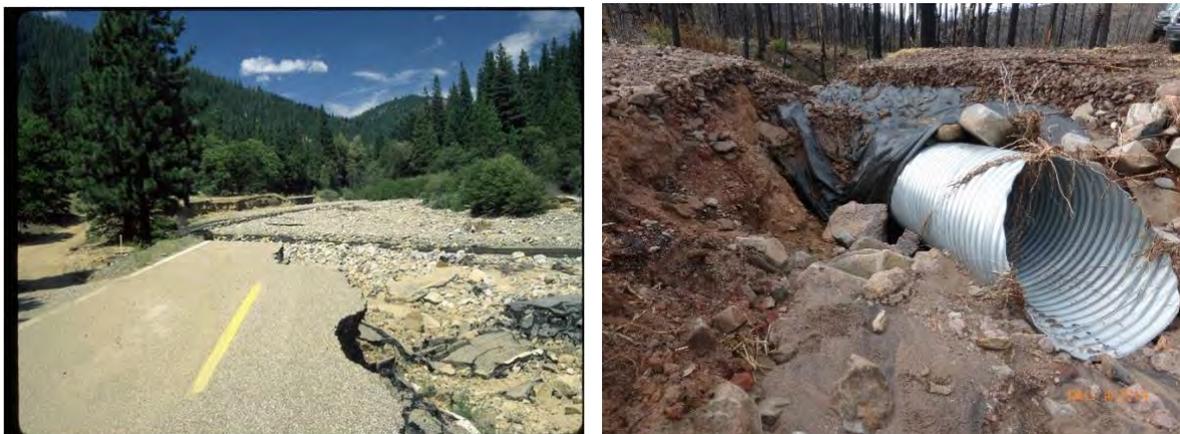
Figure 1 - Road and culvert damage caused by major mountain storms in California.

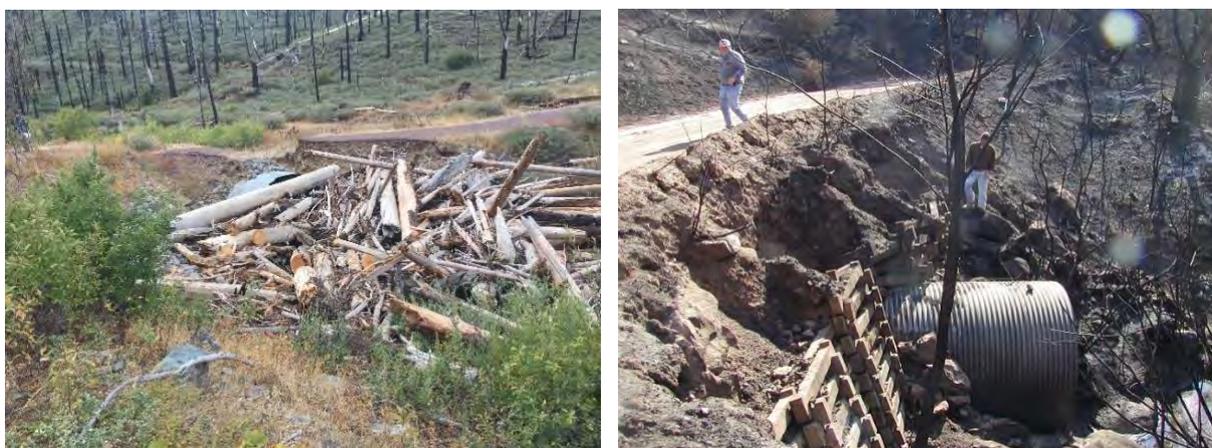
Figure 2 - Culverts plugged and damaged by the sequence of forest fires and then floods.

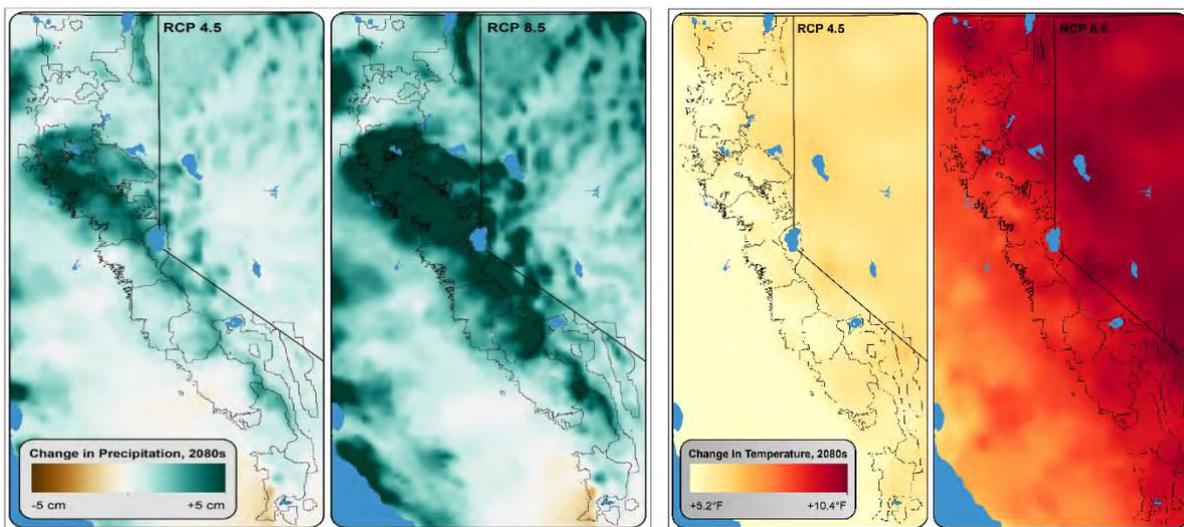
Figure 3 - Projected future changes in precipitation and temperature by 1980 in the Sierra Nevada, depending on either an RCP (Representative Concentration Pathway) 4.5 or RCP 8.5 emissions scenario for greenhouse gases.

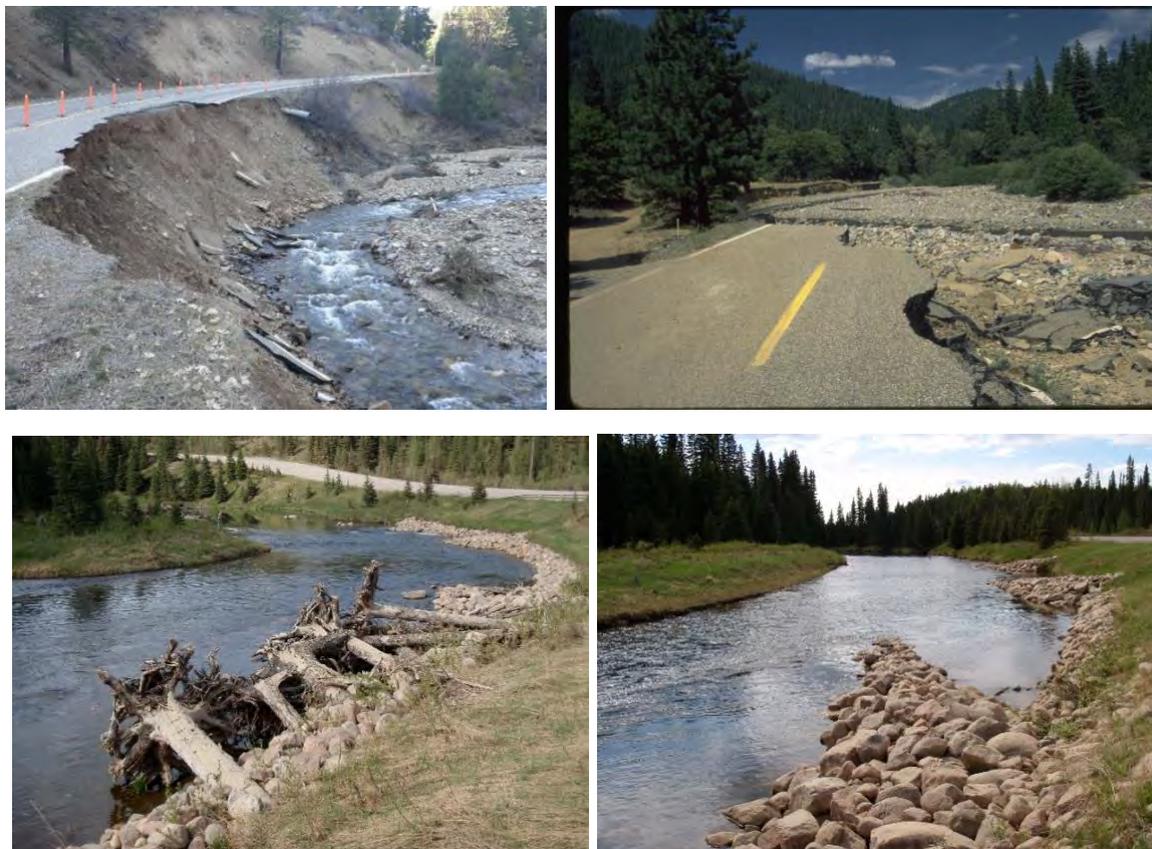
Figure 4 - Examples of roads damaged or washed out because of a location adjacent to streams or built on a floodplain (upper photos), and some streambank stabilization measures with logs, riprap, and spur dikes (lower photos from J. McCullah).

hooks, rock vanes, rock drop structures, or other methods [10]. Many treatments use a combination of soil bioengineering treatments with rock riprap. Figure 4 (upper photos) shows road damage and a road washout caused by constriction of the natural stream channel or road construction on a historic floodplain. The lower photos show nature-based solutions for streambank stabilization or protection using a combination of rock riprap, tree trunk logs, native vegetation, or spur dikes.

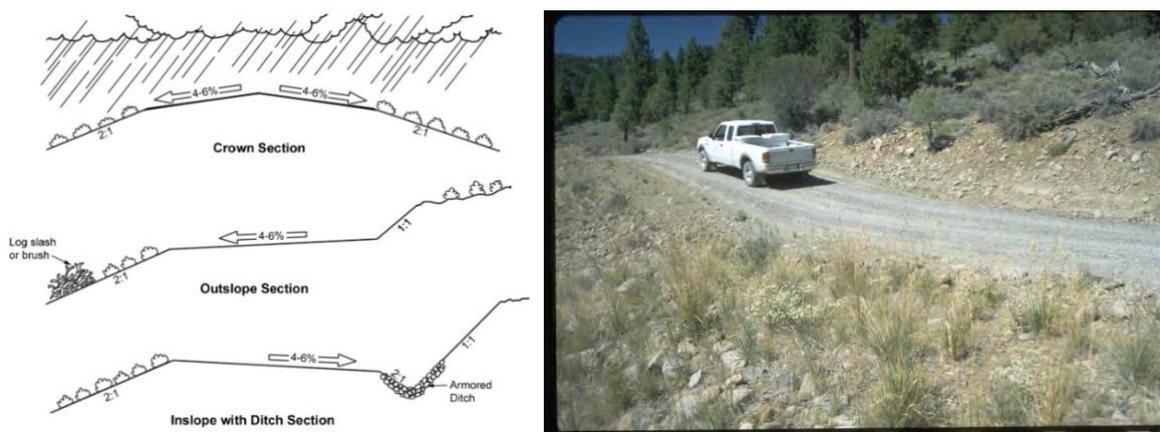
Figure 5 - Road surface drainage measures including an inslope or outslope road (left) or a rolling dip (right photo) used to prevent water concentration.

Construction of an outslope, inslope, or crown roadway section prevents water from standing on the road. Cross-slopes are typically around 5 percent of unsurfaced roads and 2 percent for paved surfaces. Use of frequently spaced leadoff ditches prevents the accumulation of excessive water in the roadway ditches. Protect the cross-drain outlets with rock (riprap),

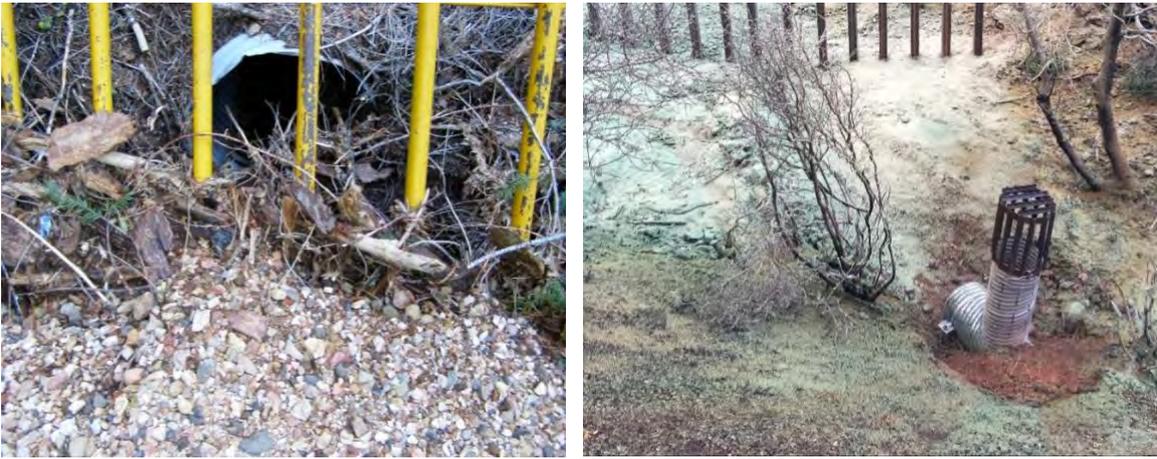
Figure 6 - Photos showing a variety of trash racks used to prevent a culvert from plugging.

Many existing culverts are undersized and susceptible to plugging, particularly in a woodland or mountain environment. Thus, to prevent plugging, a wide variety of trash racks or debris racks have been used, including steel, rebar, railroad iron, and wood or logs. Flared inlets also help pass debris through culverts. If used, trash racks must periodically be maintained and debris cleaned out. Figure 6 shows examples of metal trash racks used to prevent culvert plugging.

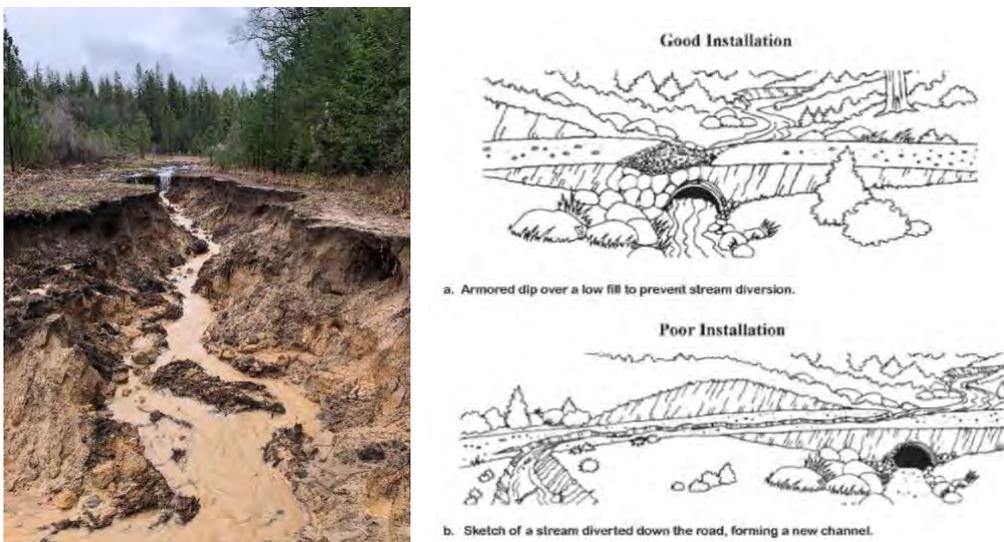
Figure 7 - Photo of a stream that has been diverted down a road and figure showing the concept of a stream diversion prevention dip (right drawing) used to minimize roadway damage from a plugged culvert.

Stream diversion occurs when a culvert plugs, the water overtops the roadway embankment, and the road grade allows the water to flow down the road rather than back into the natural drainage. Major road damage has occurred when this happens. To prevent this, an overflow dip can be constructed into the road to ensure that the water remains or returns rapidly in its natural drainage [13]. The dip serves as a “controlled failure” point. Figure 7 shows the road damage from a plugged culvert and flow diversion down the road, and concept of an armored overflow dip in the case of culvert plugging to prevent stream diversion.

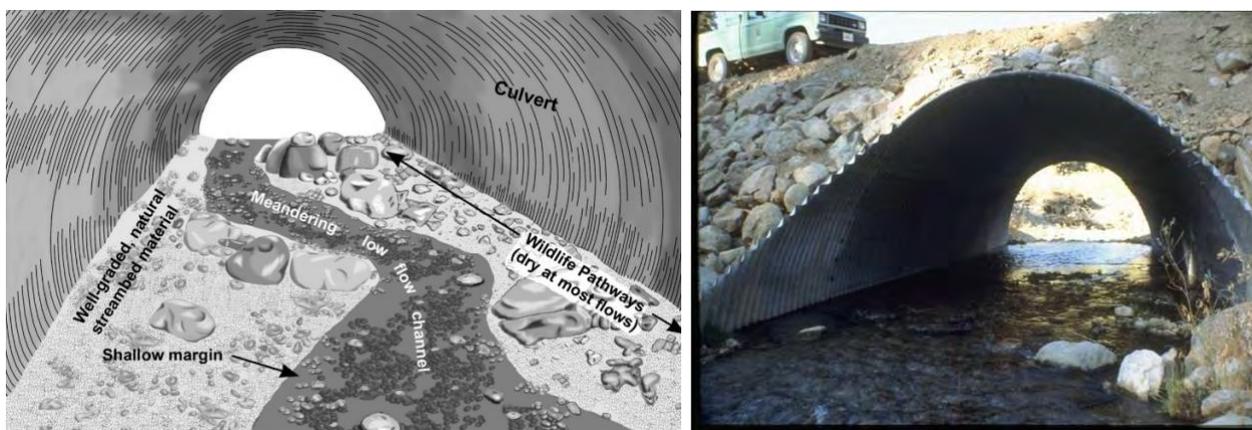
Figure 8 - Drawing and an example photo of stream simulation designs through culverts, replicating a natural stream channel bottom substrate.

Examples of stream simulation projects are found throughout California’s mountains, as seen in Figure 8. Many of the streams are ephemeral on the mountains of Southern California, but headwater reaches are perennial so resident fish populations benefit from AOP projects. Several stream simulation culvert projects were evaluated on the Green Mountain National Forest, Vermont, following Hurricane Irene in 2011, with flows exceeding the 100-year design flood. The structures survived with minimal problems, while many other conventional culverts and bridges in the region were damaged or destroyed. Only some movement of the bed material was observed [15].

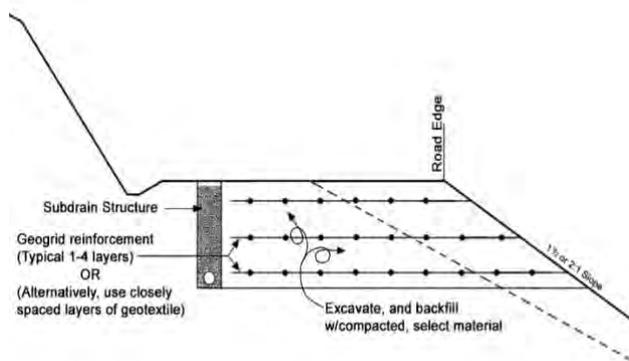
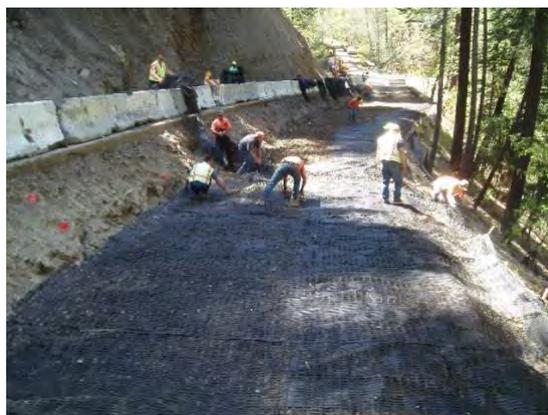
Figure 9 - Drawing of the basic deep patch design and photo of a deep patch repair under construction (right photo).

The “deep patch” design is a shallow road-fill slope repair where the upper 1-2 meters of the subsiding section of roadway is excavated, the fill material is replaced with compacted select backfill or gravel, and several layers of geogrid or geotextile are installed for reinforcement (Figure 9). A drain may or may not be included. Deep patches have slowed or stopped slope surface movement on sections of roads crossing areas of large-scale slope settlement and the technique has been used successfully on numerous sites on forest roads and highways [17].

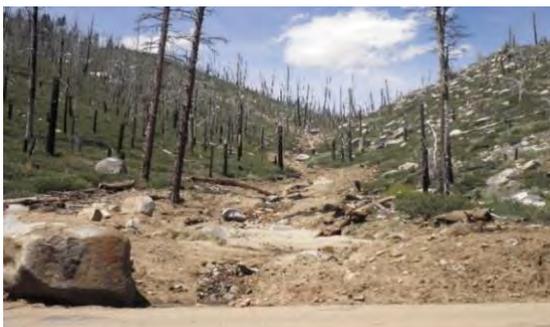
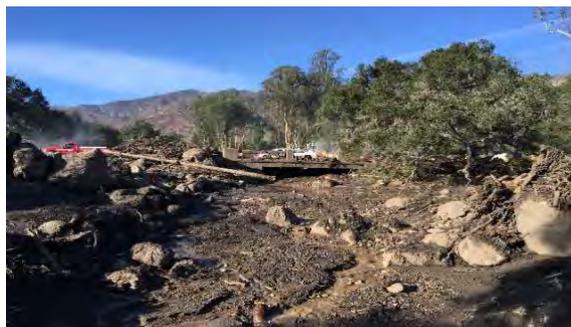
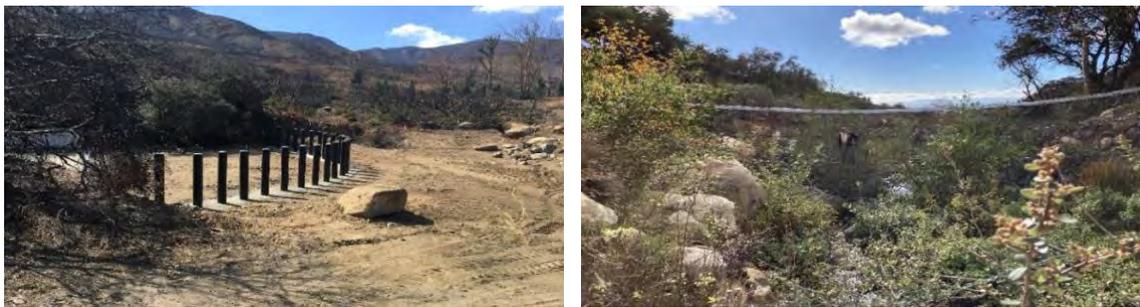
Figure 10. Upper photos show a debris flow from a fire-scarred areas that has blocked the road and plugged a culvert (left photo), and damage caused by debris flows. The lower photos showing debris retention basins, trash racks with bollards, and ring nets used to trap sediment and debris from a debris flow (lower right photo from Jonathon Schwartz).

Figure 10 (upper left photo) shows the source area of debris flows on steep, fire-scarred slopes, while the right photo shows typical damage to roads, culverts, and structures, as well as the types of material moving in debris flows. Note the quantity of large boulders being moved in each debris flow. The lower photos show a variety of methods to mitigate damage from debris flows, including bollards, trash racks, debris retention basins, and ring nets.

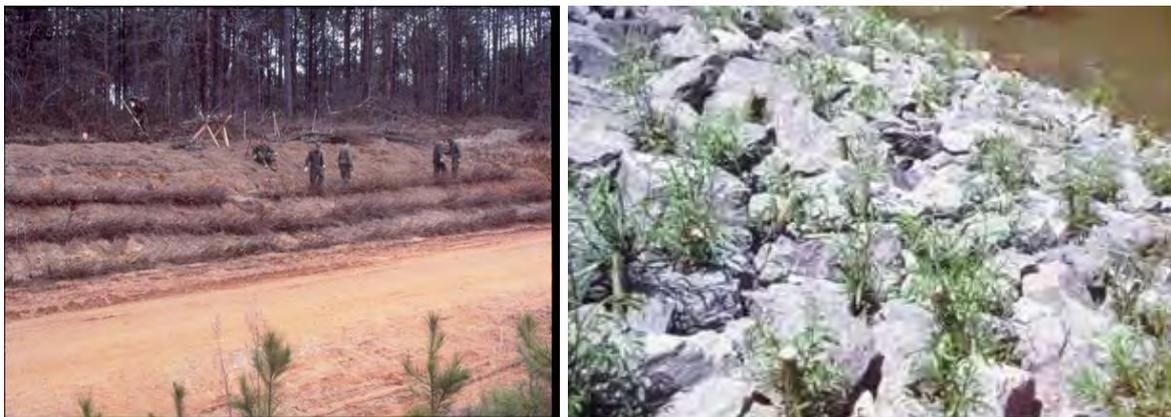
Figure 11 - Common soil bioengineering treatments of brush layering (left photo) and live stakes through riprap (right photo) (photos courtesy of Robbin Sotir).

Soil bioengineering and biotechnical treatments use integrated ecological principles to assess, design, construct, and maintain living vegetative systems to prevent or repair damage caused by erosion and slope failures [23]. These treatments are labor intensive, useful to prevent shallow slope failures, are aesthetic or natural looking, and are typically under-utilized. Common soil bioengineering and biotechnical treatments include live stakes (with willows, etc., that will re-sprout) embedded in the face of the slope to re-sprout; fascines, wattles, or bundles of branches that are laid in a trench along contour lines that sprout and grow; brush layering placed into terraces in the slope, covered with moist soil and compacted; vegetated gabions or other walls interplanted with live vegetation cuttings; and vegetated reinforced soil slopes, such as geosynthetic reinforced soil slopes with brush placed on each lift along with the reinforcement (Figure 11).

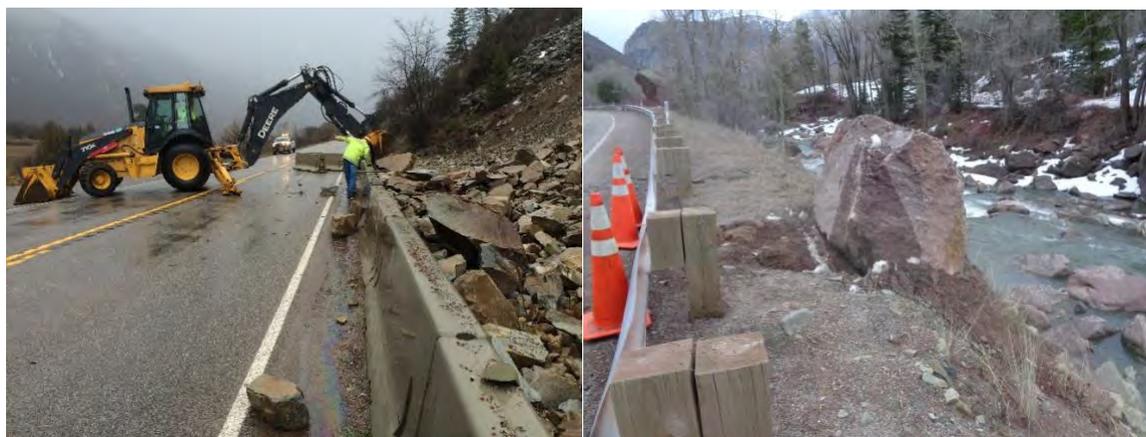
**Figure 1 – An example of typical maintenance response to rockfall events (left), and a large boulder that just missed causing significant damage as it bounced over the highway**

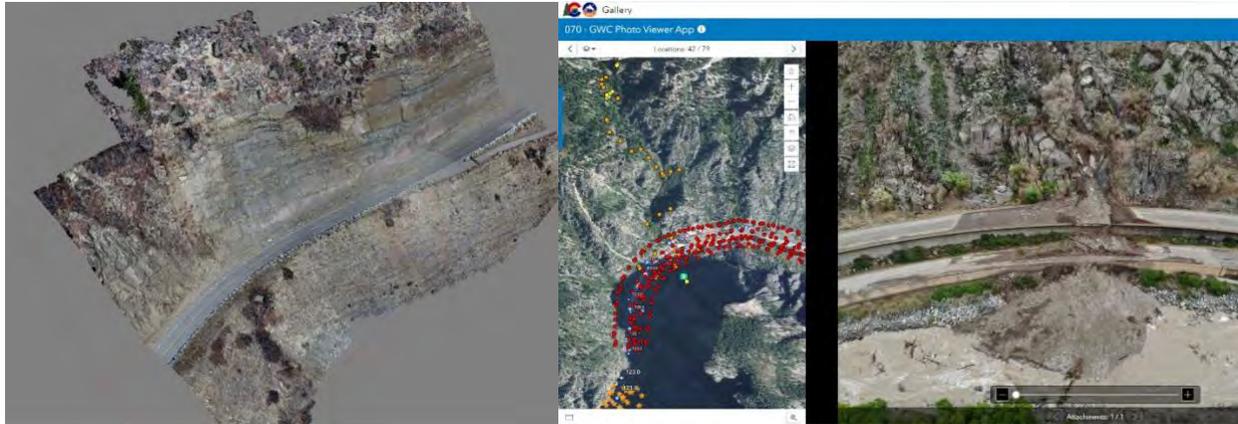
**Figure 3 – Example of AGOL Meshes and other tools used for virtual site visits and to estimate quantities and refine mitigation options**

The authors managed a data set of over 370, 3D models (meshes) that were hosted on ArcGIS Online (AGOL) and accessible to the consultant team, CDOT Geohazards Program members, other CDOT staff, and even other consultant teams. A thinned-out collection of over 5,000 of the photos used to produce the models was uploaded to AGOL to allow evaluation of areas in high resolution. No special software was needed to access the data, everything was done in a web browser interface. Other features of the AGOL portal included over 20 custom-built web apps, and over five custom mobile field apps to assist with field data collection.

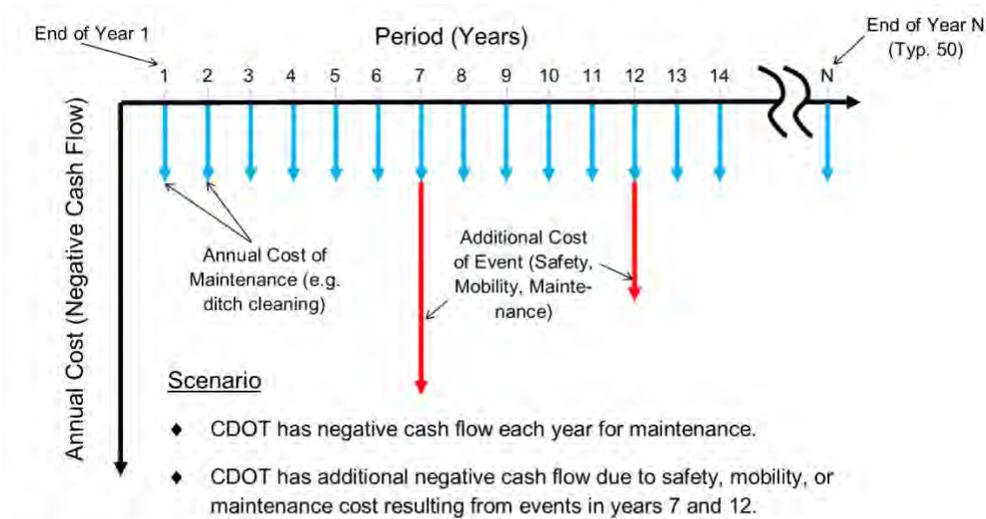
Present Worth (Pw) Calculations

$$Pw = \text{Annual Cost of Maintenance} \left[ \frac{(1+i)^N - 1}{i(1+i)^N} \right] + \text{Cost for Year 7 Event} \left[ \frac{1}{(1+i)^7} \right] + \text{Cost for Year 12 Event} \left[ \frac{1}{(1+i)^{12}} \right]$$

Pw50 = Present worth of cash flows over a 50 year period (N = 50 years).

**Figure 4 – Example of present worth analysis for existing conditions or unmitigated site**

In the case of the do-nothing option, or existing conditions, there is a series of hypothetical negative cash flows (away from CDOT) representing the annual risk exposure (Figure 4). The cash flow diagram for each mitigation option represents an initial outlay of cash for the construction of the mitigation, and a corresponding reduction in the annual risk exposure based on the estimated efficiency of the mitigation (Figure 5).

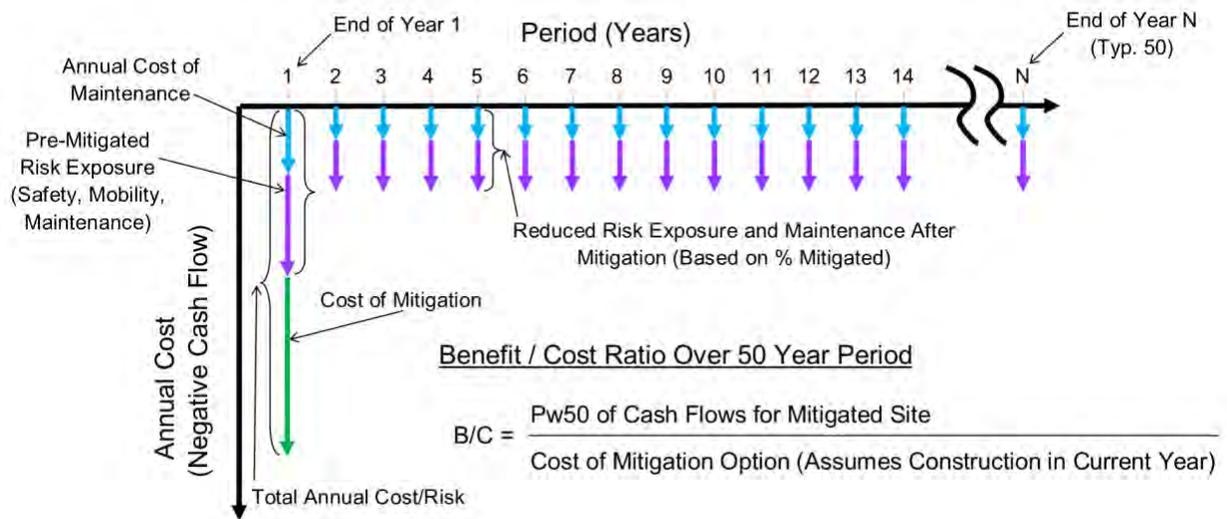
**Figure 5 – Example of present worth analysis for a mitigated site**

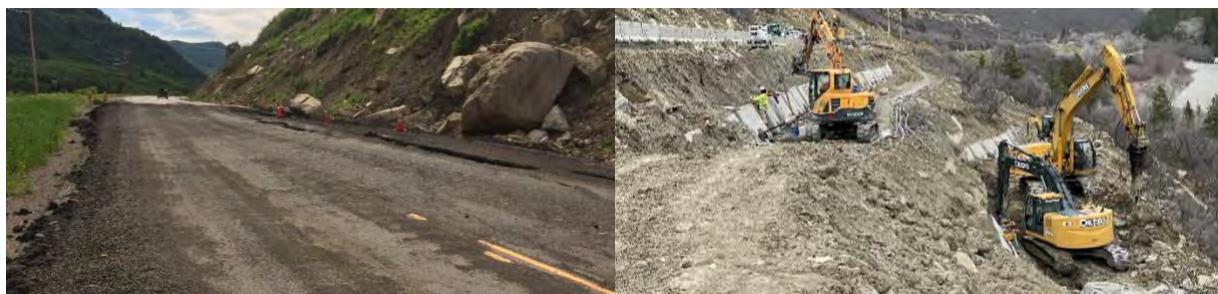
**Figure 6 – The MP 21.7 site required frequent maintenance prior to mitigation**

This landslide had been a continual maintenance problem for years before a significant period of movement in spring 2017 resulted in several feet of vertical offset with pavement crack offsets up to 8 inches. The length of the failure area was approximately 300 feet, encompassing both lanes of SH 133. After considering a variety of options, the authors selected and designed a ground anchor stabilization system for the slide. The construction of the mitigation was successfully completed in fall 2022 and no additional cracking or pavement distress has been observed in the repaired section.

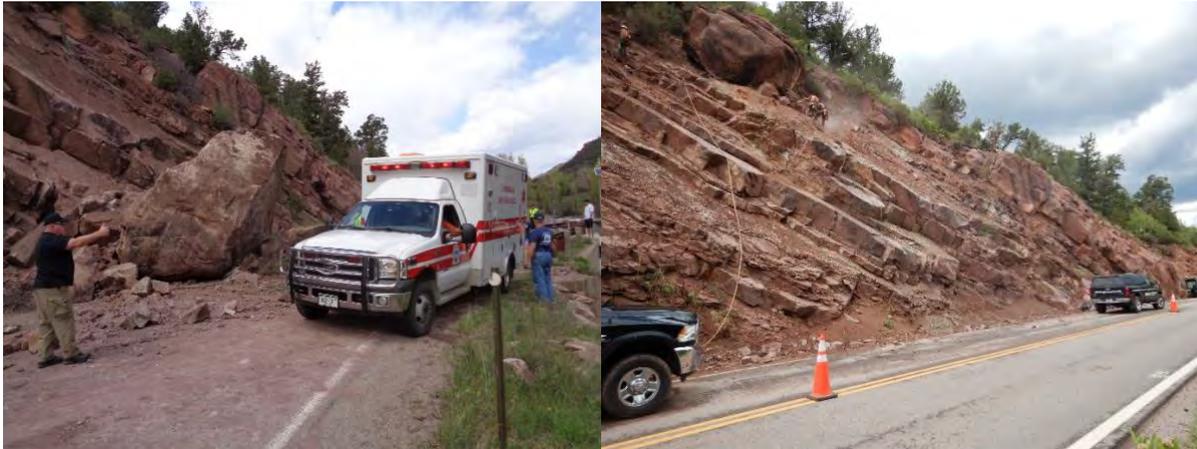
**Figure 7 – The Nettles Cut had a history of major rockfall events prior to stabilization**

The Nettles Cut had adversely dipping bedding planes and had a history of producing large sandstone blocks up to 20 feet in diameter that blocked the roadway (Figure 7). The cut was stabilized by scaling and installing a pattern of rock dowels to stabilize the sliding blocks with the shear capacity of the dowels. A roughly 15' boulder at the top of the slope was stabilized using shotcrete buttressing with additional dowels, and a draped mesh with a “hybrid” stickup of

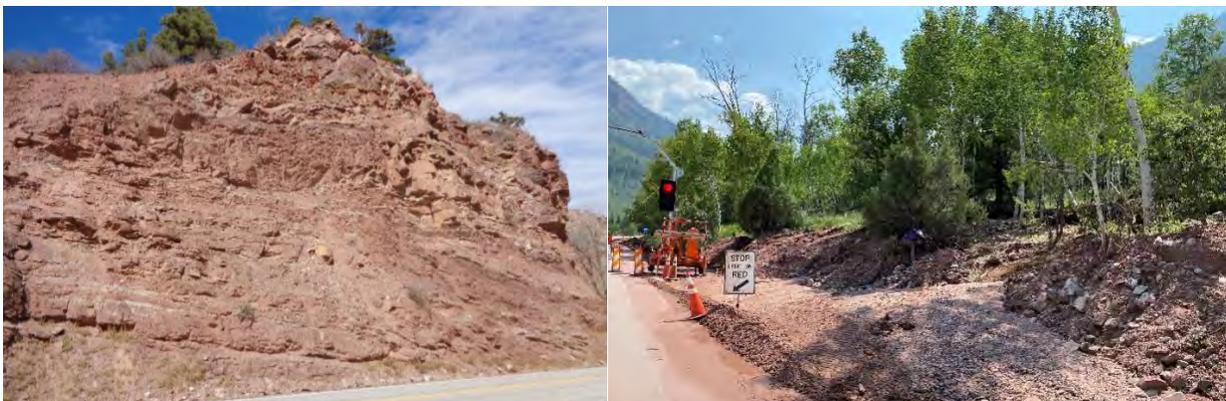
**Figure 8 – The Headgate Cut (left) will be mitigated with scaling, rock bolting, and light and heavy-weight draped mesh. Debris flows that occurred during the summer of 2021 (right) closed the highway for several days until they could be cleaned up.**

Although referred to as a rockfall mitigation project, this project included only one rockfall area consisting of two adjacent cuts, and a total of three debris flow sites, some with multiple channels. The rock cut, referred to as the Headgate Cut, had a smaller cut approximately 60 feet high, and a larger cut up to 120 feet high with a portion of that overhanging, albeit farther from the road at that location. The rockfall mitigation design includes scaling, some excavation to improve ditch configuration, spot bolting, and installation of draped mesh for the smaller cut and the lower hazard portions of the large cut, and heavier mesh / cable net for the worst portions of the large cut.

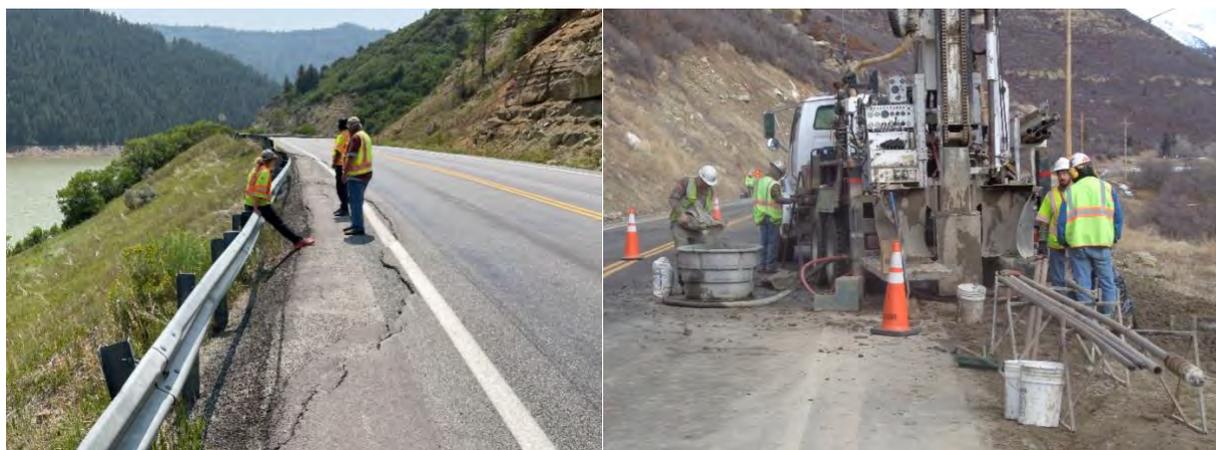
**Figure 9 – Embankment failures are common along the Paonia Reservoir (left). Six locations were selected for geotechnical investigations (right).**

A total of 32 embankment failures were identified in the Paonia Reservoir segment during the corridor study. The sites were prioritized based on progression and likely consequence of failure. A total of six locations were selected for geotechnical investigations and potential mitigation. Those six sites were further reduced to four sites for this mitigation project to fit within the budget. A variety of mitigation options were considered, including deep patch, ground anchors, road realignment, lightweight fill, and coupled shear piles. The most economical method to repair these locations was soil nails retaining walls to stabilize the roadway prism and allow removal of some of the driving forces by removing the embankment in front of the wall line. Keeping the same mitigation method for all four sites offered benefits in terms of simplifying construction and the economies of scale.

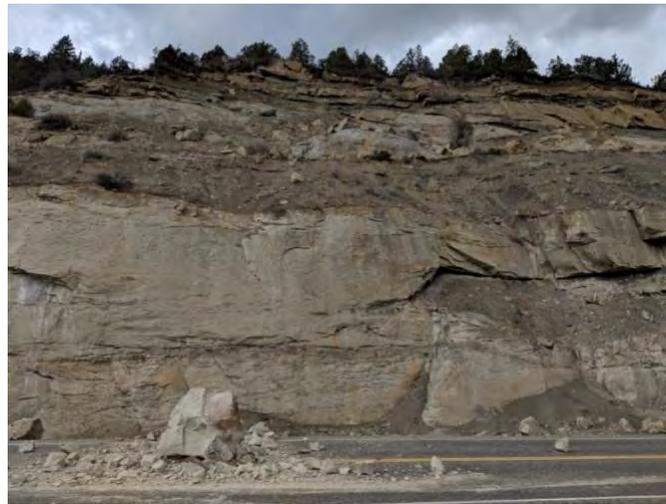
**Figure 10 – Rockfall consisting of medium to large blocks are common in this segment of SH 133.**

The geology at these sites is primarily interbedded marine and deltaic sandstone and shale beds of the Mesaverde Group. The sandstone layers form blocks from approximately one-foot diameter to as large as six-feet in diameter. The shale and mudstone beds are much more erodible and often contribute to the rockfall by undermining the sandstone beds. There are often colluvium layers at the top of the cuts with cobbles and small boulders that erode out of the matrix, particularly at the vegetated “brow” that can become essentially vertical over a height of 5 to 10 feet and is readily erodible.

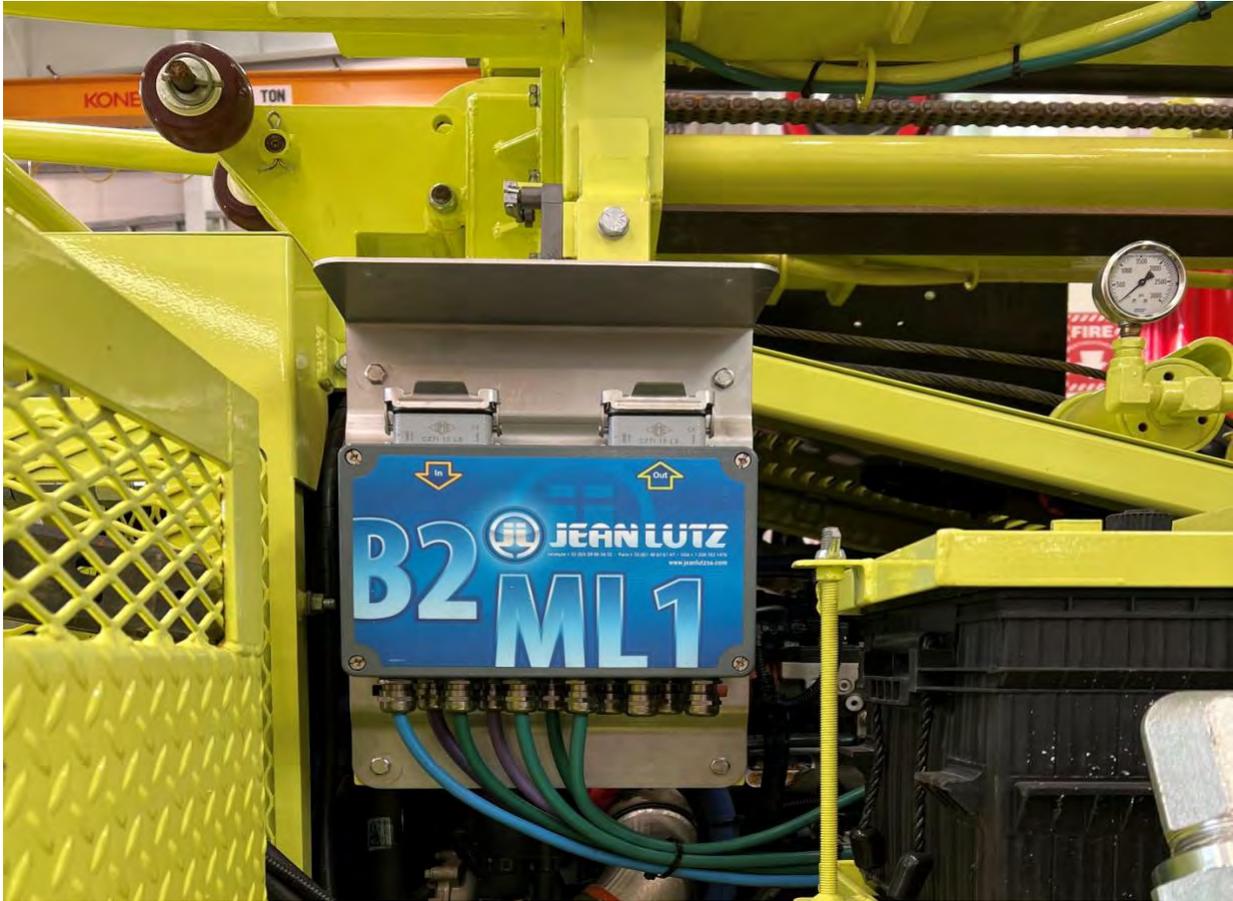
**FIGURE 1: THE B2 ML1 JEAN LUTZ COMPUTER ON THE CME LC 55 TRACK-MOUNTED DRILL RIG, FOLLOWING INSTALLATION.**

WSDOT began researching the geotechnical applications of MWD in 2022 with the purchase of the Jean Lutz B2 ML1 MWD Technology and a CME LC 55 track-mounted drill rig. Through collaboration between WSDOT, Jean Lutz, and CME, the MWD equipment was installed directly onto the new drill rig and delivered to WSDOT in October, 2022 (Figure 1). Hands-on training was conducted on October 10 and 11, 2022. Representatives from Jean Lutz and CME were both present for the training, as well as engineering geologists from the WSDOT Geotechnical Office, and the entire WSDOT Headquarters drill crew (Figure 2).
