# 72<sup>nd</sup> Highway Geology Symposium

## 2023 PROCEEDINGS

August 14-17, 2023 • Hotel Murano • Tacoma, Washington

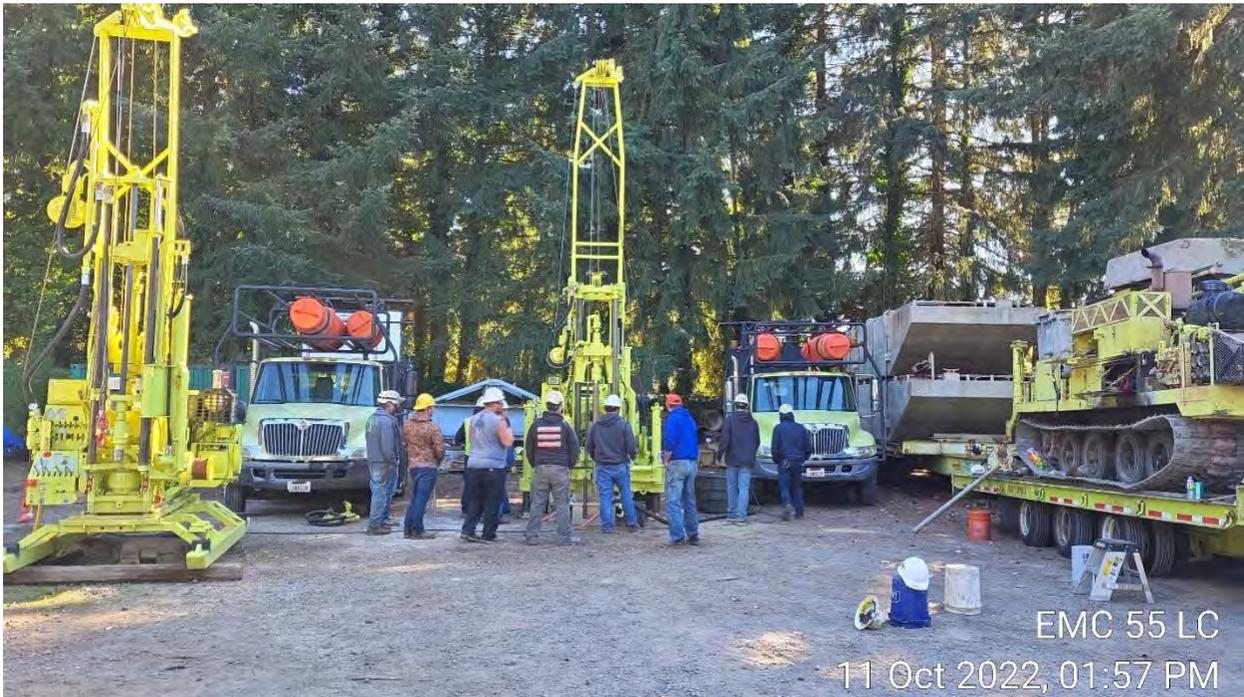
**FIGURE 2: THE ON-SITE DEMONSTRATION OF THE MWD EQUIPMENT, FOLLOWING INSTALLATION.**

WSDOT began researching the geotechnical applications of MWD in 2022 with the purchase of the Jean Lutz B2 ML1 MWD Technology and a CME LC 55 track-mounted drill rig. Through collaboration between WSDOT, Jean Lutz, and CME, the MWD equipment was installed directly onto the new drill rig and delivered to WSDOT in October, 2022 (Figure 1). Hands-on training was conducted on October 10 and 11, 2022. Representatives from Jean Lutz and CME were both present for the training, as well as engineering geologists from the WSDOT Geotechnical Office, and the entire WSDOT Headquarters drill crew (Figure 2).

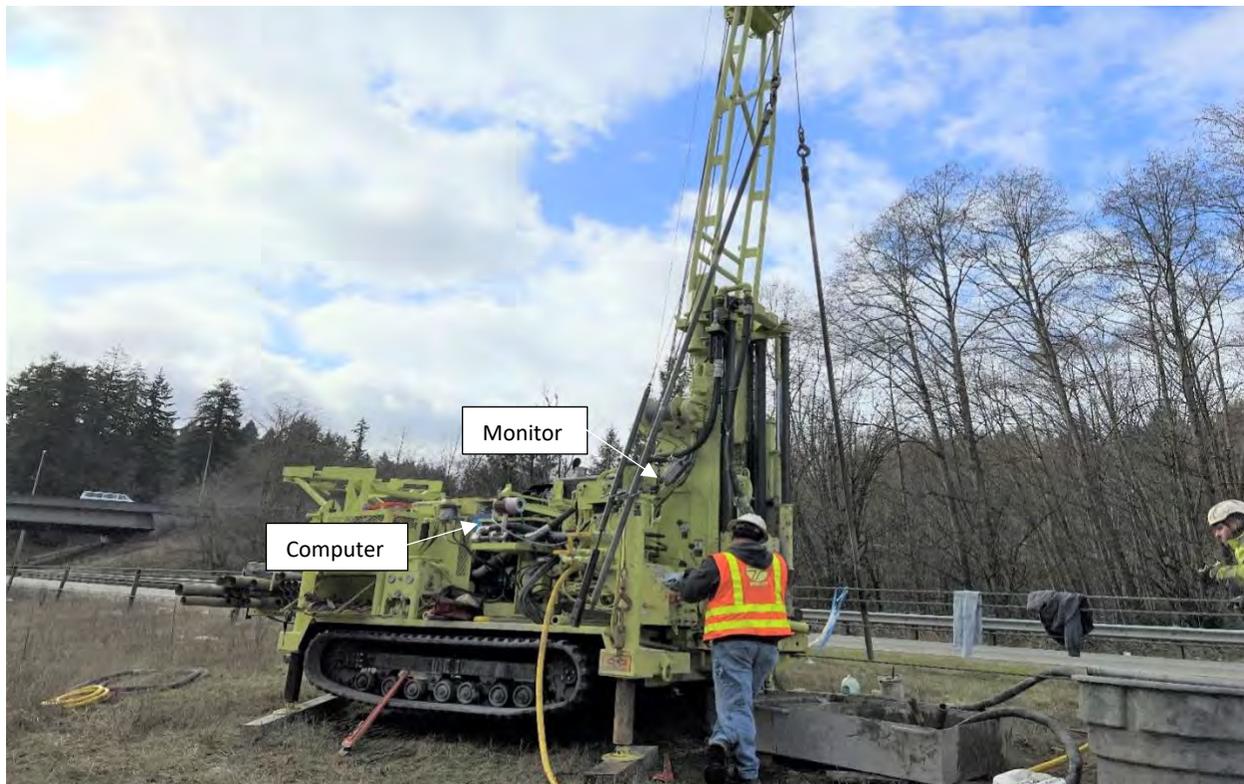
**FIGURE 3. THE DRILL RIG IN THE FIELD WITH THE MWD EQUIPMENT. NOTE THE LOCATION OF THE MONITOR AND COMPUTER.**

Once all the MWD equipment was installed, a display monitor was plugged into the computer mounted on the drill rig, and the equipment was then ready to begin recording data (Figure 3). The driller manually presses the "measure" button to begin recording and the "wait" button to stop recording between samples. Ideally, the drill clamps would start/stop the recording of data; however, we learned it is best to manually override the clamps (discussed further in the "Limitations" section, below). Real-time downhole data is displayed on the monitor's screen (Figure 4). Data collection continues for the duration of drilling, until the driller ends the recording. The MWD data is stored in the monitor and is extractable using a removable USB device (e.g., flash drive). From there, the flash drive is inserted into a computer, containing the Jean Lutz software (EXEPF, DRDPR), and the downhole MWD data for the boring can be viewed and used for geotechnical applications.

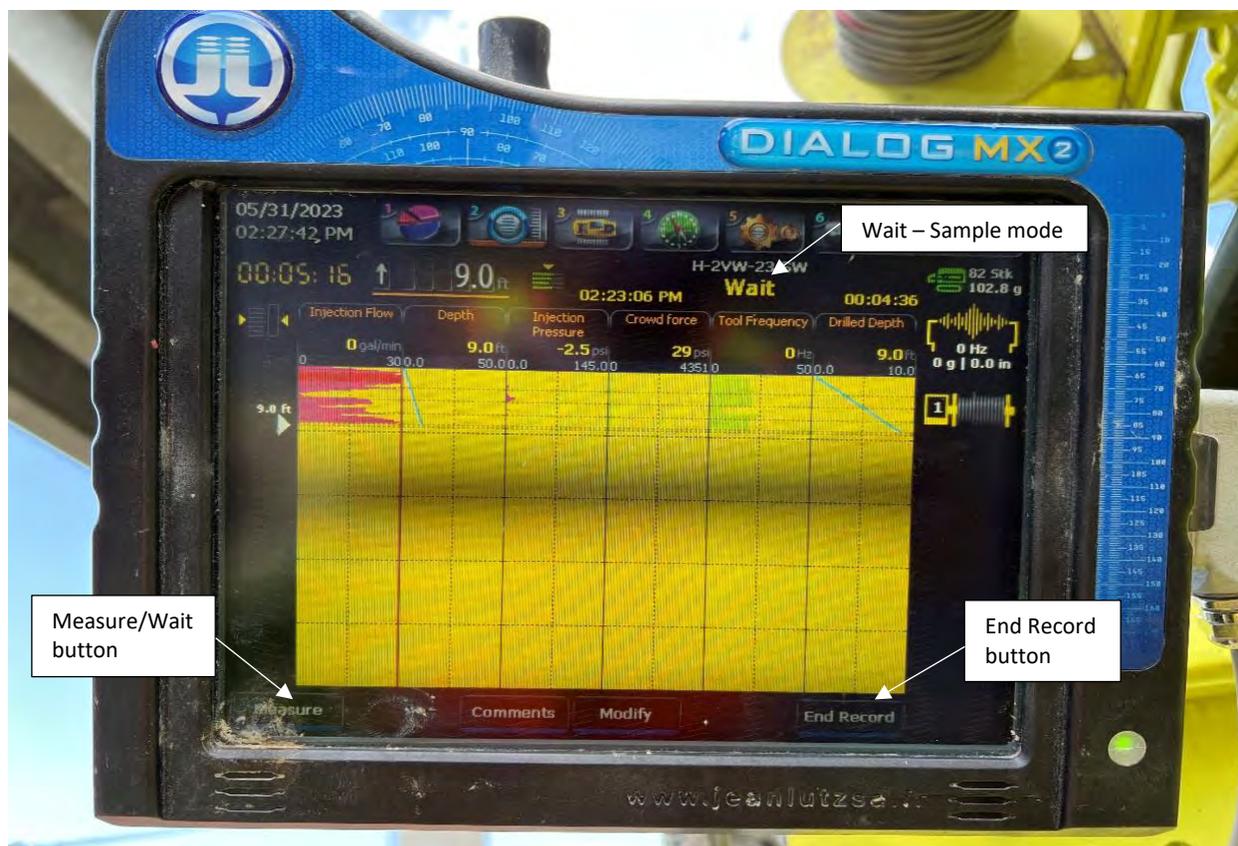
**FIGURE 4. THE MONITOR DURING DRILLING OPERATIONS. NOTE THE DRILL IS CURRENTLY IN THE “WAIT” MODE. THE DRILLER WILL PRESS THE “MEASURE” BUTTON TO RESUME RECORDING MWD DATA.**

As with any new technology, WSDOT has found that MWD has a learning curve. For example, the housing for the monitor broke during our first drilling operation with the MWD equipment installed. The monitor was placed on a table beside the drill and was able to record data; however, the driller was unable to read the monitor while operating the drill. Another setback that was observed in the field while drilling is that the clamps on the drill that are intended to “stop measuring” are too sensitive and “start/stop reading” every time the driller taps the clamps (Figure 8). We quickly realized that our subsurface elevation readings were inaccurate, since the MWD equipment continued to measure even though it should have been in “stop measuring” mode. Currently, we bypass the sensor on the clamps and manually press the “measure/wait” button while drilling (see Figure 4).

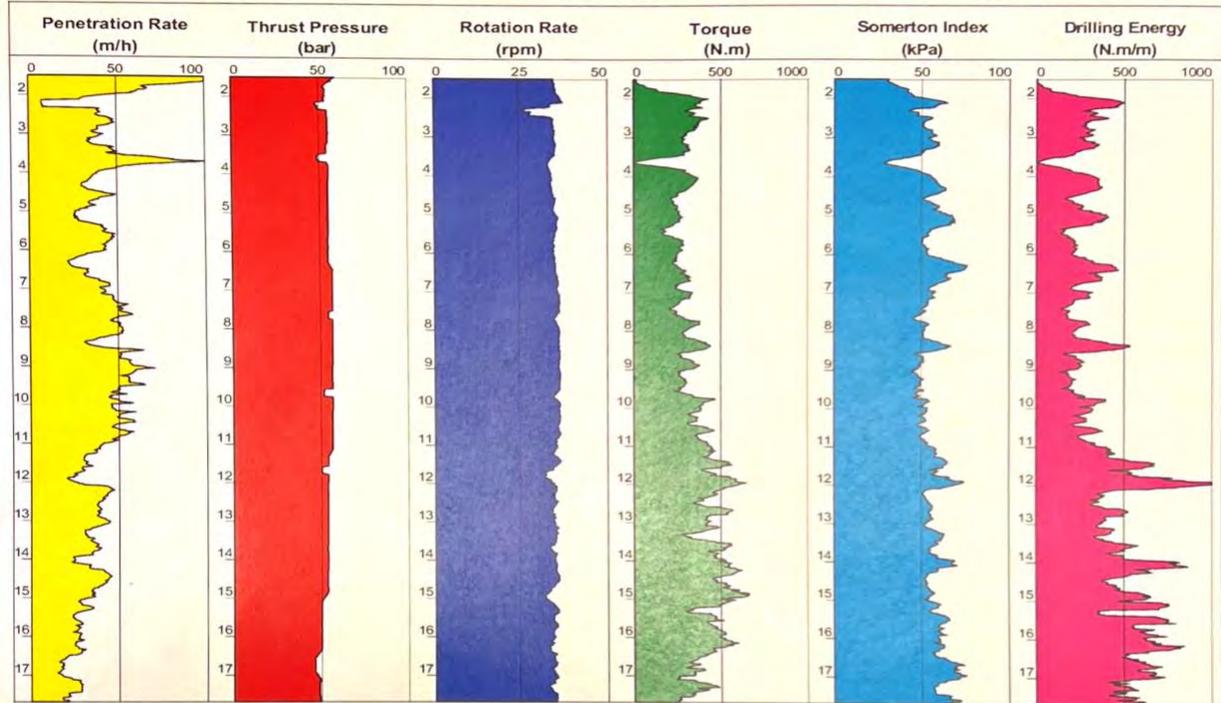
**EXERCISE 3(b): Calculating compound parameters for a single soil layer (20-cm average)**

$$\text{Somerton index: } S_d \approx P_E \cdot \left( \frac{V_R}{V_A} \right)^{1/2} \approx \frac{P_E}{\sqrt{V_A}}$$

$$\text{Drilling energy: } E_S = \frac{C_R \cdot V_R}{V_A}$$

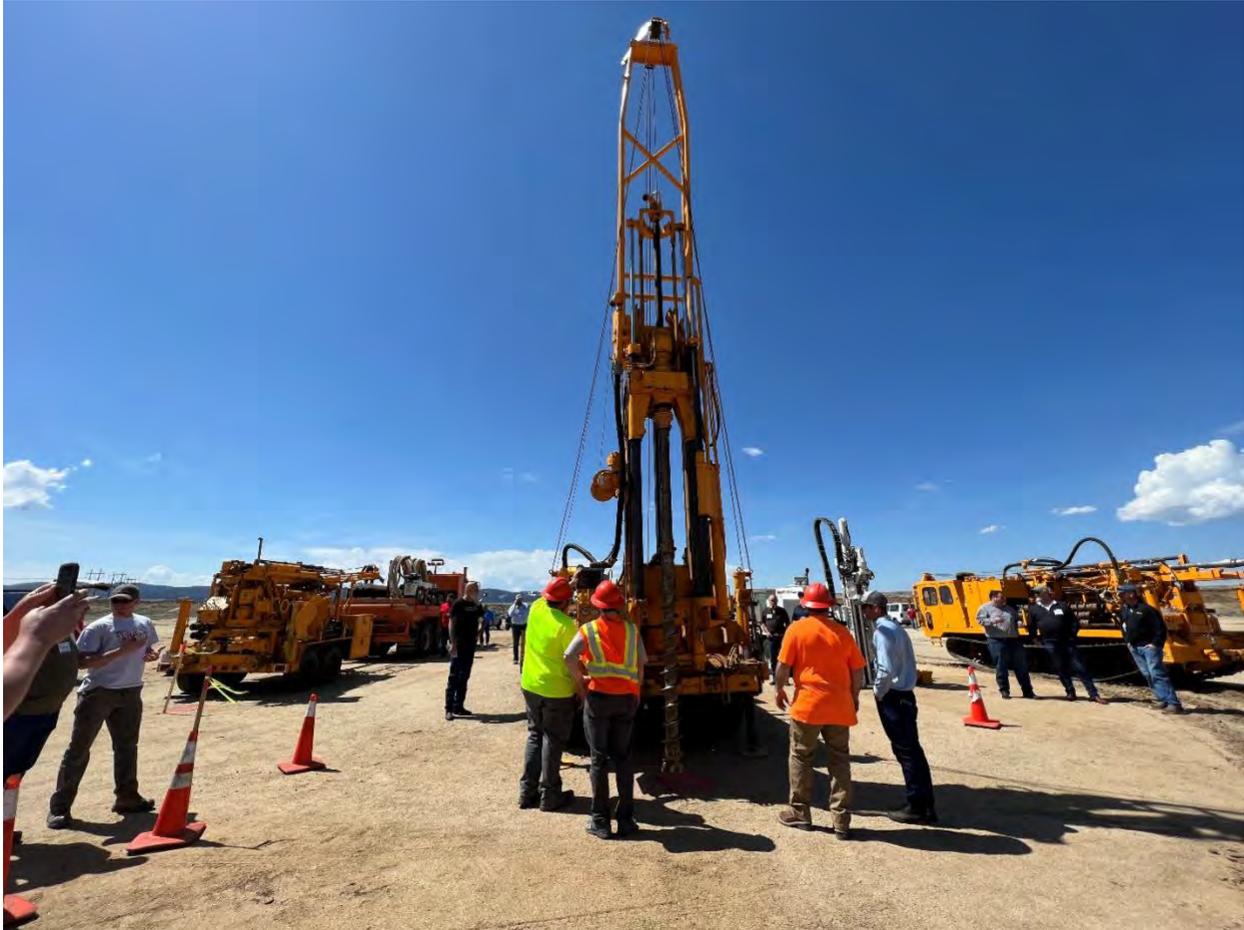
**FIGURE 6. THE ON-SITE FIELD DEMONSTRATION DURING THE RECENT SHALLOW EXPLORATION DRILLERS CLINIC IN BUTTE, MT (MTDOT).**

WSDOT attended the Shallow Exploration Drillers Clinic (SEDC) in Butte, MT on May 1-3, 2023. Among several different presentations, MWD was a highlighted topic of the conference, led by MTDOT, with an on-site demonstration on May 2<sup>nd</sup> (Figure 6).

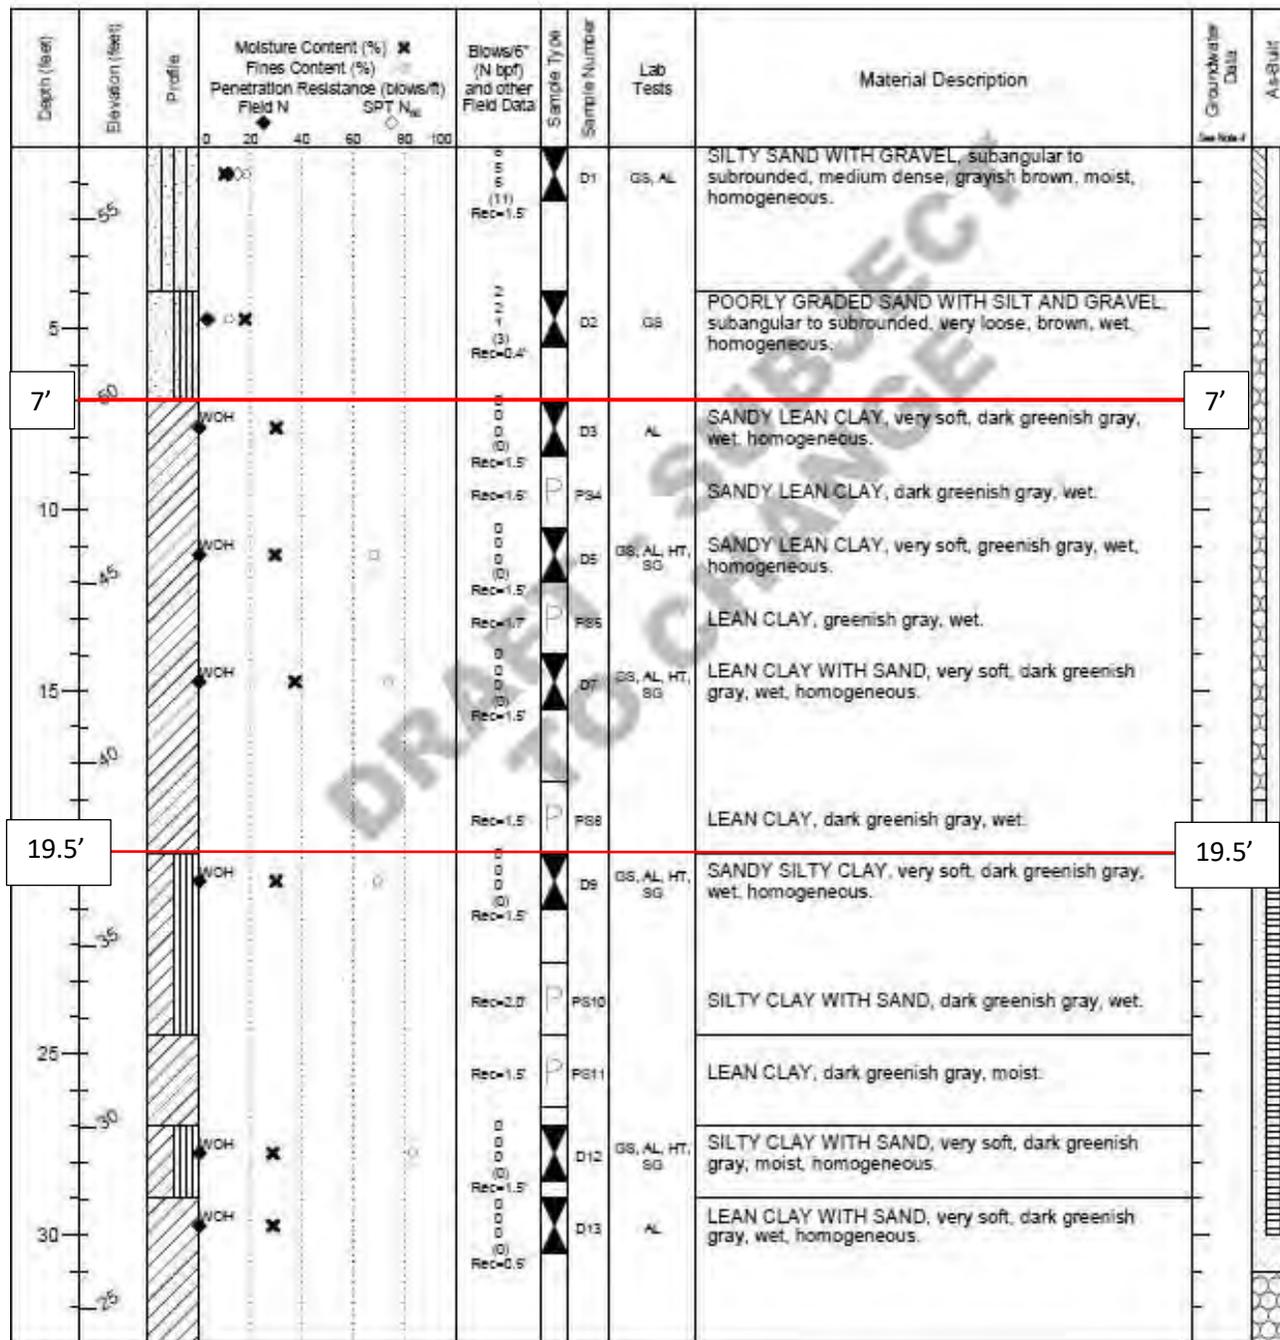
FIGURE 7A. AN EXAMPLE DRAFT BORING LOG DRILLED WITH THE MWD EQUIPMENT (SEE FIGURE 7B).

Since January 2023, WSDOT has successfully utilized the MWD equipment for several projects in Washington State. To date, we have completed drilling, with simultaneous MWD data collection, on 10 projects (99% soil drilling / <1% rock drilling) including over 2,000 lineal feet of drilled depth. We are gathering the collected information and comparing it to the boring logs which also contain lab results (Figures 7a through 7c). Comparing the draft boring log to the MWD plots, the geotechnical designer is often able to more accurately interpret/select the depths of soil change contacts (see Figures 7a through 7c).

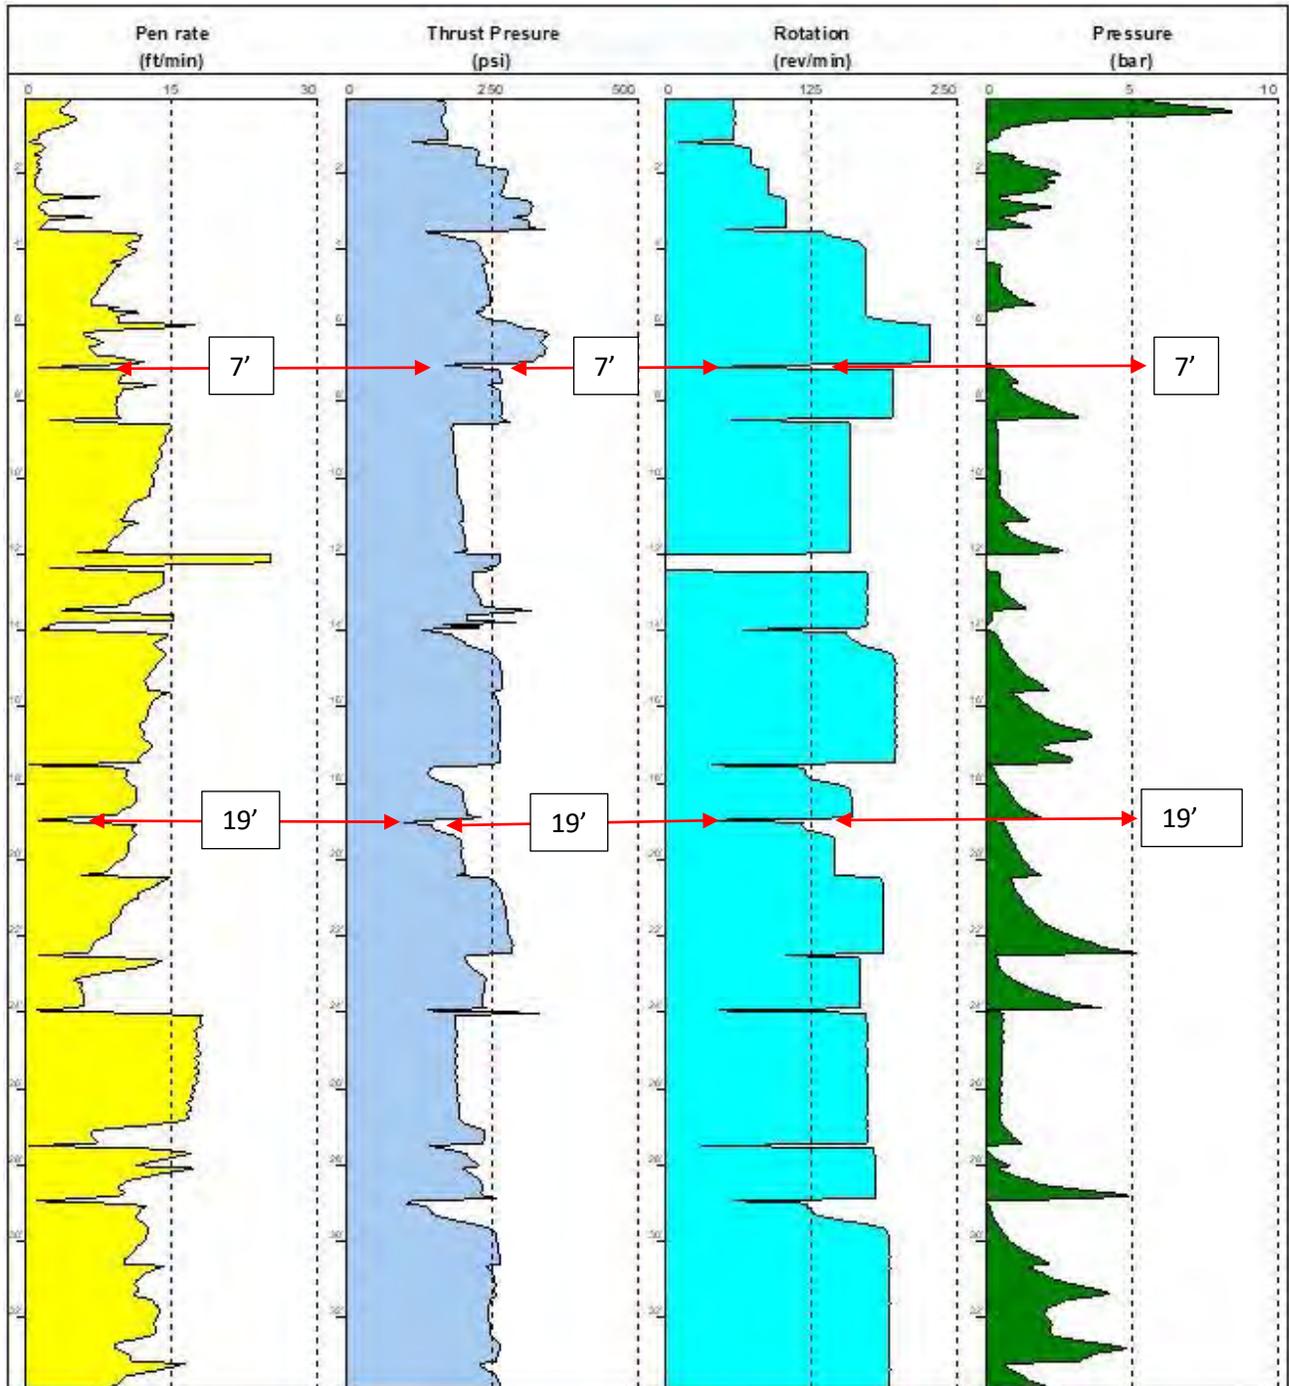
**FIGURE 7B. AN EXAMPLE MWD OUTPUT PLOT FOR THE SAME BORING AS IN FIGURE 7A. NOTE THE SOIL CHANGE CONTACT ON THE BORING LOG IS SLIGHTLY DIFFERENT THAN THE MWD PLOT (~19'). THE MWD PLOT CAN OFTEN HELP THE GEOTECHNICAL DESIGNER MAKE MORE ACCURATE CONTACT DEPTH INTERPRETATIONS.**

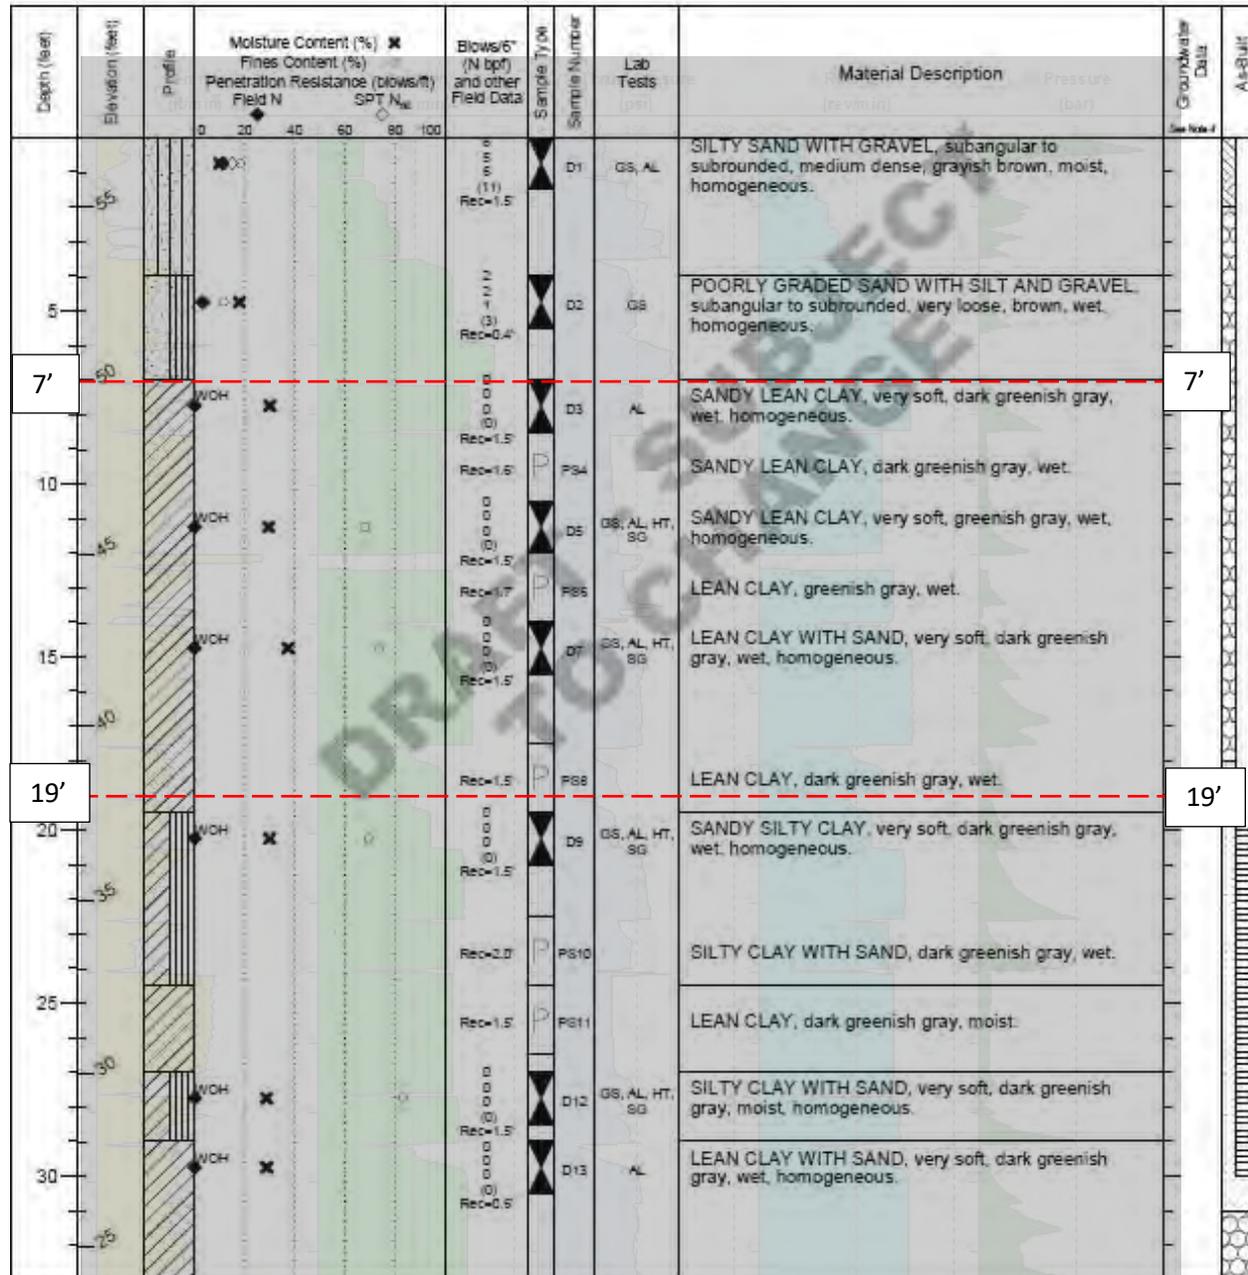
FIGURE 7C. AN EXAMPLE MWD OUTPUT PLOT OVERLYING THE SAME DRAFT BORING LOG (SEE FIGURES 7A AND 7B).

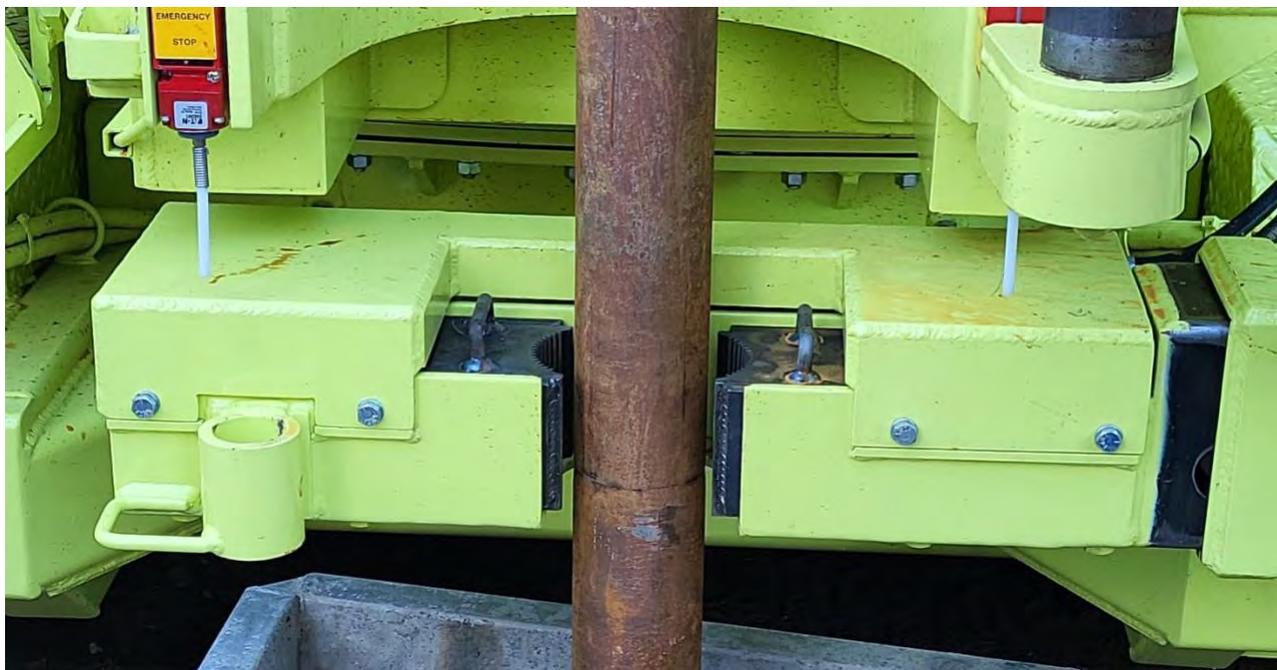
**FIGURE 8. A CLOSE-UP PHOTOGRAPH SHOWING THE CLAMPS ON THE DRILL. CURRENTLY, THE DRILLER PASSES THE “MEASURE/WAIT” BUTTON ON THE MONITOR INSTEAD OF RELYING ON THE CLAMPS (SEE FIGURE 4).**

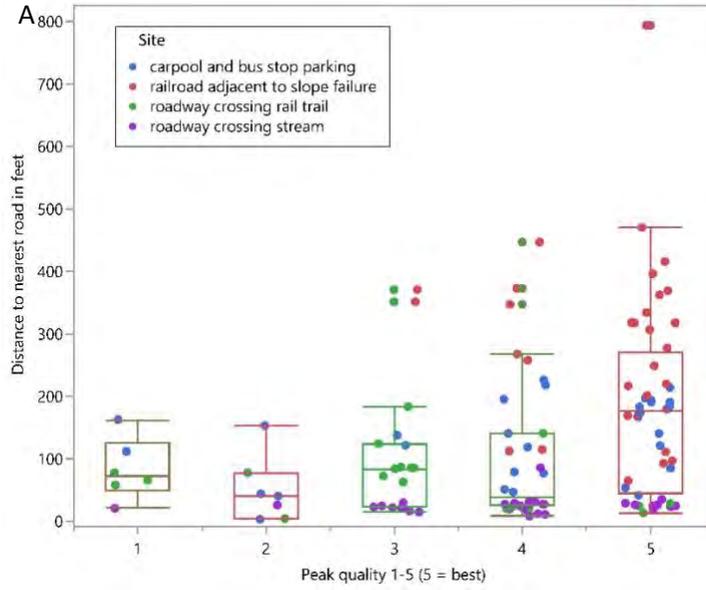
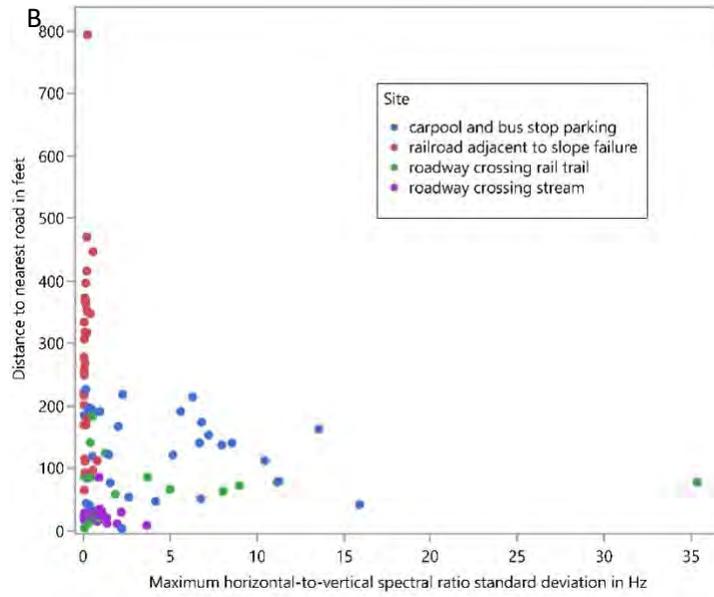
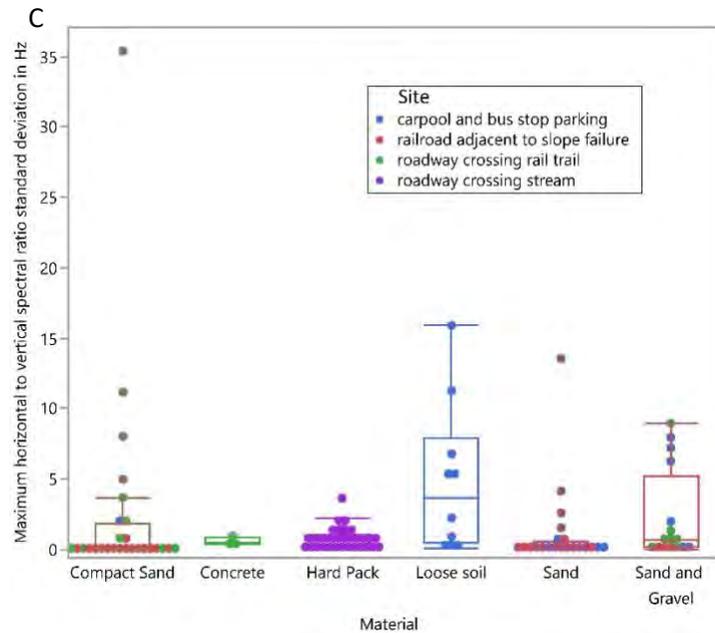
Figure 2. Charts showing passive seismic horizontal-to-vertical spectral ratio (HVSr) data quality indicators, (A) resonance frequency peak quality using a categorical rating system from 1 (worst) to 5 (best), and (B) standard deviation from horizontal-to-vertical spectral ratio measurement versus distance from nearest roadway and (C) coupling material versus horizontal-to-vertical spectral ratio measurement standard deviation.

One important observation from HVSR measurements was that data quality varied with distance from roadways. Frequency peaks in the best quality category (category 5) from HVSR analysis were obtained at various distances from roadways; however, the best quality category had the highest median distance from roadways (fig. 2A). Therefore, although it is possible to get good quality data near a road, most of the best-quality category data were obtained farther from roadways. Additionally, standard deviations were much smaller for measurements made 200 ft (feet) or farther from a roadway (fig. 2B). Also, the best quality data (with the lowest standard deviation) were acquired when the seismometers were well coupled in compact sands, and the highest median standard deviations were associated with loose soil, which generally has poor coupling (fig. 2C).

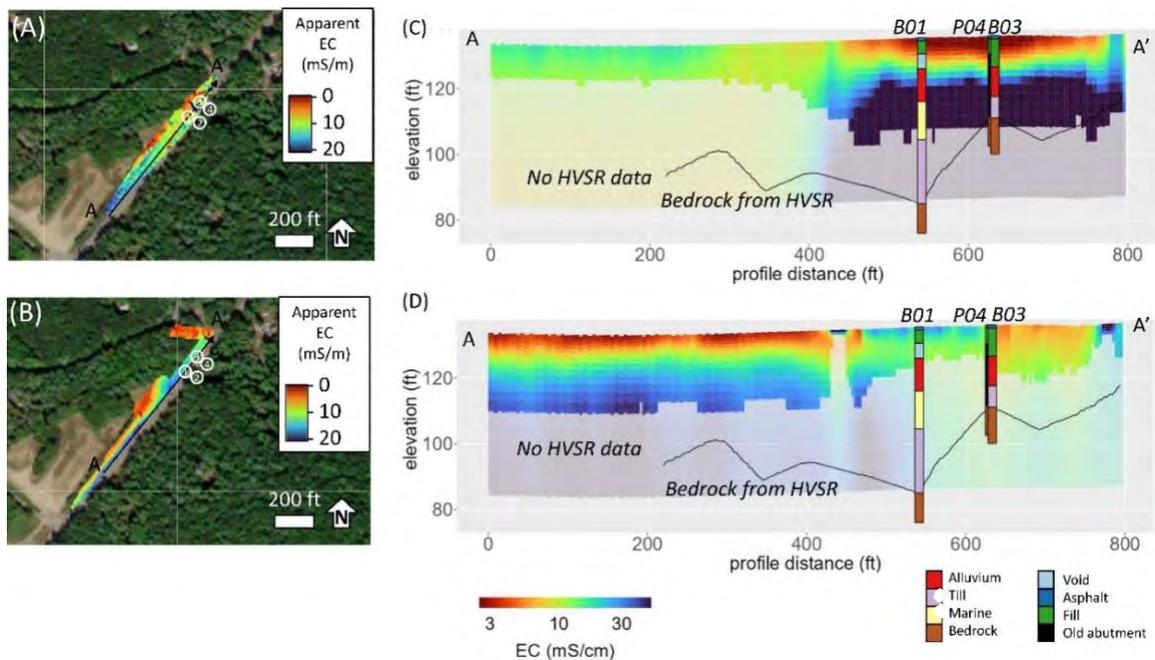
Figure 3. Electromagnetic induction survey results from the A-A' cross section at site 1, roadway crossing stream, in Lee, New Hampshire, showing (A) a map of apparent electrical conductivity (EC) from the multiple-frequency instrument 47,970 Hz band; (B) a map of apparent conductivity from the multiple-coil-spacing instrument (4-m-spaced horizontal coplanar coils); (C) profiles of inverted electrical conductivity from the multiple-frequency instrument with borings and the bedrock surface from passive seismic horizontal-to-vertical spectral ratio results; and (D) profiles of inverted electrical conductivity from the multiple-coil-spacing instrument with borings and the bedrock surface from passive seismic horizontal-to-vertical spectral ratio results. White circles with labels on panels (A) and (B) correspond to borings on panels (C) and (D).

The apparent conductivity results show anomalies (patterned variation) interpreted to represent the surface of the bedrock (fig. 3 A-D). Some anthropogenic effects from power lines and buried metal structures are likely present. Above-ground powerlines are located along State Route 125 and may have impacted the multiple-frequency EMI instrument dataset. Data were collected on the side of road away from the powerlines to attempt to reduce those effects.

The Little River culvert appears in multiple-frequency EMI instrument results as a broad conductive anomaly and a large in-phase anomaly. Both instruments detected a highly resistive anomaly in the middle of the surveyed area along the northwest edge adjacent to bedrock outcrop. The area of this resistive anomaly represents the expression of shallow bedrock subcropping (fig. 3A and B).

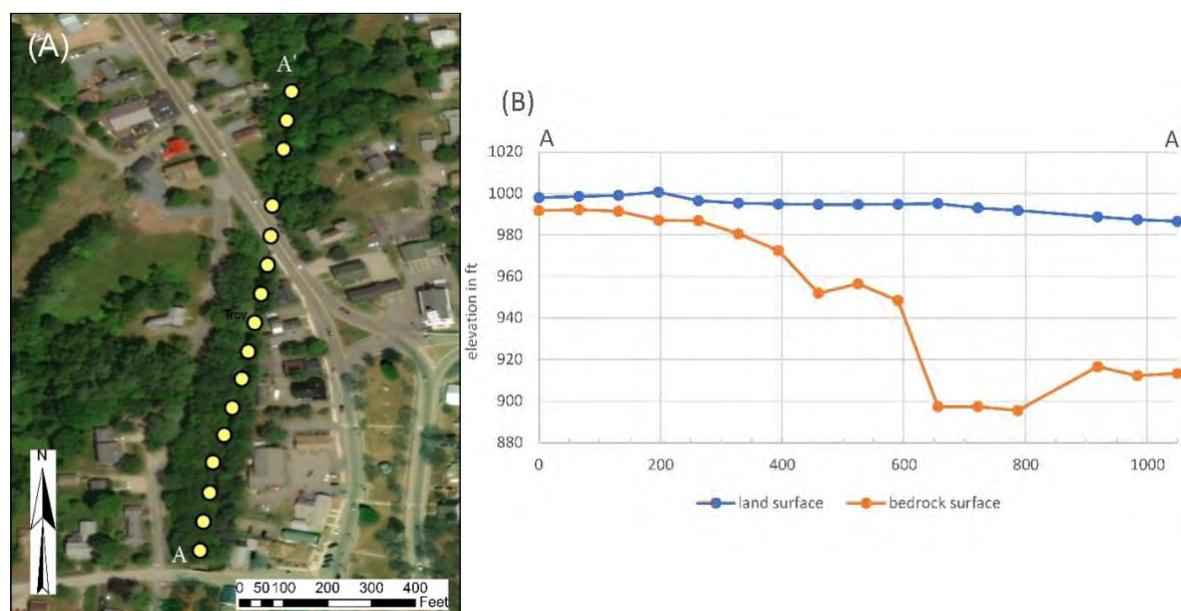
Figure 4. Passive seismic horizontal-to-vertical spectral ratio measurement results from the A-A' cross section at site 2, roadway crossing rail trail, Troy, New Hampshire, showing (A) a map of measurement locations and (B) a cross section of bedrock surface and land surface.

The bedrock surface generated with HVSr results and borings indicates shallow bedrock to the south and deep bedrock to the north (fig. 4). This is consistent with outcrops and railroad rockcuts observed at the site and with the resistive EMI results.

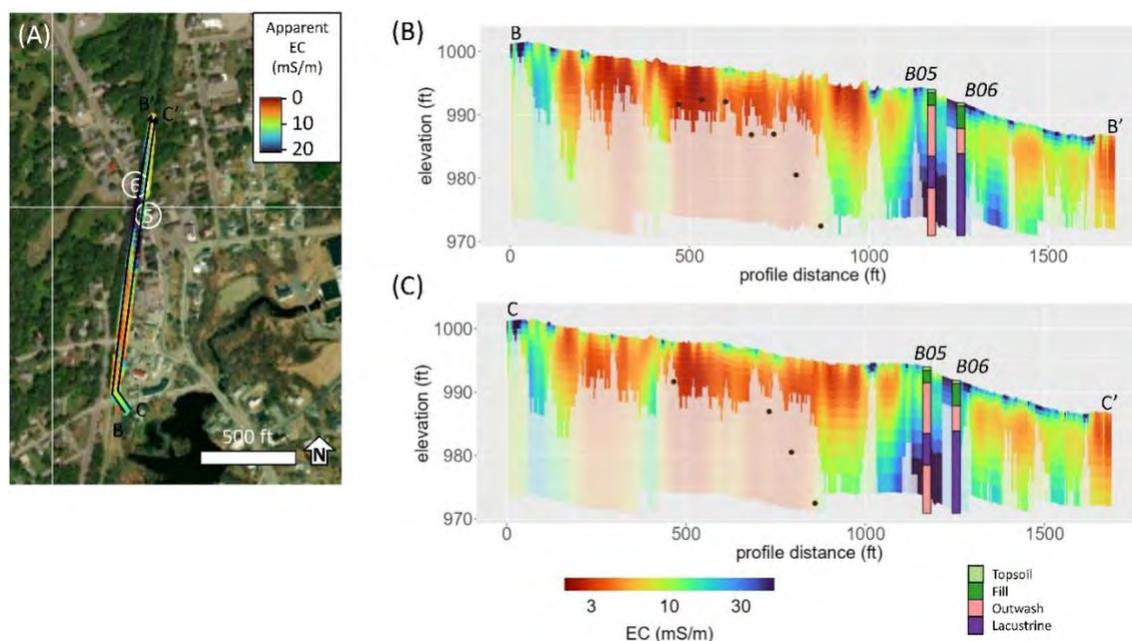
Figure 5. Electromagnetic induction survey results from the multiple-coil spacing instrument from the B-B' and C-C' cross sections at site 2, roadway crossing rail trail in Troy, NH, showing (A) a map of apparent electrical conductivity from the 4-m-spaced horizontal coplanar coils with cross section and boring locations shown with white circles and (B) and (C) profiles of electrical conductivity from inverted frequency domain electromagnetic induction data demarcated in (A). Black dots on profiles show estimated depth to bedrock from passive seismic horizontal-to-vertical spectral ratio measurements.

The EMI results from the roadway crossing rail trail site had the highest residuals and the least successful inversion of all the sites (fig. 5). This may be a result of (1) noise and (or) coupling effects which were strong and likely affected the data near shallow buried metal from the former railroad throughout the survey area and (2) metal from the State Route 12 bridge in the center of the survey area. It is possible that the old rails or other metal hardware were not removed and instead buried on site. Comparison to borings was difficult because electrical noise was higher in this area than at other sites. Inversions were successful but had higher data residuals compared to other sites. The geophysical inversion process used to analyze EMI data assumes a smoothly varying or layered bulk electrical conductivity distribution of the subsurface and has difficulty fitting features that violate these assumptions, such as discrete human-made objects.

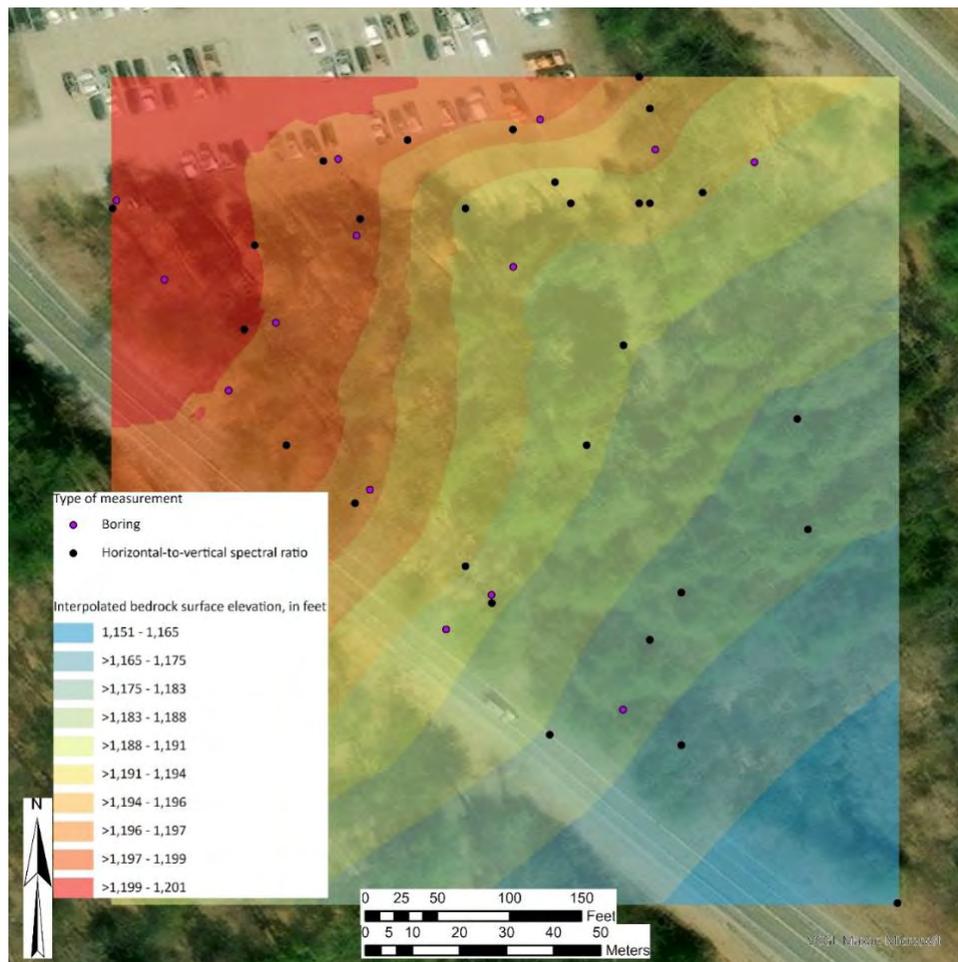
Figure 6. Map of the bedrock surface elevation calculated from passive seismic horizontal-to-vertical spectral ratio measurements at the carpool and bus stop parking site.

Bedrock outcropping was not observed at the site; therefore, shallow bedrock was not expected. However, this site had the most shallow bedrock of all the sites—as shallow as 5 ft in some locations (Table 1). The interpolated bedrock surface elevation map from HVSR results (fig. 6) indicates a higher elevation bedrock surface to the northwest that deepens to the southeast. Further, there is a northwest-southeast trending shallow trough in the bedrock surface at the northern edge of the map just to the south of the existing carpool and bus stop parking site

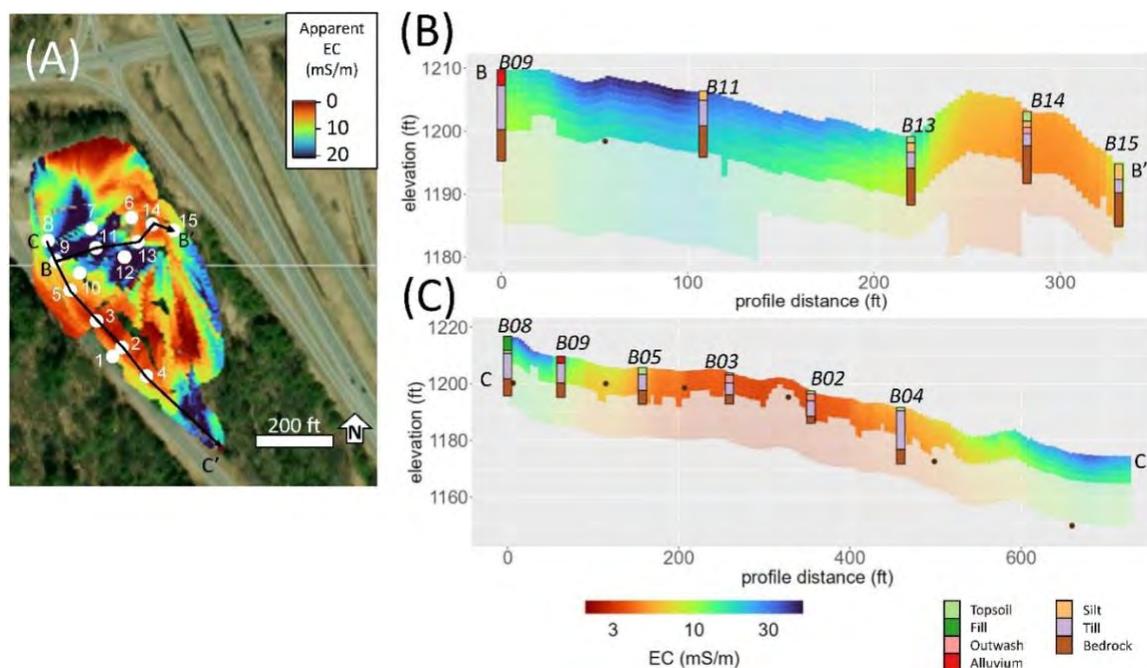
Figure 7. Electrical conductivity (EC) from electromagnetic induction survey results from the multiple-frequency instrument from the B-B' and C-C' cross sections at site 3, carpool and bus stop parking, New London, New Hampshire, showing (A) map of apparent electrical conductivity from the 47,970 Hz band and cross section locations. The white circles show boring locations. (B) and (C) show cross sections demarcated in (A) of inverted electrical conductivity with the bedrock surface from passive seismic horizontal-to-vertical spectral ratio results shown with black dots and borings identified.

The multiple frequency EMI instrument data was likely influenced by vehicles and other infrastructure in the parking lot. Evidence of this influence was apparent based on large positive returns of in-phase components observed when surveying near the parking lot. Interference from metal items near the parking lot rendered EMI data uninterpretable and therefore could not be used to delineate the subsurface electrical conductivity in this area. The remainder of the site (forested area in fig. 7) exhibited low interference and yielded data free of noise contamination.

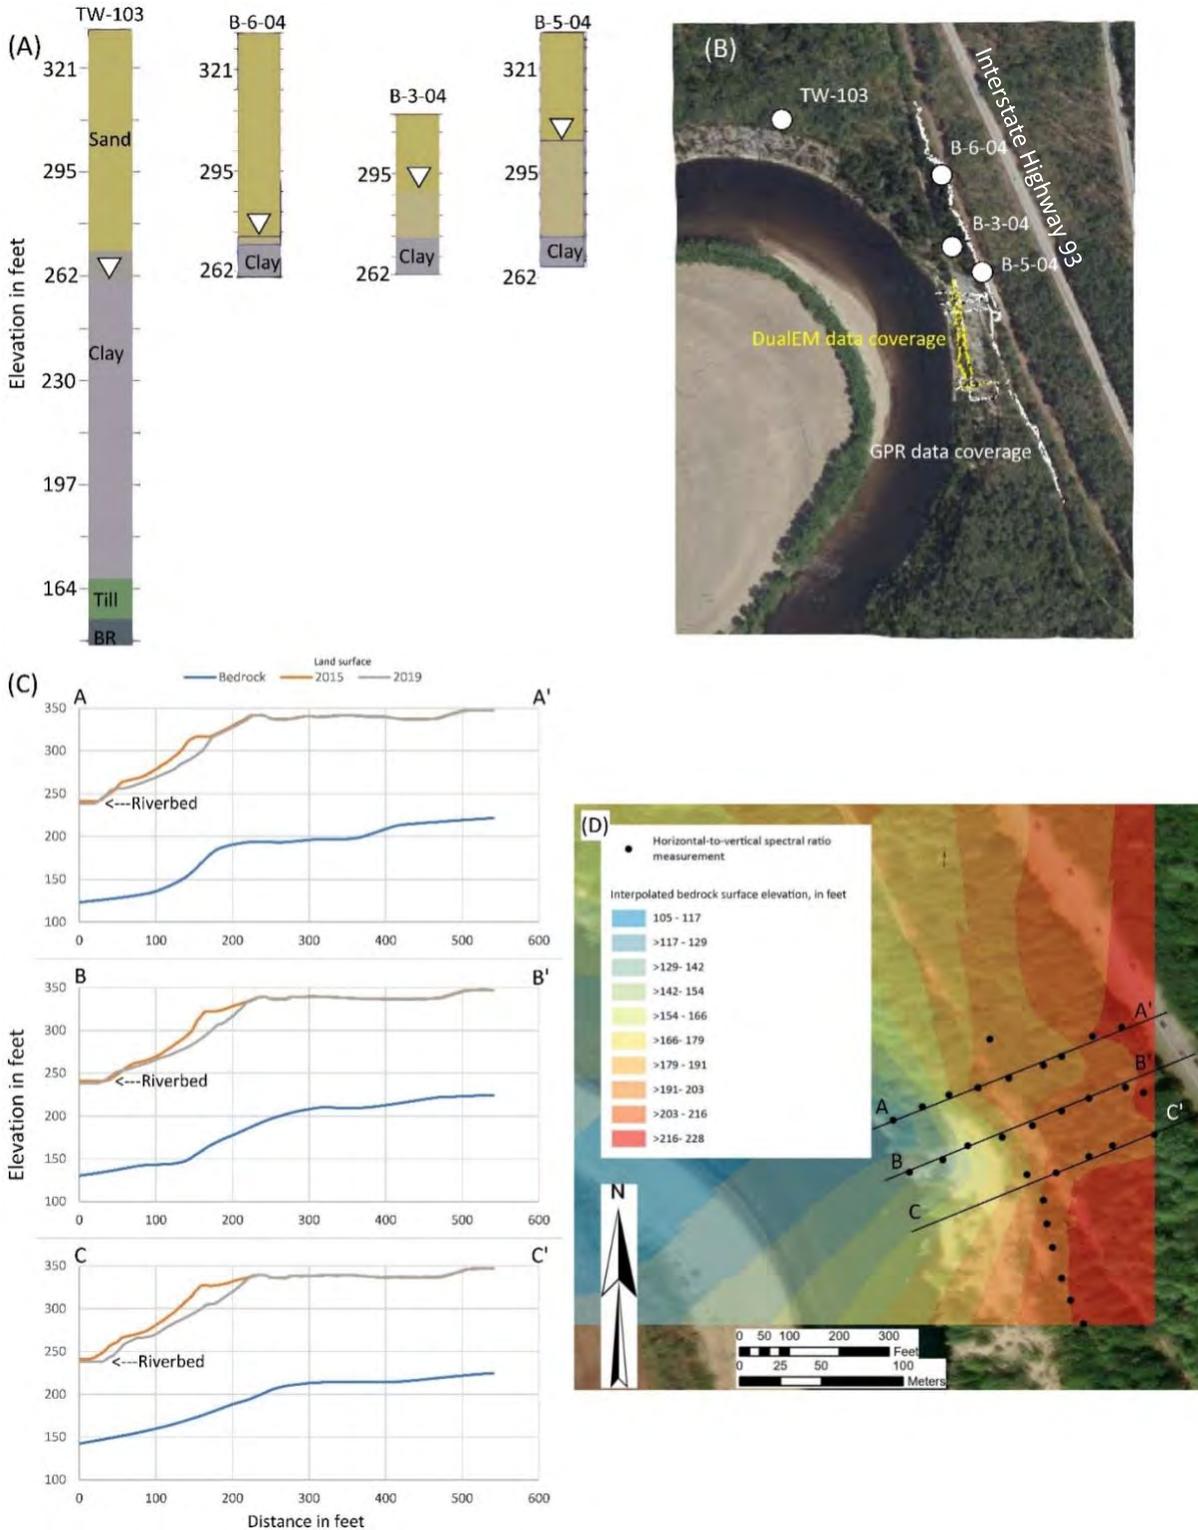
Figure 8. Boring logs and passive seismic horizontal-to-vertical spectral ratio measurement results from the A-A', B-B', and C-C' cross sections at site 4, railroad adjacent to slope failure, Canterbury, New Hampshire, showing (A) lithologic logs, (B) boring location map, (C) cross sections of the bedrock surface and land surface, and (D) map of interpolated bedrock surface elevation from passive seismic horizontal-to-vertical spectral ratio measurements.

Thirty-two HVSR measurements were made at locations along the top of the slope failure scarp, on the failed slope, and in a grid pattern in the adjacent wooded area between the railroad and Interstate 93. One of the HVSR locations was adjacent to a boring location with documented overburden stratigraphy and depth to bedrock, and the other 31 measurements were used to delineate the bedrock surface (fig. 8).

The bedrock surface elevation delineated by HVSR is higher towards the northeast. The location of the bedrock surface does not provide any protection from additional riverbank erosion as it is well below (approximately 100 ft) the bed of the river (fig. 8B and C) and would not limit channel migration.

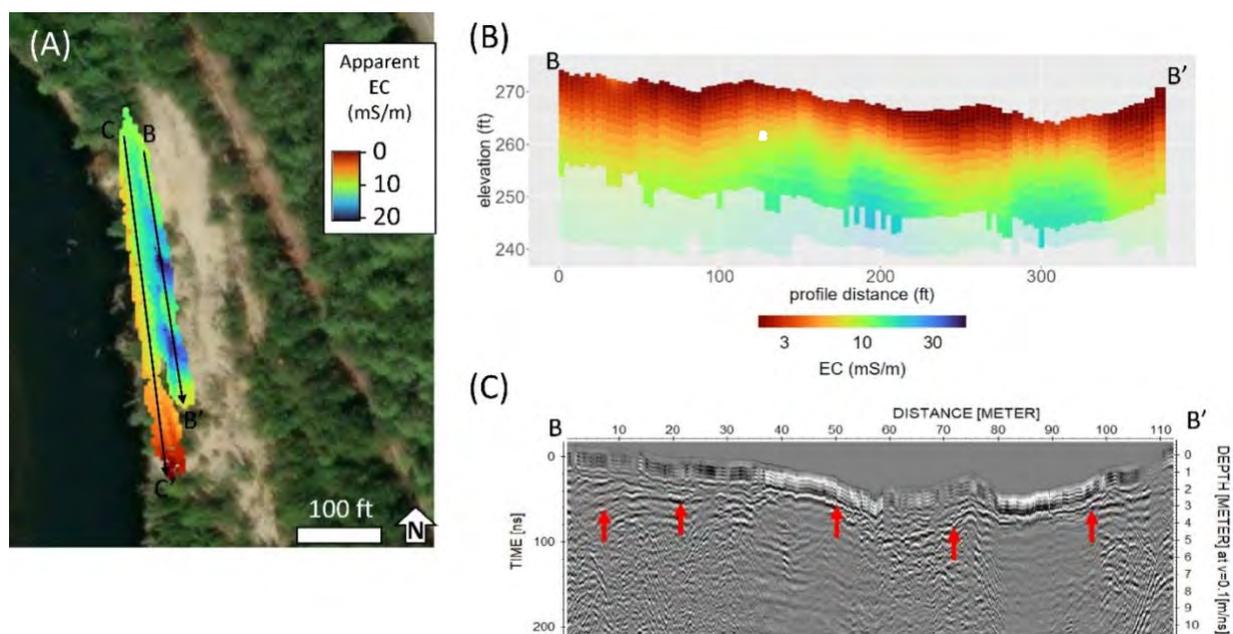
Figure 9. Multiple-frequency electromagnetic induction instrument and ground-penetrating radar survey results from the B-B' cross section at site 4, railroad adjacent to slope failure Canterbury, New Hampshire, showing (A) map of apparent electrical conductivity (EC) from the 4-m-spaced horizontal coplanar coils and cross section locations, (B) cross section of inverted electrical conductivity, and (C) ground-penetrating radar survey results.

The multiple-coil-spacing EMI instrument and GPR data are of high quality. Near-river profiles show a high resistivity layer over a high conductivity layer. A reasonably strong GPR reflector, that gets deeper closer to river, is also present.
