# 72<sup>nd</sup> Highway Geology Symposium

## 2023 PROCEEDINGS

August 14-17, 2023 • Hotel Murano • Tacoma, Washington

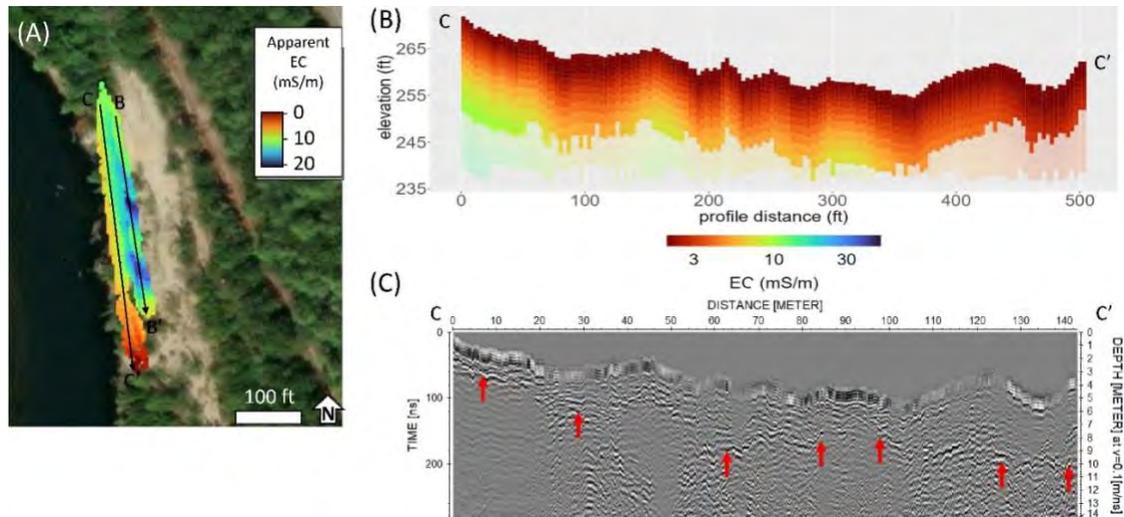
Figure 10. Multiple-frequency electromagnetic induction instrument and ground-penetrating radar survey results from the C-C' cross section at site 4, railroad adjacent to slope failure Canterbury, New Hampshire, showing (A) map of apparent electrical conductivity (EC) from the 4-m-spaced horizontal coplanar coils and cross section locations, (B) cross section of inverted electrical conductivity, and (C) ground-penetrating radar survey results.

The multiple-coil-spacing EMI instrument was used to collect data along three survey lines at the railroad adjacent to the slope failure site. Apparent conductivity values were inverted and provided stratigraphic information to depths of 40 ft below land surface. Survey line 1 was parallel to the river and the closest survey line to the river. Electromagnetic induction results from survey line 1 showed an approximately 6 ft thick resistive layer overlying a conductive layer (fig. 9). Survey line 2 was upslope and parallel to the river (and line 1) and had an approximately 3-6 ft thick resistive layer overlying a conductive layer. At some locations along survey line 2 the conductive material was observed near the surface, which was corroborated by varved clay and silt seen in outcrop adjacent to the line. Survey line 3 was perpendicular to and south of survey lines 1 and 2. Low conductivity sand with minimal variation in EC values was indicated in results from survey line 3 (not shown), and inversion results had a very shallow depth of investigation, likely due to a low signal overall from resistive ground. In general, conductivity increased with distance from the river in lines 1 and 2.

Ground penetrating radar (GPR) was used only at this site, to improve the interpretation of the subsurface stratigraphy. Results provided information as deep as 100 ft in many locations. Penetration of the GPR signal was enhanced in electrically resistive materials and was best along lines 1 and 3 on the slope failure and above the scarp where the stratigraphy was relatively undisturbed by the failure.

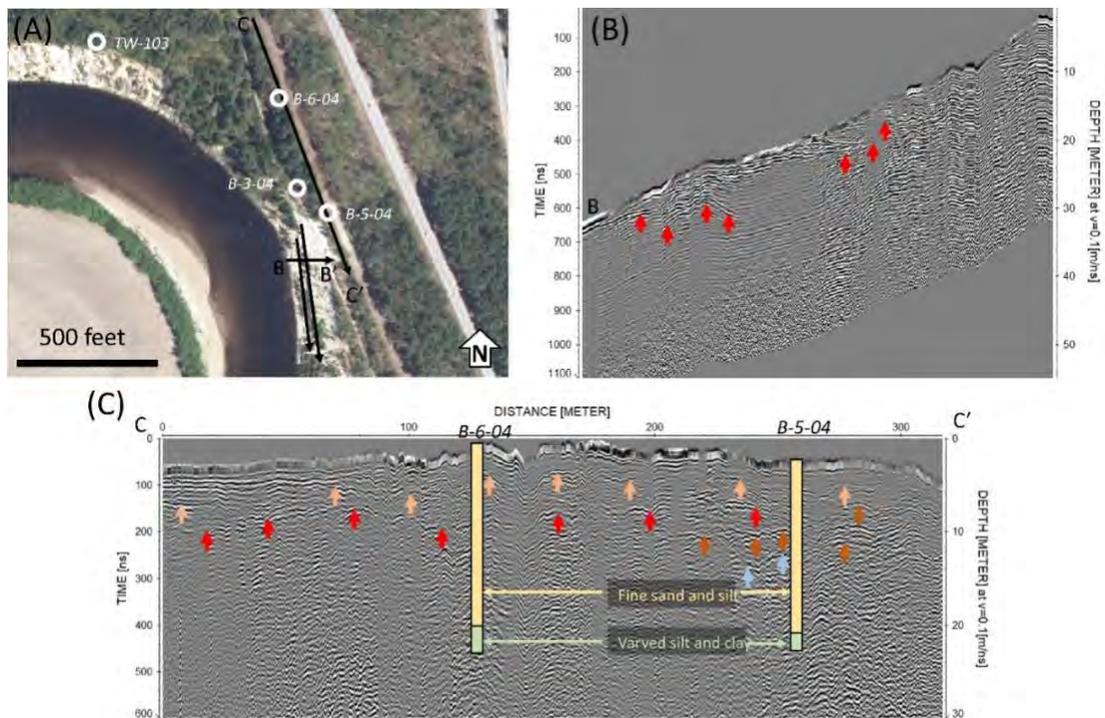
Figure 2. Ground penetrating radar results at site 4, railroad adjacent to slope failure Canterbury, New Hampshire, showing (A) map of survey and boring locations, (B) B-B' cross section, and (C) C-C' cross section. Different colored arrows indicate multiple reflectors that were observed. Materials described by boring logs and their depths are indicated along this profile.

Ground penetrating radar data identified many anomalies that could not be interpreted because of limited information from wells and (or) test pits. Some layered GPR reflectors are indicated by the different colored arrows in fig. 11; these are likely soil layers or in the slope, possibly features related to the slope failure, such as fissures or shear planes (fig. 11B and C). The red arrows may indicate the water table in the C-C' GPR cross section (fig 11C) because the reflector is near the previously identified water-table depth (Aries Engineering, Inc., 2005).

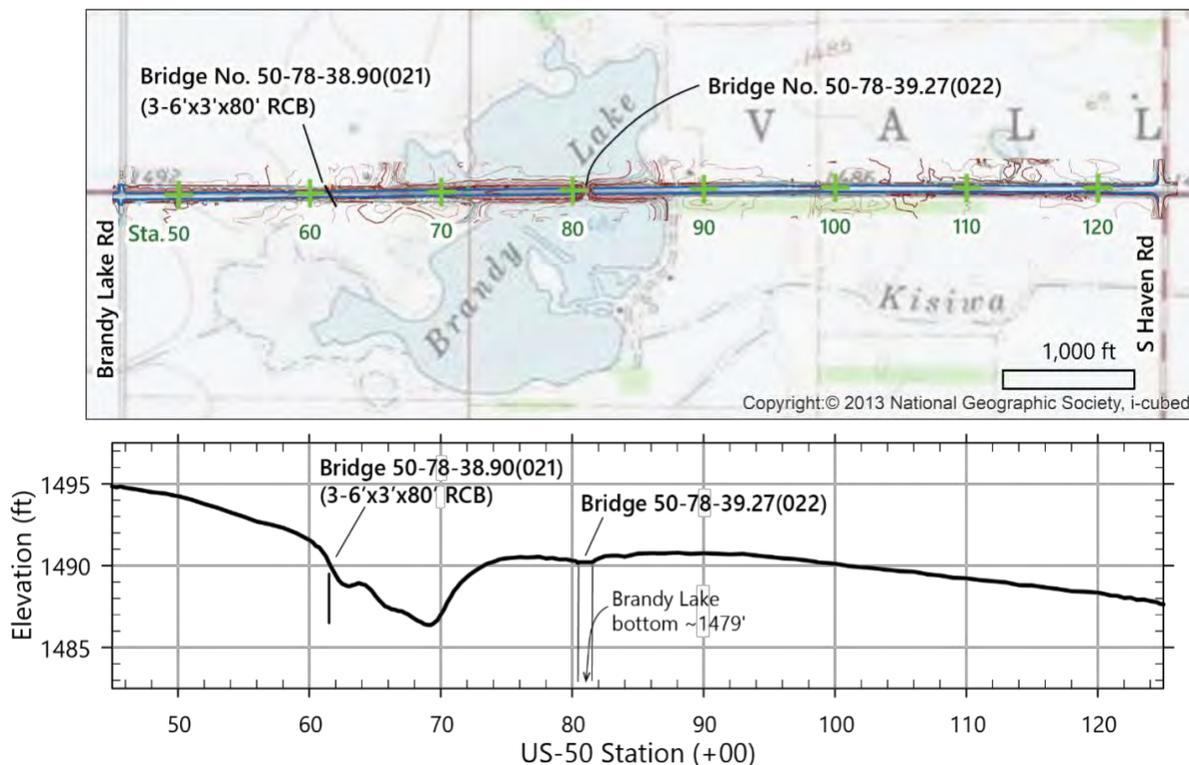
**Figure 2:** Location of KDOT survey data along US Highway 50 in the Brandy Lake study area.

Shallow dips in the highway (Figure 6) were observed along ReMi Line 6 (Figure 4) in the area along US Highway 50 west of Brandy Lake where subsidence is documented in Figures 2 and 3. The crest of the westernmost dip in the highway (Figure 6A) terminates near the culvert (labeled as a RCB bridge in Figures 2 and 4) close to the private property on the northern side of the pavement (Figure 6B). A constant, relatively high volume of vehicles (e.g., cars, pickups, and trucks) was observed traveling on this major east-trending transcontinental highway during the field data collection.

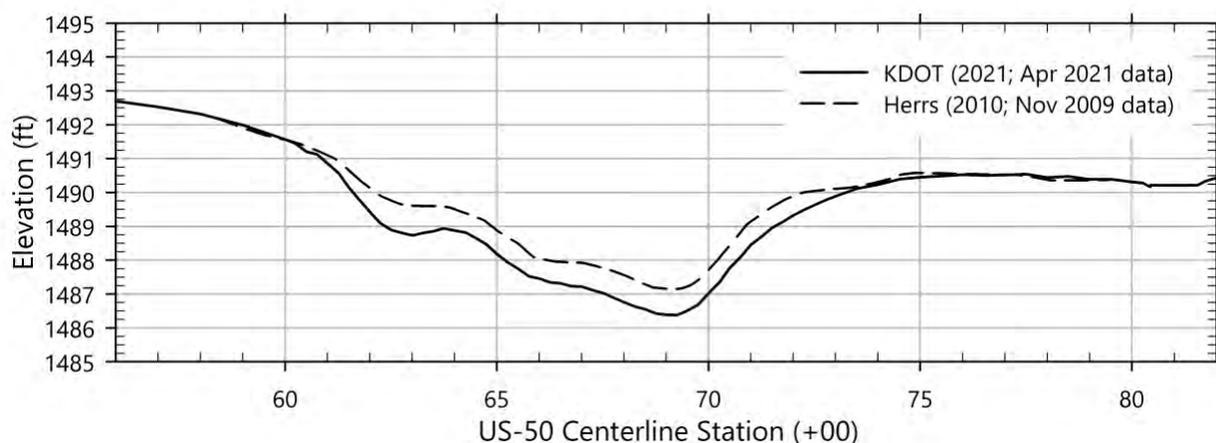
**Figure 3:** US Highway 50 centerline profiles from 2009 (Herrs, 2010) and 2021 (KDOT, 2021)

The master's thesis 'Quantifying Surface Subsidence along US Highway 50, Reno County, KS, using Terrestrial LiDAR' (Herrs, 2010) provides a detailed profile of the Brandy Lake subsidence feature dated to 2009. Three LiDAR surveys were performed in February 2009, May 2009, and November 2009, in an attempt to document a continuing subsidence rate, but no change in the subsidence profile was measured during that time. The measured length of the local subsidence feature was 358 meters, and the maximum apparent subsidence was 1.15 meters (3.77 ft) relative to extrapolation from the far-field highway grade. The reported RMS error in the LiDAR point cloud during the November 2009 survey was <1mm. Comparative profiles of the KDOT (2021) April 2021 centerline elevation and the Herrs (2010) November 2009 laser scan results (Figure 3) show subsidence between approximately Sta. 61+00 and Sta. 73+50. It should be noted that the 2009 profile was taken from Figure 29 in Herrs (2010) thesis, which was a plot of all laser strikes on the highway surface that captured the driving lanes including the centerline. The KDOT (2021) centerline survey was a physical survey with point measurements spaced at 50 or 25 ft directly on the centerline.

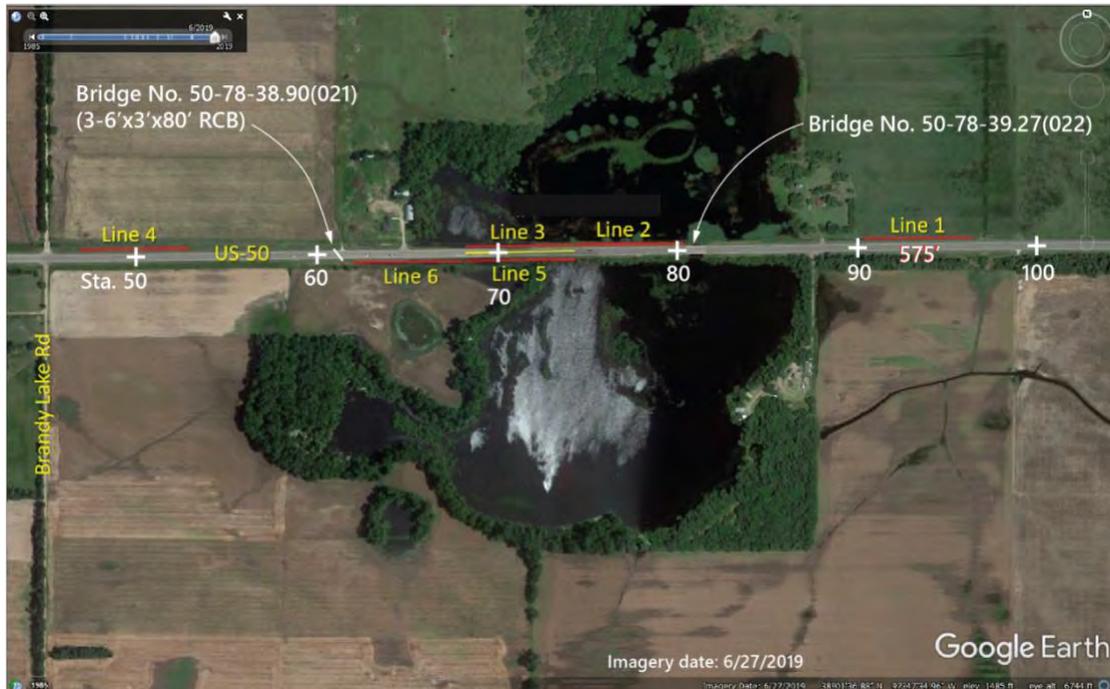
**Figure 4:** Locations of the six-line ReMi survey along US Highway 50 at Brandy Lake.

The investigation was restricted to KDOT right of way along US Highway 50 and consisted of six ReMi surveys at between Sta. 50, east of Brandy Lake Road, and Sta. 93, east of Brandy Lake (Figure 4), encompassing the lake-forming subsidence area locally called a “sinkhole” (Herrs, 2010). The bridge at Sta. 81 on the highway spans two embankment sections which is the hydraulic connection between the southern and northern parts of Brandy Lake. The water level in the lake was a few feet lower than the pavement at the time of WSP’s field observations. Power lines supported on tall poles are located along the north side of the highway (Figure 5A). Thick vegetation encompasses the shorelines of the Brandy Lake, with grass up to a few feet tall, covering the entire area from the edge of the pavement to thicker vegetation along the lake margin (Figure 5B).

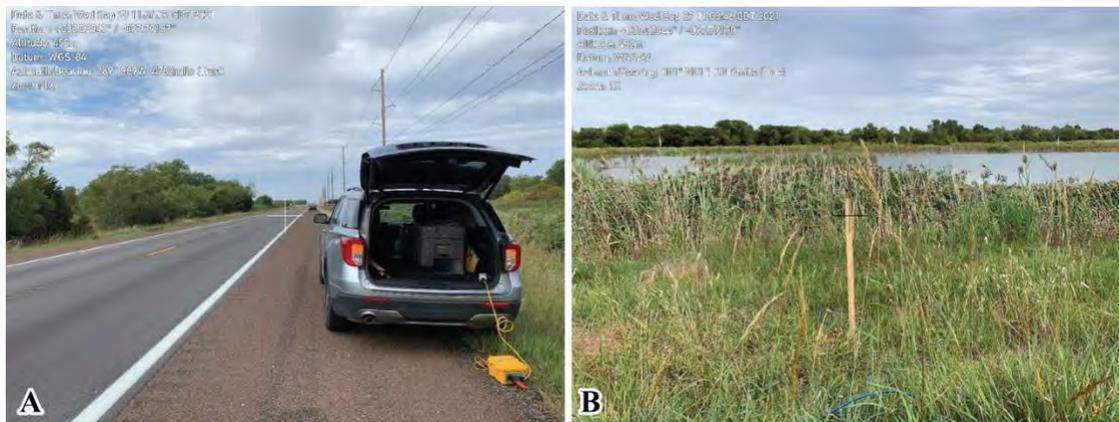
**Figure 5:** Field photos during ReMi survey along US Highway 50 at Brandy Lake.  
**A.** View west along highway from west end of Line 2; power lines on north side of road; yellow box is Geometrics Geode 24-channel seismograph. **B.** View north from Line 2 at vegetation along road shoulder and Brandy Lake.

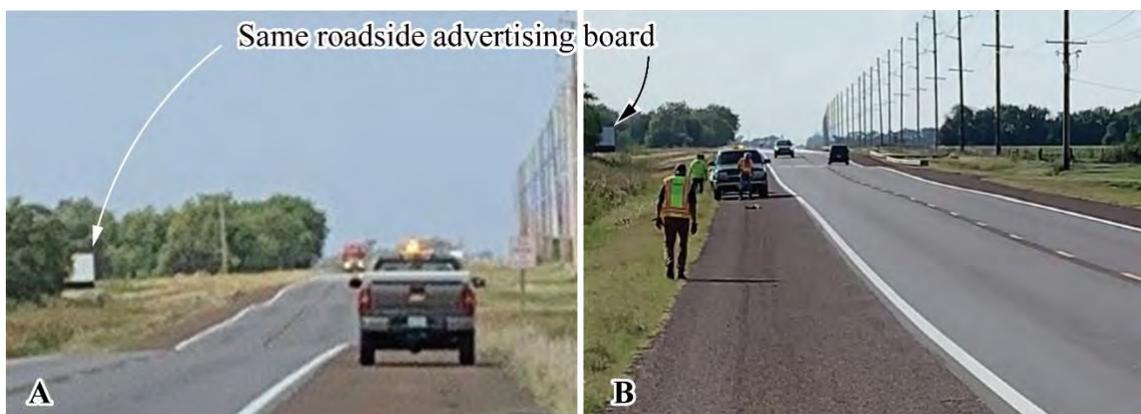
**Figure 6:** Field photos during ReMi survey along US Highway 50 at Brandy Lake. **A.** Enlargement of part of a photo looking west from Line 3; paint stripe on south side of road enhances the dips. **B.** View west from Line 5; guard rail adjacent to westbound vehicle is at residence driveway across from Line 6 (visible in Figure 4).

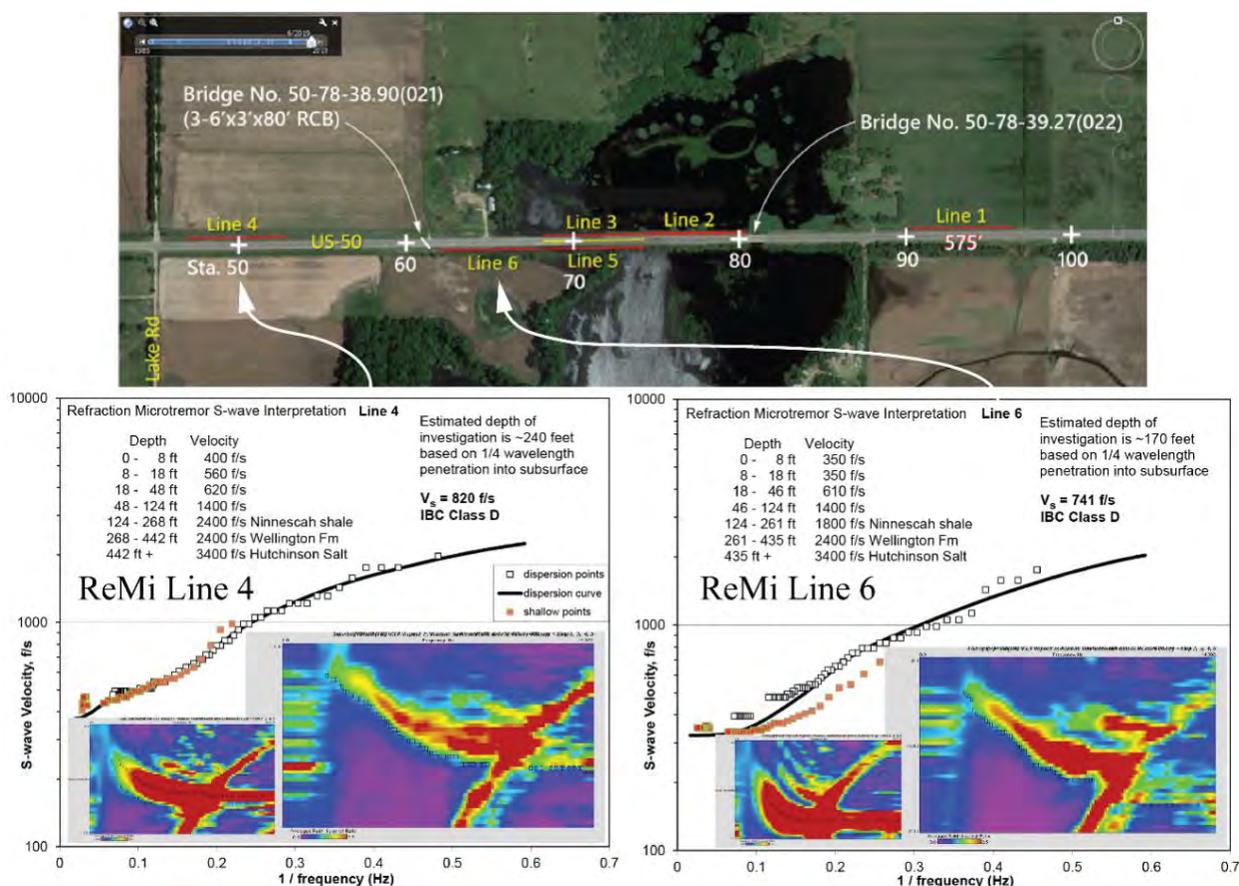
**Figure 2:** Examples of interpreted ReMi lines.

and further from it. Seismic Line 1 was placed to the east of the Brandy Lake bridge, away from the known area of recent and current subsidence where the salt bed dissolution front may have already passed (see Keaton et al., 2023, Figure 6). The intent was to sample background s-wave velocities of the subsurface geological units east of the subsidence zone. Seismic Lines 2 and 3 were placed (in sequence adjacent to each other) on the north (westbound) side of US Highway 50 in the subsidence zone; Line 3 extended across the lowest point of ground surface deformation (Sta. 69, Figure 3). Seismic Lines 5 and 6 were placed on the south (eastbound) side of US Highway 50. Lines 3 and 5 were directly across the highway from each other. Seismic Line 6 was placed further west and adjacent to Line 5. The Seismic Line 4 was placed on the northern side of the US Highway 50 near the west end of the study area, close to the intersection of Brandy Lake Road, with the intention of sampling s-wave velocities of undisturbed subsurface geological units west of the subsidence feature and the subsurface dissolution front (see Keaton et al., 2023, Figure 6). Interpreted results for ReMi Lines 4 and 6 are displayed in Figure 7.

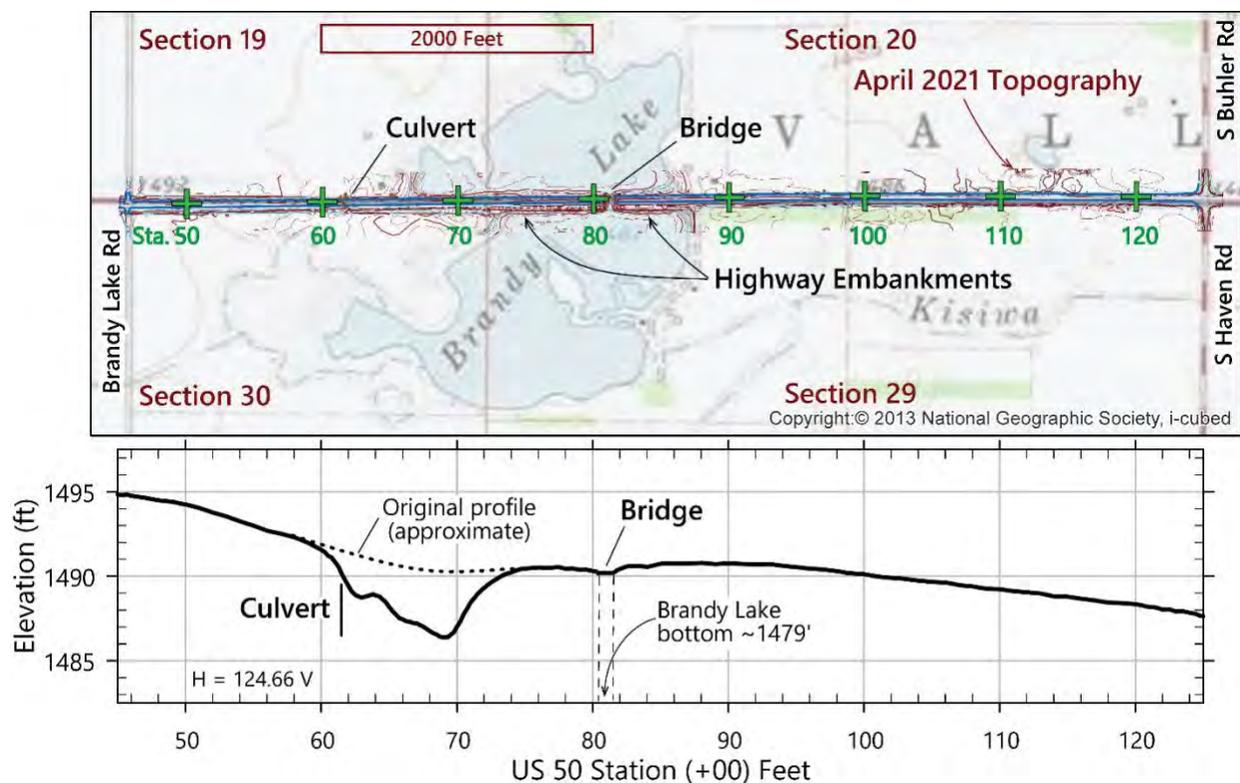
**Figure 3. US Highway 50 across Brandy Lake showing station numbers and locations of bridges on a 1961 topographic map (photo revised 1978) supplemented with April 2021 topography (upper diagram). Centerline 2021 topographic profile showing locations of the bridge, the culvert, and the area of major subsidence (lower diagram).**

This paper describes the second part of a geotechnical transportation engineering project focused on US Highway 50 at Brandy Lake, Reno County, Kansas (Figures 1 and 2). The objectives of this project were to design improvements to the two-lane highway to restore uniform grade across an area of gradual subsidence and elevate the road above local inundation when the level of Brandy Lake is high. High water for this project was taken as elevation 1490 feet (mean sea level datum), which is the elevation of the base of a pile-supported bridge connecting the highway across an approximately 120-foot-wide gap between compacted earth embankments across Brandy Lake (Figure 3).

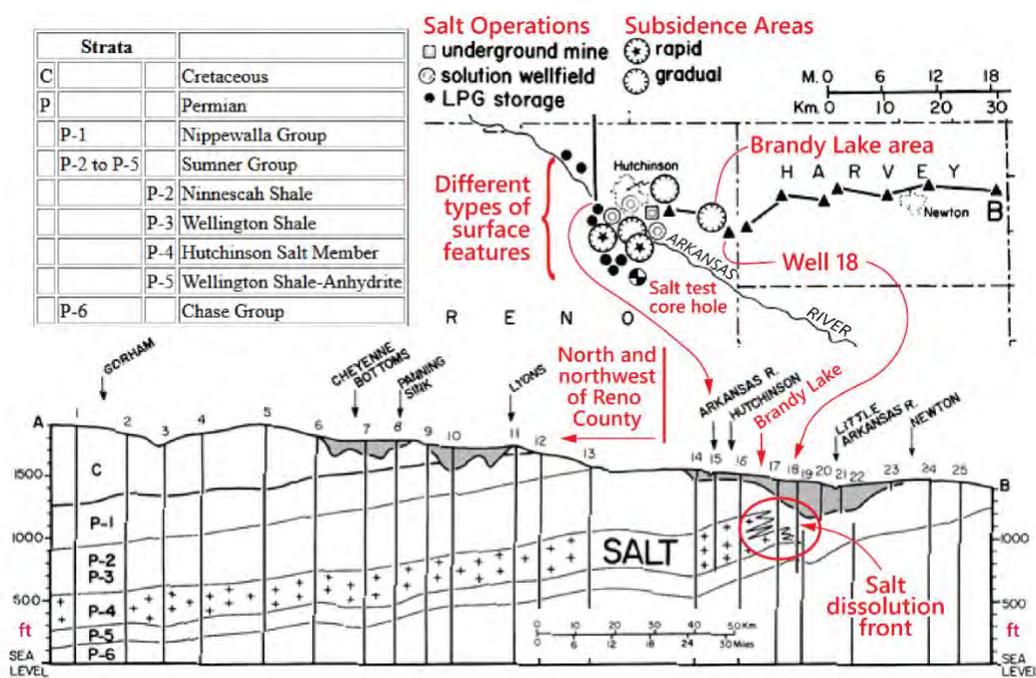
**Figure 6. Stratigraphy sketch in the Brandy Lake vicinity. Shaded areas in section are unconsolidated water-bearing beds. Modified from Walters (1978).**

resource development results in the geology of the region being well known. The geologic profile in the Brandy Lake area consists of late Pleistocene terrace deposits overlying Permian bedrock (Bayne, 1956). The Permian bedrock formations in the study area consist of bedded shale and evaporite deposits of the Ninnescah Shale and Wellington Formation of the Sumner Group that dip relatively gently toward the west (Figure 6; Walters, 1978; West et al., 2010). The Hutchinson Salt Member is a subunit of the Wellington Formation at a depth of approximately 425 feet at Brandy Lake (Judy, 2015). The Brandy Lake area is within a naturally occurring zone of dissolution of the Hutchinson Salt located approximately 20 miles west of the where the salt bed would be exposed if it had not dissolved during late Cenozoic time. The surface expression of salt dissolution at depth is irregular subsidence-induced depressions in terrace deposits. The shallow aquifer in Pleistocene terrace deposits produces ponds and lakes, such as Brandy Lake, where subsidence intersects the groundwater table.

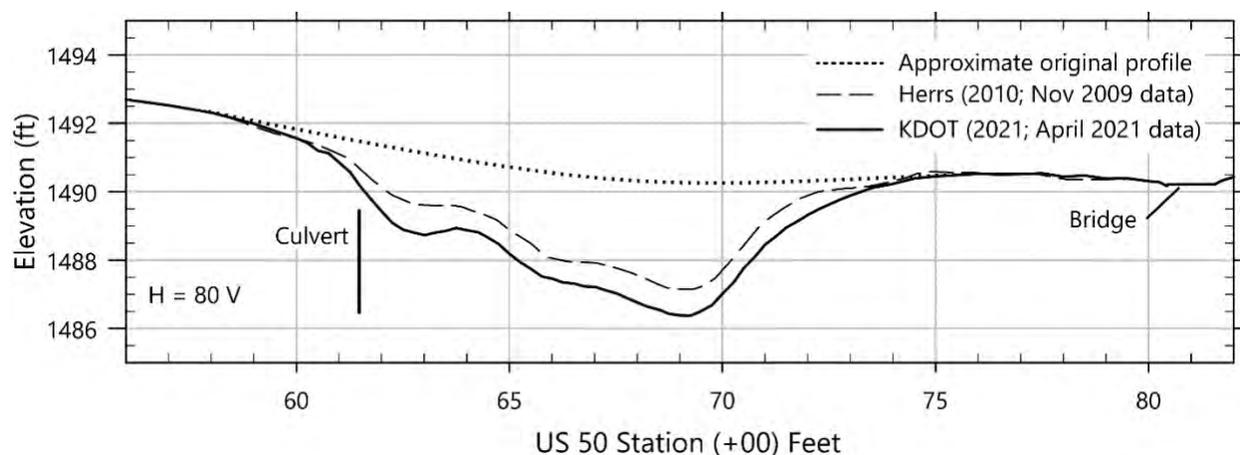
**Figure 7. Comparison of US Highway 50 centerline elevation profile from November 2009 and April 2021. Modified from Herrs (2010) and plotted from KDOT (2021).**

The complete history of subsidence along the Brandy Lake segment of US Highway 50 in Reno County, KS, is unknown or at least undocumented in detail. A 2010 Master of Science thesis entitled "Quantifying surface subsidence along US Highway 50, Reno County KS, using terrestrial lidar" (Herrs, 2010) suggests that subsidence at Brandy Lake was becoming a nuisance by the early 2000's. Herrs (2010) performed three lidar surveys in 2009 (February, May, and November) in an attempt to document short-term subsidence rate, but no detectable change was documented among the three surveys. A stable benchmark distant from the subsidence area was used as the elevation reference. The November 2009 survey was used in the present analysis and compared to the April 2021 survey by Kansas Department of Transportation, an approximately 11.4-year time difference (Figure 7).

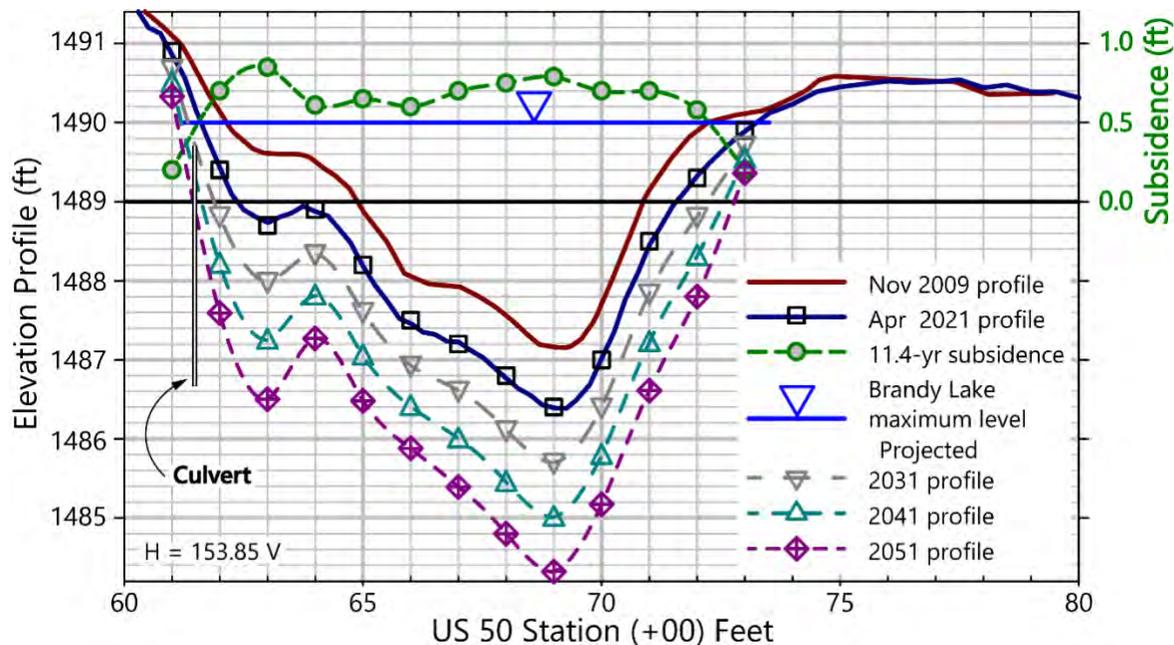
**Figure 8. Comparison of US Highway 50 centerline elevation profile from November 2009 and April 2021 (11.4 years). Modified from Herrs (2010) and plotted from KDOT (2021).**

The two topographic surveys of the subsiding portion of the US-50 highway (Figure 7) indicated that less than one foot of subsidence occurred over the approximately 11.4-year period of time between the two surveys (Figure 8). The main subsidence is limited to the reach between US-50 Sta. 60+00 and Sta. 74+00. The elevation profiles by Herrs (2010) from November 2009

and by KDOT (2021) from April 2021 are plotted at an enhanced vertical scale in Figure 8. The elevation difference between the two profiles is plotted on the supplemental y-axis as the amount of subsidence that occurred during the approximately 11.4-year period of time. That annualized rate exceeds 0.02 ft/yr between Sta. 62+00 and Sta. 72+00. The mean and standard deviation annualized subsidence rates are 0.061 ft/yr and 0.007 ft/yr. The projected future subsidence amounts after 10, 20, and 30 years were calculated based on the measured 2009-2021 subsidence amount. The mean and 84th percentile projected subsidence amounts are summarized in Table 1.

The annualized subsidence rate is an index of the hazard ( $0.061 \pm 0.007$  ft/yr; Table 1), which is approximately 0.5 ft in 7.4 to 9.3 years. The two most rapidly subsiding areas during the ~11.4-yr period between surveys (Figure 8) suggest that 0.5 ft of subsidence could occur in ~6.72 yr at Sta. 63 and in ~7.23 yr at Sta. 69. The subsidence mechanism seems to be related to salt dissolution at depth with strain allowing the area of subsidence to continue to subside. Repeated centerline surveys every 2 to 4 years would advance understanding of the rate of continuing subsidence within incremental subsidence amounts of approximately 0.1 to 0.25 ft. Currently, two surveys ~11.4 years apart are the only data points on which the projected subsidence rate is based. The extent along the highway of continuing subsidence is taken to be fixed, but confirmation of the subsidence limits would be desirable.

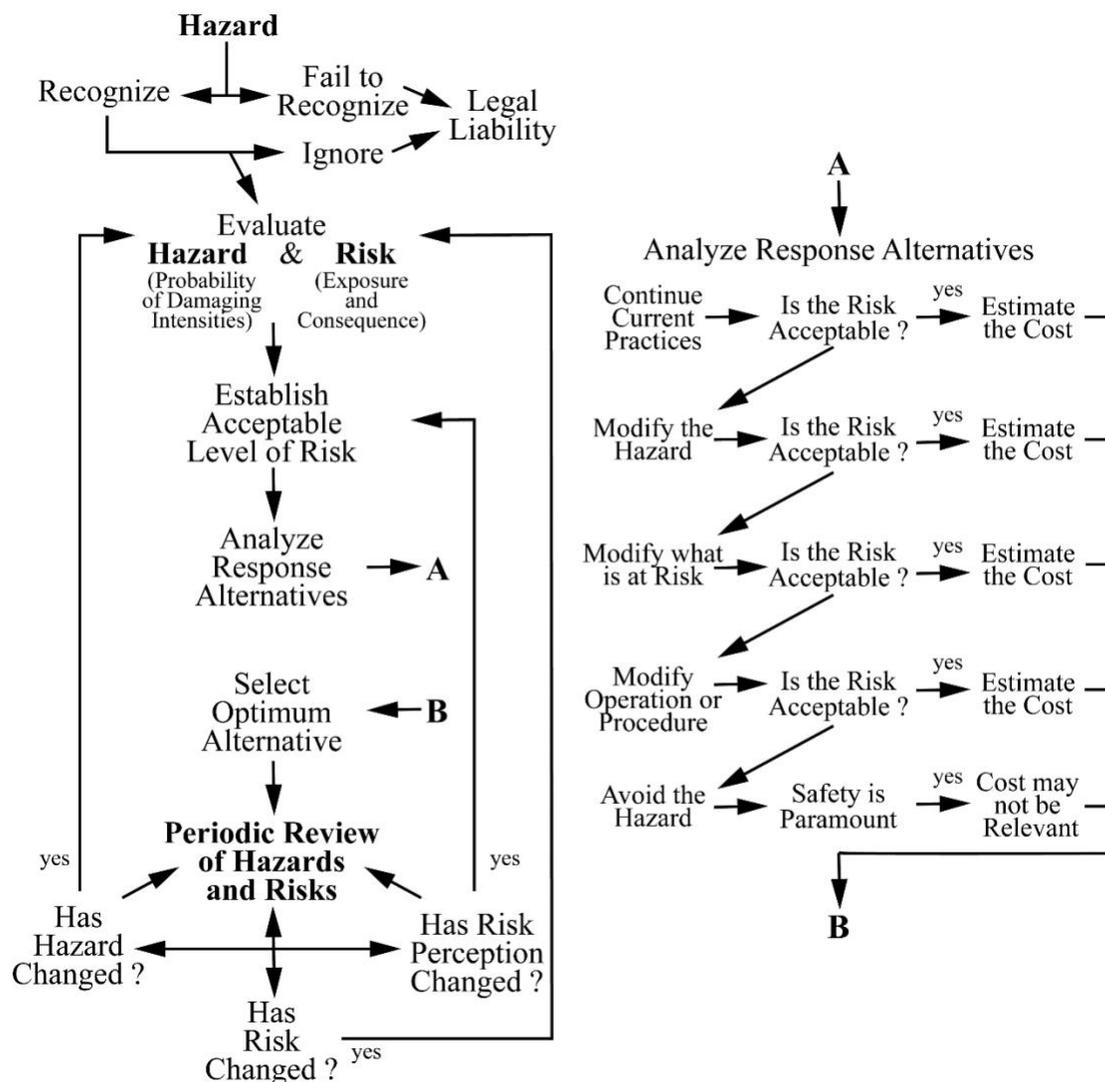
**Figure 9. A model for geologic hazard risk management. Modified from Keaton and Eckhoff (1990).**

The five types of approaches in the hazard-response model (Figure 9) are:

- 1) continue current practices,
- 2) modify the hazard,
- 3) modify what is at risk,
- 4) modify operation or procedure, and
- 5) avoid the hazard.

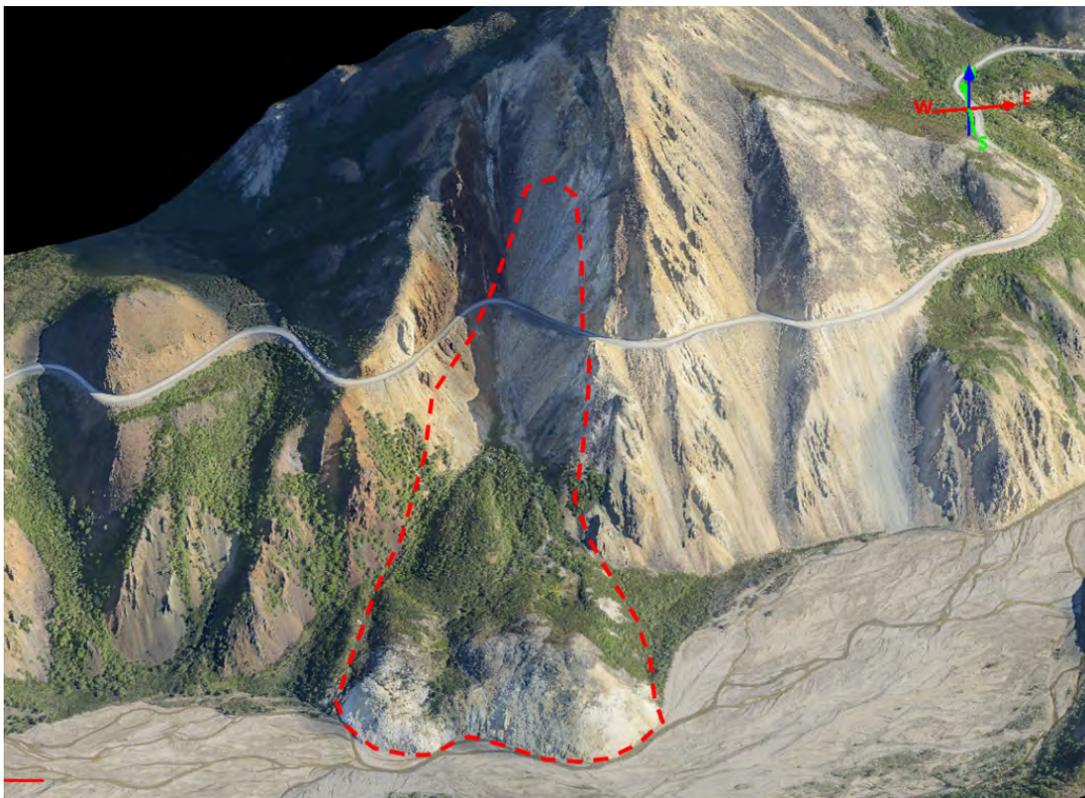
**Figure 1 - Composite photo of the Pretty Rocks Landslide from 2015 with approximate landslide outline indicated by red dashed line (1).**

The Denali Park Road is a 92.5 mile long dead-end road that heads west from the park entrance near Healy, Alaska to remote Kantishna, an outpost within in the heart of DNA. The first 15 miles of the Park Road is paved and open to public traffic. Past Mile 15, visitors are transported on buses to limit the number of vehicles traveling the Park Road. This project site is located at the Pretty Rocks Landslide at milepost 45.4. While the road is currently closed near the midpoint by the Pretty Rocks Landslide, the first half remains fully accessible to visitors and staff. A composite photograph of the landslide is shown in Figure 1 (1).

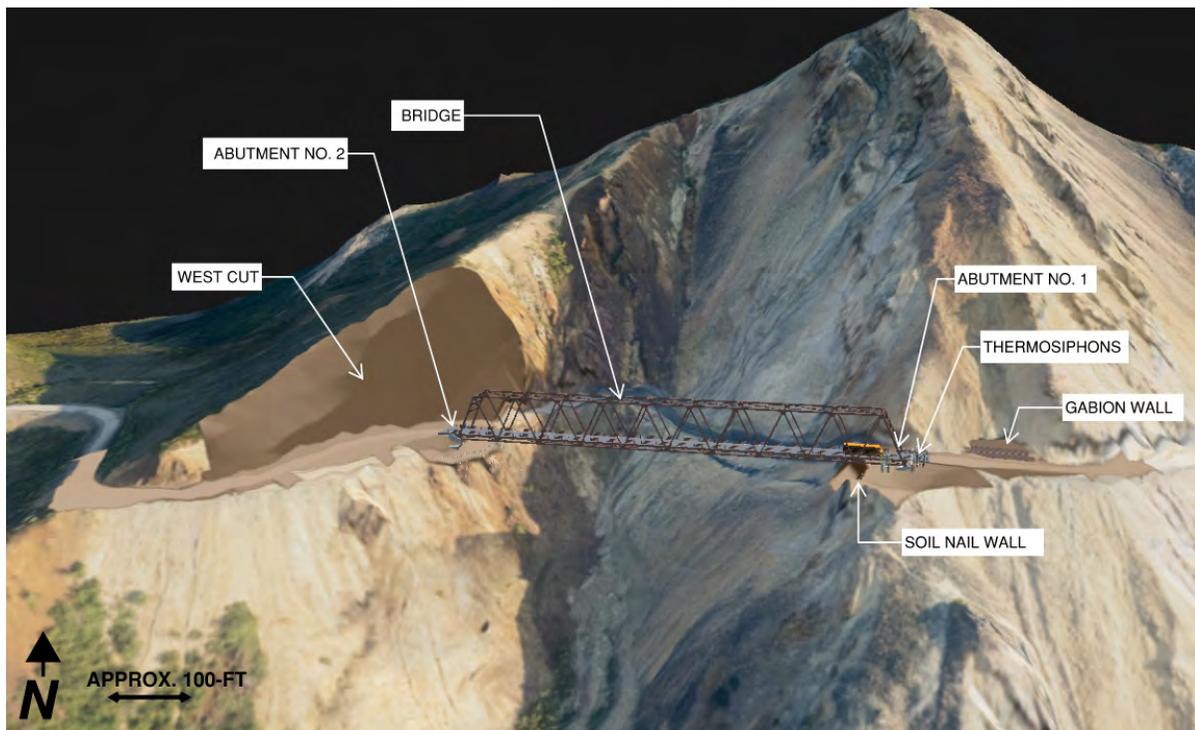
**Figure 2 - Proposed Bridge and Related Project Features.**

The scope of work for the consultant design team on the project includes designing the 475-foot span bridge and the approach cut slopes and retaining walls. Thermosiphons were also part of the design due to a layer of ice encountered below the proposed Abutment No. 1. A conceptual image of the proposed bridge and other major project elements, which is a screenshot of a fully three dimensional (3D) mixed reality model used by the team, is shown in Figure 2.

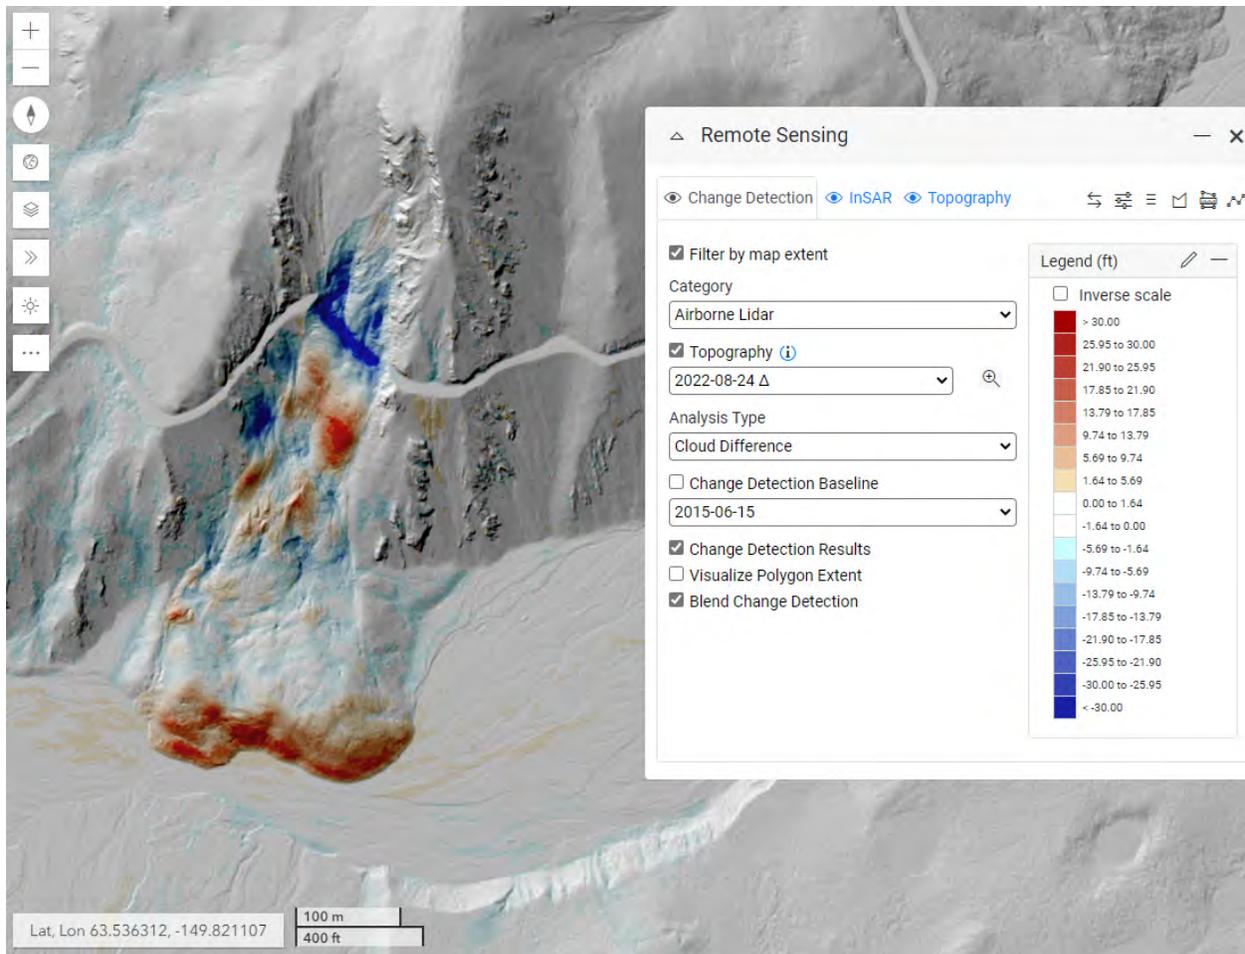
**Figure 3 - Lidar Change Detection between 6/15/2015 to 8/24/2022, viewed in Cambio.**

Change detection is measured from different data sources (airborne lidar, photogrammetry, terrestrial lidar) and in some cases, different lidar returns, each with different limitations, such as look angles, vegetation, snow cover and other considerations. The lidar datasets were analyzed for topographical change using a custom software developed by BGC. BGC used the M3C2 algorithm and an iterative closest point method of comparison and alignment of point cloud data to minimize the potential error and the limit of detection for meaningful movement (3). These values are a function of the original data quality and alignment, and some limitations and anomalies are inherent given the different sources (Table 1). The data here are of sufficient quality they can be used to assess movement trends and conditions across the site. The data and change detection results are presented in Cambio so that they can be viewed two-dimensionally (2D) in plan and profile, in 3D, compared spatially with other observations, and so that direct measurements of change can be made. In Cambio and in Figure 3, positive change is shown in a warm color and negative change is shown in a cool color, according to the dynamic change detection scale chosen and the legends presented. Positive change can be interpreted as material accumulation or bulging of the surface, and negative change can be interpreted as a settlement or loss of material. No color is shown where the change is less than the set limit of detection. This limit can be varied by the user, but the default level of  $\pm 1.64$  ft is set to minimize noise or error in the data and only present real changes due to ground move

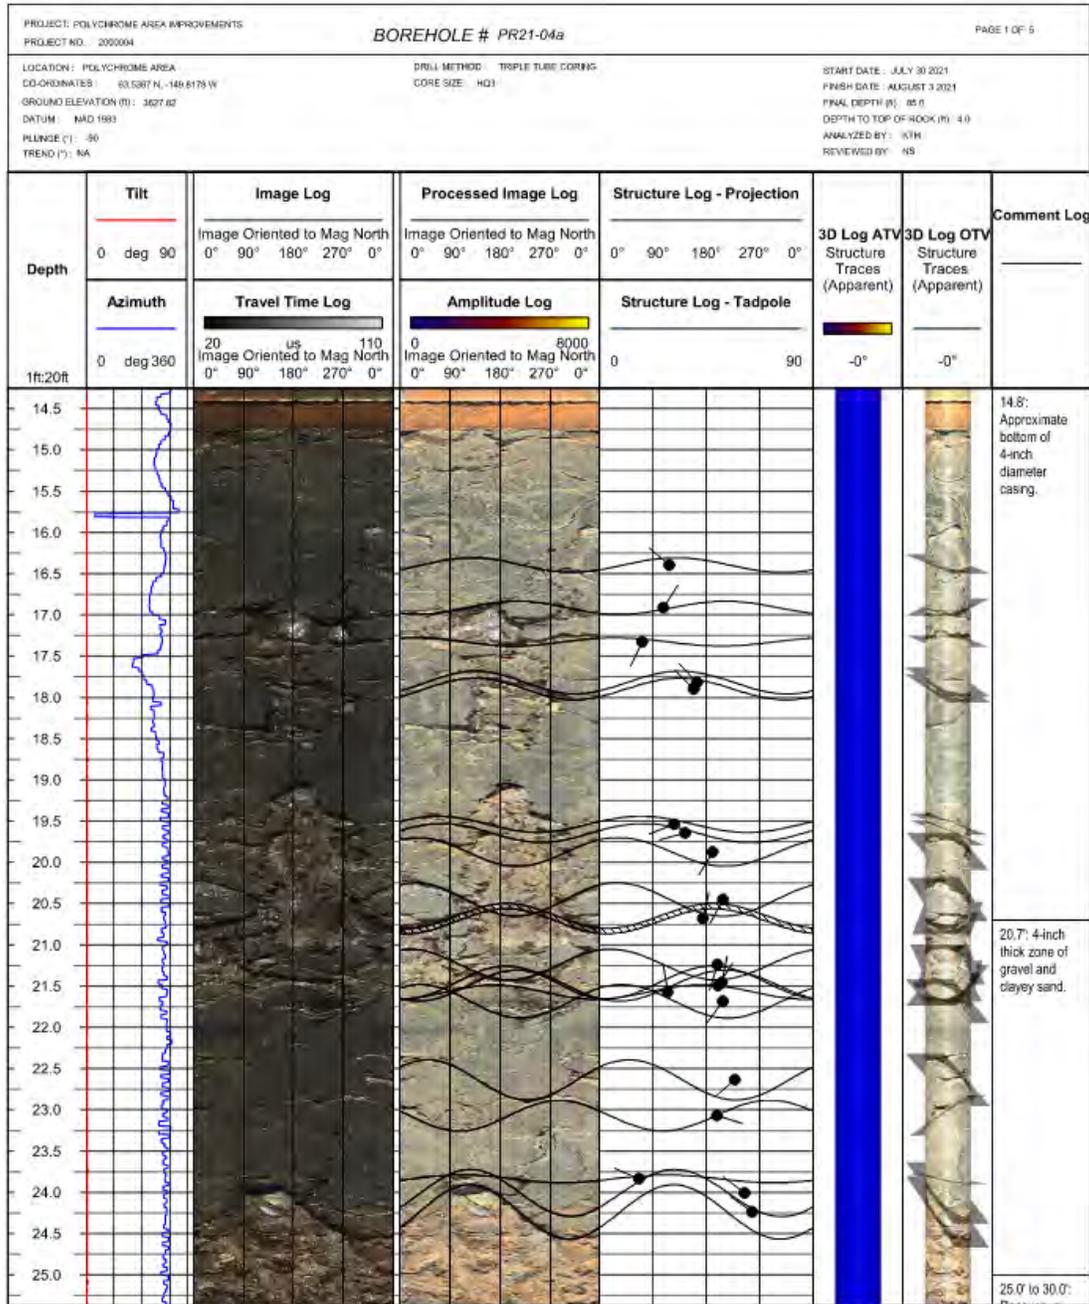
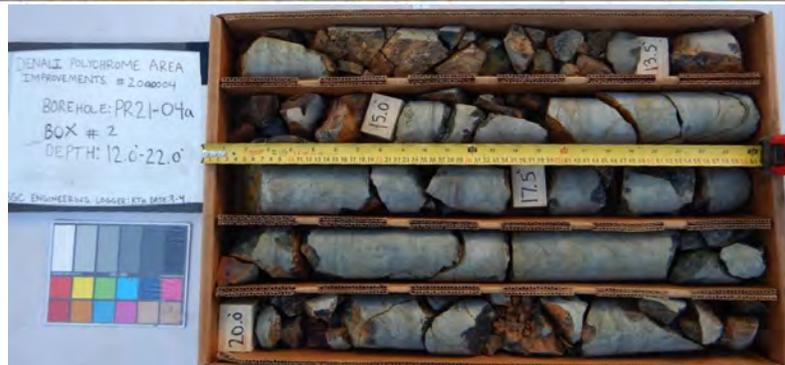
Figure 5 - Example Optical Televier Survey Report and Core Box from Same Interval.

The boreholes were advanced with hollow-stem auger, casing advancer, and HQ3 coring techniques. Standard Penetration Tests (SPTs) were completed to characterize the relative density and collect samples of the overburden. Downhole televiewer surveys were completed along uncased sections of boreholes in bedrock to characterize the discontinuities in the geologic units across the site. Downhole acoustic televiewer (ATV) surveys were completed in boreholes where groundwater was present and optical televiewer (OTV) surveys were completed in boreholes where groundwater was absent. The ATV survey produces a subsurface velocity profile that can delineate geological structure within the borehole wall. OTV survey methods use a downhole camera to record a photo of the borehole wall. Depth, dip, dip direction and aperture of discontinuities were determined from both the ATV and OTV surveys. An example OTV survey is shown in Figure 5 along with the core box photograph from the same interval (5). Figure 5 illustrates the benefit of the televiewer; layers of soil-filled discontinuities that are difficult to accurately describe because they are usually washed out of core can be clearly seen in the televiewer image log.

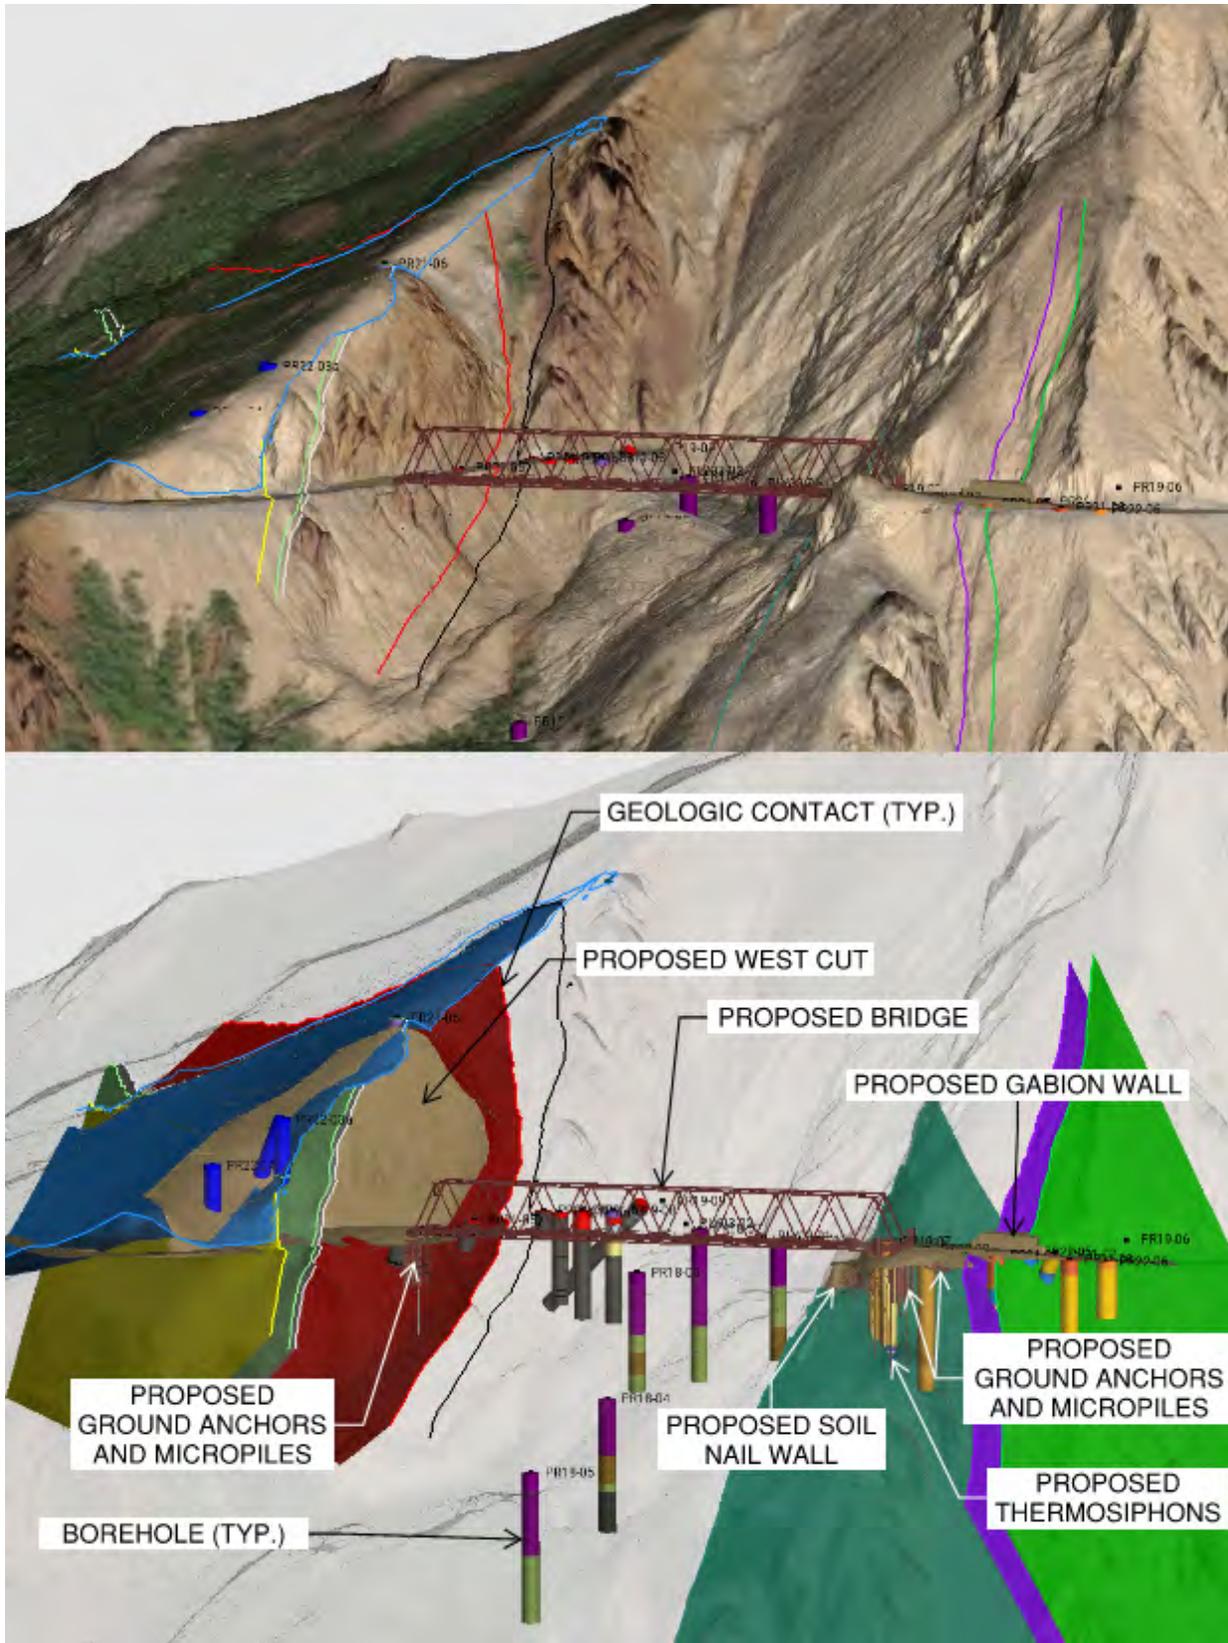
**Figure 6 - Screenshots of 3D Geologic Model, with DEM on (Top) and with DEM/orthophoto at 20% Opacity (Bottom).**

Screenshots of the 3D geologic model are shown in Figure 6 and Figure 7. The top image in Figure 6 has all the geologic contacts projected onto the surface of the digital elevation model (DEM) with orthophotos overlaid onto it. The lower image has the DEM/orthophoto opacity set to 20 percent, which reveals the geologic contacts (shown as planes) with the design elements. The geologic units encountered in the boreholes are color-coded and the boreholes are over-sized for viewing clarity. Figure 7 illustrates the inclusion of the geophysical survey (ERT) results in the model combined with a 3D surface of the proposed west cut.

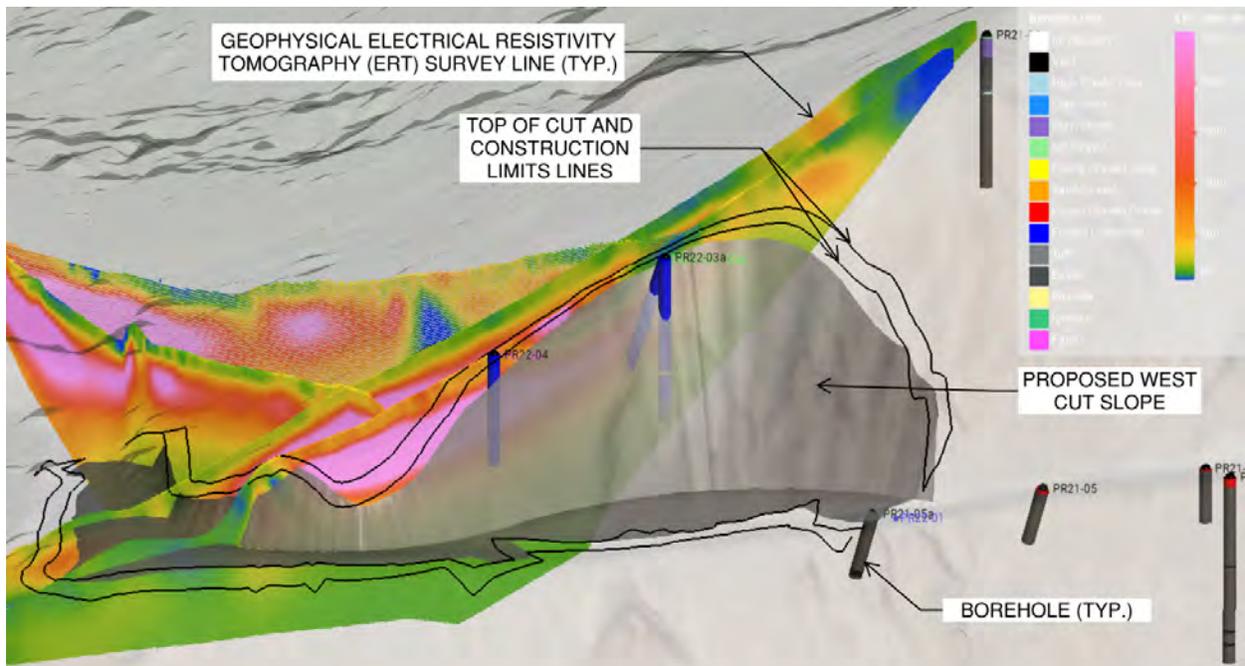
**Figure 7 - 3D Geologic Model of West Cut with Electrical Resistivity Tomography Survey Lines Shown and DEM/orthophoto at 20% Opacity.**
