# 72<sup>nd</sup> Highway Geology Symposium

## 2023 PROCEEDINGS

August 14-17, 2023 • Hotel Murano • Tacoma, Washington

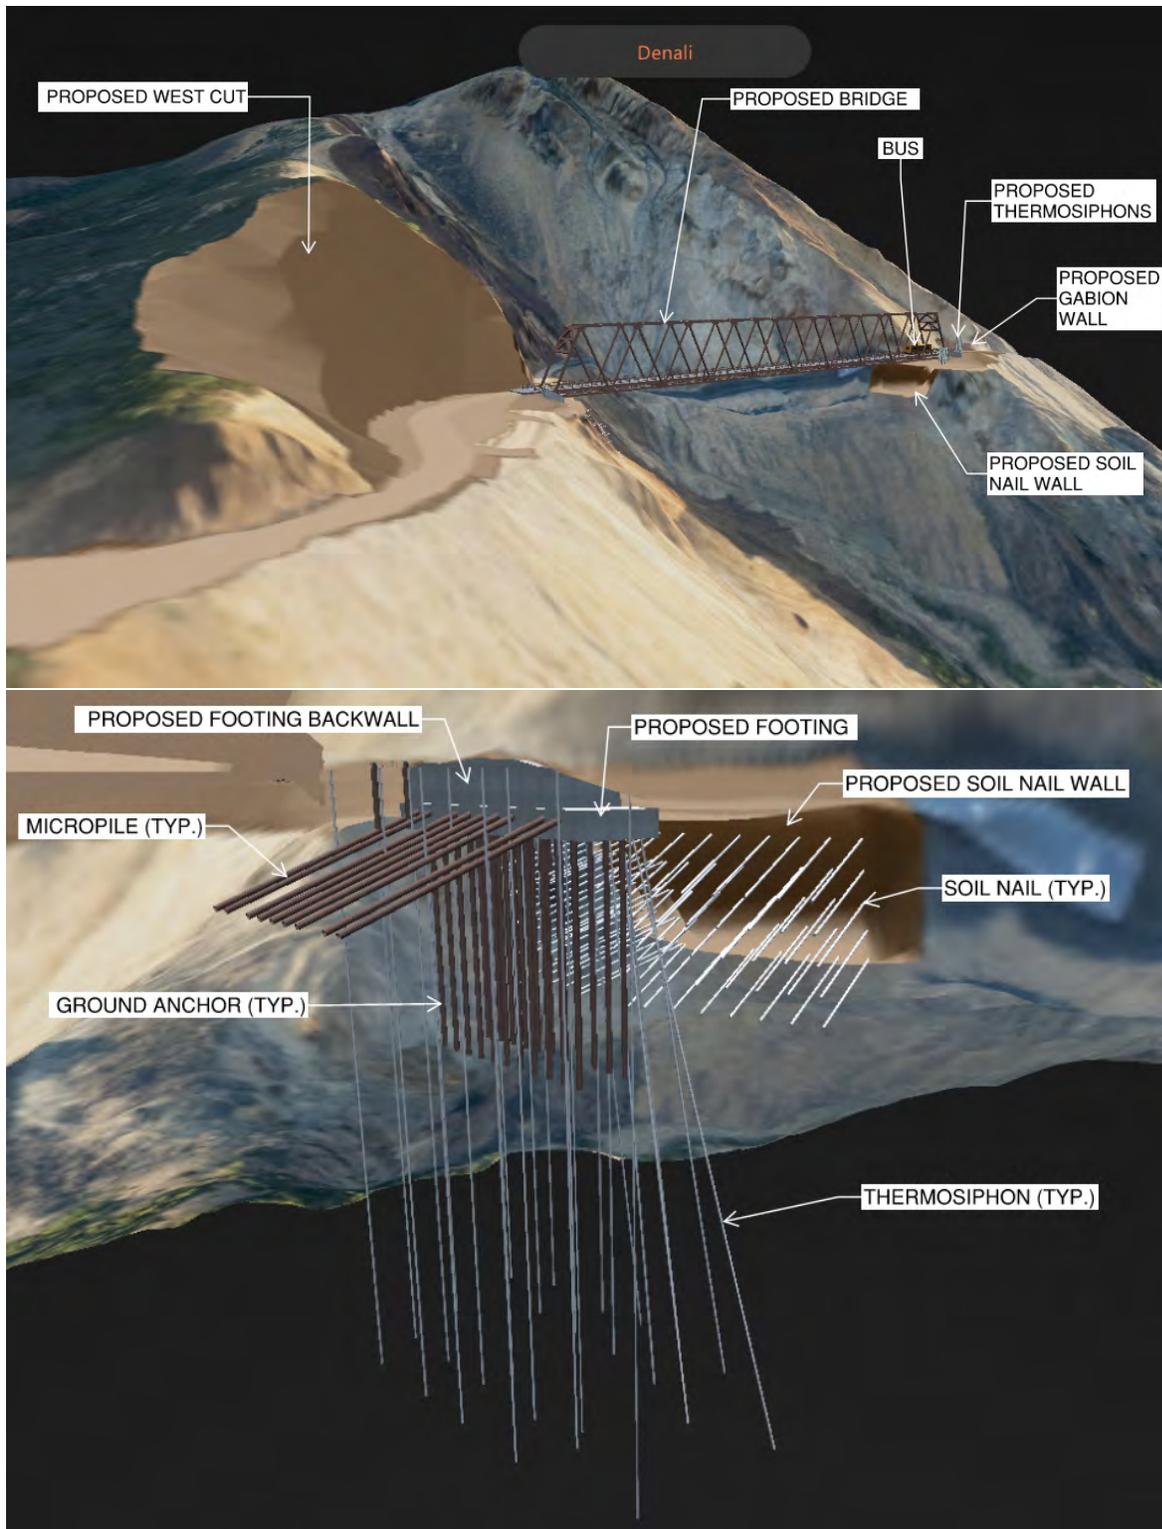
**Figure 8 – Clirio Screenshots of Proposed Construction. Upper Image is from West Approach Road. Lower Image is Below Ground View Looking Southwest towards Abutment No. 1 and the Soil Nail Wall.**

A 3D model of the proposed project was built in collaboration with Clirio that included the road alignment, cut and fill slopes, retaining walls, bridge superstructure and foundation, and geotechnical subsurface elements including thermosiphons, soil nails, micropiles, ground anchors, and rock dowels. The 3D model was available to the design team through a mobile App, a desktop App, and through a mixed-reality headset. This tool was used to communicate the features of the design to the design team, the owner, the contractor, and other stakeholders. An example ‘screenshot’ of the Clirio model is shown in Figure 8, though the term ‘screenshot’ is not very accurate because the mixed reality model exists in space and only through user choice is it projected to a screen. The major design features that can be seen in Figure 8 include the west cut, the bridge, a soil nail wall, a gabion wall, and thermosiphons. The upper image is a view of the project from the west approach road and the lower image is an underground view looking up at the foundation and soil nail wall elements at Abutment No. 1 (east abutment), including soil nails, ground anchors, micropiles, and thermosiphons.

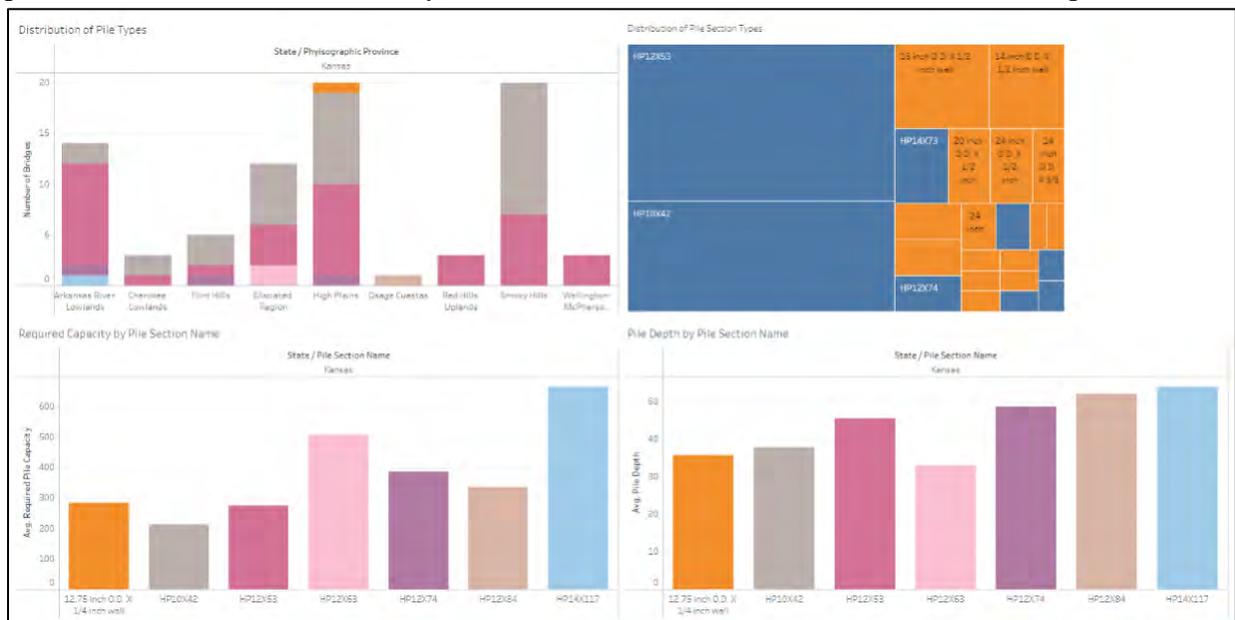
Figure 1: PileTrac Dashboard- Distribution of Pile Types

into PileTrac, and as more records are keyed into PileTrac, KDOT's ability to look at more projects in various locations across the state with similar site conditions increases. In Figure 1, above, is a visual representation of pile type distribution along with the geologic setting is displayed.

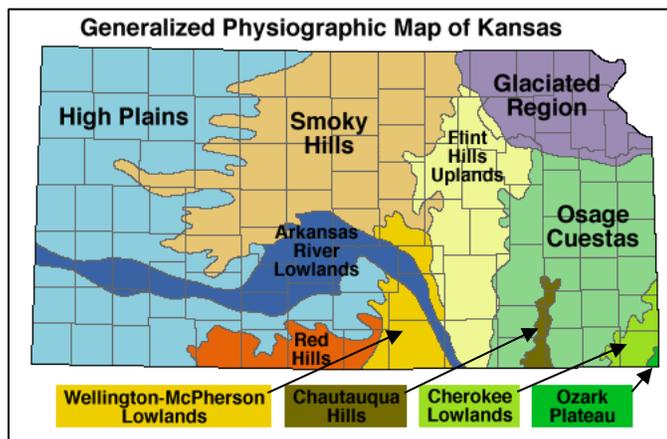
Figure 2: Generalized Physiographic Map of Kansas with arrows indicating smaller regions within the state

The KDOT's most common foundation type is an H-Pile footing. Geologically, Kansas is separated into eleven (11) different physiographic regions as seen in Figure 2. These regions play a significant role in determining which foundations will be utilized on a specific KDOT structure. In the High Plains, the Arkansas River Lowlands, and the Wellington-McPherson Lowlands, end-bearing H-Pile are exclusively used due to the relatively shallow depth to bedrock. In the Smoky Hills and the Glaciated Region of Kansas, H-Pile are predominately used but not exclusively. All the other physiographic regions utilize H-Pile but other foundation types such as drilled shafts and spread footing are generally considered more cost effective. Furthermore, generally speaking, the depth of bedrock significantly increases from east to west across the state. Where this is not always the case, an adequate geotechnical investigation can help refine foundation recommendations.

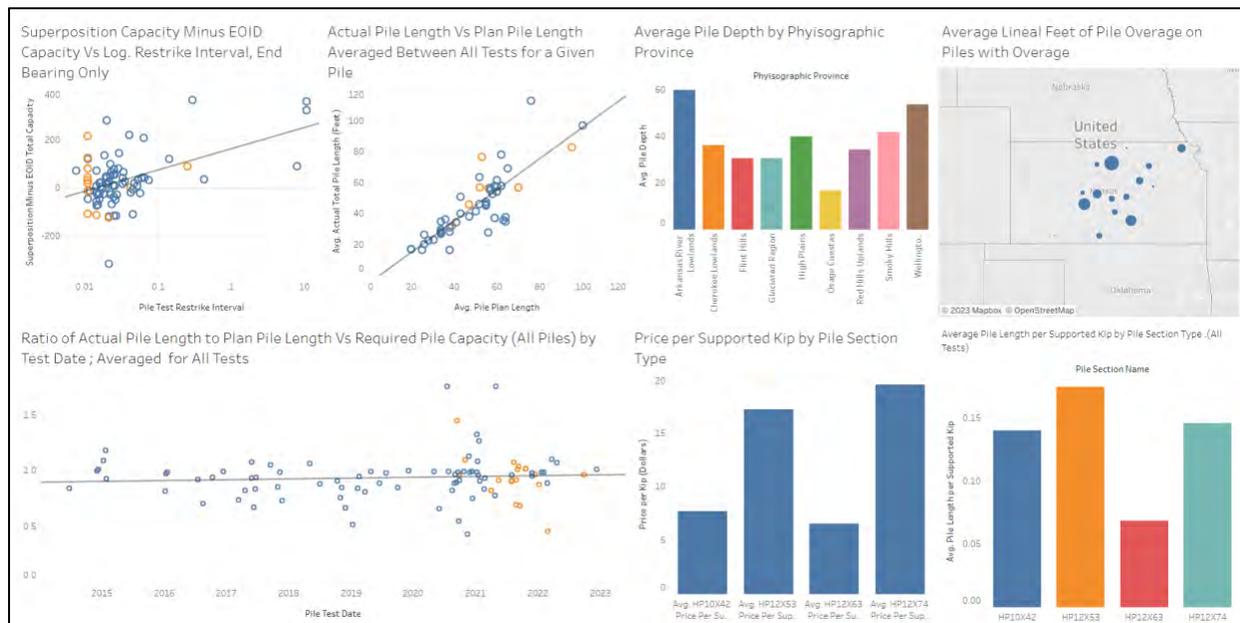
**Figure 5: PileTrac Master Dashboard-Pile Depth by Physiographic Province, Actual Pile Length vs Plan Pile Length, EOID vs Restrike, Average Lineal Feet of Pile on Pile with Overages**

With the addition of PileTrac, KDOT now has an additional tool in our toolbox to help refine recommendations which is expediting construction and allowing for more accurate and precise pile length prediction. KDOT is applying borings from the foundation investigation, historical high strain dynamic testing in similar subsurface conditions and inputting the information into PileTrac to help improve pile recommendations. As a result, KDOT has taken PileTrac and implemented it into our standard process of running analysis for pile length recommendations. Additionally, PileTrac has numerous other valuable functions that are displayed in Figure 5.

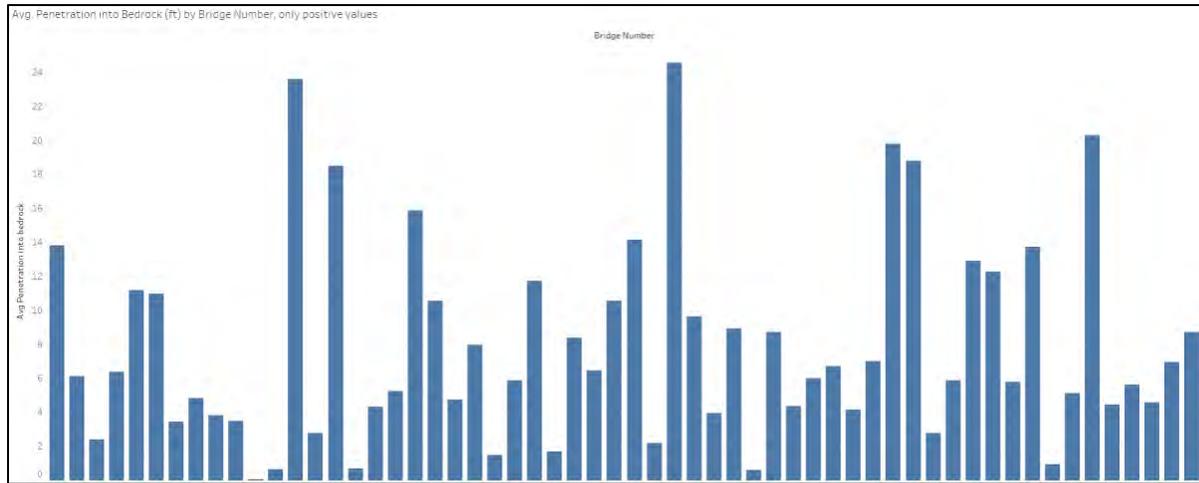
Figure 6: PileTrac Dashboard- Average Penetration into Bedrock

engineering properties. By utilizing the various dashboards within PileTrac, KDOT geologists can look at the average pile penetration into that rock (Figure 6), average pile capacity per pile section (Figure 7), pile depth vs bedrock depth (Figure 8), and numerous others.

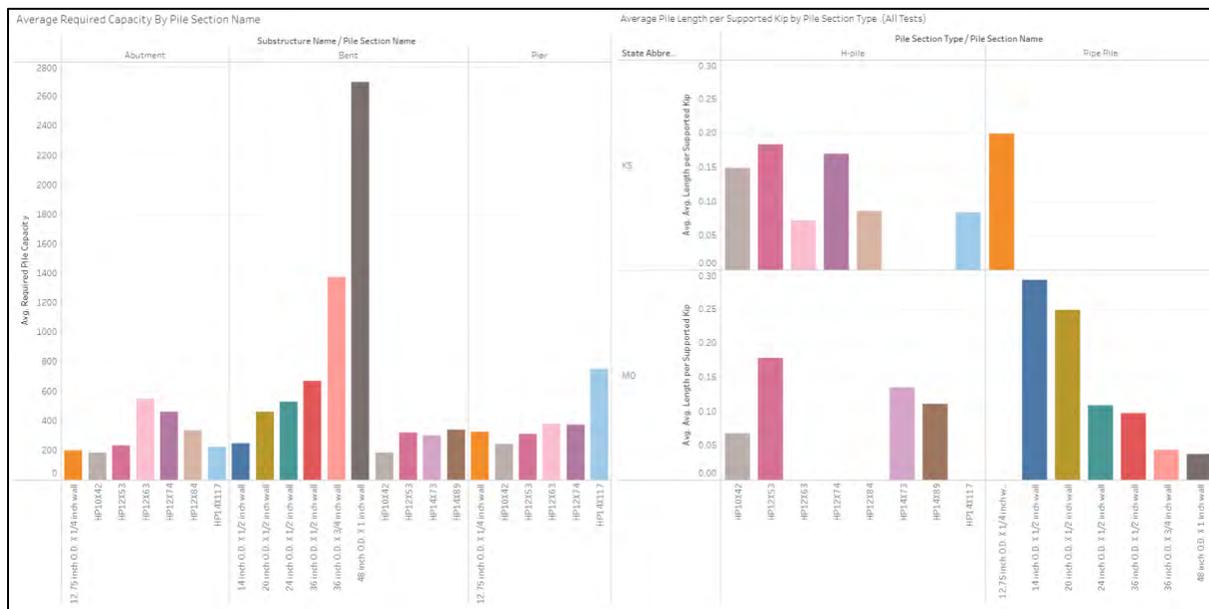
Figure 7: PileTrac Dashboard- Average Required Capacity by Pile Section, Average Pile Length per Supported Kip by Pile Section Type

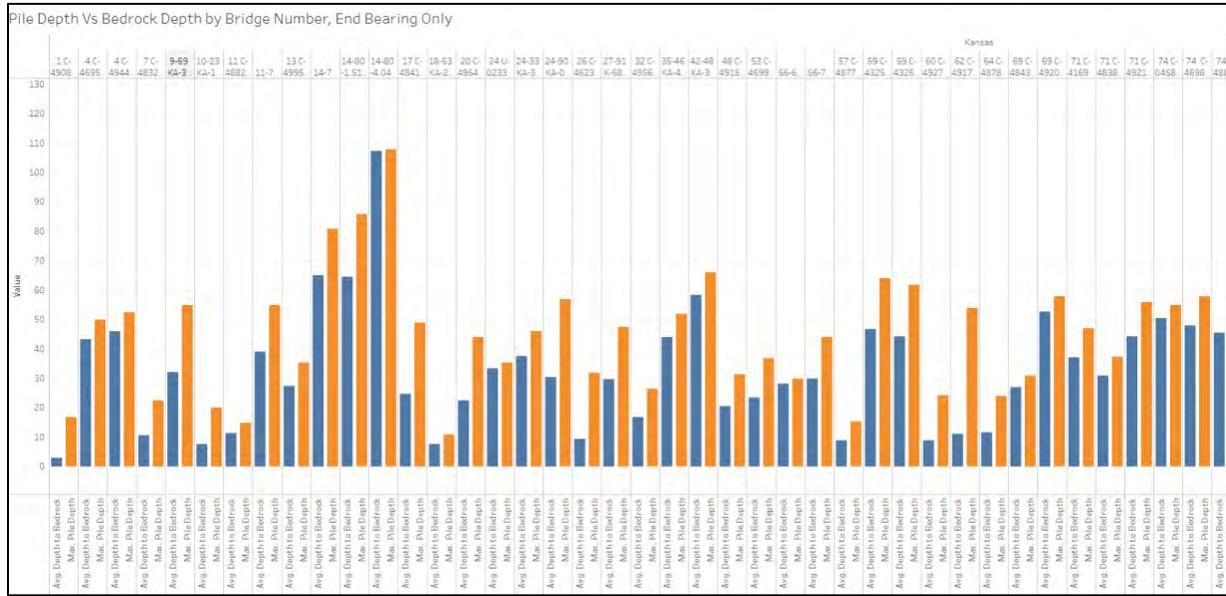
Figure 6: PileTrac Dashboard- Pile Depth vs Bedrock Depth by Bridge Number, End Capacity Only

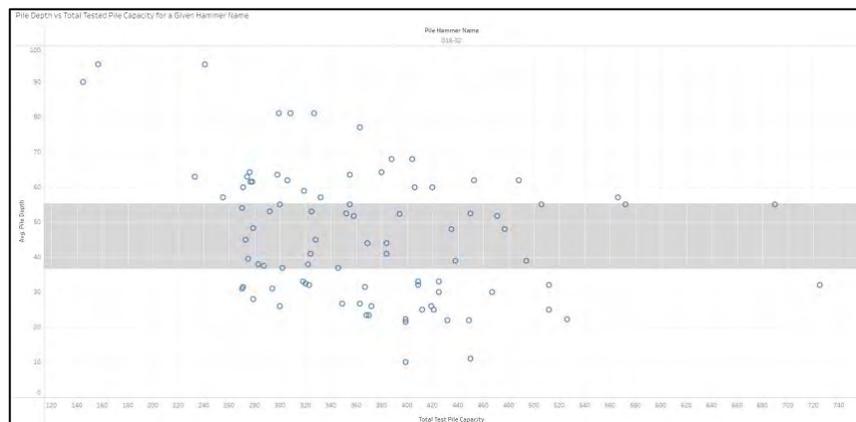
Figure 7: PileTrac Dashboard- Pile Depth vs Total Tested Pile Capacity for given Hammer Name; D16-32

Furthermore, what KDOT is beginning to look at is how PileTrac can be used during construction. There are several dashboards within PileTrac that can help construction inspectors verify hammer size suitability. These visual representations can provide inspectors with a set and stroke for a given hammer size to look for, and a capacity versus depth for a specific hammer as well. As a cloud-based application, PileTrac can be used in the field as a real-time confirmation of pile capacity and hammer verification. That

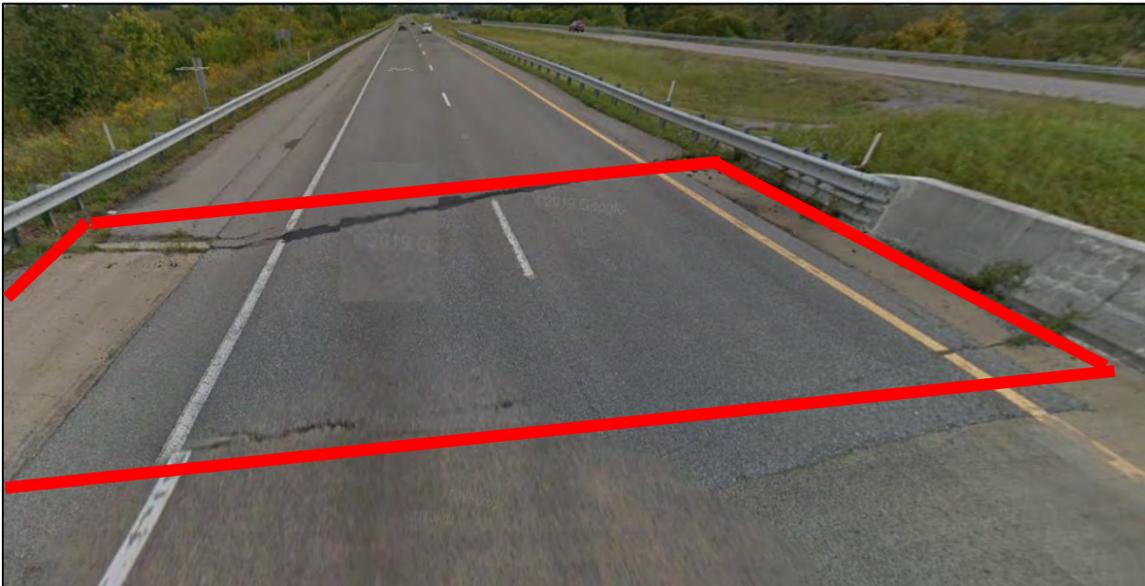
**Figure 1 – Typical PABE with approach slab related “bump” on I-840 in Williamson County, Tennessee. The approach slab is within the red lines (image source Google Earth, 2019).**

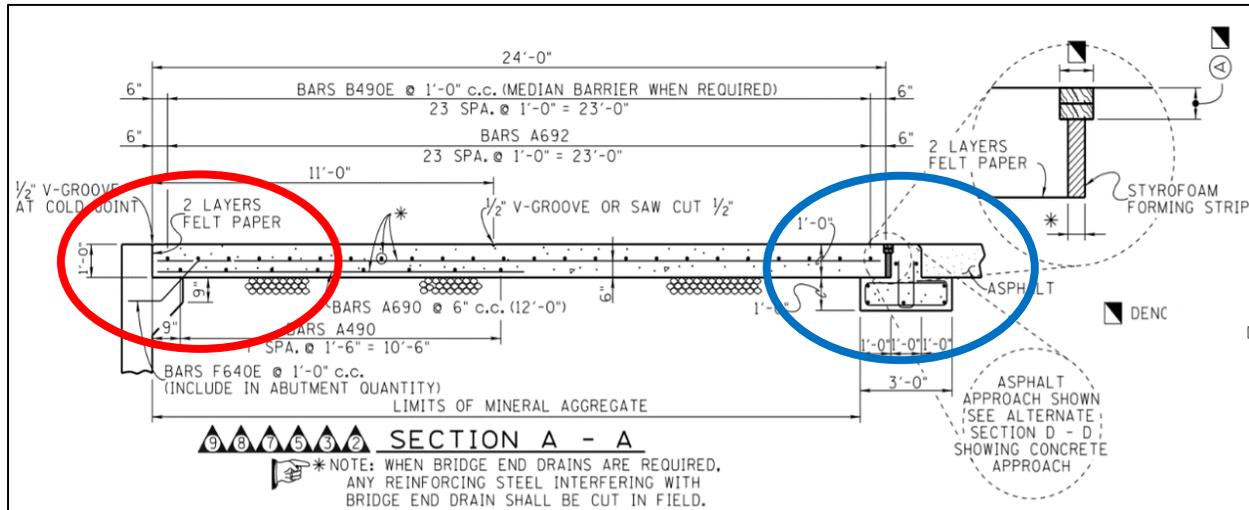
**Figure 3 - The locations that lead to the "bump" in a typical PABE diagram. The area within the red oval is the fill behind the endwall/abutment subject to settlement if not compacted or drained adequately. The area within the blue oval is subject to differential settlement due to the transition from flexible pavement to the rigid approach slab (from Kniazewycz, 2020).**

The approach slab settling was identified as a major problem. Controlling drainage was identified as a requirement to controlling the settlement. Integral abutments and improved sub-base were identified as benefits to further reducing approach slab settlement and reducing the “bump”. TDOT’s preference for jointless bridges means that integral abutments have already been implemented on TDOT’s bridge assets. At the PABE, a combination of poor compaction and drainage behind the endwall/abutment was identified as an issue contributing to the approach slab subsidence along with the transition from the flexible pavement to the rigid approach slab (Figure 3).

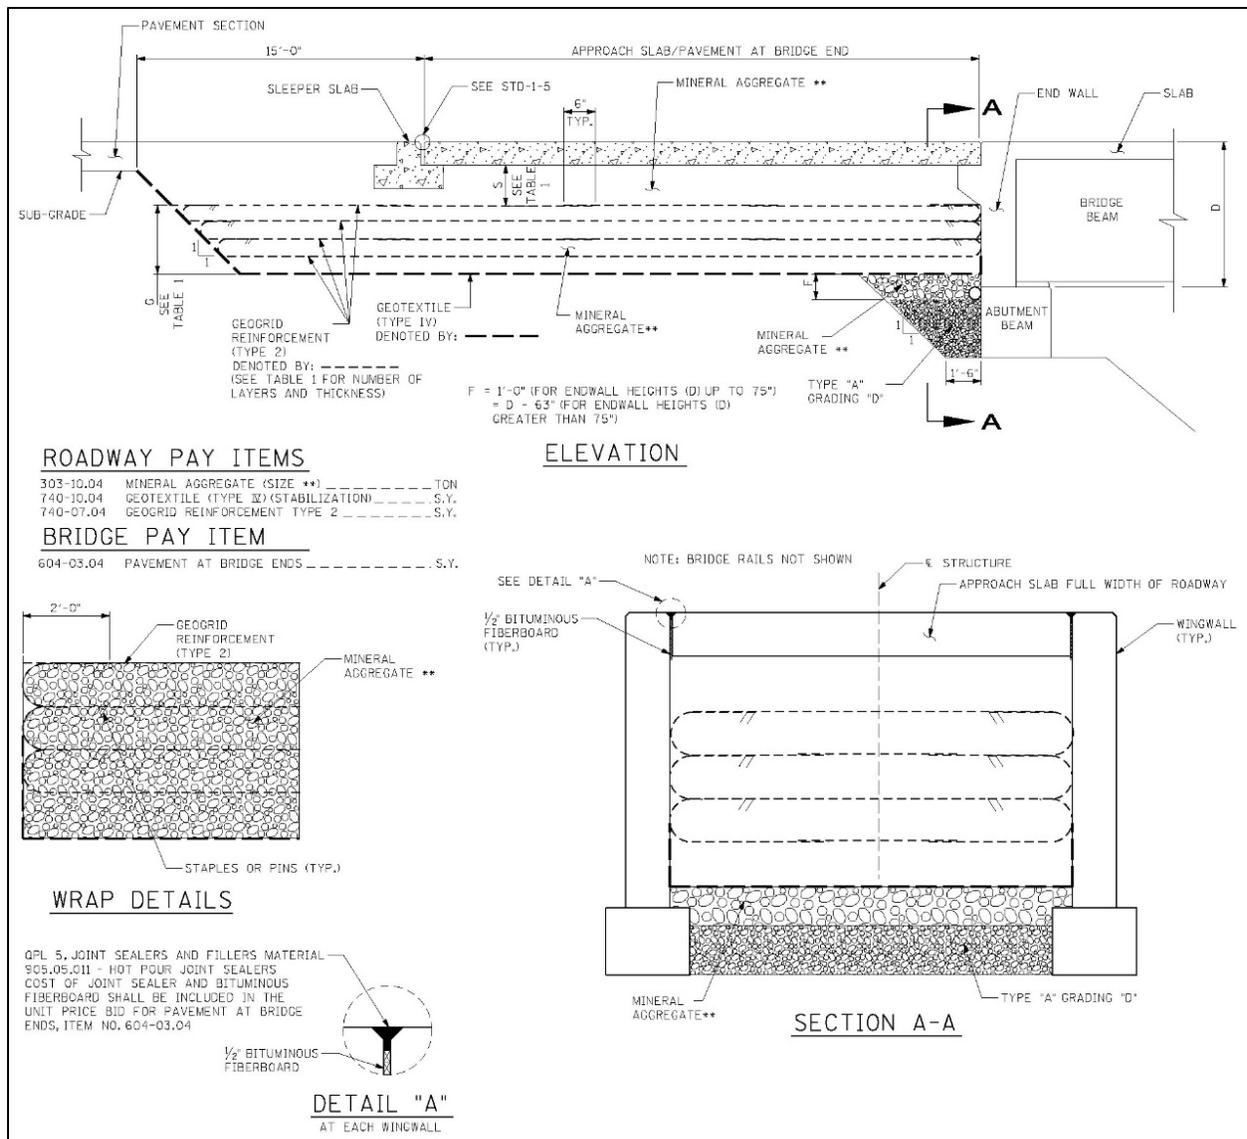
**Figure 4 – Select portions of TDOT Structures STD-10-2 2020 “Miscellaneous Abutment and Pavement at Bridge Ends Backfill Details” showing the elements of the reinforced backfill.**

The ultimate result of Scan 19-01 was the creation of a new TDOT Structures standard design, TDOT Structures STD-10-2 “Miscellaneous Abutment and Pavement at Bridge Ends Backfill Details”, that was supervised by Mr. Kniazewycz (Figure 4). The new standard drawing creates a free draining, geosynthetic reinforced, mineral aggregate backfill that increase the bearing capacity and reduces the differential settlement of the flexible pavement and rigid approach slab. The design was tested during the 2015 I40 Fast Fix 8, the 2018 I-840/I-24 Ramp, and the 2019 I-240 Memfix 4 prior to its adoption (Kniazewycz, 2020). The new standard drawing is also supported by FHWA guidance from FHWA-HRT-17-080 “Design and Construction Guidelines for Geosynthetic Reinforced Soil Abutments and Integrated Bridge Systems”, June 2018.

The standard design extends mineral aggregate backfill from the abutment/endwall to fifteen (15) feet past the end of the approach slab. A layer of geotextile, meeting American Association of State Highway and Transportation Officials (AASHTO) M 288 Stabilization Class 1, is placed along the base of the fill to separate the soil embankment fill and the mineral aggregate fill. A layer or multiple layers of mineral aggregate backfill are placed in varying thickness based on the minimum endwall/wingwall height (Table 2). Each layer is wrapped by geogrid with long term tensile strength greater than or equal to 2400 pounds per foot. A drainage layer of mineral aggregate 12 inches in thickness for endwall heights of 36 to 75 inches, or a drainage layer thickness of endwall height minus 63 inches where the endwall is greater than 75 inches in height. The drainage layer conducts water towards the drainage pipe. Base stone is

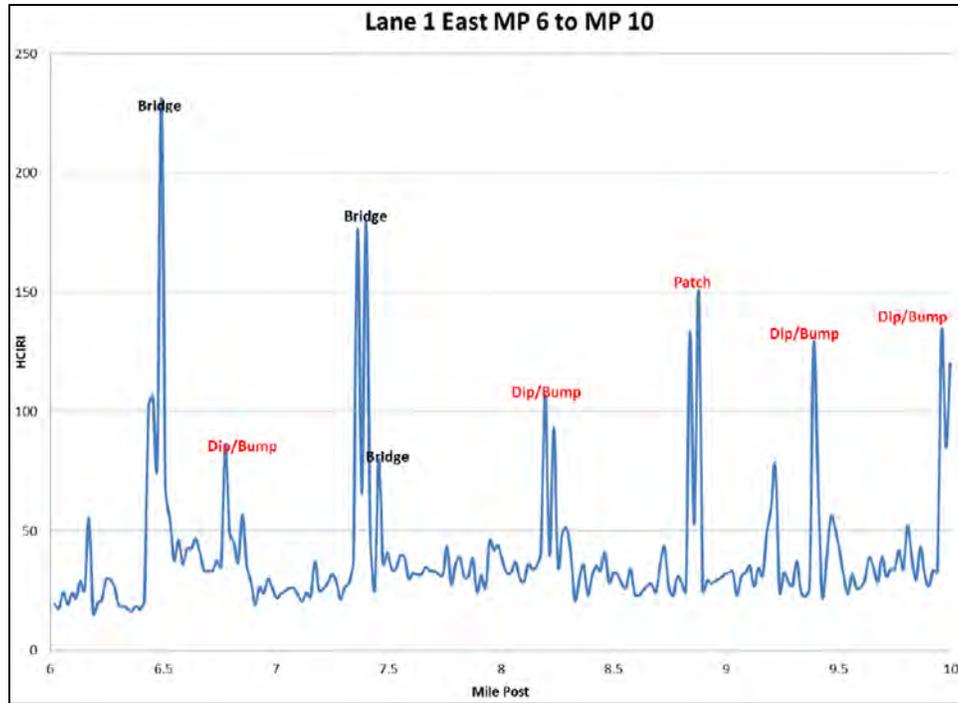
Figure 6 – Results of the Roadway Profiler along eastbound I-840 between MP 6 to 10 (source TDOT Materials & Tests).

The IRI is the statistic used to measure how smooth or rough a pavement surface is. The lower the calculated IRI, the smoother the pavement will ride. The higher the IRI, the rougher the pavement will ride. According to the FHWA IRI Categories for roadways, anything greater than 170 is “unacceptable”. The TDOT specification for bridge deck and approaches is an IRI of 190 or 250 for roadways with speed limits below 40 miles per hour. The TDOT specification for Mean Roughness for the full length of the deck plus approaches of a IRI of 130. The results of the Profiler are shown in Figures 6 through 11. Multiple bridge approaches along the Williamson County I-840 corridor had IRIs over 170 (Bennett and Smith, 2018).

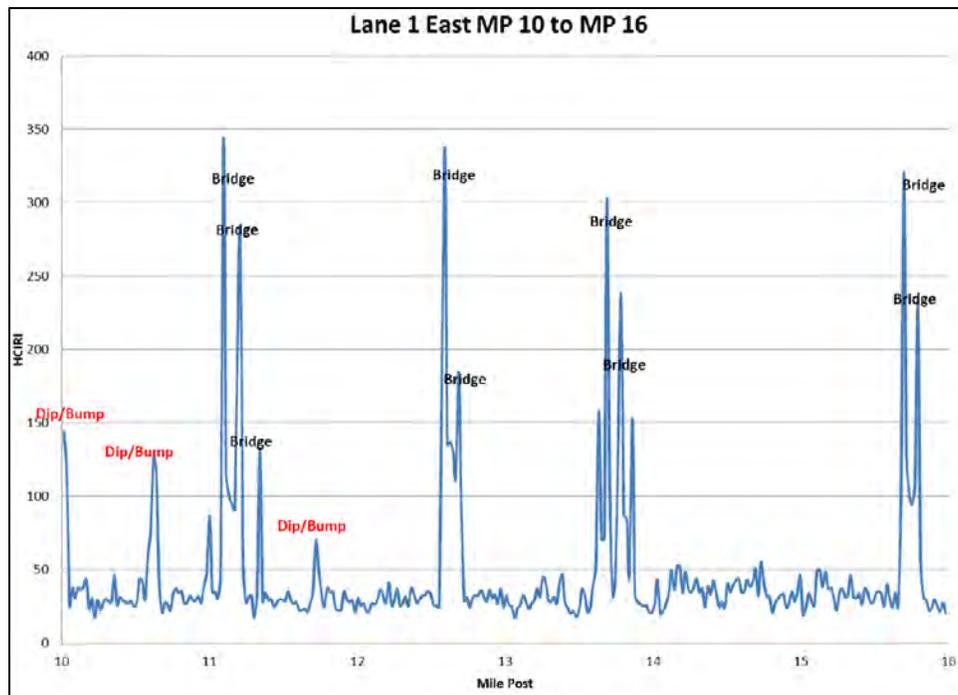
Figure 7 – Results of the Roadway Profiler along eastbound I-840 between MP 10 to 16 (source TDOT Materials & Tests).

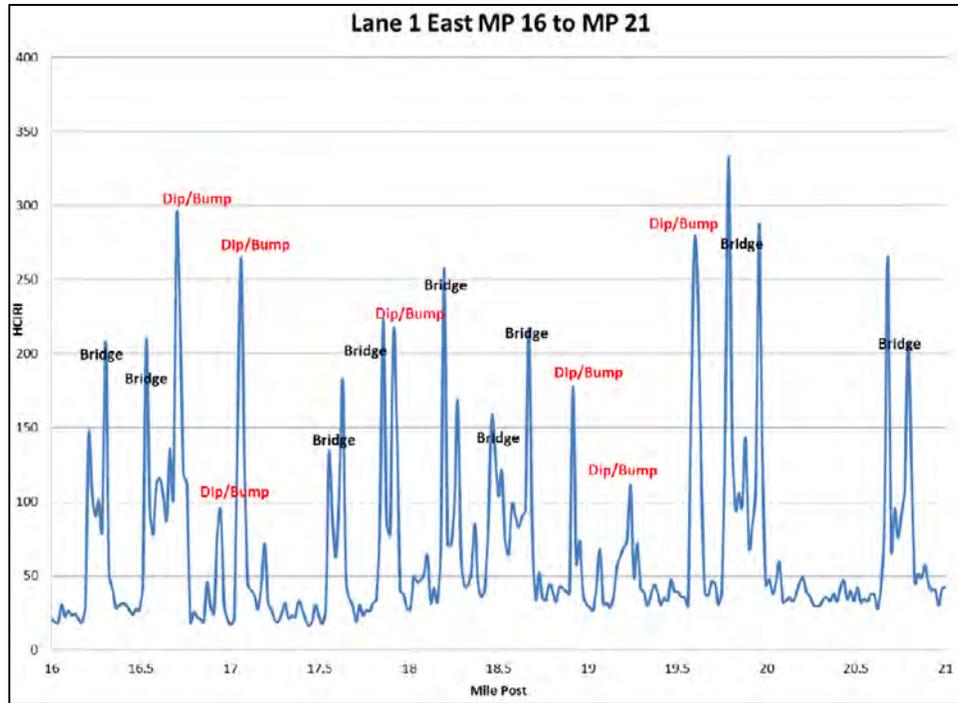
**Figure 8 – Results of the Roadway Profiler along eastbound I-840 between MP 16 to 21 (source TDOT Materials & Tests).**

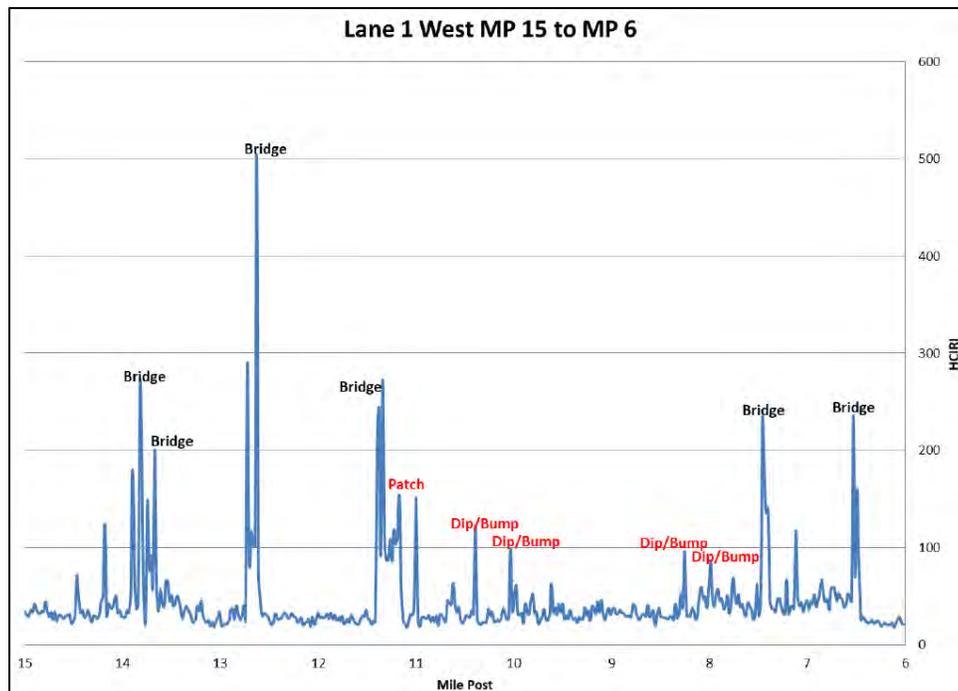
**Figure 9 – Results of the Roadway Profiler along westbound I-840 between MP 6 to 15 (source TDOT Materials & Tests).**

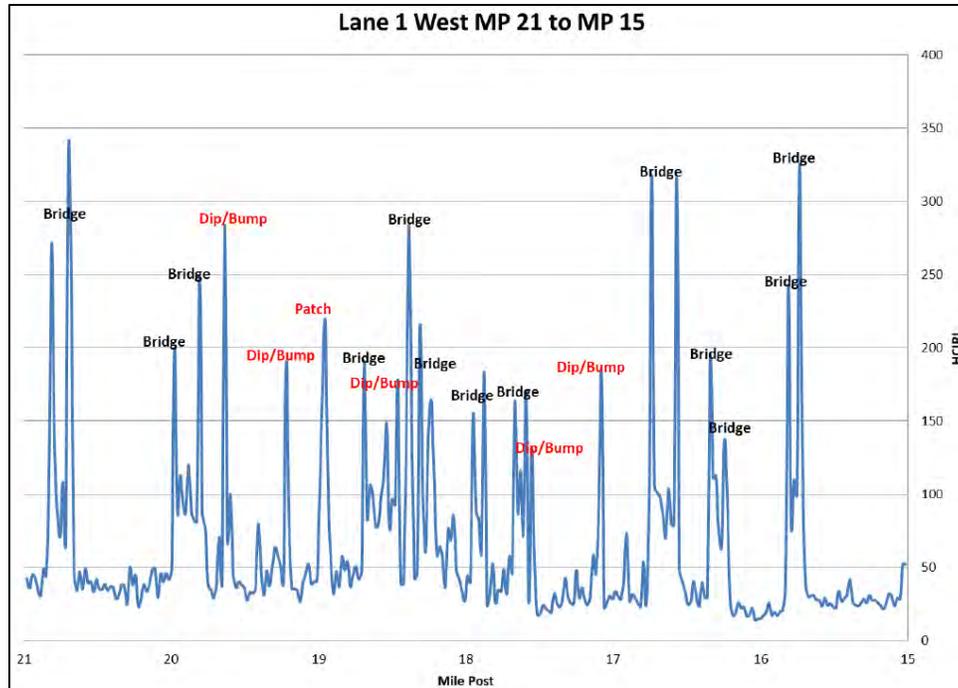
**Figure 10 – Results of the Roadway Profiler along westbound I-840 between MP 15 to 21 (source TDOT Materials & Tests).**

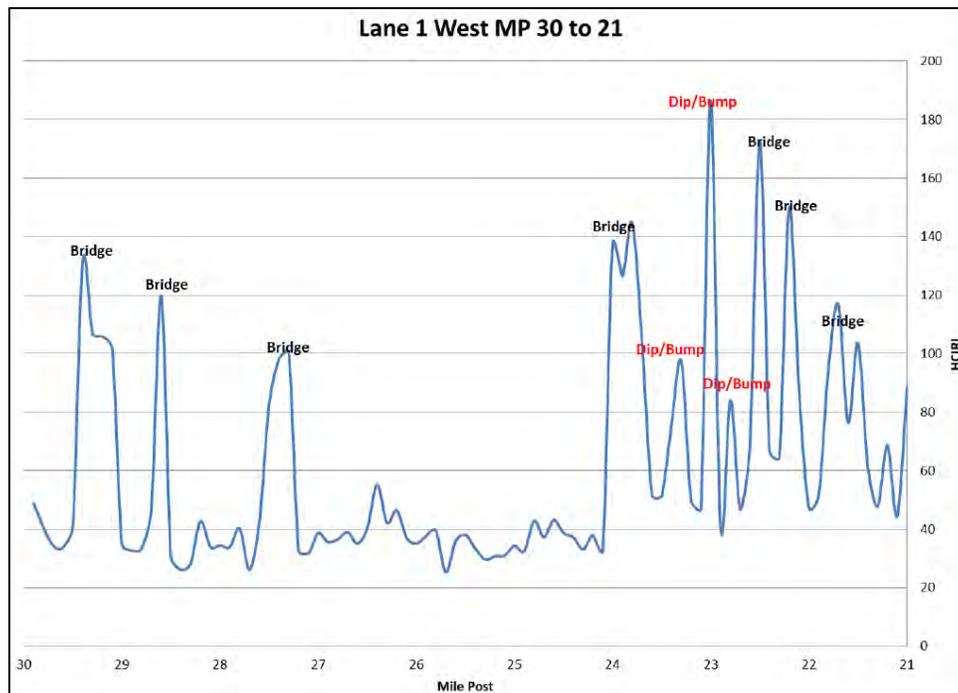
**Figure 11 – Results of the Roadway Profiler along westbound I-840 between MP 21 to 30 (source TDOT Materials & Tests).**

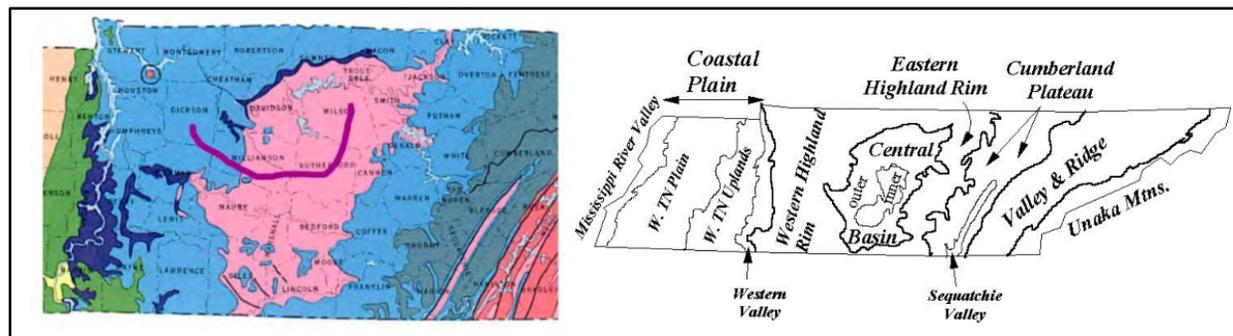
**Figure 12 – An excerpt of the Generalized Tennessee Geologic map and Tennessee Physiographic Province map. The pink shade corresponds to the Ordovician aged formations of the Central Basin. The dark and light blue corresponds to the Devonian-Silurian (dark blue) and Mississippian (light blue) aged formations of the Highland Rim. The magenta line is the approximate location of the I-840 corridor (from Burns and Jowers, 2021).**

As the roadway segment of I-840 traverses Williamson County, the physiographic province transitions from the Western Highland Rim and into the outer portions of the Central Basin of Tennessee (Figure 12).

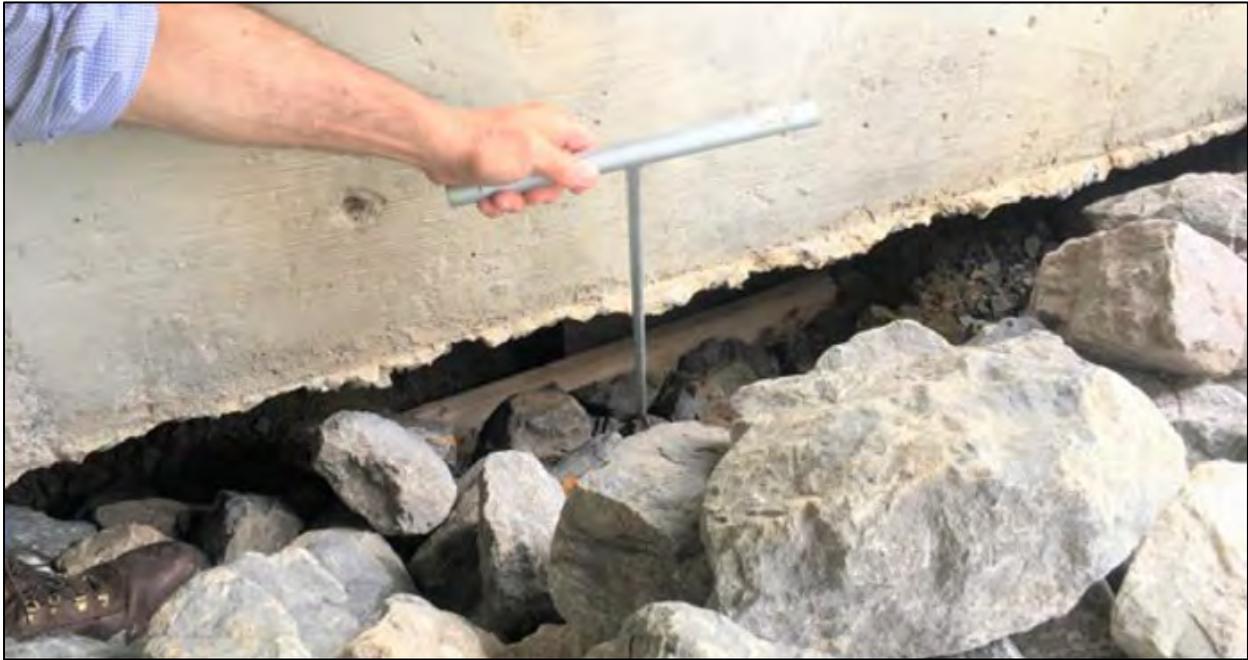
*Figure 13 - Erosion of abutment backfill due to settlement (Photo Rivers 08/19/2021).*

“undrained” state in the ten- or twelve-years following construction (Burns and Jowers, 2021). This condition has led to continuous settlement and erosion of the backfill in the abutments (Figure 13) (Jowers, 2023).

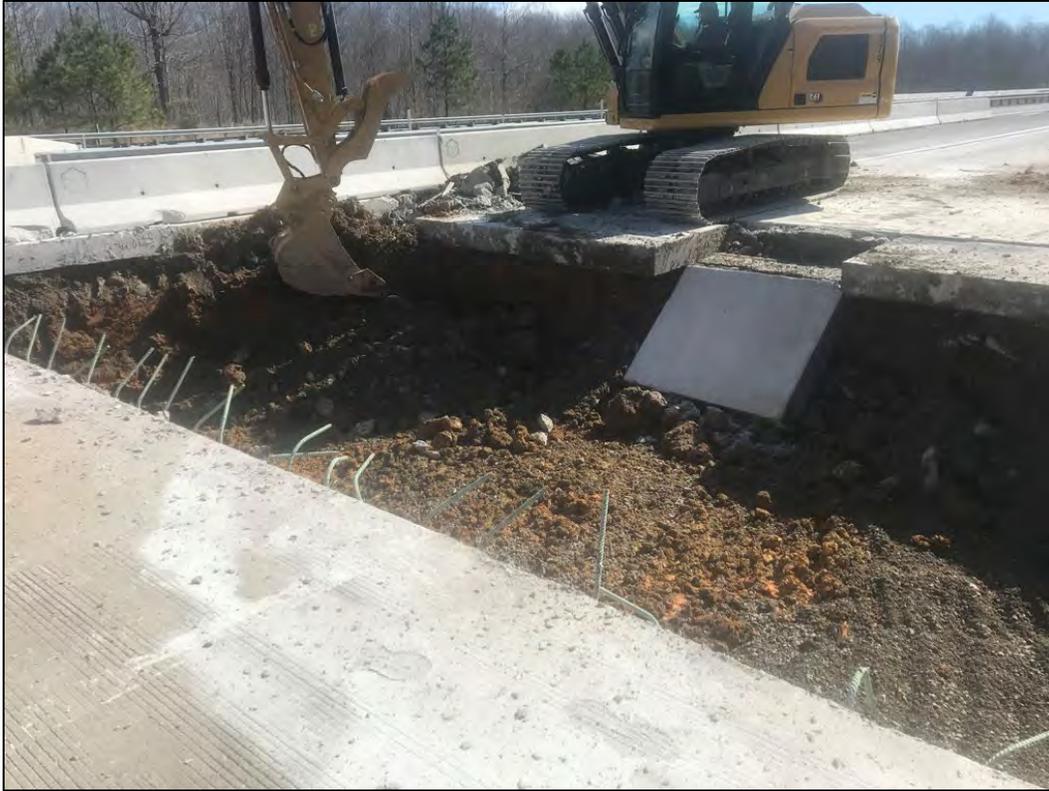
***Figure 14 - Williamson I-840 removal of the existing approach slab during the PABE replacement (image Region 3 TDOT).***

Following the 2021 Geotech investigation, TDOT began resurfacing programs for the Williamson County I-840 Corridor between MP 8 to 24. The existing PABEs with high IRI were removed and replaced with PABEs that are in compliance with STD-10-2 (Figures 14 through 17) (Jowers, 2023). The results have been promising. TDOT Materials and Tests Division Roadway Profiler was deployed in 2023 to reevaluate the I-840 riding surface. The results final report is due to be released soon.

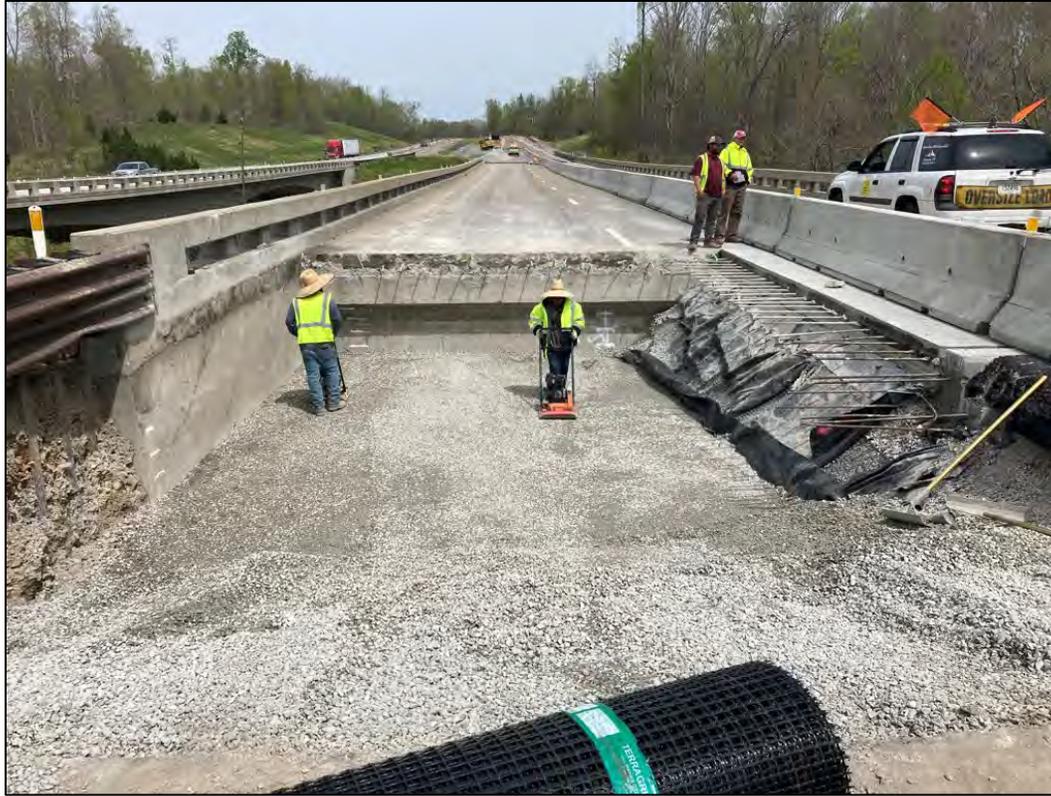
*Figure 15 - Williamson I-840 mineral aggregate backfill being compacted. Note the geogrid in the foreground (image Region 3 TDOT).*

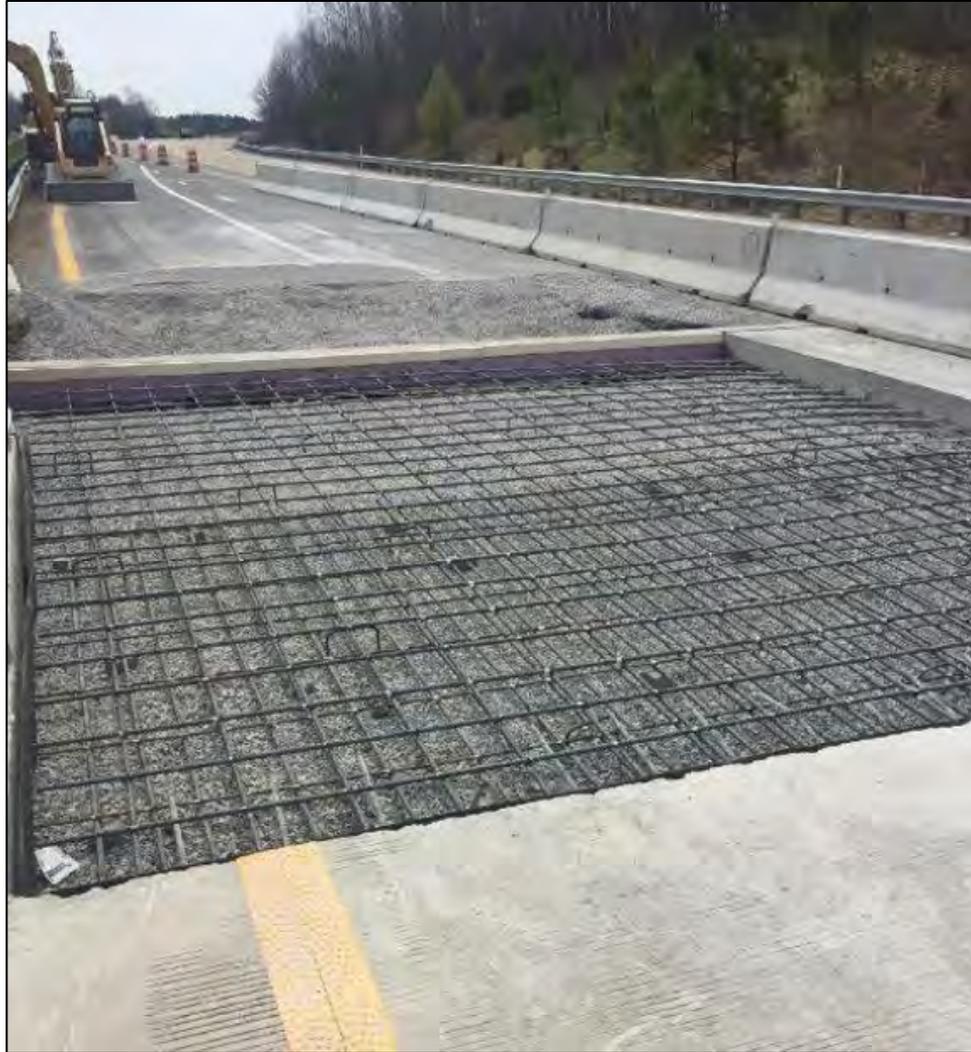
**Figure 16 - Williamson I-840 approach slab replacement (image Region 3 TDOT)**

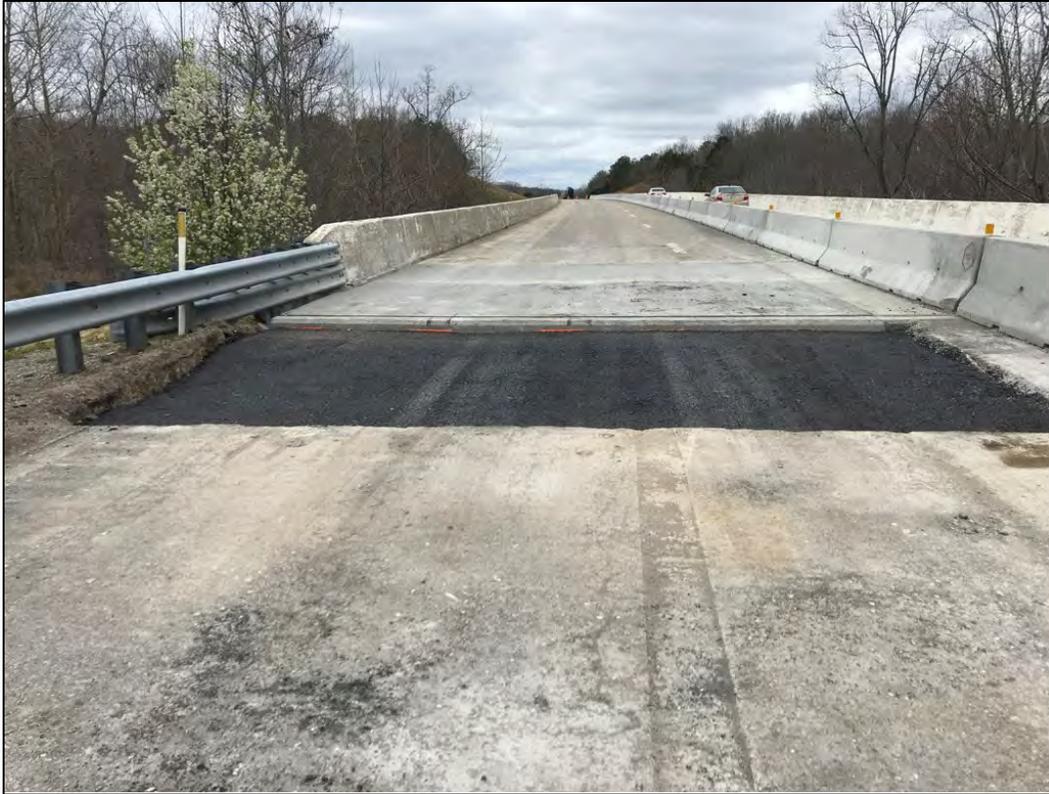
**Figure 17- Williamson I-840 finalizing the resurfacing of the PABE (image Region 3 TDOT).**

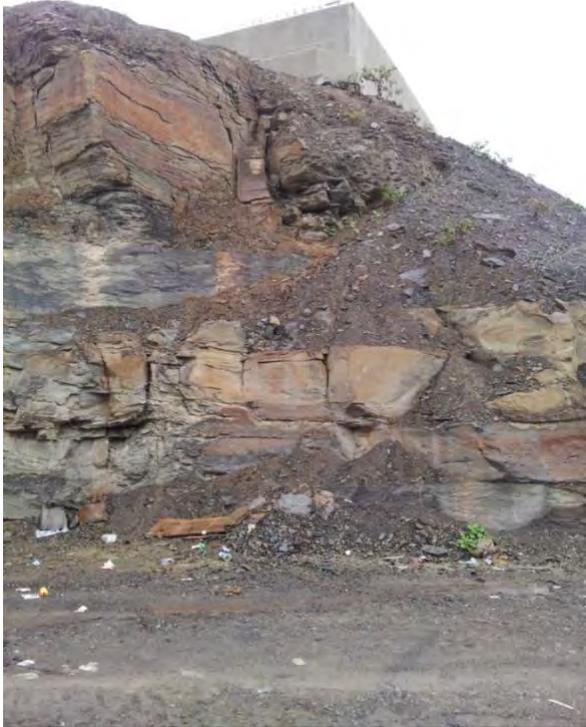
Figure 2. Abutment No. 1 foundation west bound before relocating into cut.

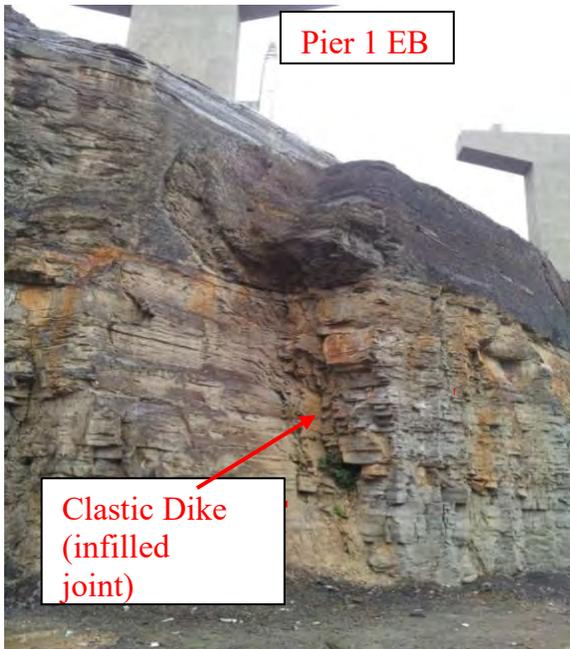
Figure 3. Pier 1 EB prior to relocating.

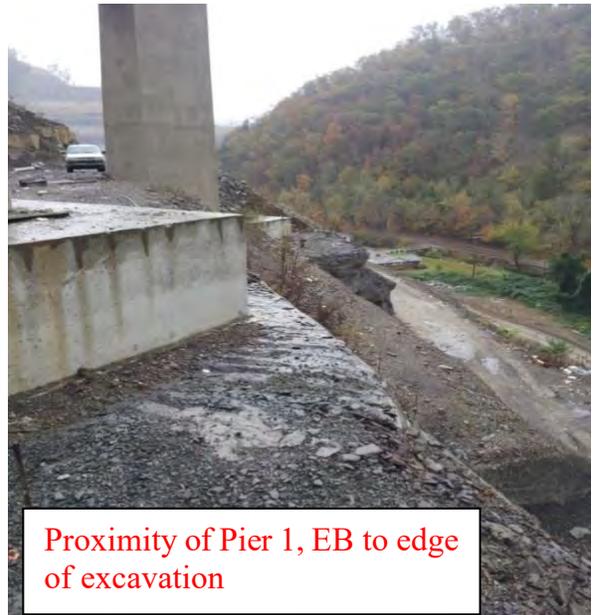
Figure 4. Pier 1 EB prior to relocating.

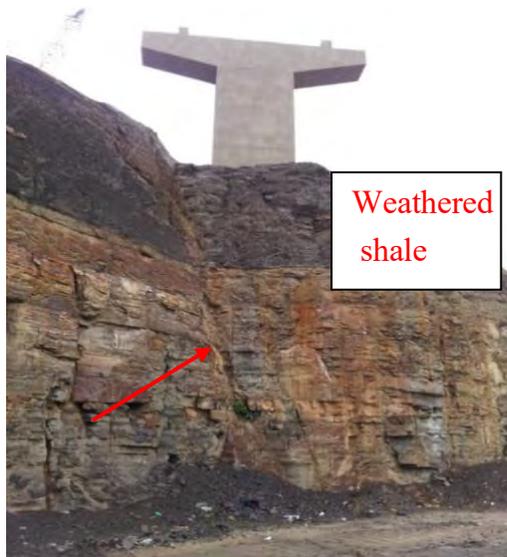
Figure 5. Pier 1 WB initial construction.

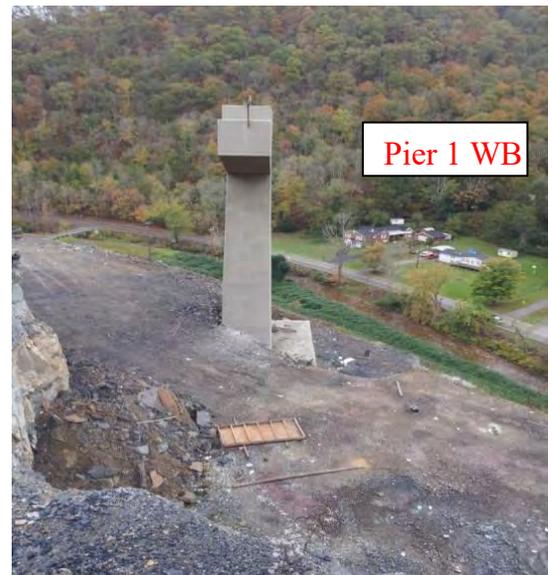
Figure 6. Pier 1 WB before replacing.

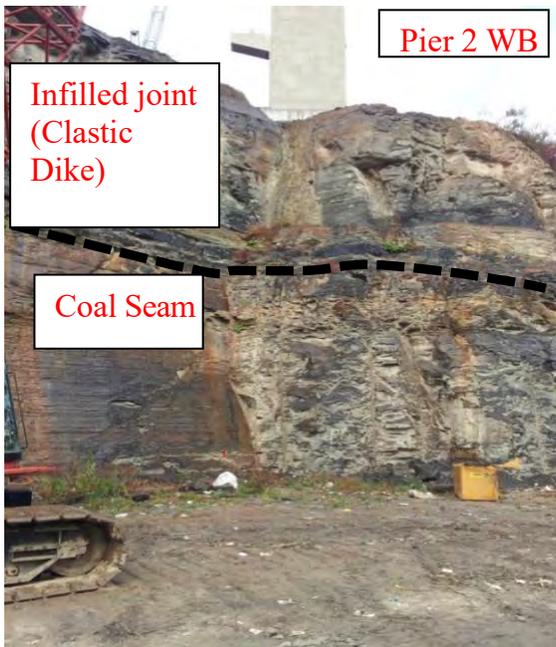
Figure 7. Clastic dike and coal seam at Pier 2 WB.
