# 72<sup>nd</sup> Highway Geology Symposium

## 2023 PROCEEDINGS

August 14-17, 2023 • Hotel Murano • Tacoma, Washington

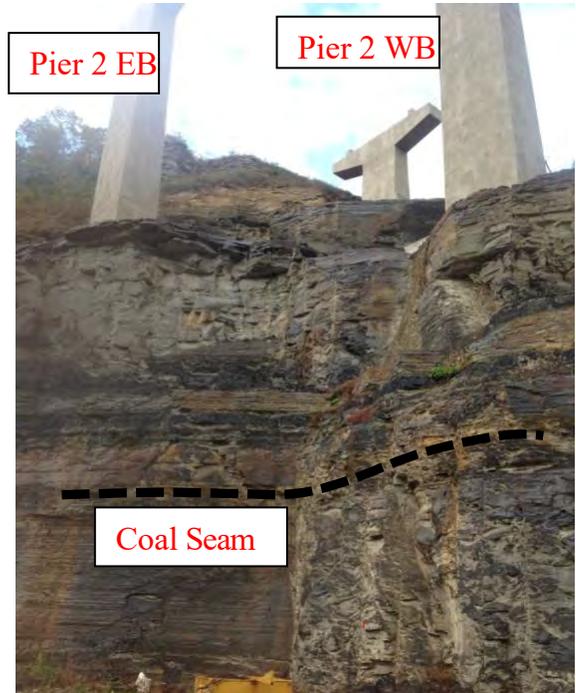
Figure 8. Weathered bedrock and coal seam.

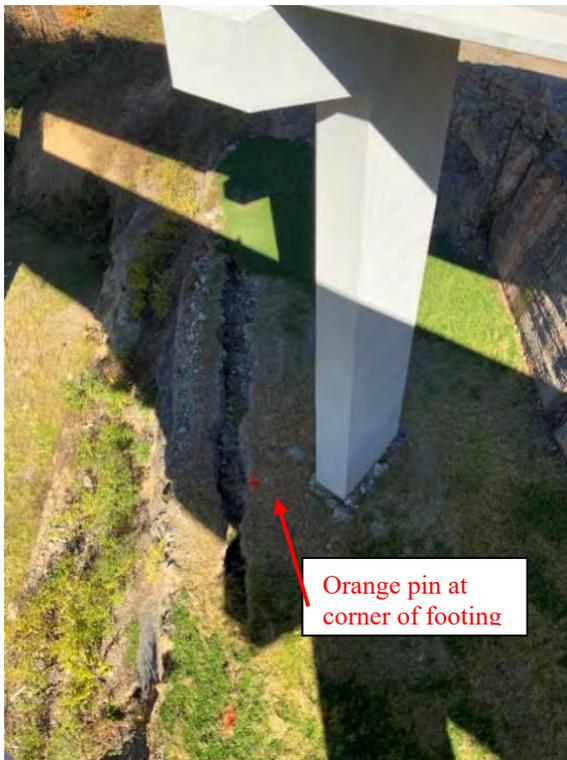
Figure 9 Fissure at Pier 8 WB.

During the final inspection in October 2020 a large fissure was observed adjacent to the Pier 8 west bound bridge spread footing foundation. The crevice had apparently grown larger due to stress relief caused by removal of bedrock to construct benches below the footing. Vertical, clastic dikes with highly weathered thin bedding planes dikes were observed in the crevice. Several other crevices with weathered, vertical bedding planes were also located during field investigations. The fissures (clastic dikes) generally trended parallel to the crevice adjacent to bench face at Pier 8 WB with one trending directly under the foundation of WB Pier 8 toward Pier 8. EB Other crevices were observed near both No. 2 abutments. Vertical clastic dikes in highly weathered shale were also observed at the abutments No. 2 during subsequent field investigations. See Figures 9 through 12.

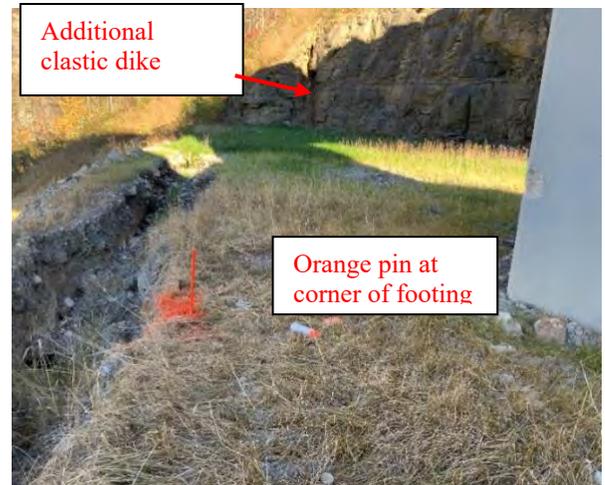
Figure 10. Fissure at Pier 8 WB, October 2020, orange pin is at corner of footing.

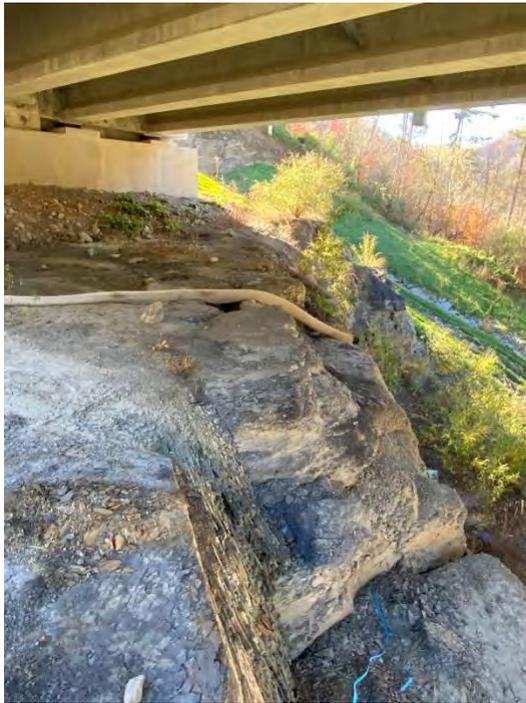
Figure 11. Clastic dike at Abutment 2 eastbound.

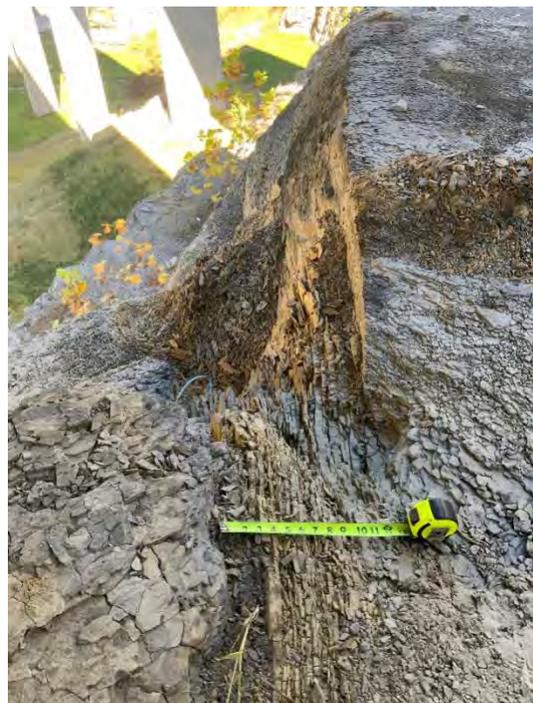
Figure 12. Clastic dike at Abutment 2 eastbound.

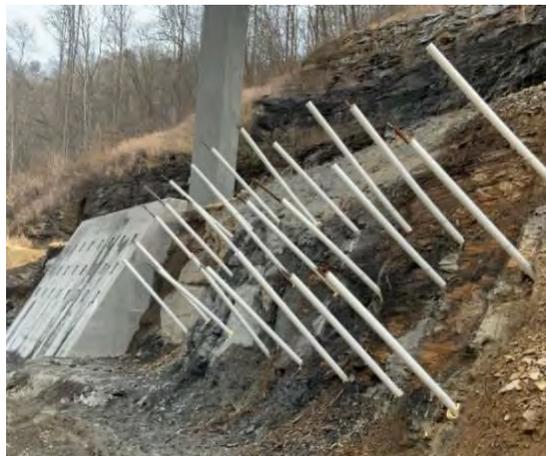
Figure 13. Pier 8 WB post tensioned PCC wall and EB Post tensioned anchor sleeves.

A contract was awarded to a consultant in December 2020 to design mitigation measures to prevent future widening of the crevices and potential failure of the foundations (4). Angle drilling was performed to supplement existing borings obtained during design to determine location of the vertical features. An additional clastic dike was observed in the bench cut and confirmed to be extending under both Pier 8 (WB and EB) foundations. A cast in place PCC wall with post tensioned stranded rock anchors was designed to prevent expansion of crevices at the WB Pier 8 foundation. A shotcrete wall with post tensioned strand anchors was designed for the EB pier 8 (Figures 13-15). Shotcrete walls with post tensioned solid bar nails were designed for No 2 abutments (east end). Construction of mitigation units at both Piers 8 and Abutment Nos. 2 was completed in May 2023.

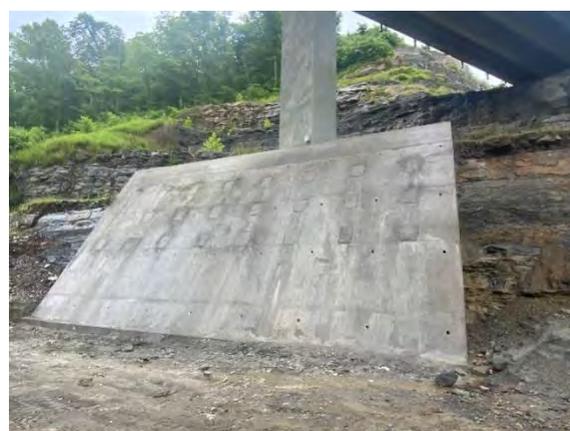
Figure 14. Completed post tensioned concrete wall, Pier 8 WB.

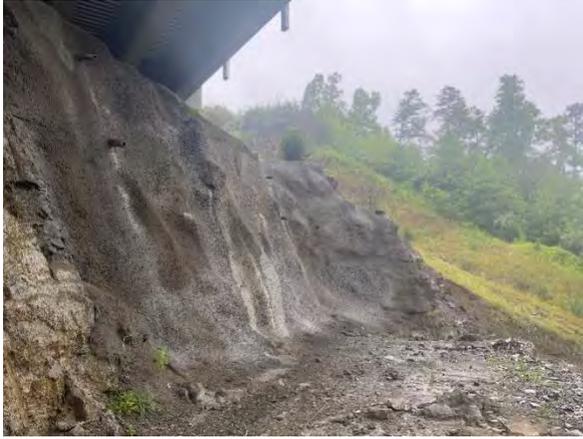
Figure 15. Completed shotcrete anchored Abut. 2 EB.

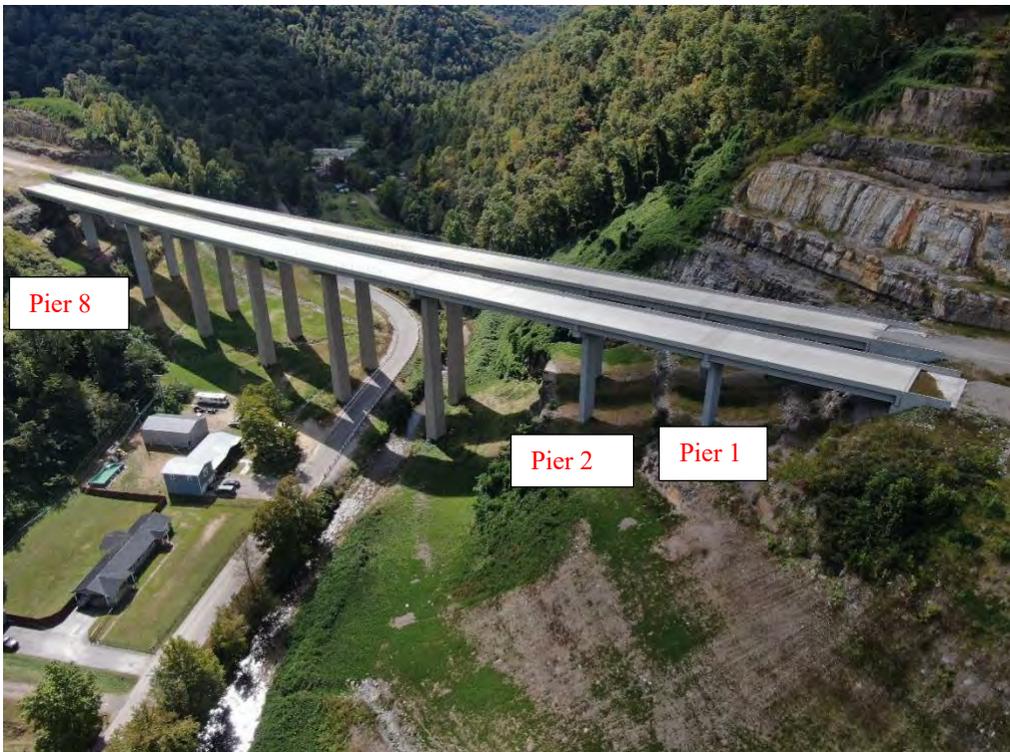
Figure 16. Aerial view of Marrowbone Bridge in 2020 Abutment No.1 is on right. Notice color of Piers 1 and 2 showing newer construction.

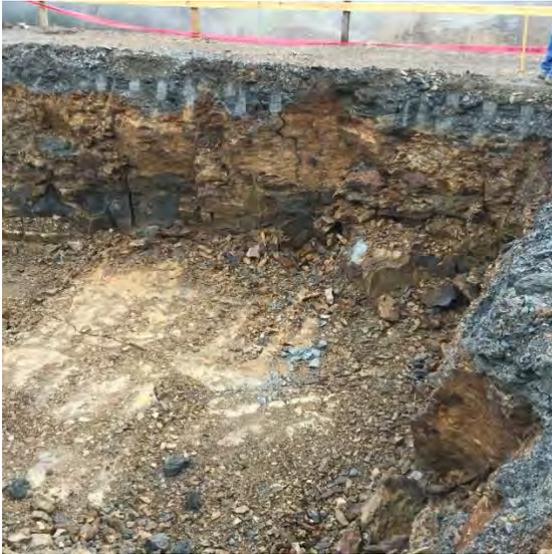
Figure 17. Excavation for Pond Creek Bridge Pier 4 EB foundation.

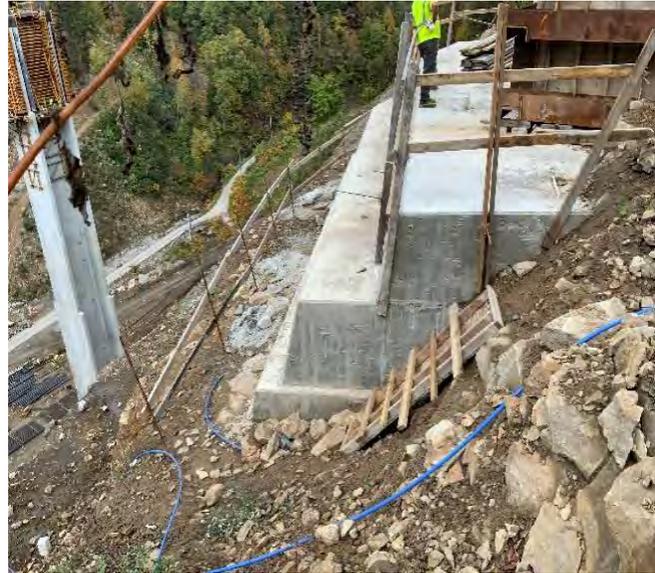
Figure 18. Anchored Concrete wall on cut face, Pier 4 EB, Pond Creek.

borings, was performed and a stepped concrete retaining wall with rock anchors was designed and constructed to provide additional support and prevent further degradation of the bench face below the Pier 4 EB foundation (Figures 18 and 19).

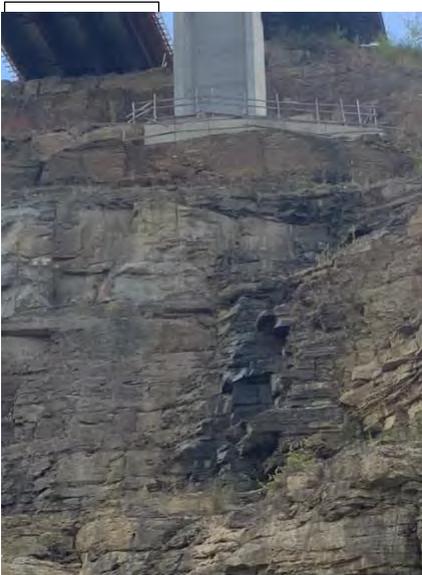
Figure 19 Anchored Wall, Pier 4 EB, Pond Creek.

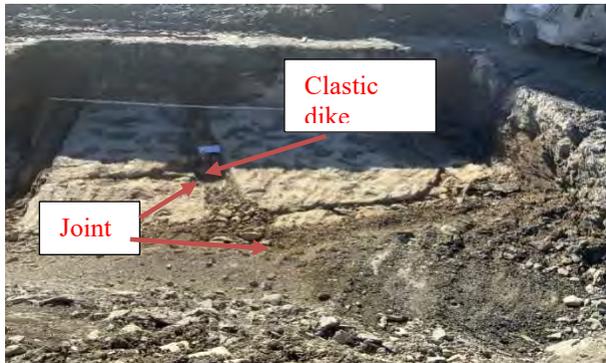
Figure 20. Joints and clastic dike at Pier 1 WB footing, Pond Creek.

The required setback criteria (15 feet) into competent bedrock from the bench face was not achieved when the Pier 1 WB footing was excavated in December 2020 to plan elevation (Figure 20). A clastic dike and joints were also present. The bottom of footing elevation was lowered approximately four feet into competent sandstone to meet plan requirements.

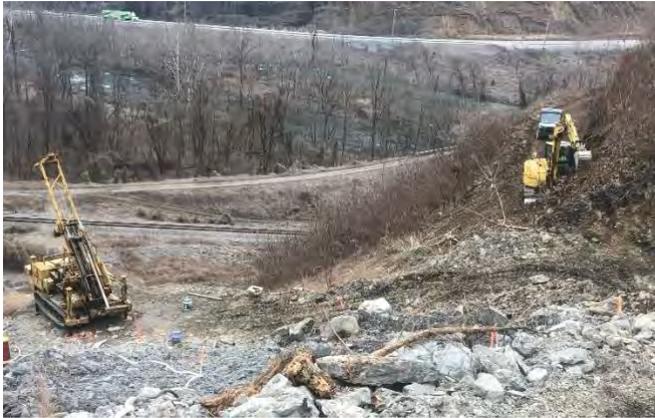
Figure 21. Angle drilling Pier 1 EB Russell Fork.

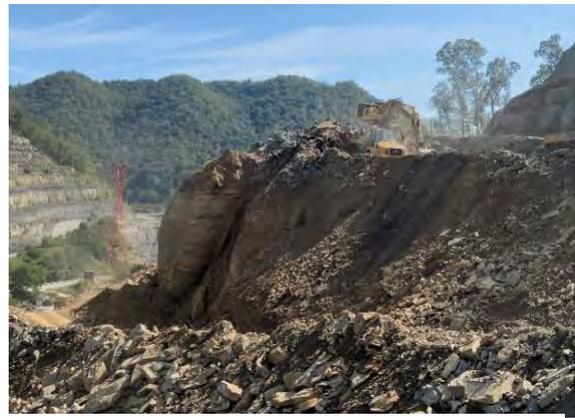
Figure 22 Clastic dike below Pier 1 EB foundation.

A large clastic dike with highly weathered vertical bedding planes was encountered during the angled exploratory core drilling at Pier 1 EB (Figure 22). The footing was lowered approximately ten feet to competent bedrock to provide adequate bearing capacity and to meet the minimum setback distance from the bench face. Mass concrete was then placed in the excavation to

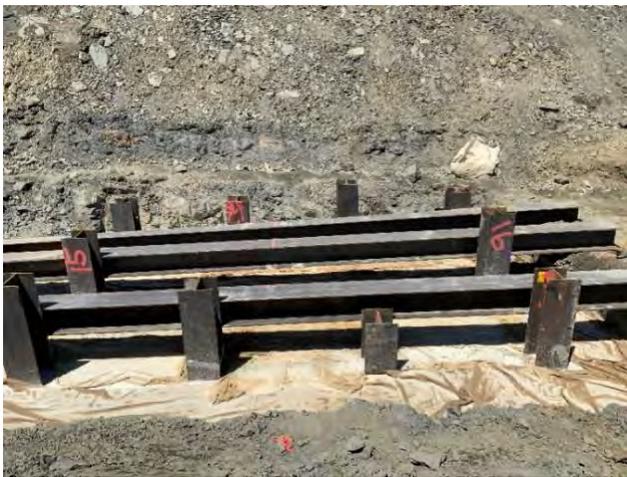
Figure 23. H piles placed in mass concrete to support Pier 1 EB foundation, Russell Fork.

plan bottom of footing elevation. Steel H- piles (Figure 23) placed in the mass concrete to extend into the concrete for the footing to provide support between the mass concrete and footing (10).

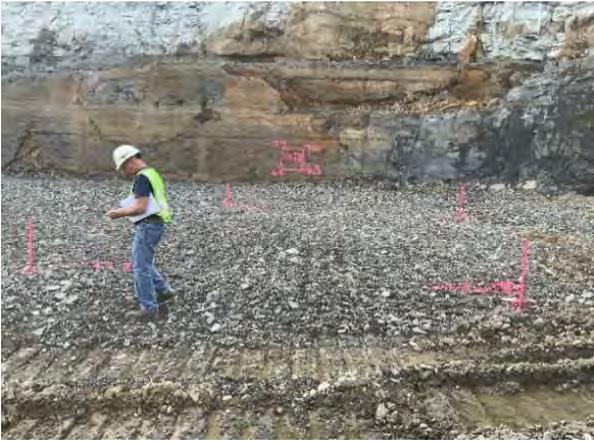
Figure 24. Pier 2 EB location, Russell Fork.

Pier 2 EB foundation was lowered 17 feet into competent bedrock to avoid a coal seam encountered eleven feet below plan BOF and be constructed at an elevation below a highly weathered clastic dike (Figures 24 to 26). The coal seam and a clastic dike were documented

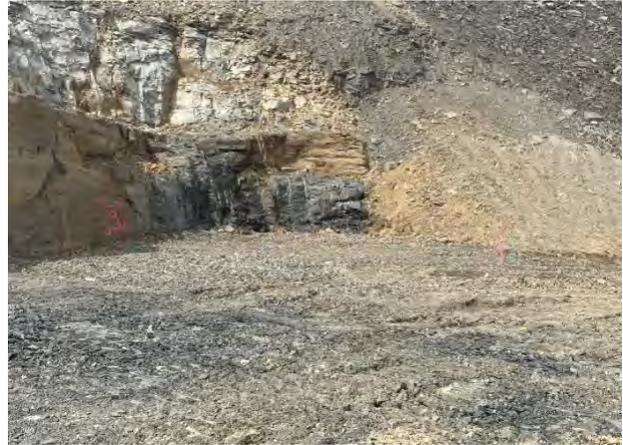
Figure 25. Pier 2 EB location, Russell Fork.

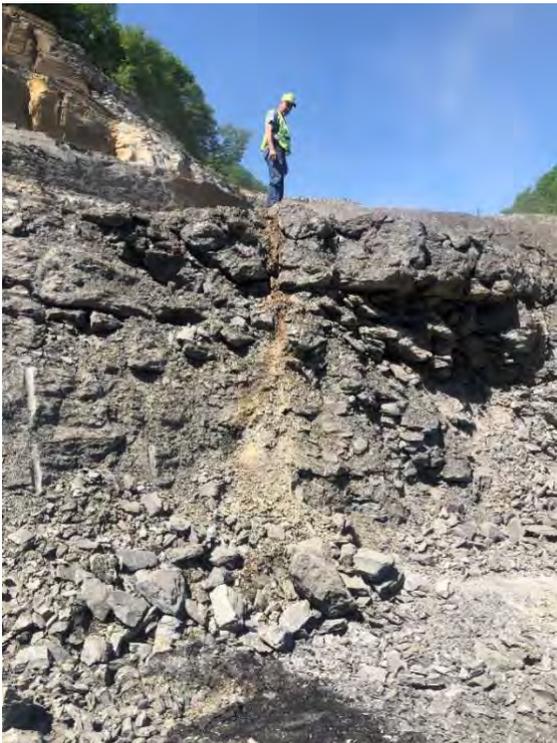
Figure 26. Clastic dike in bench face below proposed Pier 2 EB elevation, Russell Fork.

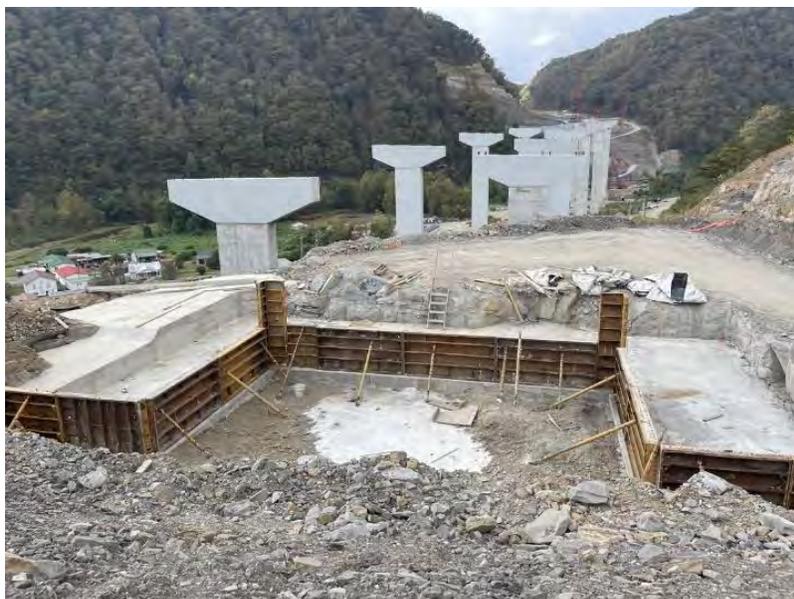
Figure 27. Additional mass concrete (left side) at Abutment No.2 WB looking east

Mass concrete (Figure 27) was placed at abutment No. 2 west bound due poor-quality bedrock not meeting the minimum offset distance from foundation to top of the lower bench face (11).

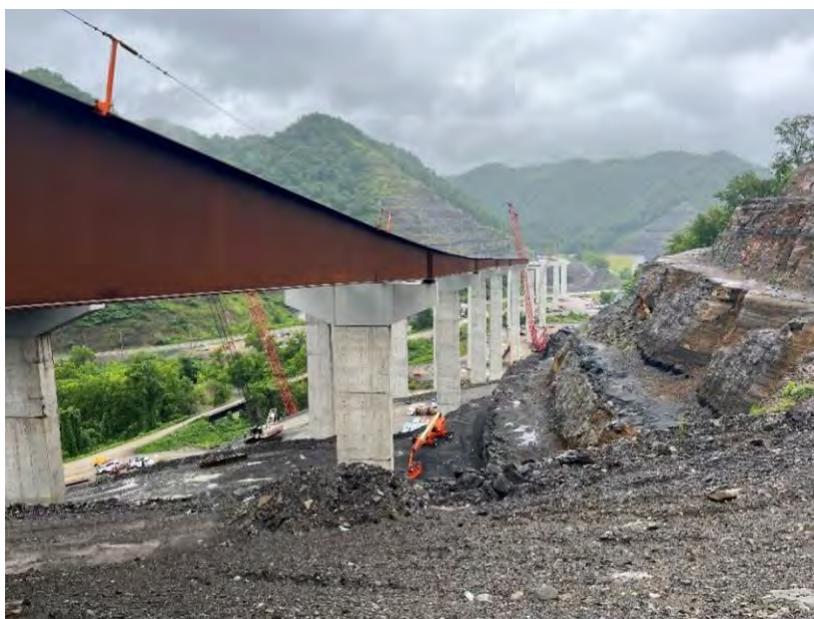
Figure 28. View from Abutment 2 looking east May 2023, Russell Fork.

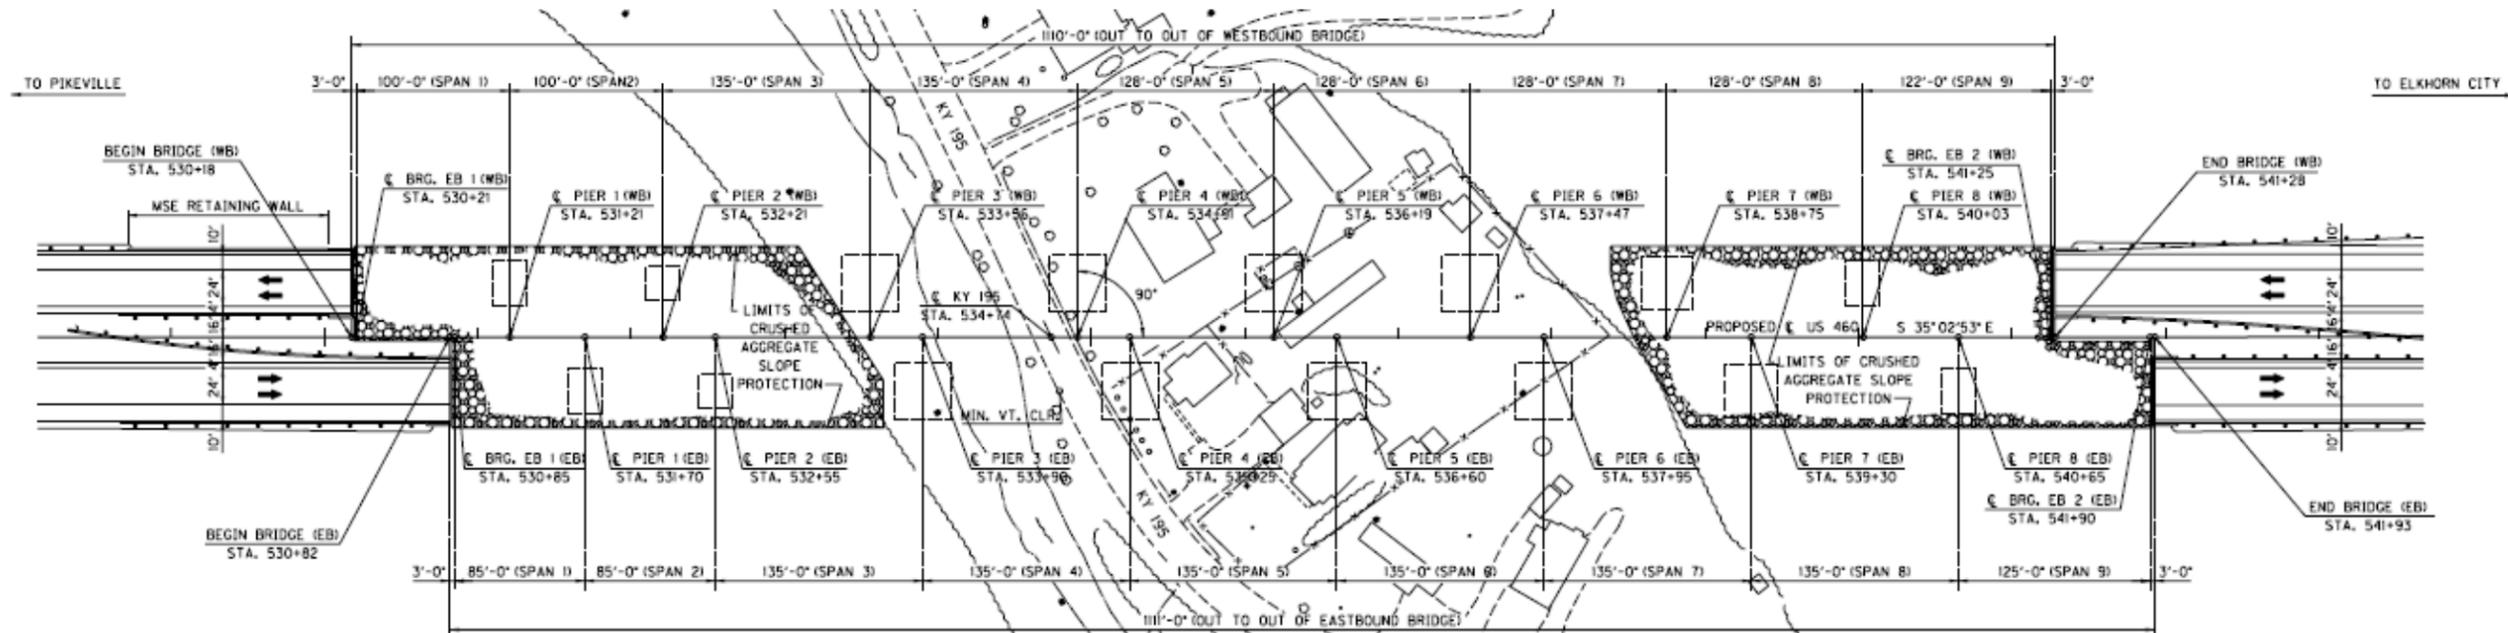
Original 2008 Plan View.

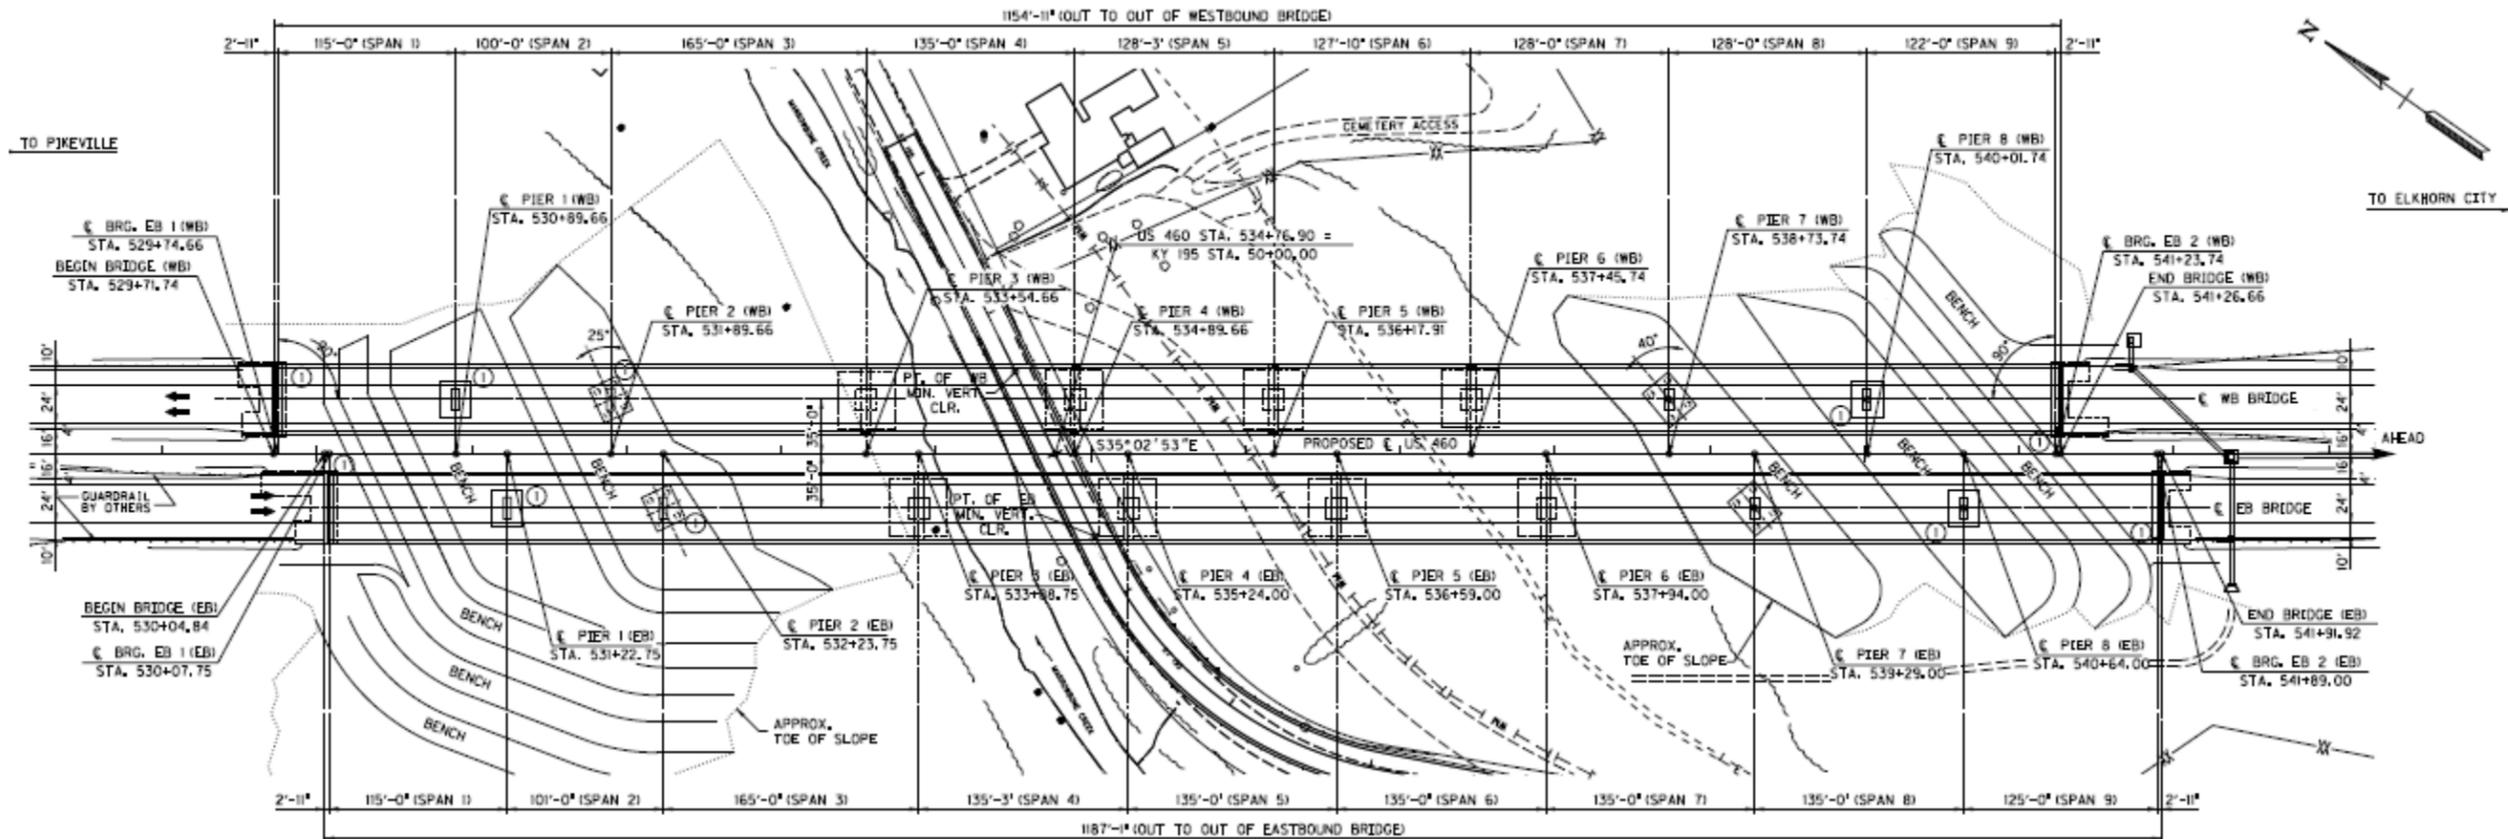
Plan View after Modifications 2016.

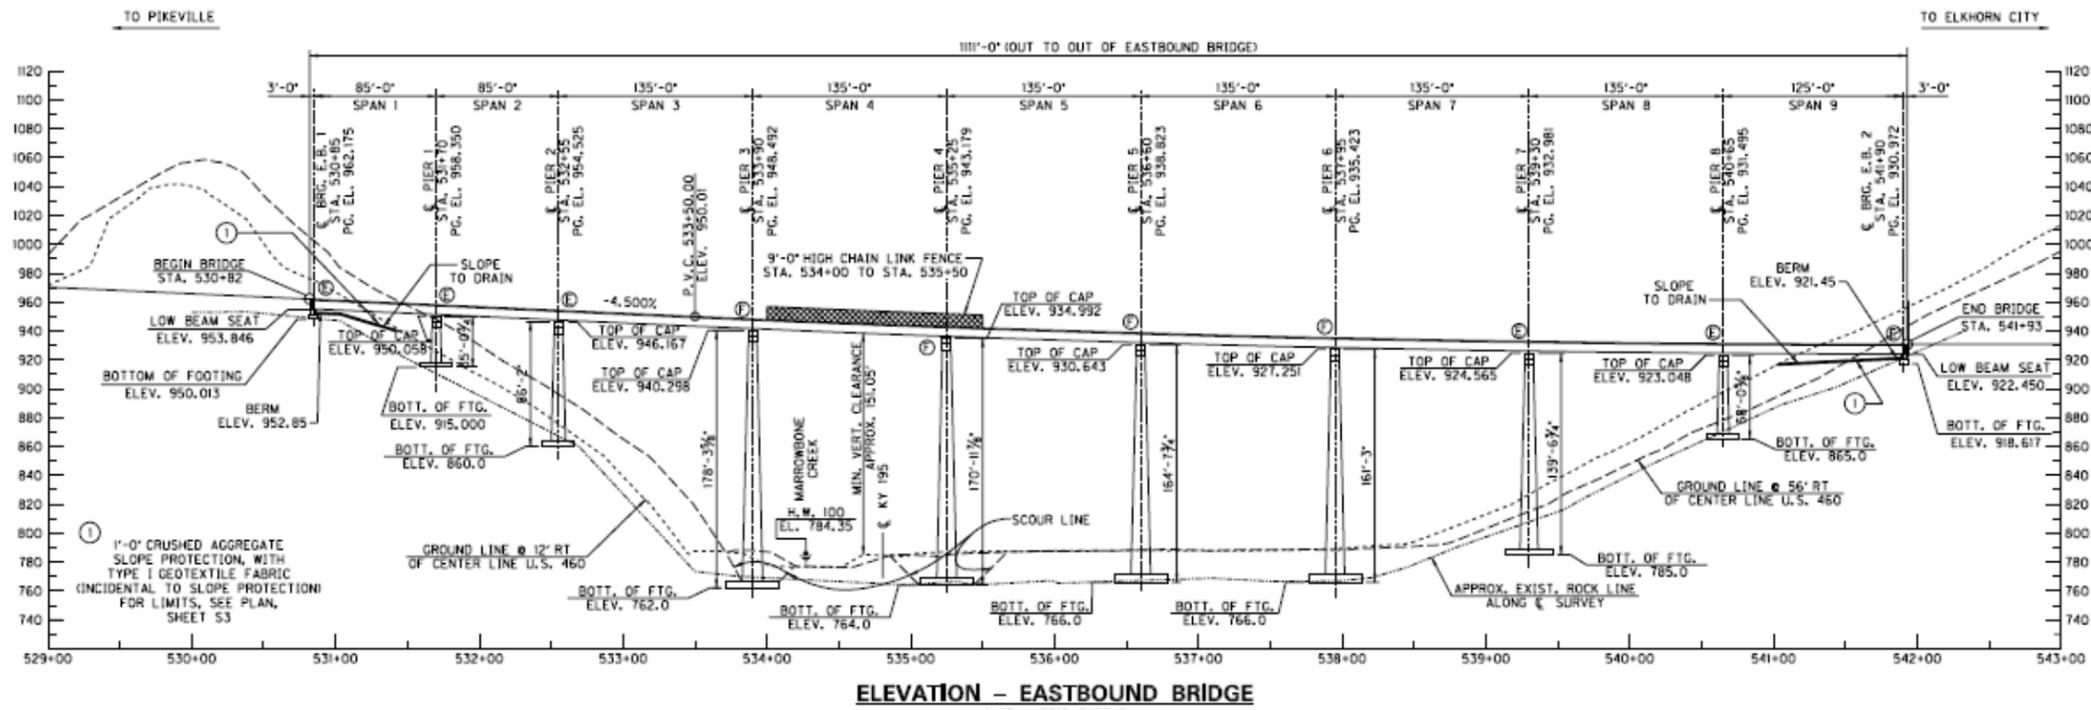
Original Elevation EB Bridge 2008

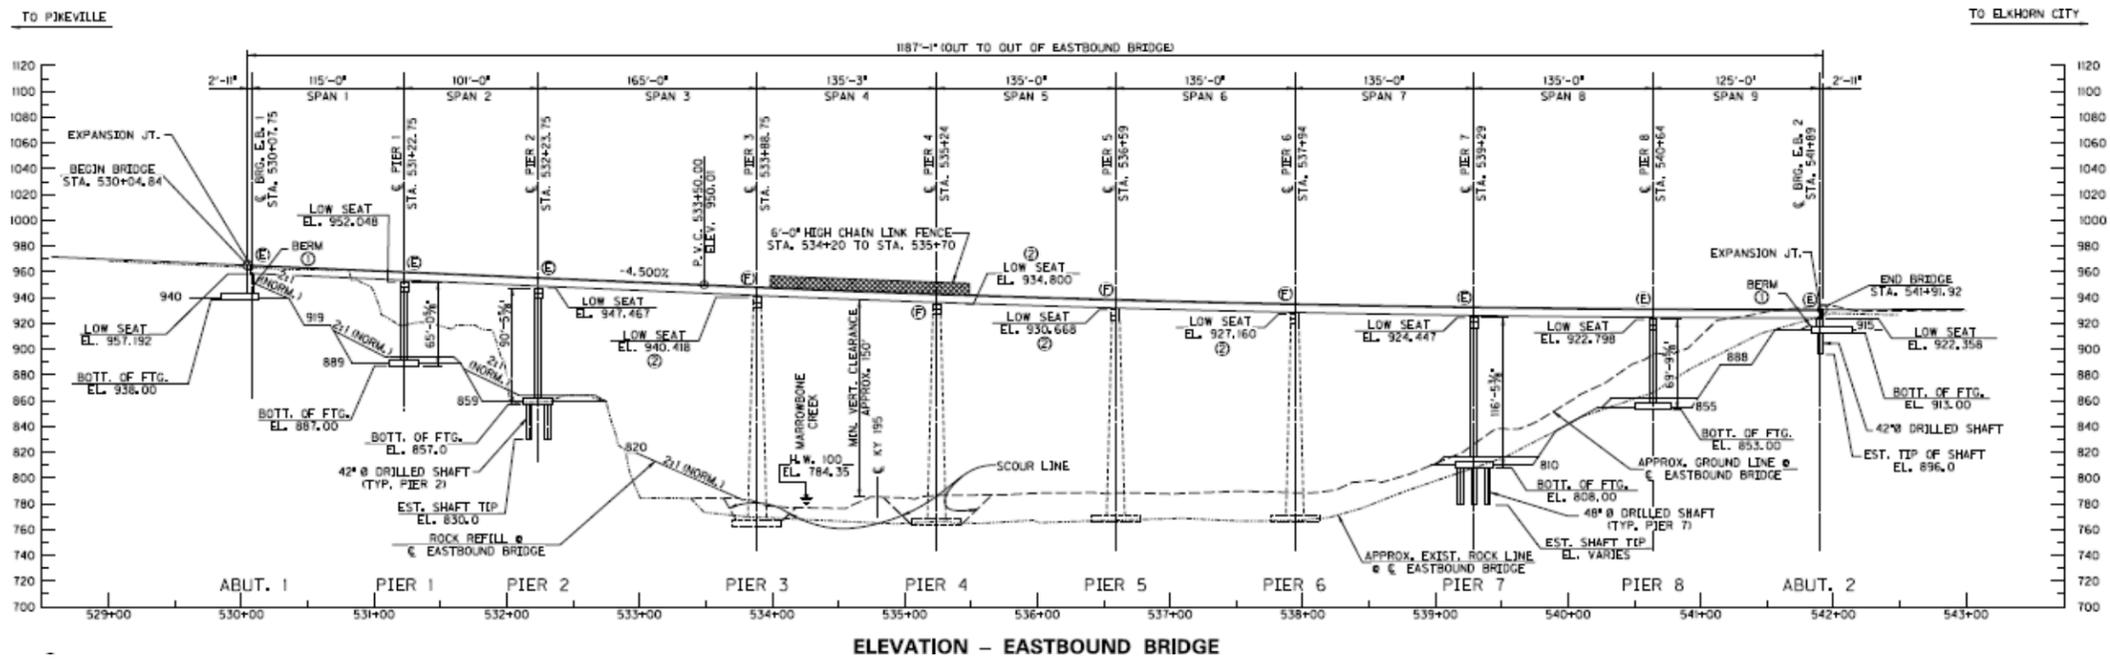
Elevation EB Bridge After Modifications 2016

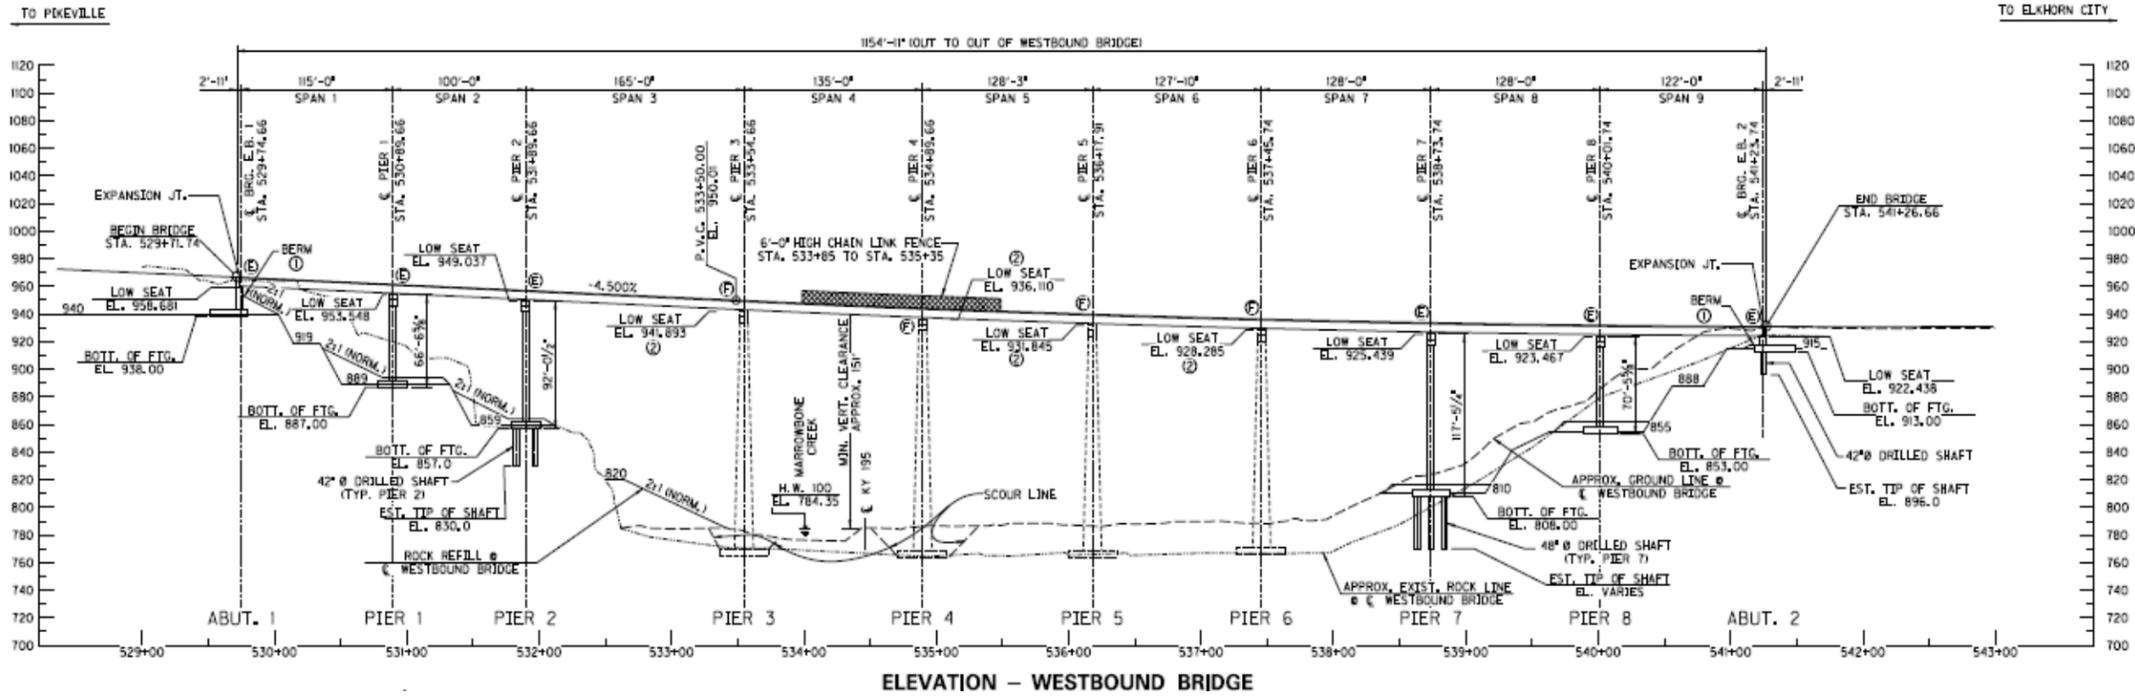
Original Elevation WB Bridge 2008

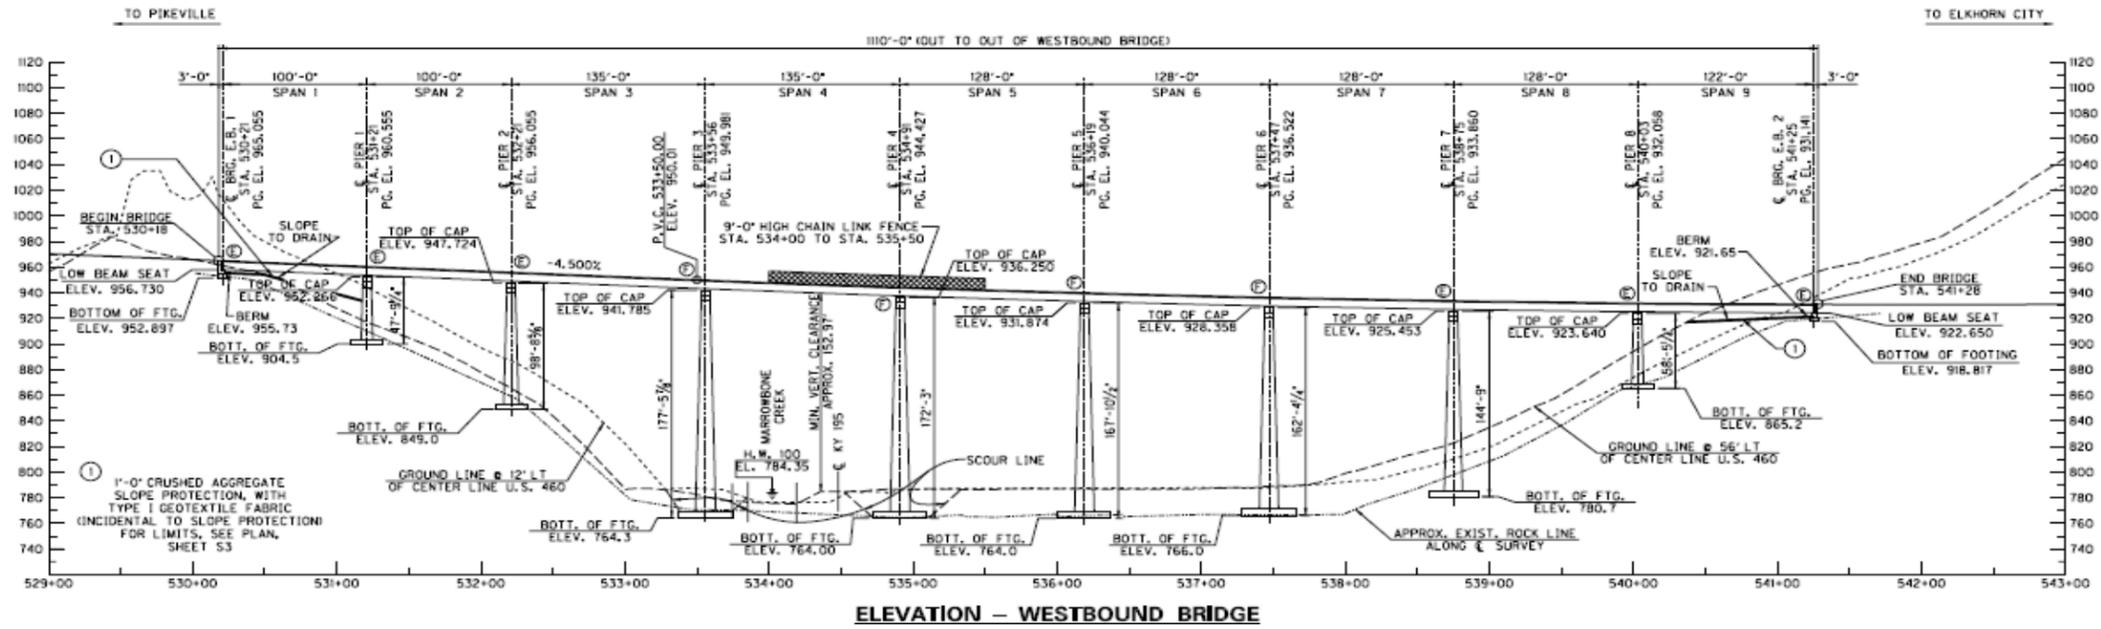
Elevation WB Bridge after Modifications 2016

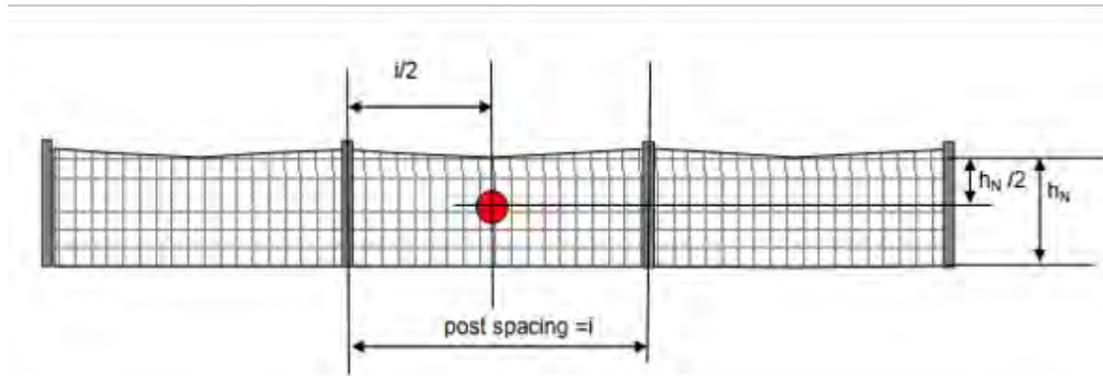
**Figure 1. Impact Location of the SEL and MEL Launches during certification tests (EOTA 2018).**

Following the original Swiss guideline, in 2008, the ETAG 027 (EOTA 2008) was the first European testing standard that made it possible to compare different rockfall barriers based on their energy level in for European countries. The test procedure is based on tests at two different energy levels: Service Energy Level (SEL) and Maximum Energy Level (MEL) (EOTA 2018). The SEL test consists of two consecutive impacts with a third of the maximum energy level without maintenance to the kit in contrast to the single Swiss 50% SEL impact. The SEL Launch 1 is passed if there are no ruptures to any kit components. SEL 2 is passed if the block is stopped by the kit and the block has not touched the ground until the kit has reached maximum elongation during the test. The MEL launch is passed if the block is retained by the kit. A detailed description of damages after a MEL impact has to be provided and included in the ETA. The impact location is set for all three launches in the middle of the central functional module (Figure 1), representing the most favourable impact location for the barrier.

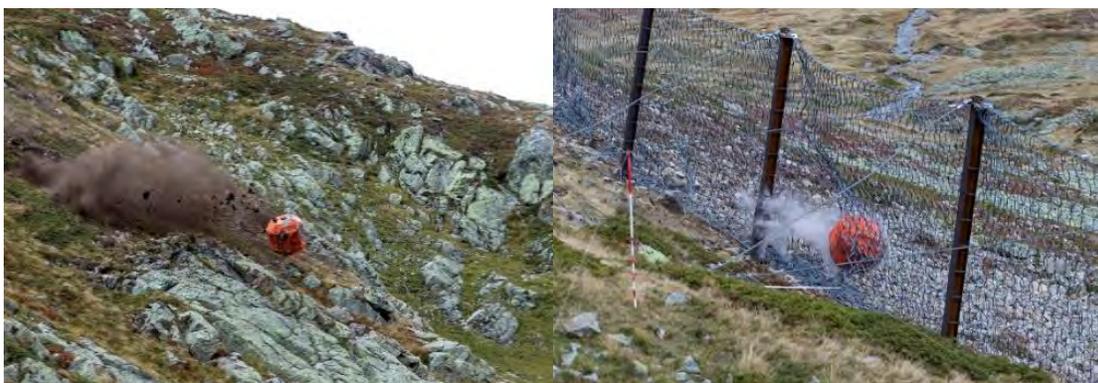
**Figure 4. Left: A test block, released by helicopter bounces, rolls and slides down the slope. Right: Fully instrumented flexible rockfall protection barrier experiencing a random rock impact.**

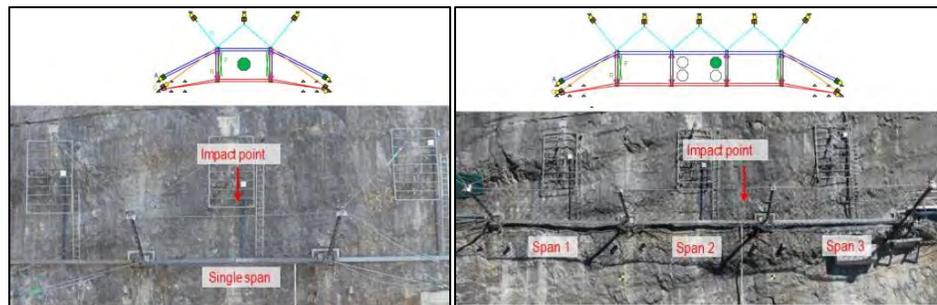
**Figure 5. Left: Single span impact at Maximum Energy Level, corresponding to a border field impact. Right: Eccentric impact at Maximum Energy Level, in the top corner, near the post head of the middle field of a three-field system. Example of a 1'000 kJ rockfall barrier (TSUS, 2021a)**

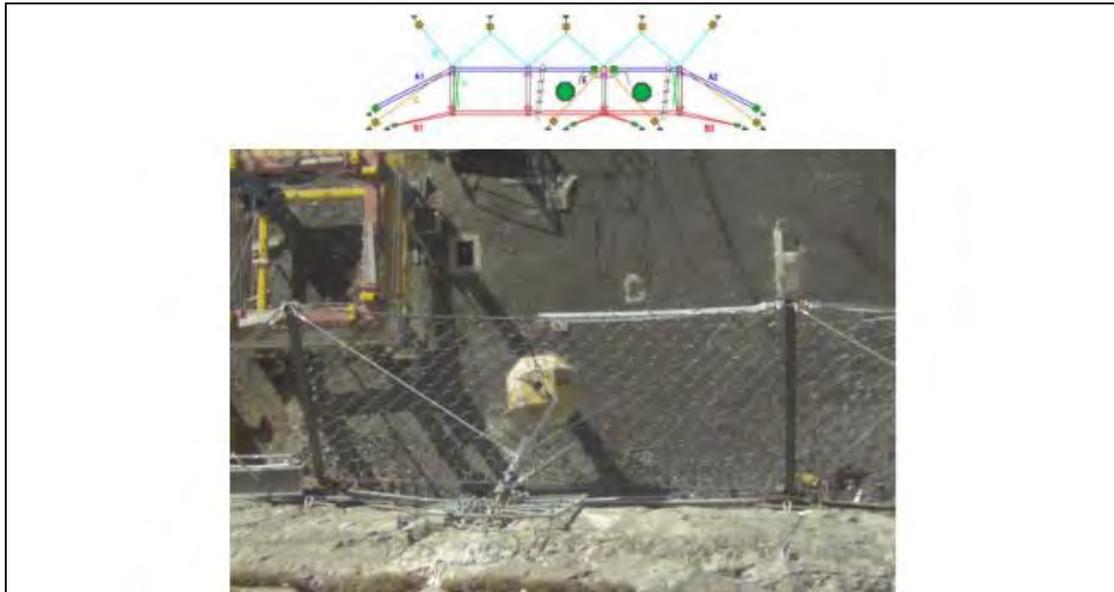
**Figure 6. Support Rope Separation Test on a 2'000 kJ rockfall barrier (TSUS, 2021b). The bottom support ropes are led to two anchors on the ground while the top support ropes are separated and connected at the post head instead of being also led to anchors in the ground. This ensures that no support rope gets hit during an impact.**

separation of the support ropes of the barrier is necessary, to ensure that the forces acting upon the barrier arrive at a timely interval to the anchors on either side, so that the energy-dissipating elements can be activated. In Switzerland, it is customary to do so after a length of 60m. But this setup has never been tested before. A support rope separation was successfully tested in 2021, during the development of the new barrier line, by means of two consecutive maximum energy level tests on either side of the support rope separation (Figure 6, TSUS 2021b).

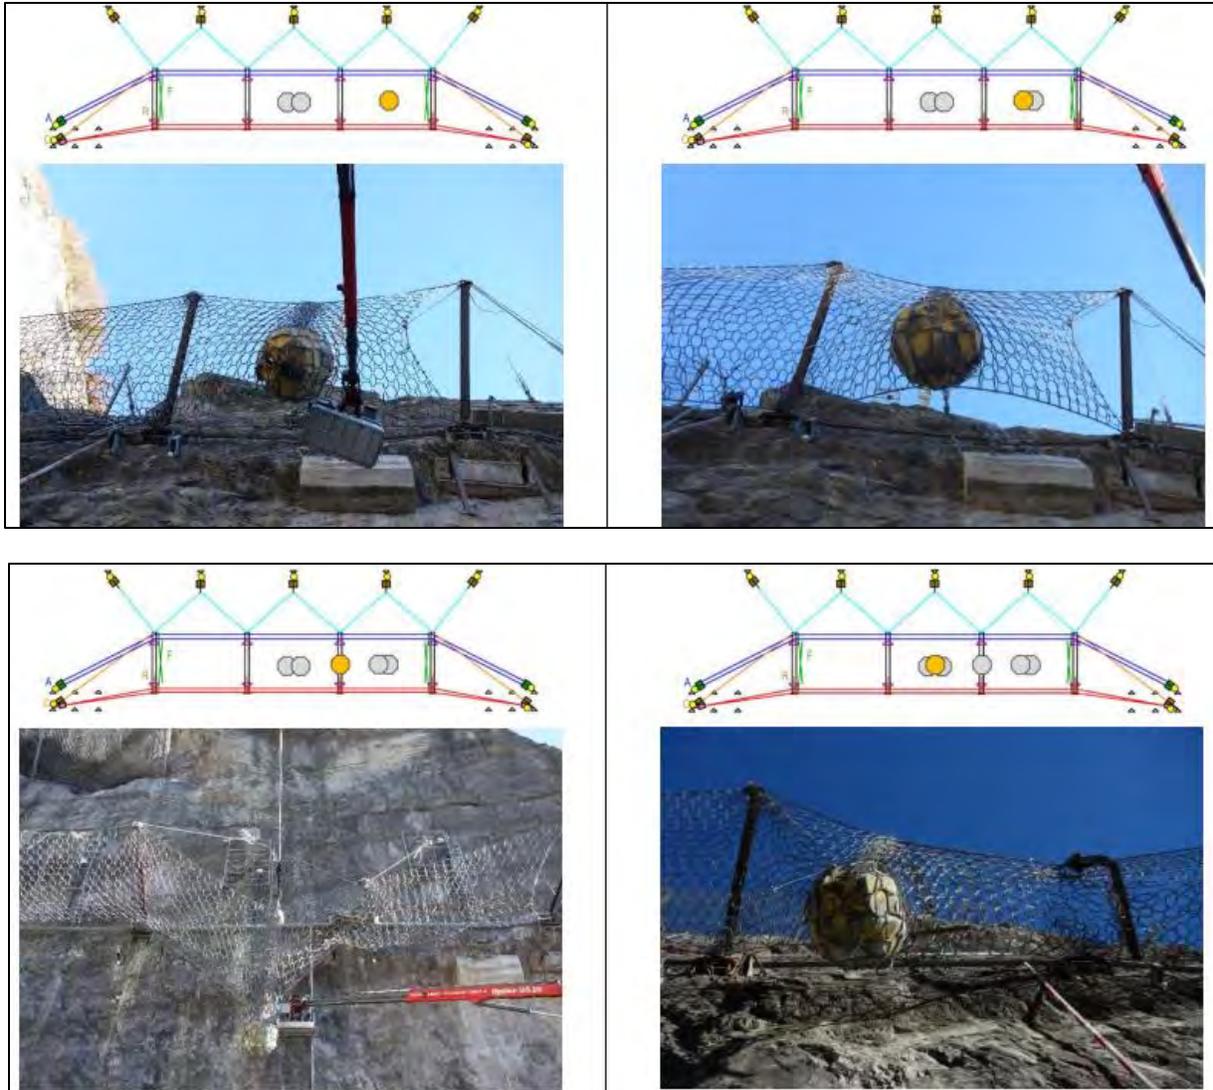
**Figure 7. Succession of several SEL impacts in the same barrier without repairs between tests (TSUS, 2021c).**

Finally, an always-arising interrogation lay in the question of how much rest capacity a barrier has when dimensioned in order to receive Service Energy Level impacts (SEL). Therefore, after certifying a 3'000 kJ barrier with a MEL and two consecutive SEL hits, further SEL hits were launched in various locations, trying to replicate impacts observed in the field over the years as well as during the research project with the SLF. It was decided, after the two SELs in the middle field, to impact twice a lateral field, then a post and a final impact in the middle field again (Figure 7). The barrier successfully managed to retain all six SELs load cases (TSUS, 2021c).

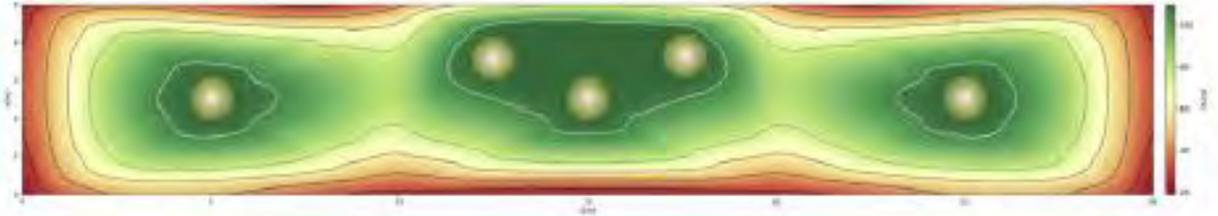
**Figure 8. Schematic illustration of the theoretical energy distribution (in % of MEL) on the barrier surface considering the full-scale test in the natural environment and the additional vertical tests on critical points of the protective surface.**

Two substitute loads that guarantee the best possible coverage along the entire length of the barrier line were, therefore, determined to reproduce the tangential forces caused by the rotation and consider border field hits. These additional tests lead to a new assessment of the energy capacity absorption of the protection surface of a rockfall barrier. The results of these tests are highlighted in Figure 8.

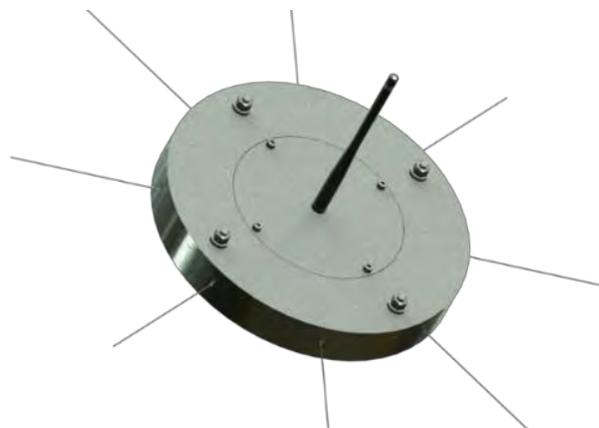
**Figure 1: The HELLOMAC Device**

HELLOMAC is an alloy disk with thin tie rods or “arms” that extend out from the disk as shown in Figure 1. The arms connect the disk to the different positions on the rockfall protection system. An antenna, located on the top of the device, sends the alarm signal when an event has occurred. The main structure of the HELLOMAC unit is made of a highly resistant and durable argal aluminum alloy.
