# 72<sup>nd</sup> Highway Geology Symposium

## 2023 PROCEEDINGS

August 14-17, 2023 • Hotel Murano • Tacoma, Washington

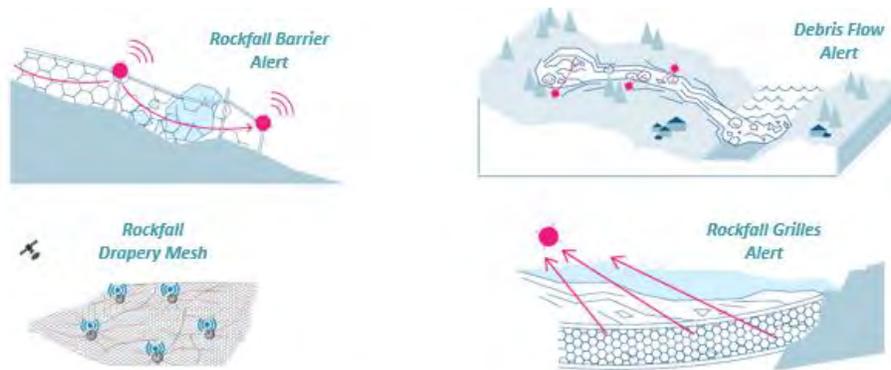
**Figure 2: Fields of Application**

Calibrated and tested by the Polytechnic of Milan, HELLOMAC can be used to monitor rockfall and debris flow protection systems for impact, or to determine the need for mitigation in a certain location. Often installed in remote areas, this new device is compact and robust and can be applied to simple and secured draperies, rockfall barriers and attenuators, and debris flow barriers as shown in Figure 2. HELLOMAC provides real-time information about the occurrence of an impact event and can be installed on any type of rockfall system or calibrated and retrofitted to an existing system.

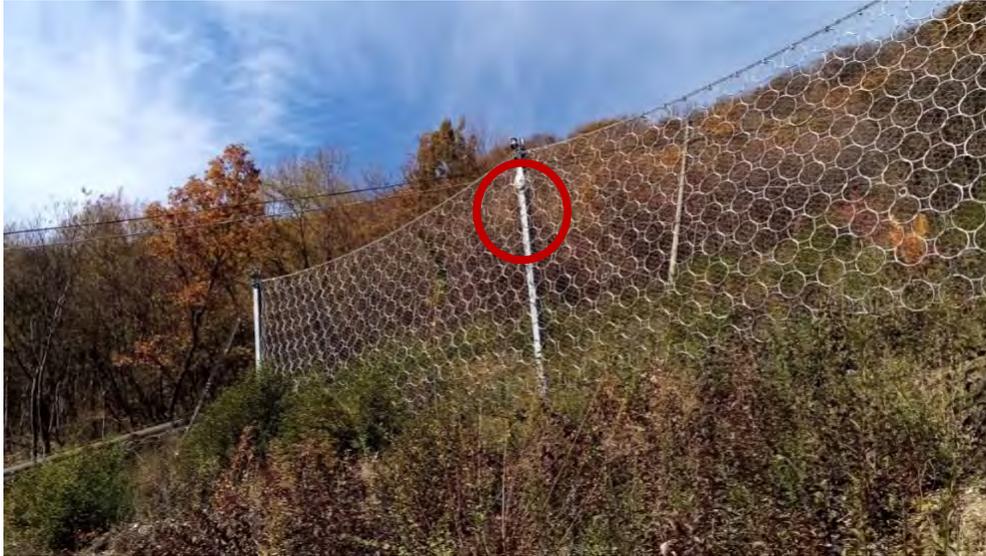
**Figure 3: Installation of the HELLOMAC Device on the Barrier Post**

The transmitting tool of the HELLOMAC device is usually installed at the top of the rockfall barrier post as shown in Figure 3. The device can be installed either upslope or downslope on the barrier post, but it is recommended to be installed downslope to prevent impact.

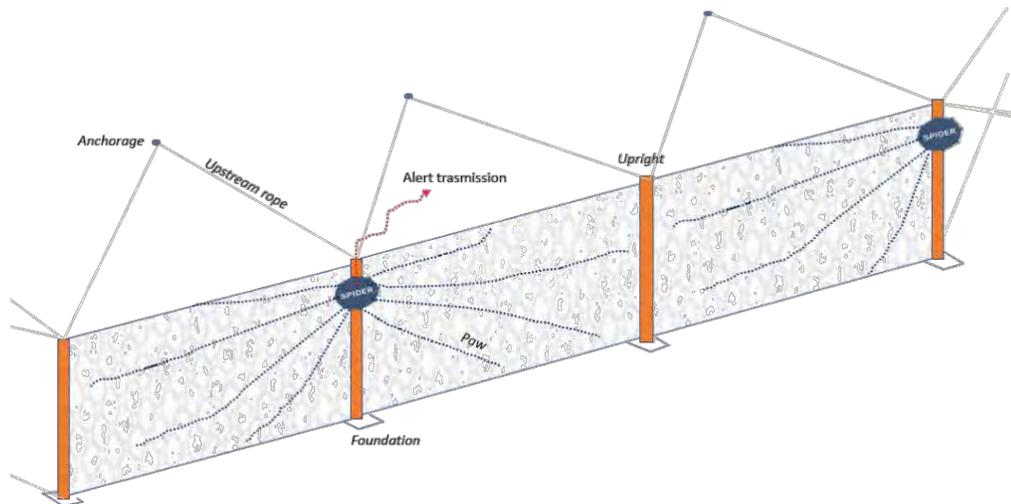
**Figure 4: Tie Rods Connect the Transmitting Device to the Adjacent Interception Panels**

The transmitting tool is connected to eight (8) tie rods attached to control points that are fixed to the interception structure, four (4) extending from each side of the post and connected to two spans of the barrier as shown in Figure 4. The tie rods are properly calibrated according to the deformation parameters measured from the full-scale tests and are positioned to monitor different vertical and horizontal locations of each interception panel, thereby informing about the exact location of impact. The length of each tie rod is specific to the barrier being monitored and

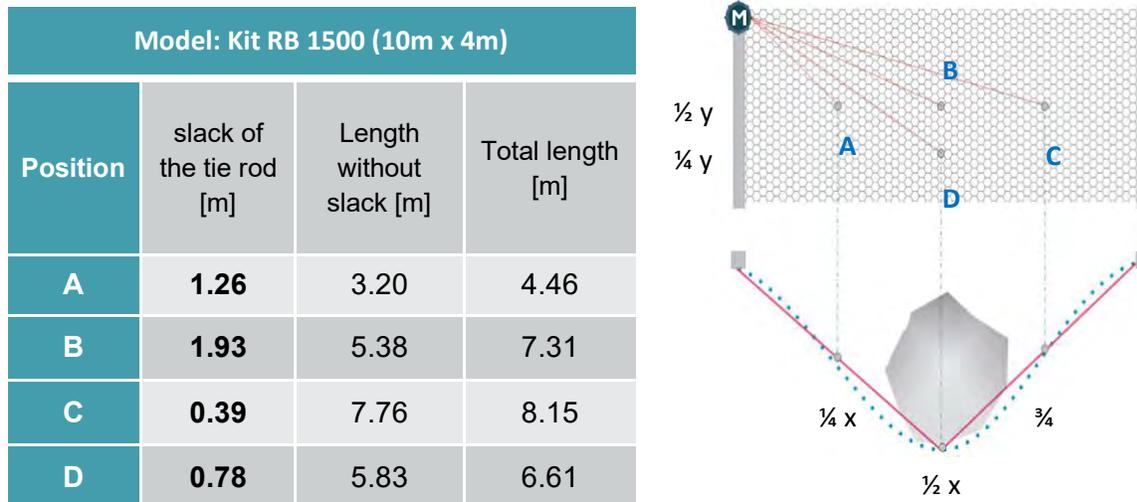
**Figure 5: Example of Tie-Rod Dimensions Calibrated to a Rockfall Barrier**

Figure 5 shows the calibrated tie-rod dimensions and positions for a specific barrier and how they would be installed on the interception panel. The length of each tie-rod is associated with a specific location to be installed on the interception panel.

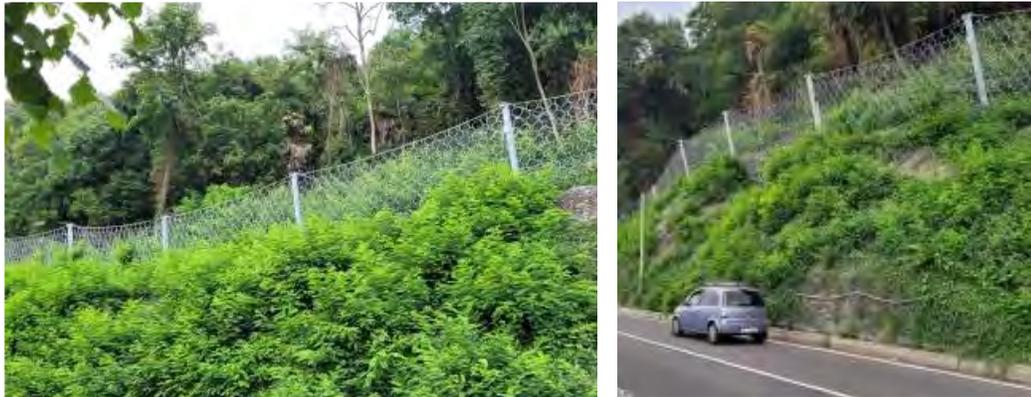
**Figure 6: Installed Rockfall Barriers Above SS 34 in Verbania, Italy**

Figure 6 shows the installed rockfall barriers, Maccaferri RB1500 and RB2000, chosen to provide a Maximum Energy Level (MEL) rating of 3 times the SEL, or 1500 kJ and 2000 kJ, respectively. Twelve alignments of RB2000 barriers and two alignments of RB1500 barriers were installed, all with an interception height of 13 ft (4 m), allowing nearly 2 miles (3 km) of linear protection.

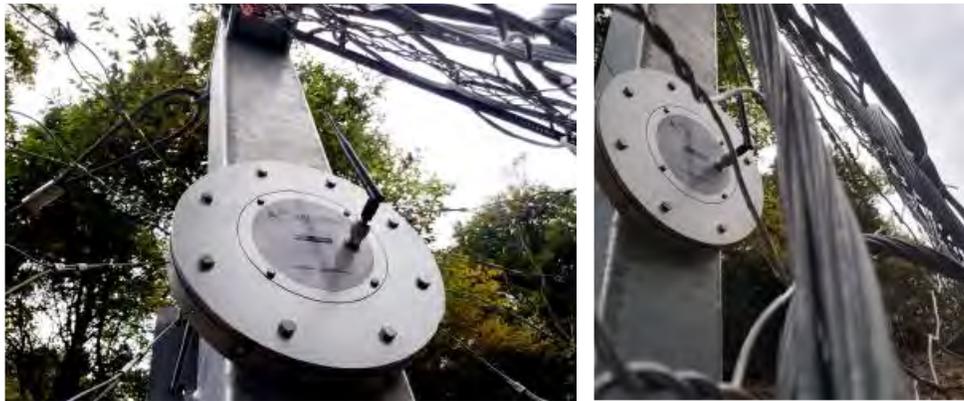
**Figure 7: HELLOMAC Installed on Barrier Post**

The rockfall barrier systems were integrated with the HELLOMAC monitoring device. The rockfall barriers were equipped with over 40 HELLOMAC devices, which were all connected to the same transceiver device, Hubir. The transceiver was installed in a safe area, where it can easily be checked following an impact. Figures 7 and 8 show the HELLOMAC transmitter device attached to the barrier post and the tie-rods connected to the interception panel of the barrier.

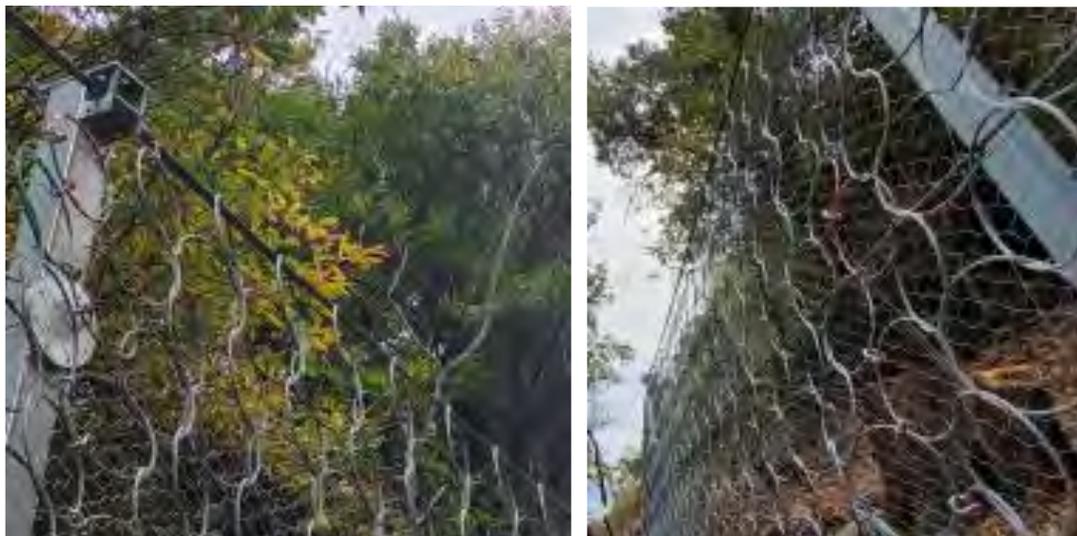
**Figure 8: Tie-Rods of HELLOMAC System Connected to the Interception Panel**

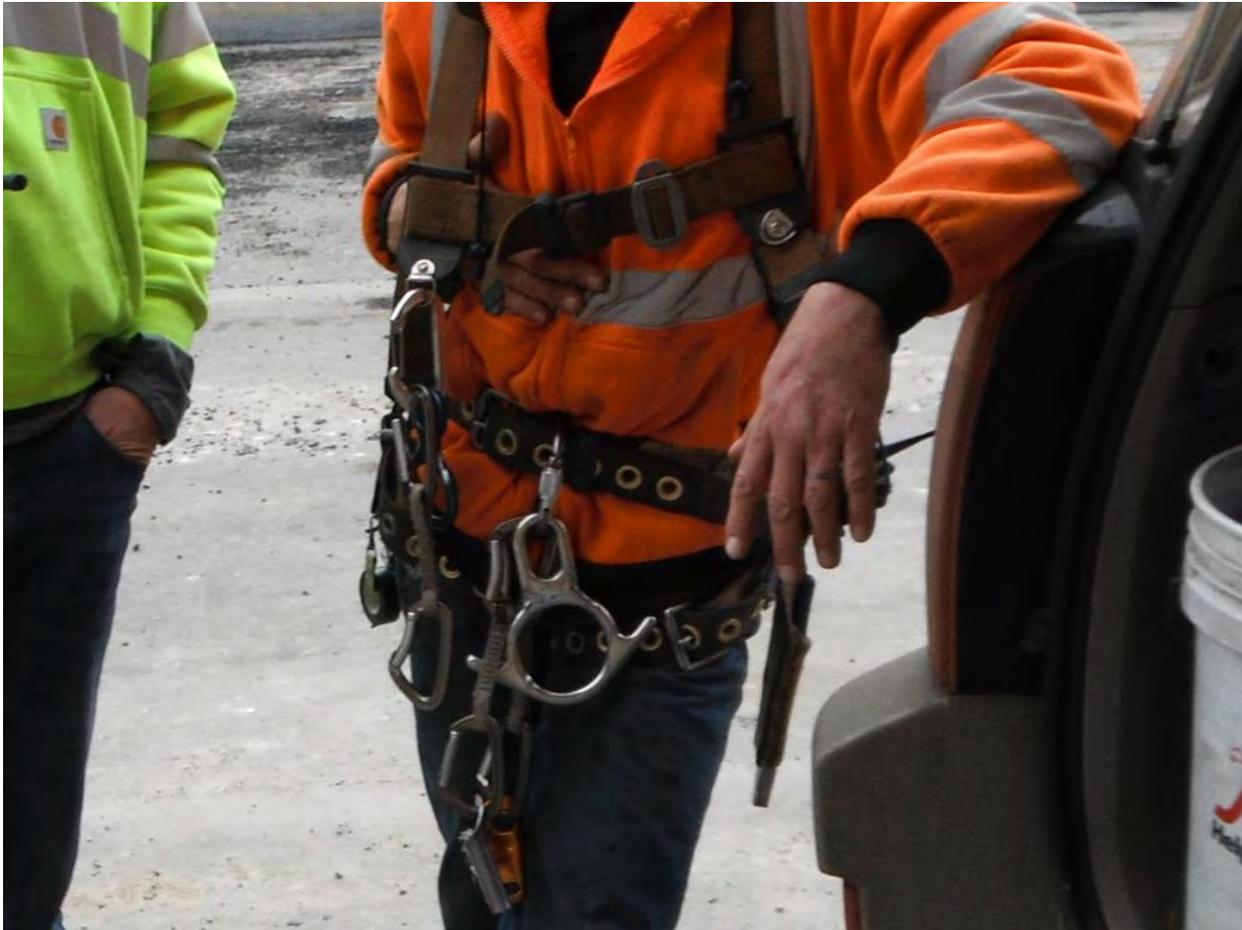
**Figure 1 – Incorrect use of a fall harness and mixed equipment for rope access (Source: FHWA, Todd Hansen).**

While individual agencies and corporations have independently endured the increasing chatter from industrial rope methods encroaching onto geohazard slopes, no unified code or universal standard has been developed or adopted which creates an opening for interpretation of what constitutes proper gear (Figure 1). Because of this recognized gap of an unregulated work practice, the FP-24 standard specification manual for Federal Highway Administration (FHWA) will include a new standard for all projects administered on or by Federal contracts.

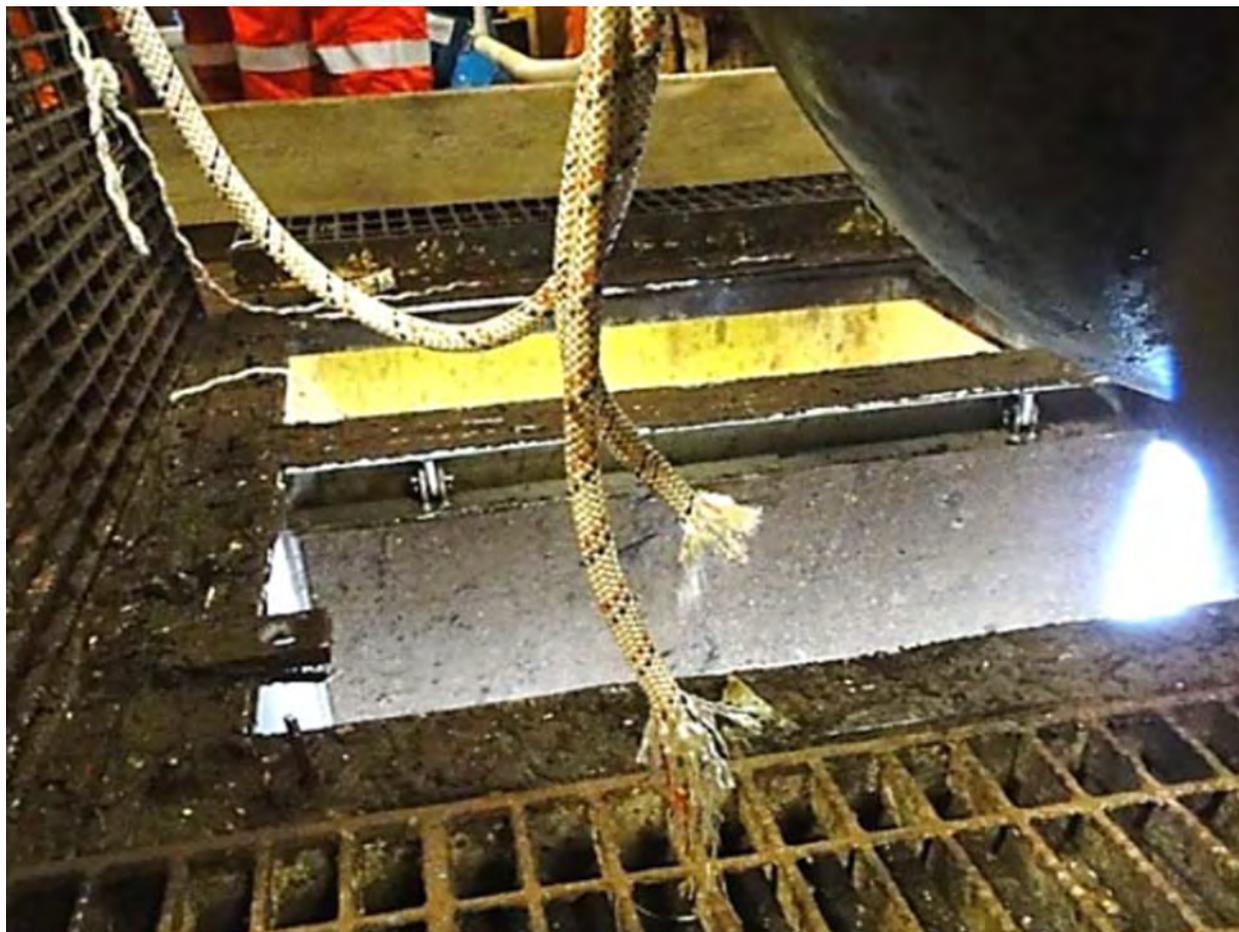
**Figure 2 – Failed main and backup ropes on the Brent Charlie Platform (IRATA “Fall From Height” report, 2015)**

Official findings determined that the worker had rappelled through an access hole in the base of the platform, which had required directing ropes over sharp metal edges. As the worker climbed up to exit the work area, the rope protection was shifted exposing the sharp metal beams which cut the main rope (Figure 2). The report states the backup device was being held by the worker to reposition it on the rope when the rope was cut. The backup device appears to have not been engaged until after the worker fell over 30 feet, generating enough energy to snap the backup rope when it finally caught. The IRATA reporting body specifically noted that RAT users must never grab the body of a backup device or place hands above a device, and that rope and edge protection training must be emphasized. IRATA’s report also determined that the job

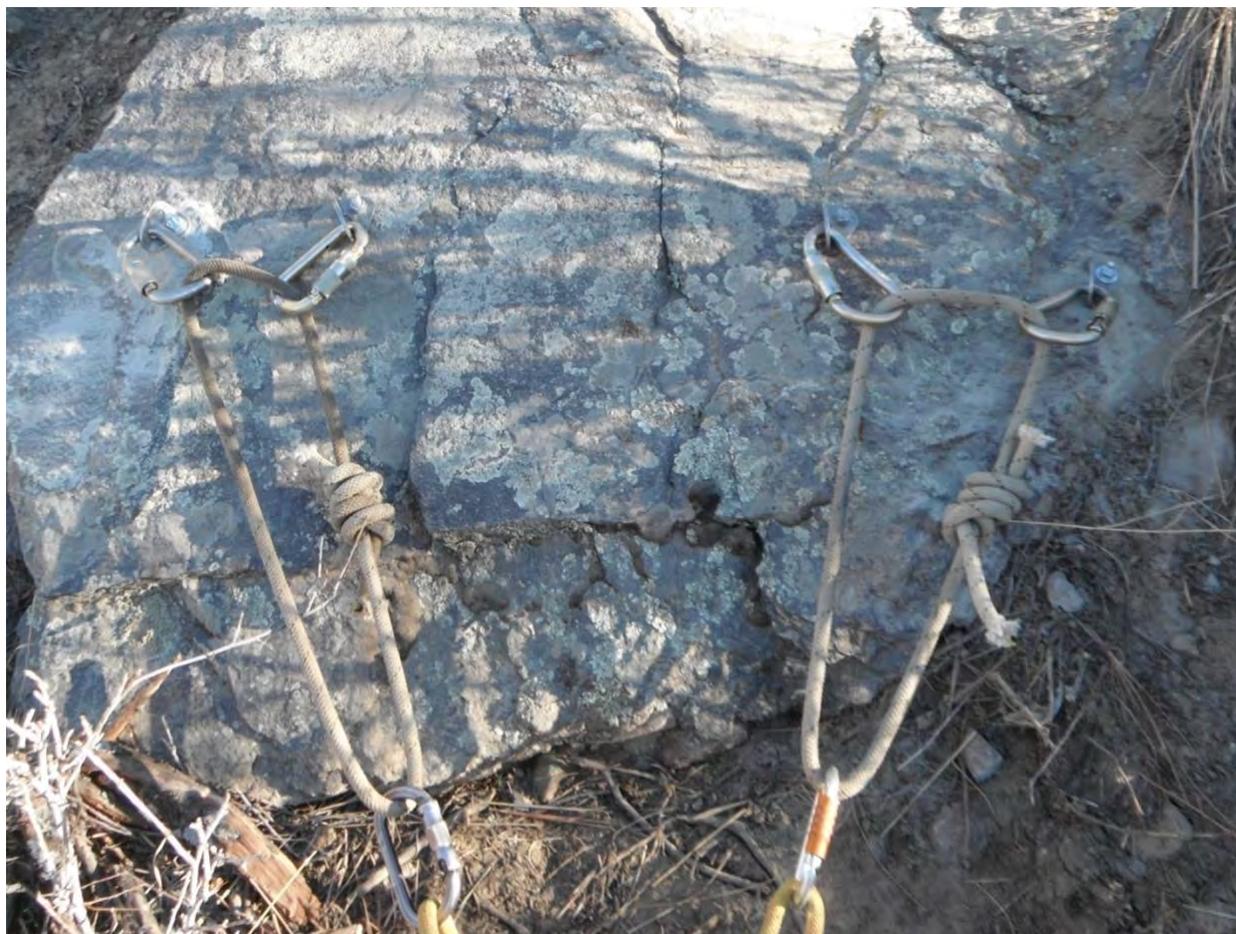
**Figure 3 - Incorrectly rigged anchors are an indication of unsupervised or untrained rope workers (Source: FHWA, Todd Hansen)**

Geohazard mitigation projects constantly deal with the inherent dangers associated with rockfall and unstable slopes, with the added risk multiplier from the work being performed at height. A 2013 *Comparison Study between ISO 22846 and IRATA Code of Practice* reviewed differences in the two documents with the intent of identifying omissions and major differences. ISO recommends worksite supervision be managed by workers with experience reflecting the complexity or degree of risk. ISO 22846-2: 2012 required that the work to be performed dictates the level of expertise the supervisor and technicians should have. With this assertion ISO acknowledges that not all specialty work is the same, and assigned supervisors need to have practical knowledge and not just meet a training criterion. This is especially true for geotechnical professionals responding to emergency geohazard events with the overall expectation of getting the situation under control and the road open as soon as feasibly possible with properly trained personnel (Figure 3).

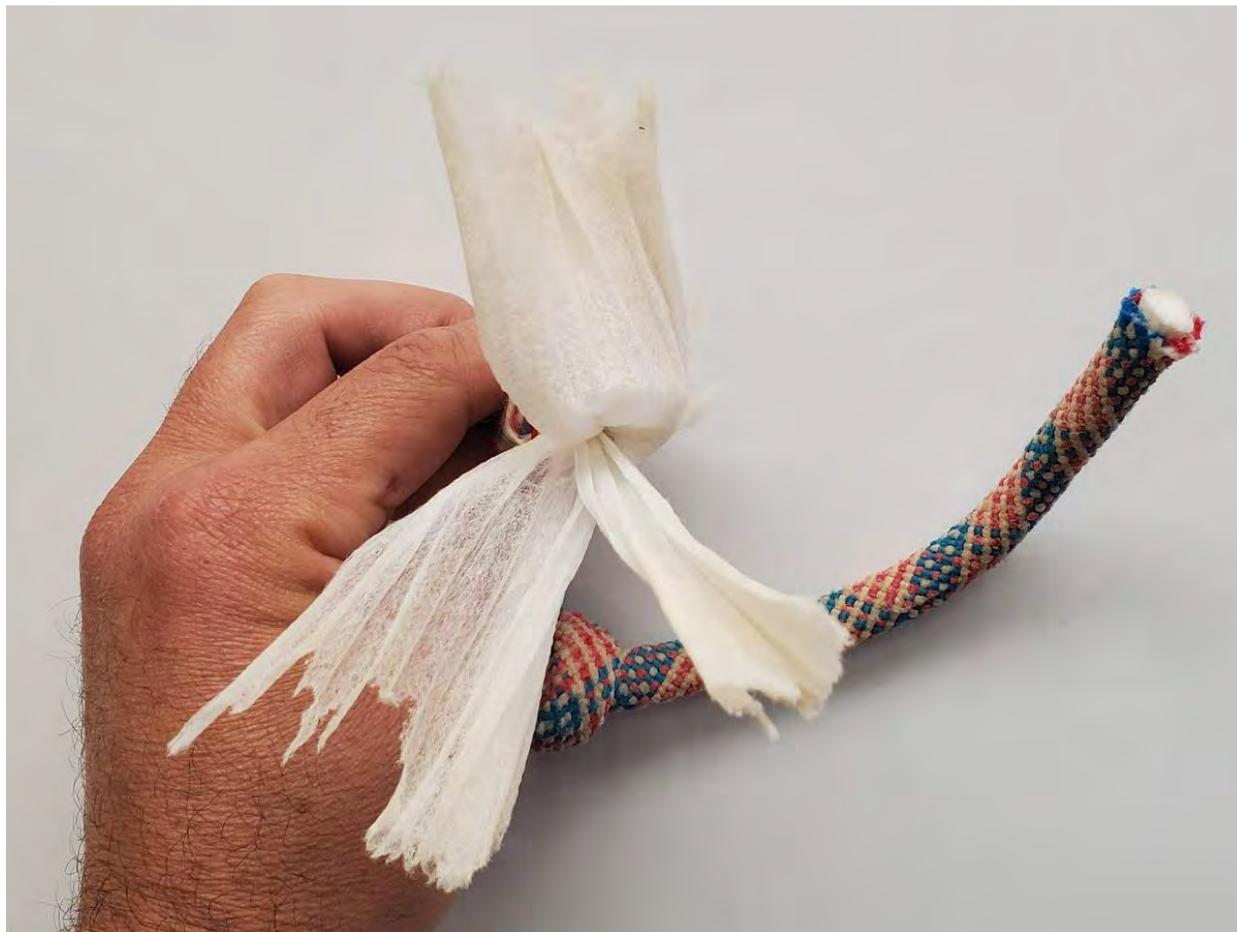
**Figure 4 – Sample of rope used for rappelling on a FHWA project (Source: FHWA, Todd Hansen)**

level. Considering that expert recreation climbers are 3 to 7 times as likely to be seriously injured as other climbers, it is critical that any rope worker can be dismissed from a project. If the CEO of a New Zealand window washing company is willing to risk one worker falling and physically attack the remaining employees who stand up for their own rights, then Section 262 is written for those rare cases of intimidation being used to push workers beyond safe working practice of using an incorrect rope for example (Figure 4).

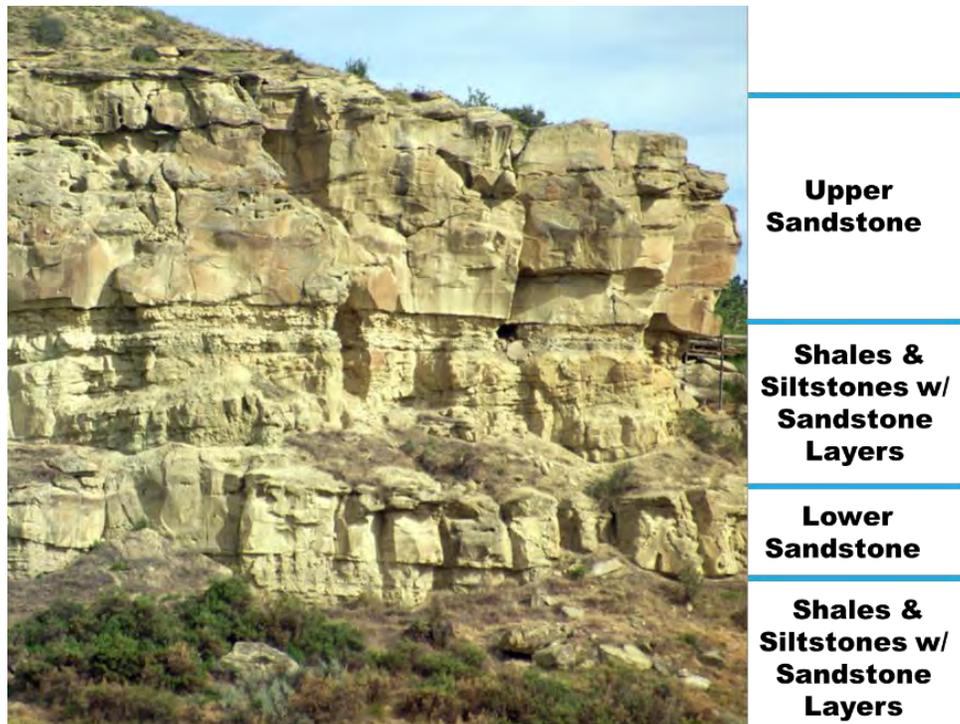
There are four major rock layers exposed on the east, south, and west side of the Pillar. Working up from the flat at the base of the pillar, these layers are: a lower sequence of shales and siltstones with interbedded sandstone layers; the lower sandstone; an upper sequence of mixed shales and siltstones with interbedded sandstone layers; and the upper sandstone (see Figure 1). Above the upper sandstone, there is a poorly exposed sandstone with many thin shale interbeds. The north side of the pillar does not have high vertical cliffs, but rather slopes more gradually in steps down to the base elevation.

**Figure 1** Local Stratigraphy

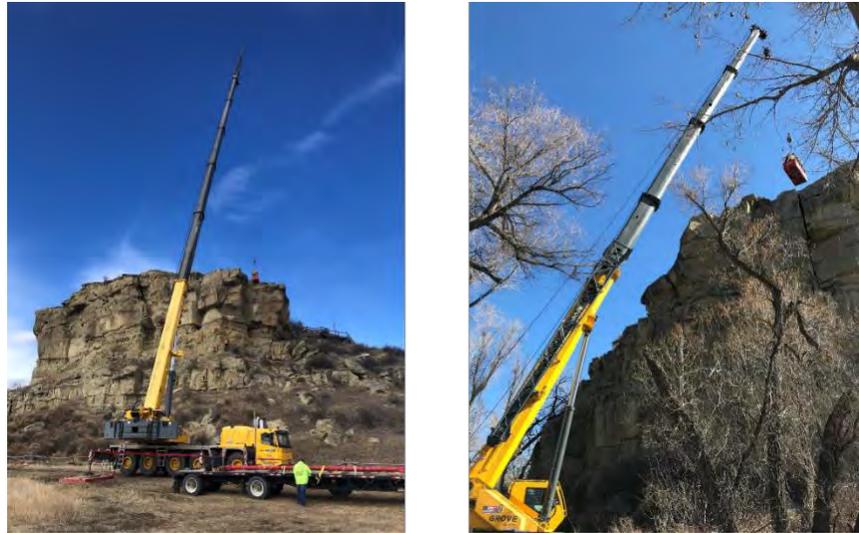
Much of this work was done from rental cranes, as shown in Figure 2.

**Figure 2 Cranes Used for Close-up Site Investigation Activities**

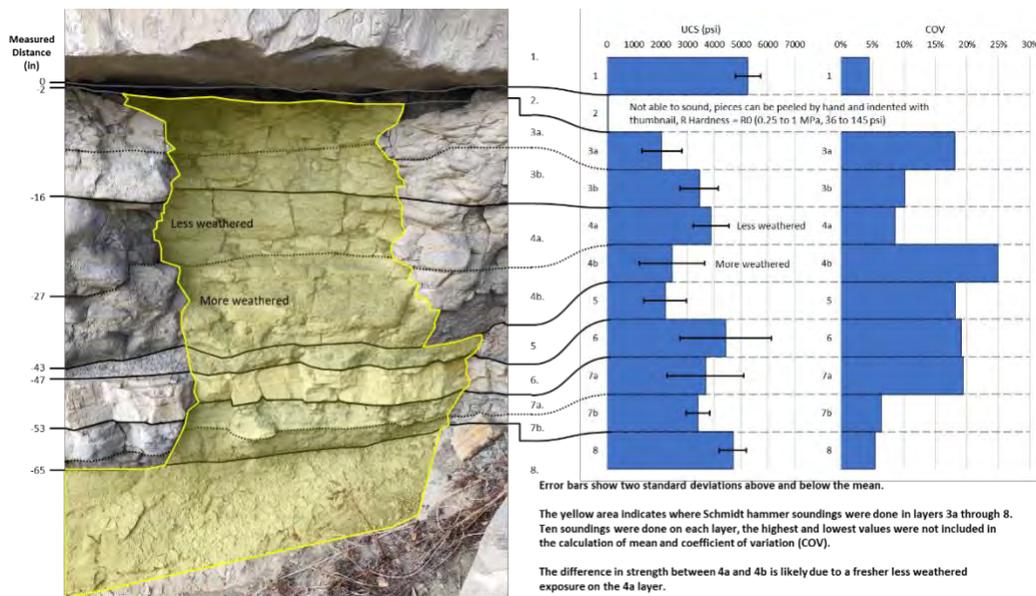
The siltstone, shale, and sandstone layers under the Signature Block were characterized by close-up observations, sounding, and a Schmidt hammer (see Figure 3). The weakest, most friable layers were found immediately under the sandstone and from 27 inches to 47 inches below the sandstone.

**Figure 3 Siltstone, Shale, and Sandstone Characterization Findings**

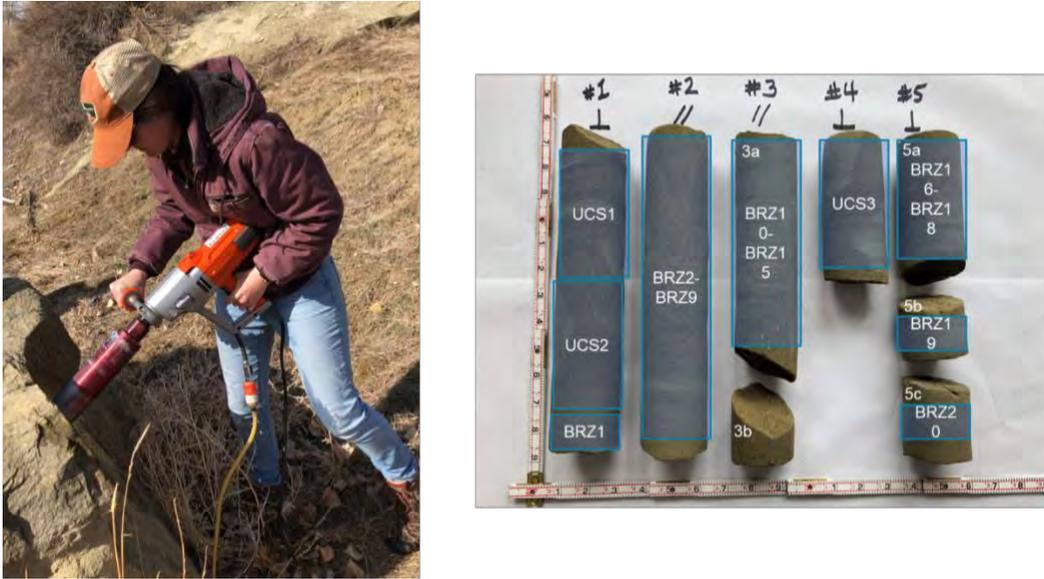
Sandstone cores were collected from a previous rockfall block, as shown in Figure 4. Five cores were collected for three UCS tests and 20 Brazilian tests.

**Figure 4 Sandstone Core Collection**

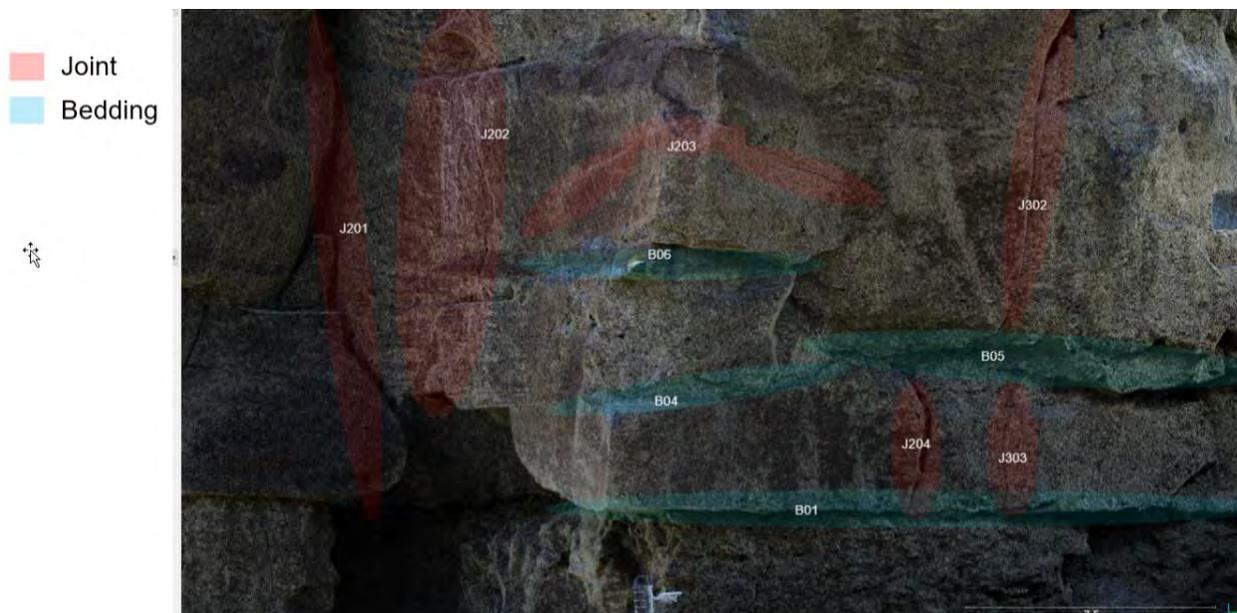
The findings from the closeup observations of the Signature Block and Turtle Rock areas were eventually incorporated in the *3DEC* models. Figure 5 shows a subset of the features used in the Signature Block model, where the figure background is the point cloud developed from photogrammetry previously collected by BMI.

**Figure 5 Subset of the Signature Block's Joint and Bedding Plane**

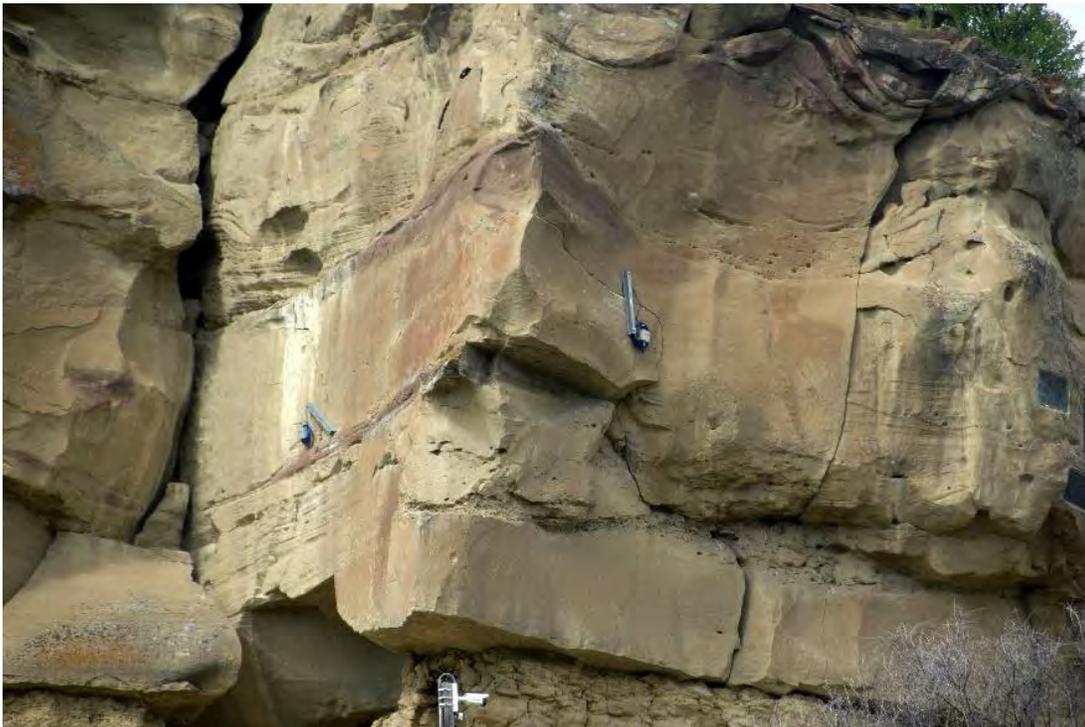
**Figure 6** Crack Gauge Locations Near the Signature

As of June 2021, the latest rock block monitoring system has been installed with ten crackmeters (CM), three reflectorless electronic distance meters (DM), and four tiltmeters (TM). Figure 6 shows an image of the crack gauges installed near the Signature Block. Figure 7 and Figure 8 **Error! Reference source not found.** illustrate the names and locations of the instruments at: Signature blocks east and north face, Signature blocks top, respectively. Trigger limits were established from baseline measurements.

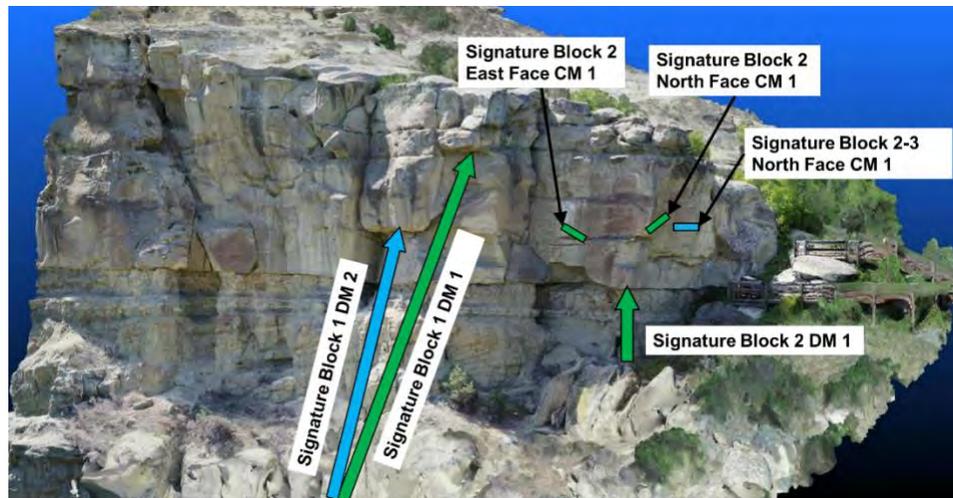
**Figure 7** Signature Blocks East and North Face Instrumentation

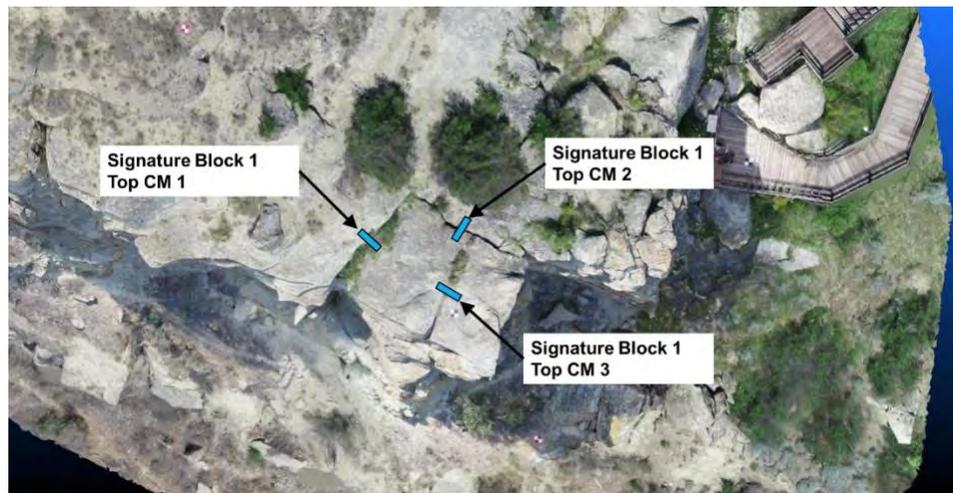
**Figure 8** Signature Blocks Top Instrumentation

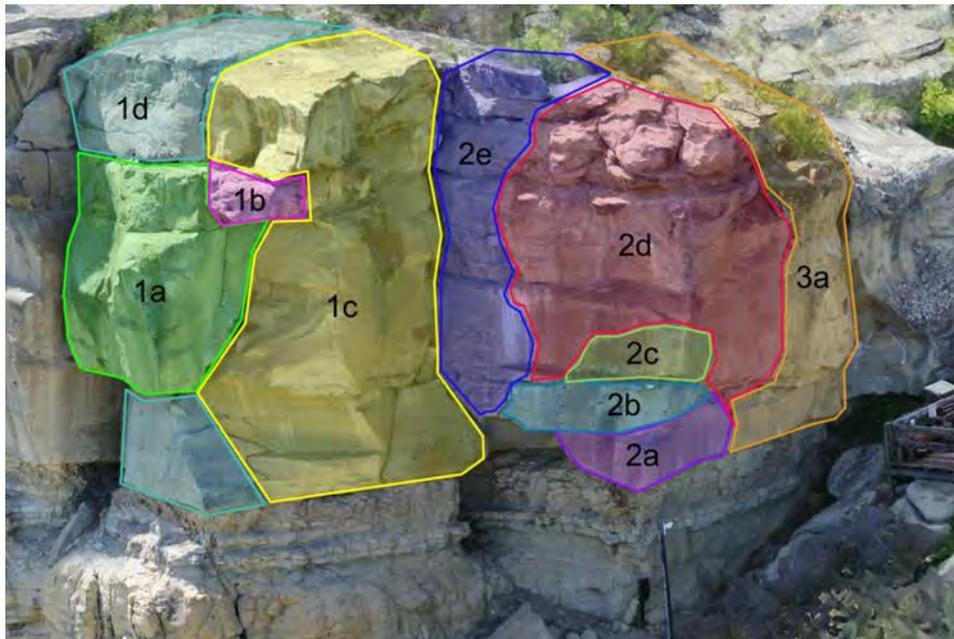
**Figure 9** Numbered Sub-blocks in the Signature Block Area

The rock blocks at the Signature Area were numbered to facilitate coordination, as seen in Figure 9. The Signature Block area modeled using 3DEC is illustrated in Figure 10. The modeling area covered approximately 90 feet in length and 50 feet in height. Figure 11 shows the rock blocks in the Signature Block area formed by joints and bedding planes. The geometry was created using the mesh obtained from photogrammetry and then imported into 3DEC.

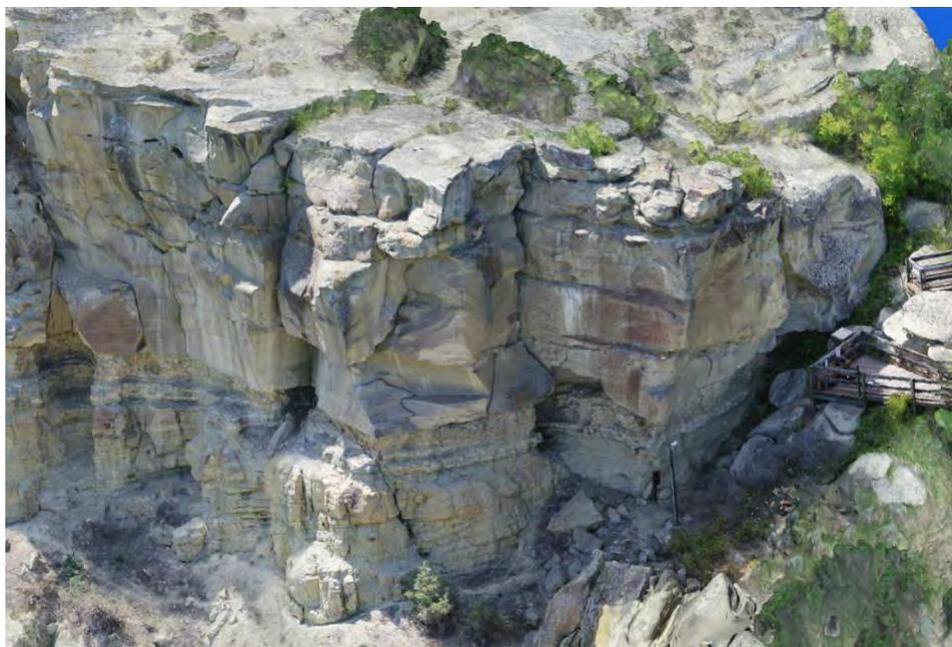
**Figure 10** 3D Mesh for the Signature Block Area Obtained from Photogrammetry

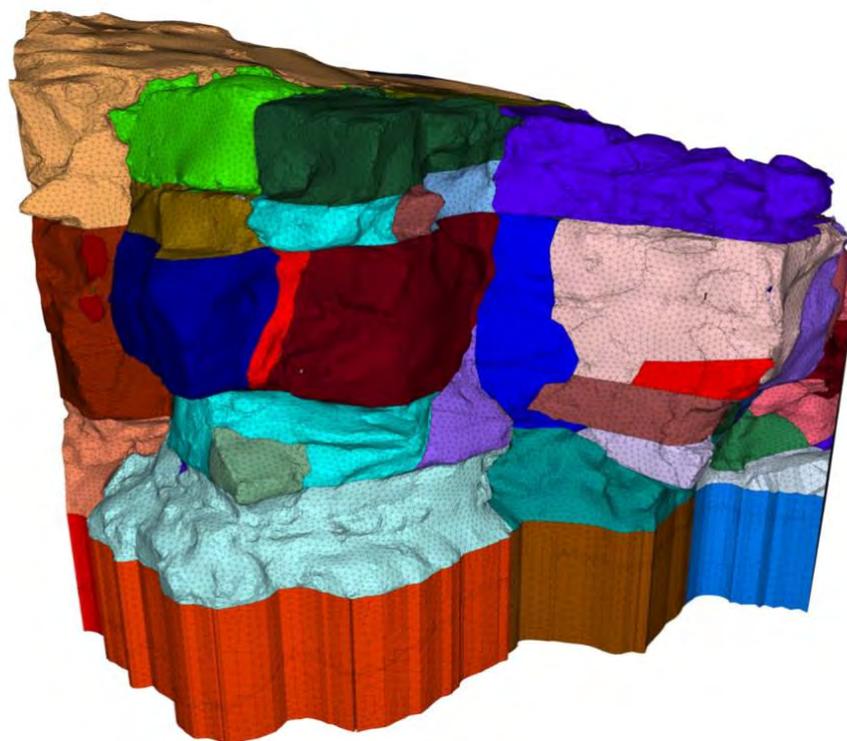
**Figure 11** Signature Block Model mesh in 3DEC

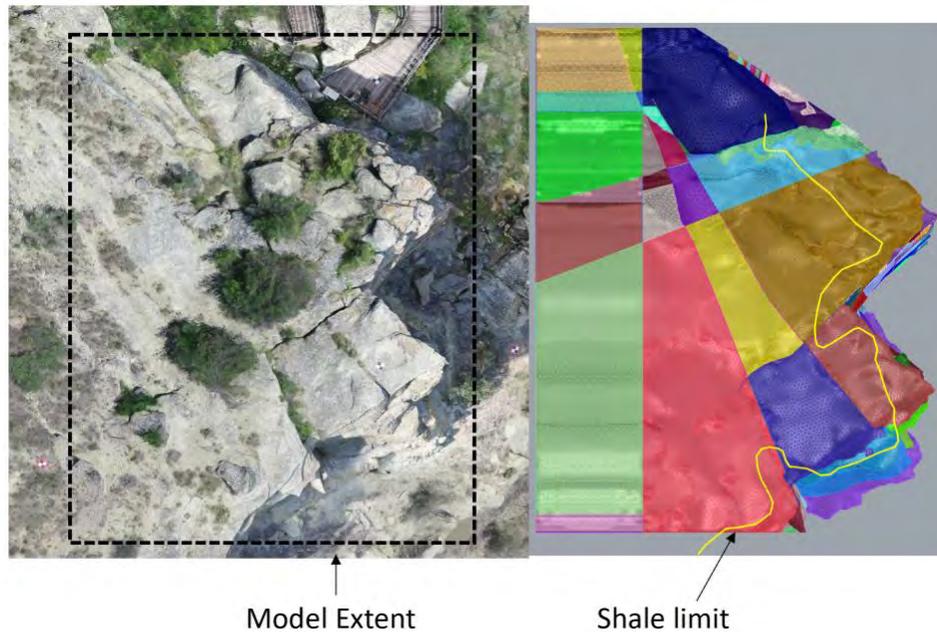
**Figure 12 Signature Block Plan View Illustrating Model Extent and Shale Limit**

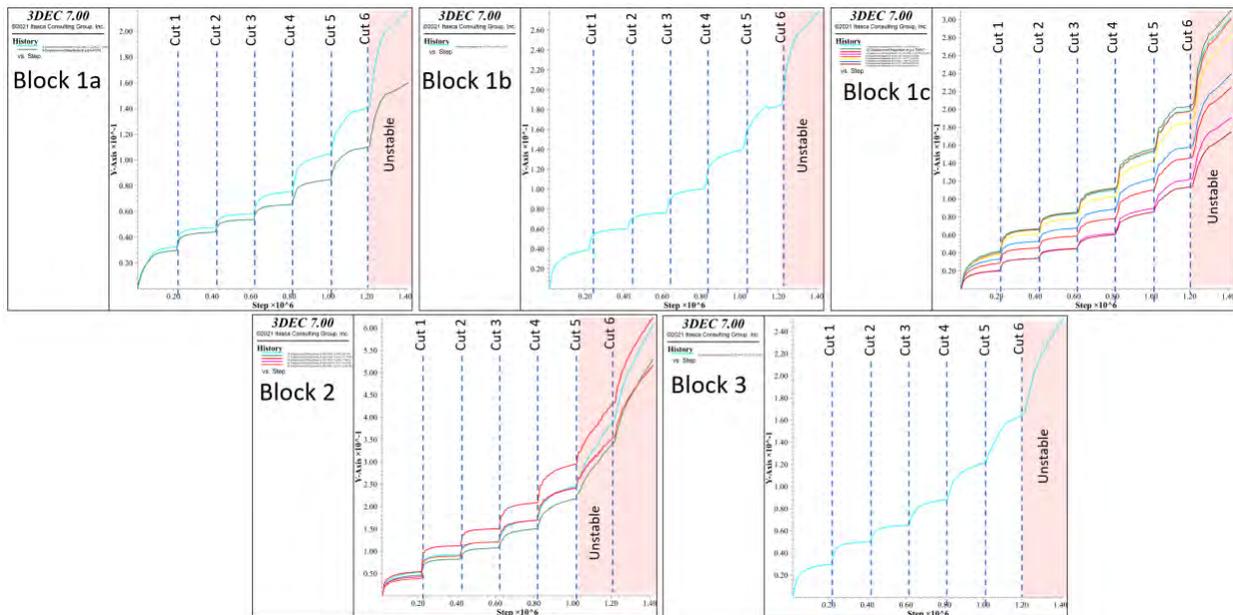
For the incremental siltstone removal method, the displacement histories are shown in Figure 13. (Note that the model includes all the blocks and subblocks shown in Figure 11, although Figure 13 shows history results for only 16 locations: two on Block 1a, one on Block 1b, eight on Block 1c, four on Block 2, and one of Block 3.) The dashed vertical line represents the model step when each siltstone cut was removed (each cut represents 0.5 feet of siltstone removal). The cut after which the block is unstable is highlighted in red. The displacement histories show that Block 2 becomes unstable after 2.5 feet of shale is removed (Cut 5) and Blocks 1 and 3 become unstable after 3 feet of shale is removed (Cut 6).

**Figure 13 Signature Block Displacement Histories for Incremental Siltstone Removal**

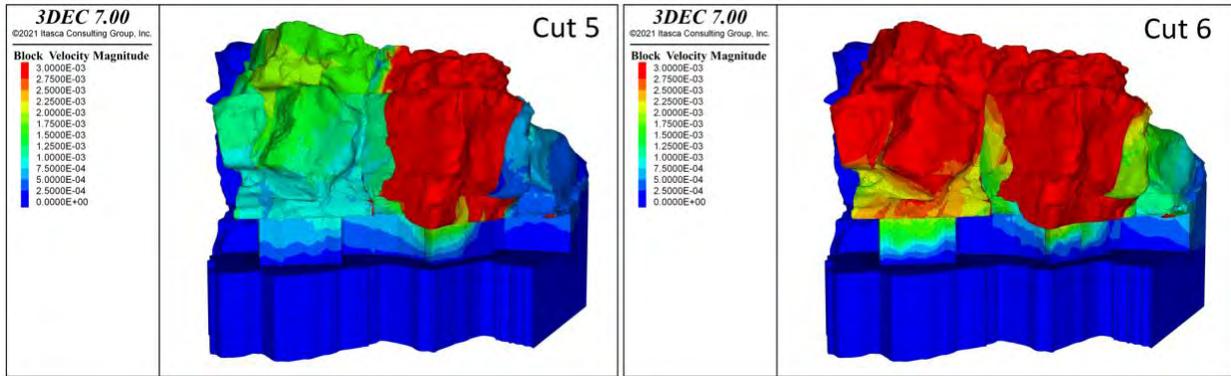
Velocity contours with magnitudes above 0.003ft/sec represent unstable volumes. Figure 14 shows the velocity contours after 2.5 feet of siltstone is removed (Cut 5 shown on left) and after 3 feet of siltstone is removed (Cut 6 shown on right). After 2.5 feet of siltstone is removed, Block 2 has velocities are more than 0.003ft/sec, indicating instability. Once increased to 3 feet of siltstone removal, all blocks in the Signature Block area are unstable.

**Figure 14 Signature Block Velocity Contours for Cuts 5 and 6**

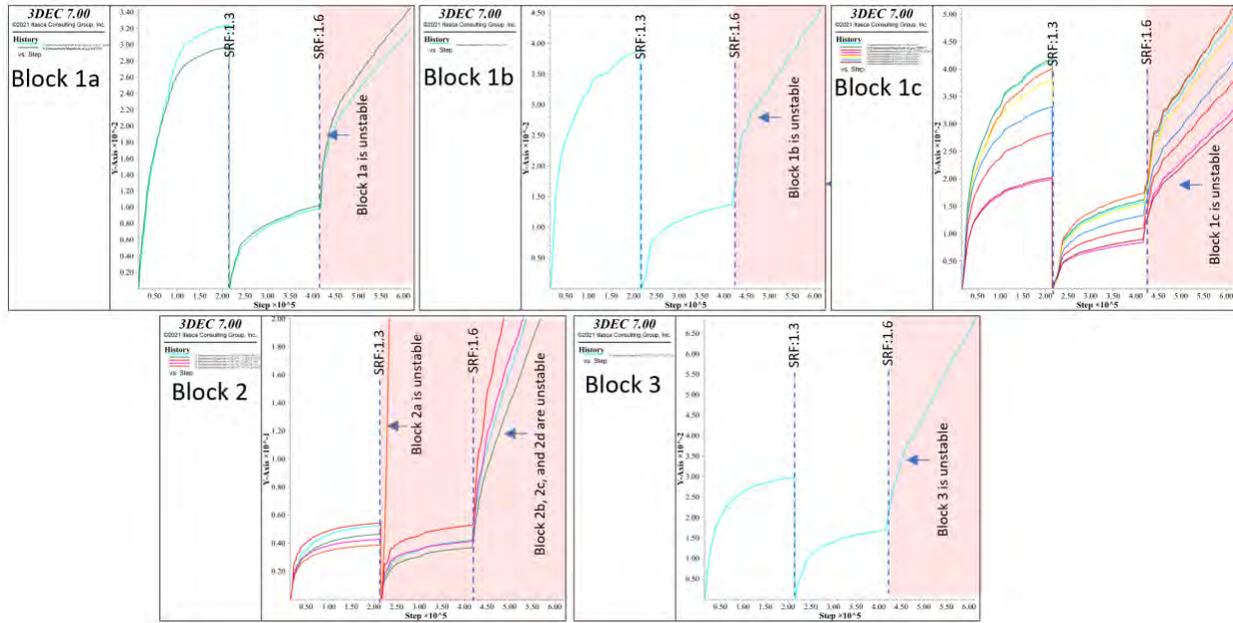
The displacement histories for the global strength reduction method are shown in Figure 15. The dashed vertical line represents the model step when each strength reduction occurred. The stage at which the block became unstable is highlighted in red. The displacement histories show that Block 2 becomes unstable with after an SRF of 1.3 and Blocks 1 and 3 become unstable after an SRF of 1.6.

**Figure 15 Signature Block Displacement Histories for Global Strength Reduction**

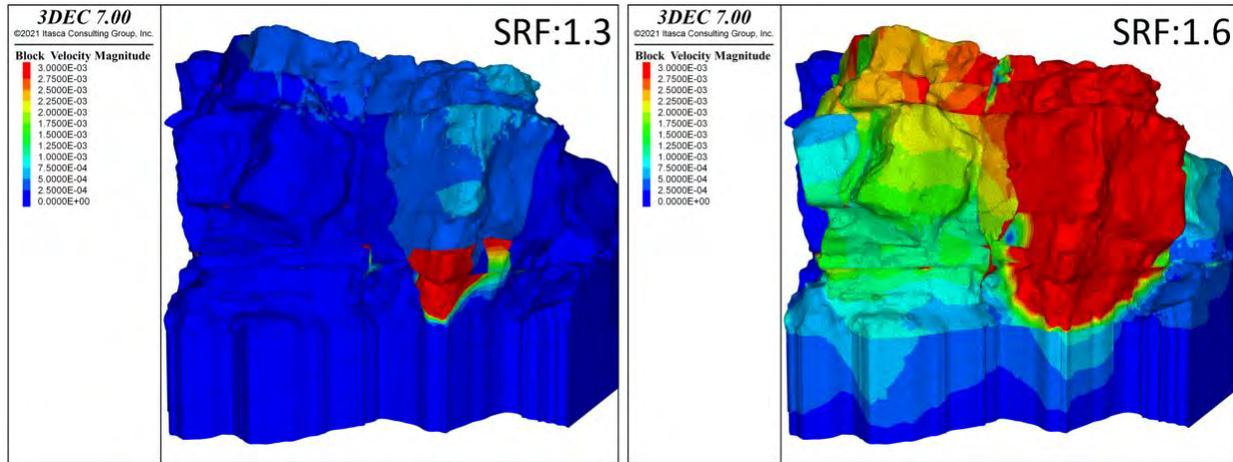
Velocity contours with magnitudes above 0.003ft/sec represent the extent of unstable volumes. Figure 16 shows the velocity contours after an SRF of 1.3 (shown on left) and 1.6 (shown on right). After an SRF of 1.3, Block 2 is showing continued movement, indicating instability. Once increased to an SRF of 1.6, all blocks in the Signature Block area show continued movement.

**Figure 16 Signature Block Velocity Contours for Global Strength Reduction**

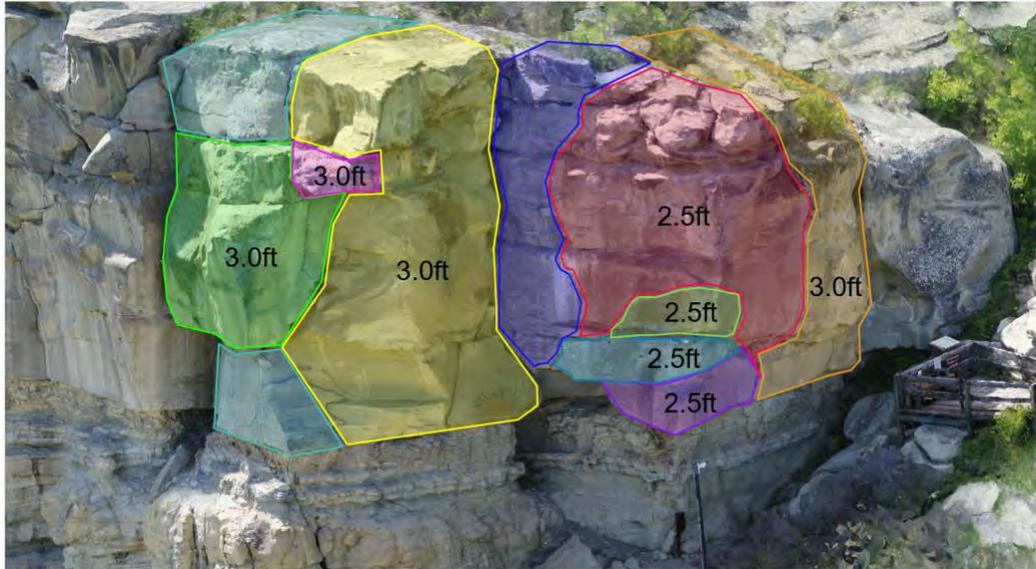
**Figure 17** Amount of Siltstone Removal to Cause Instability

A summary of the siltstone removal model is shown in Figure 17. The measurements listed on each rock block indicates how much siltstone was removed prior to instability. A summary of the global strength reduction model is shown in Figure 18. Each rock block is labeled with the SRF at which the block became unstable.

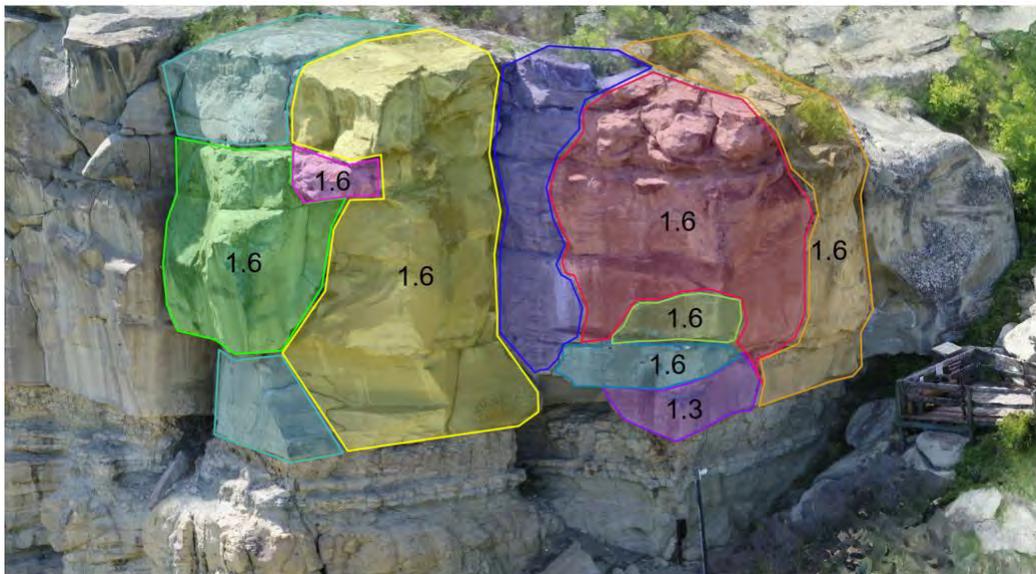
**Figure 18** Global SRF Stability

values without shotcrete were 1.6 except for Block 2a at 1.3, see Figure 18.) This is also reflected in the velocity contours shown in Figure 20.
