# 72<sup>nd</sup> Highway Geology Symposium

## 2023 PROCEEDINGS

August 14-17, 2023 • Hotel Murano • Tacoma, Washington

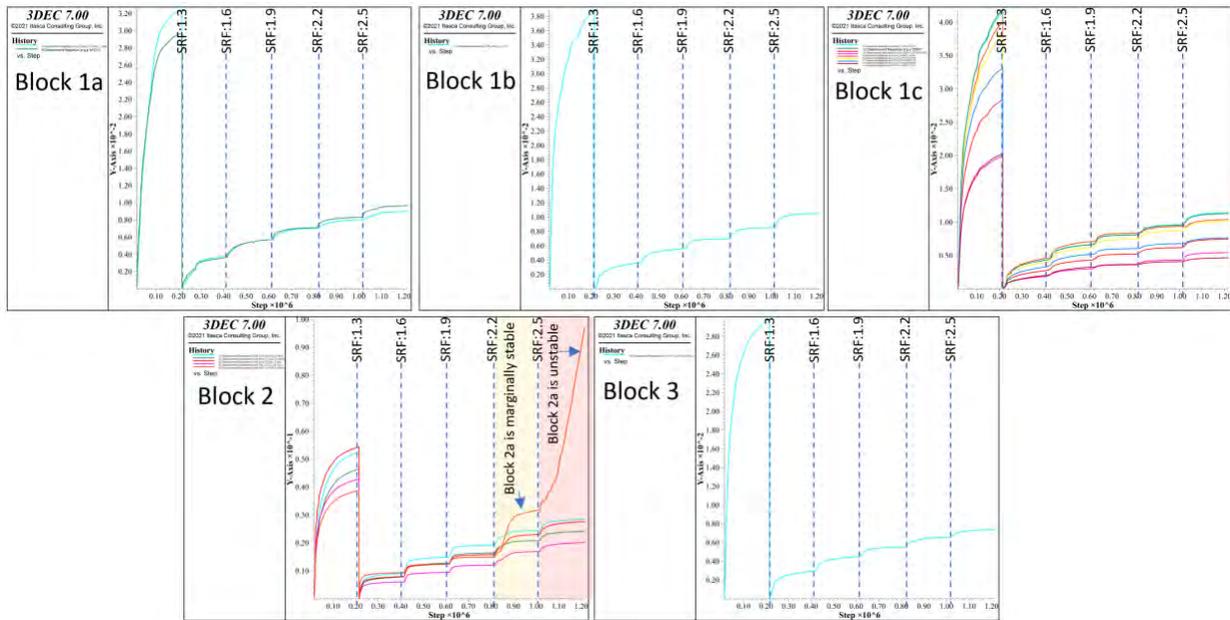
*3DEC* was used to assess the effectiveness of shale and siltstone stabilization. This remedial measure was represented by 0.5 feet of shotcrete applied to the outer layer of the siltstone in the global strength reduction model to determine the efficacy of shotcrete in stabilizing the blocks. Figure 19 shows the displacement histories after 0.5 feet of shotcrete has been applied to the siltstone. The strength reduction at which instability occurs increases to greater than 2.5 in all blocks except for Block 2a, which is marginally stable after an SRF of 2.2. (For reference, the

**Figure 19 Signature Block Displacement Histories for Global SR with 0.5 feet of Shotcrete**

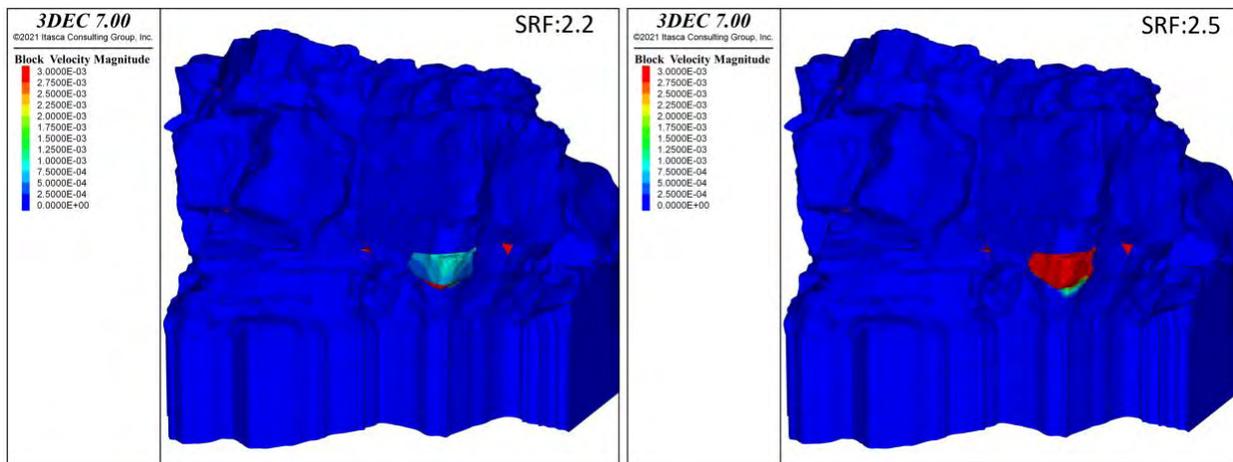
**Figure 20 Signature Block Velocity Contours for Global SR with 0.5 feet of Shotcrete**

values without shotcrete were 1.6 except for Block 2a at 1.3, see Figure 18.) This is also reflected in the velocity contours shown in Figure 20.

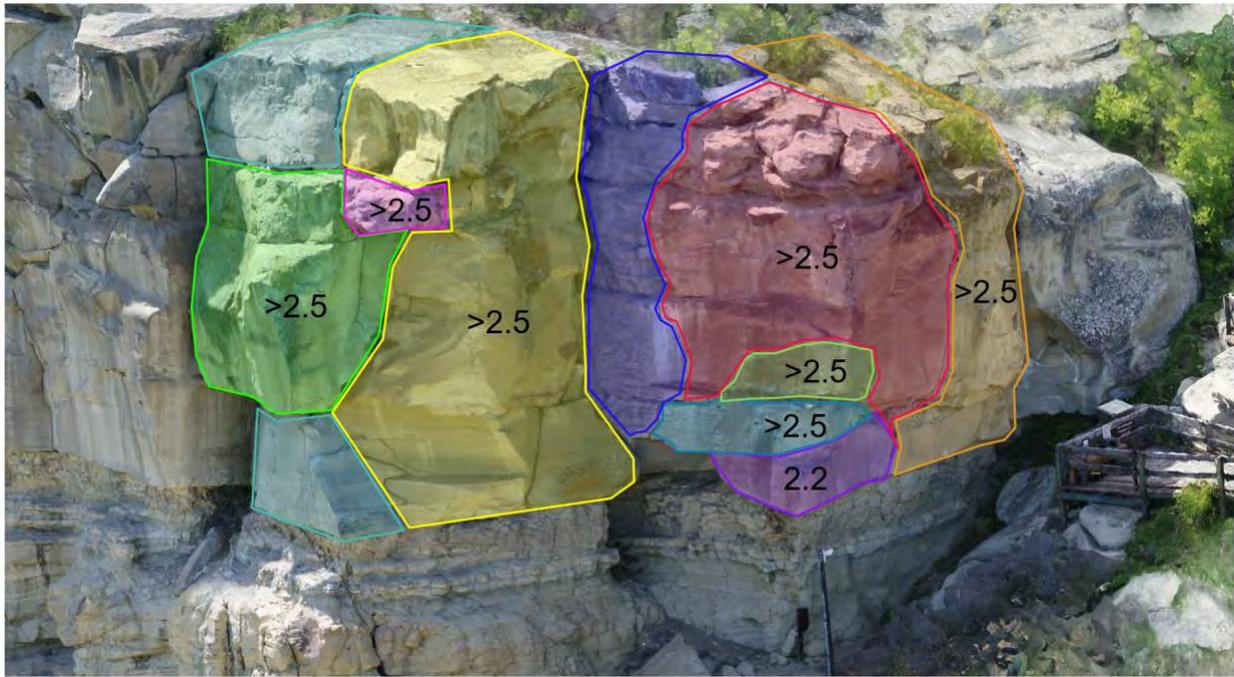
Figure 21 summarizes the shotcrete modeling results. Each rock block is labeled with the SRF at which the block becomes unstable.

**Figure 21 Global SRF Stability with 0.5 feet Shotcrete**

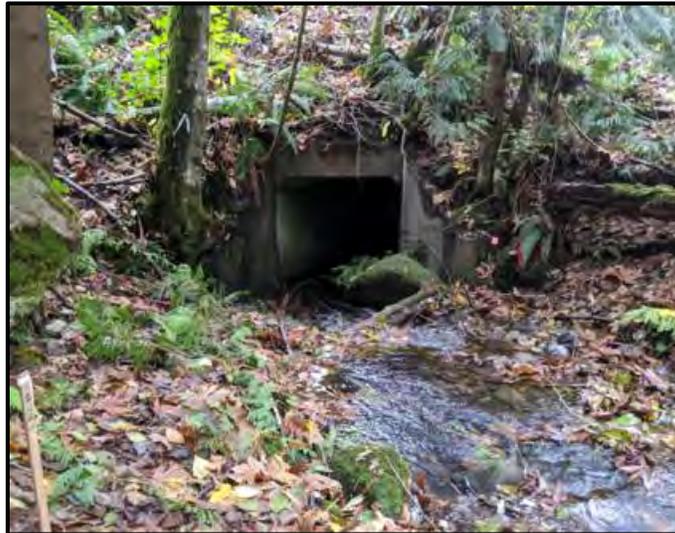
Padden Creek crossed I-5 from east to west via a 425-foot-long, 5-foot by 5-foot concrete box culvert that ran beneath the north and southbound lanes at a 2.5 to 3.5 percent gradient. To meet fish passage standards, the project would replace the antiquated culvert with two 45-foot-long full-span bridges that would provide room for a carefully designed—and much wider—stream habitat beneath. With a stream alignment 30 to 40 feet below the I-5 grade, this meant as much as 30,000 cubic yards of material had to be excavated during construction.

**Figure 1 – Pre-construction concrete box culvert under I-5.**

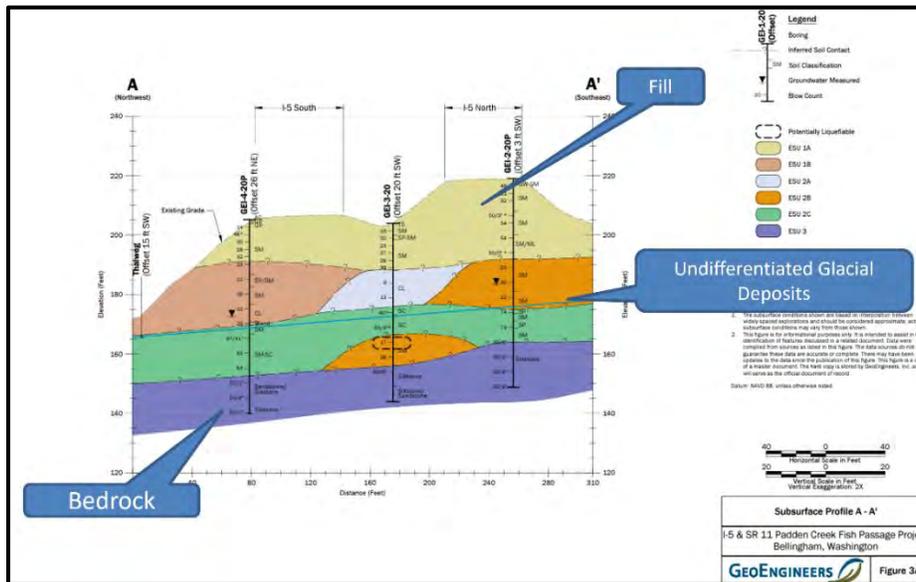
Figure 3 – Subsurface geology of the site.

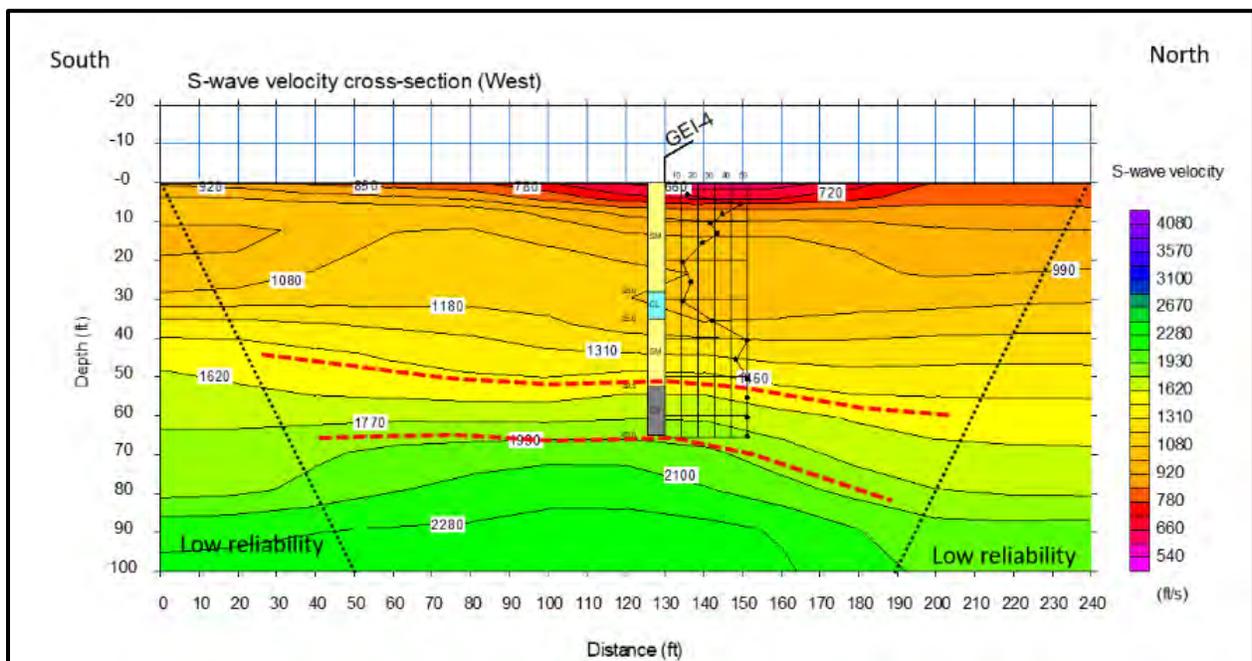
exploration methods due to its minimal traffic disruption and lower cost of completion. The resultant shear wave velocity data was correlated with discrete boring data to aid in interpreting bedrock contact, as shown for one transect in Figure 4. Sedimentary bedrock was interpreted to occur where the soil profile had a shear wave velocity of 1,500 to 1,900 feet per second.

Figure 4 – MASW shear wave velocity profile for the west highway shoulder (4).

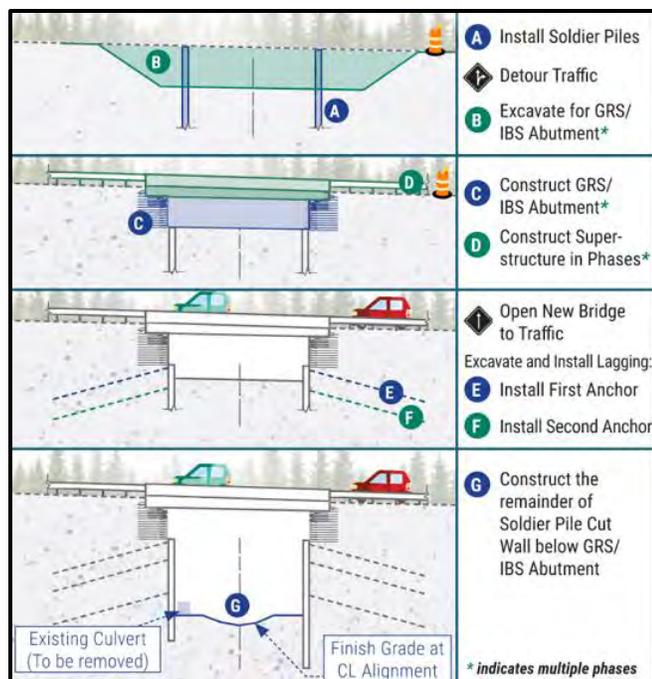
In top-down construction sequencing, permanent internal structures are built as excavation progresses down, providing lateral support for the retaining walls along the way. By completing the upper bridge superstructure first, most of the excavation could wait until after I-5 traffic was in its permanent alignment. See Figure 5 below for a detailed breakdown of the top-down construction sequence.

**Figure 5 – Top-down construction sequence**

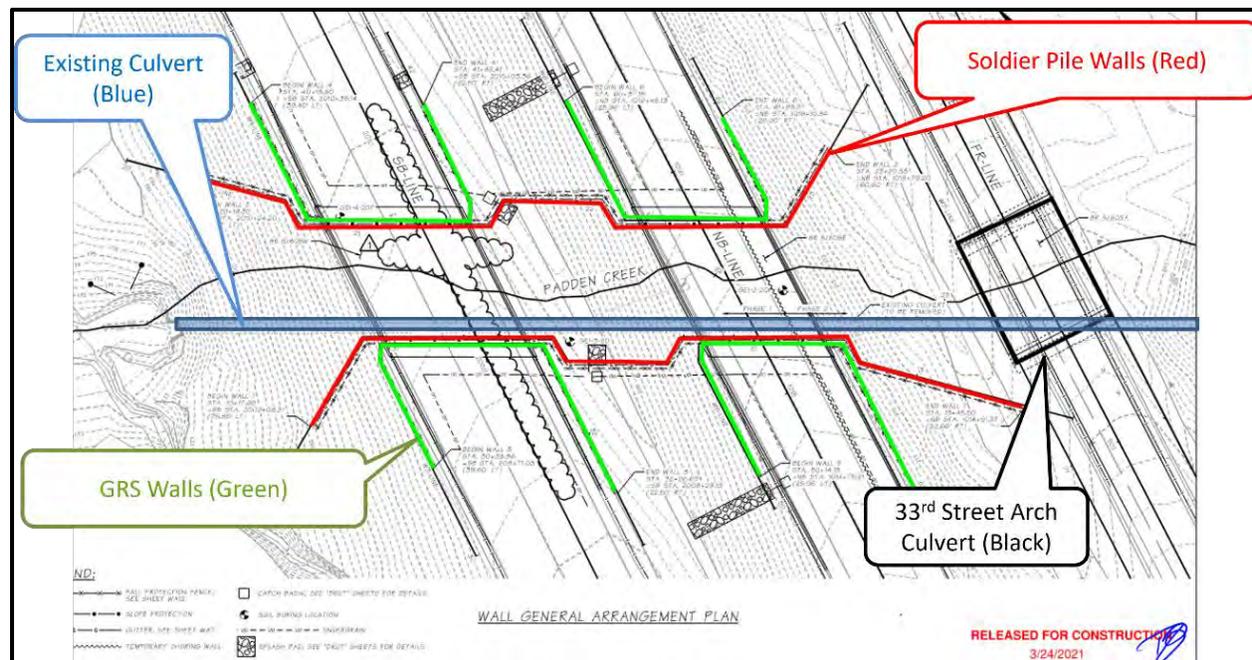
The final I-5 crossing design included two continuous parallel soldier pile walls below the GRS-IBS bridge abutments to support excavation to stream grade, as shown in Figure 7. The 25 to 30-foot walls extended the full length of the crossing on either side of Padden Creek and were designed to include bridge and traffic surcharge under the I-5 lanes.

Figure 7 – Padden Creek Crossing wall arrangement plan.

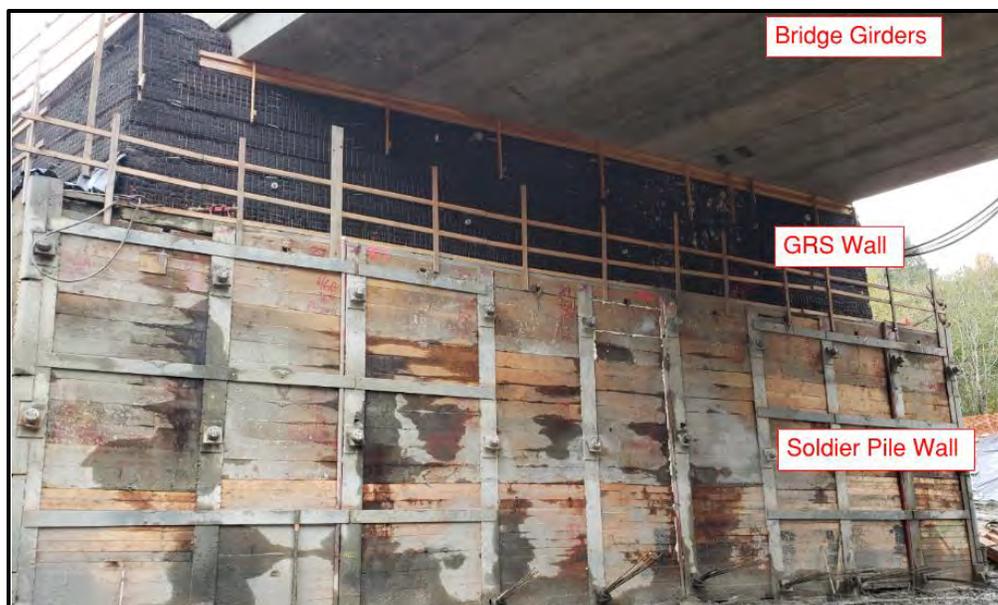
**Figure 8 – Bridge and two-tiered wall system construction in progress prior to permanent concrete fascia construction.**

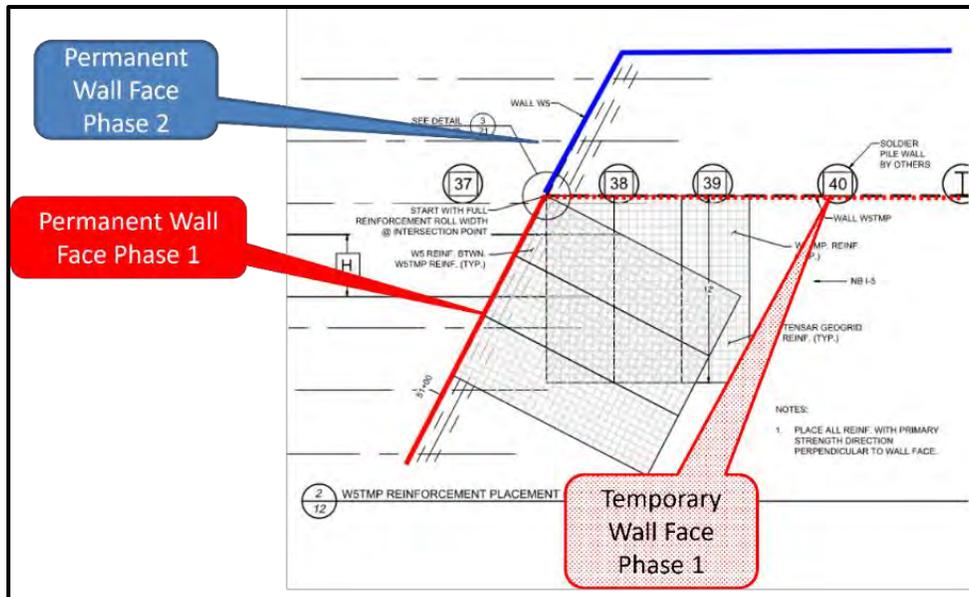
Figure 9A – GRS Construction Phase 1

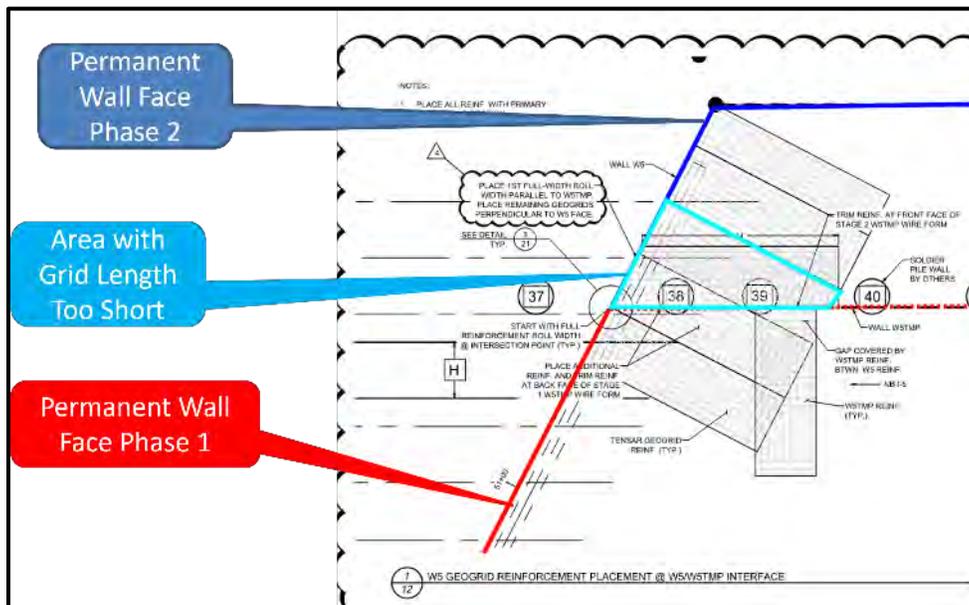
Figure 9B – GRS Construction Phase 2

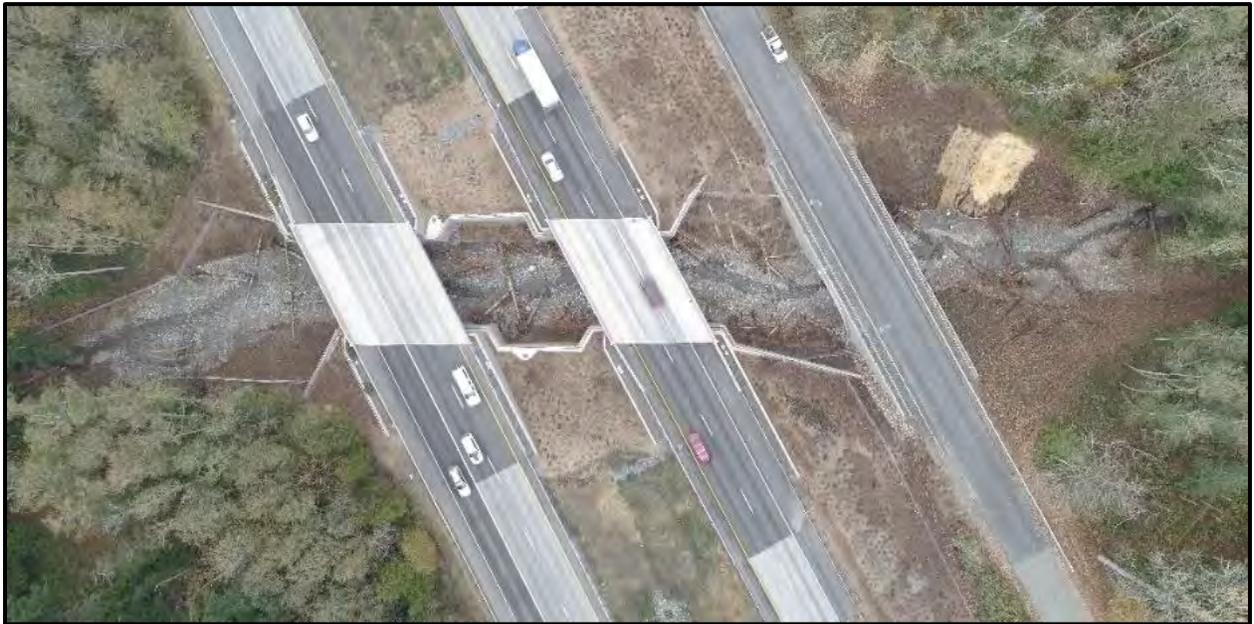
**Figure 12 – Completed Padden Creek Crossing of I-5.**

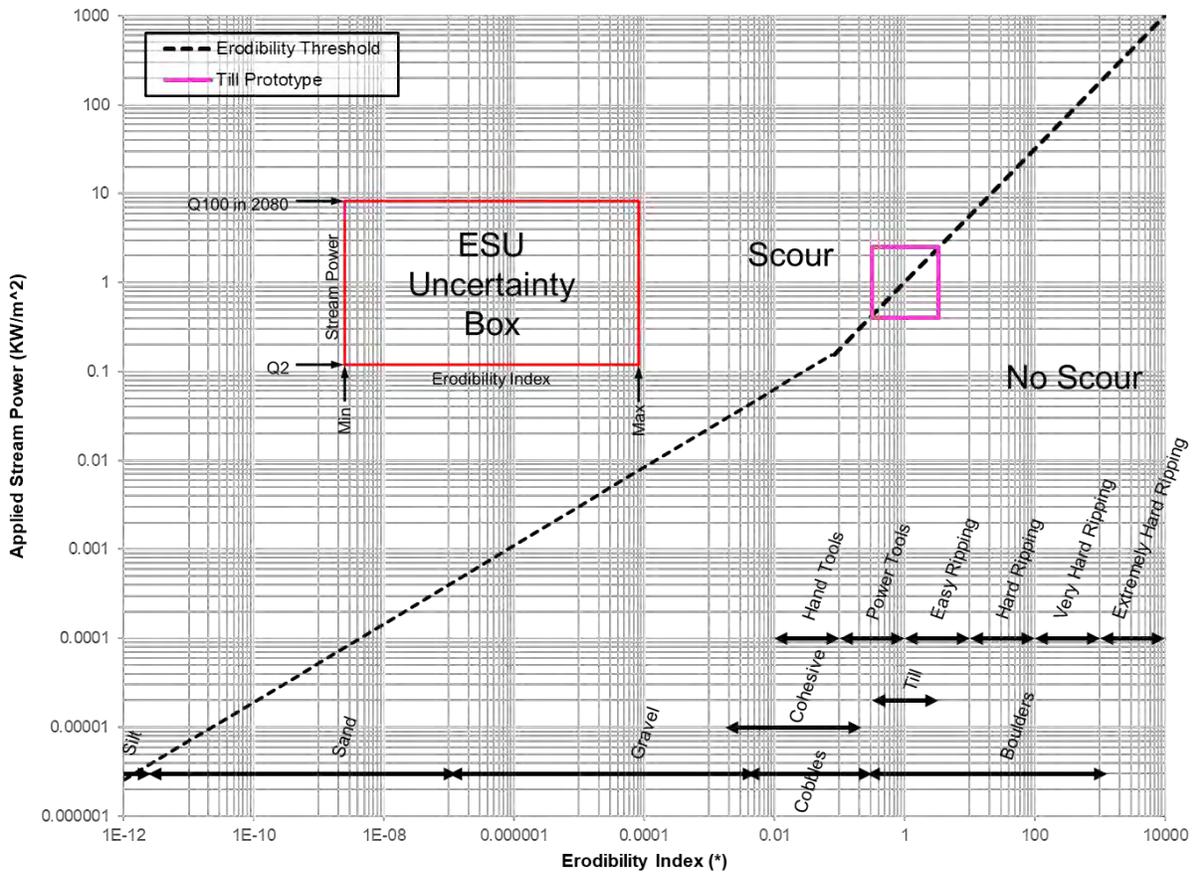
Similar to the familiar Shields' diagram, which depicts the threshold of incipient motion (Shields, 1936), the dashed line in Figure 1 also identifies a threshold of motion or scour, and not a rate of transport or scour. This is an important distinction from scour methods that integrate with respect to time, as this version of the EIM can answer the question 'can scour occur,' but not the often more important question 'how much scour is likely to occur?' The EIM can predict scour magnitudes, but only if the change in hydraulic conditions on the bed as scour progresses are known. Interestingly, when plotted on the dimensional axes of grain size and shear stress, Shields' threshold of motion is approximately congruent with Annandale's definition of the Erodibility Index threshold of scour for non-cohesive particles of sand size and larger.

**Figure 1 –The Erodibility Index Method Scour Threshold Plot**

An application of the EIM is conducted by placing the conditions of a project site within a phase diagram defined by the Erodibility Index (EI) on the x-axis and the Applied Stream Power of the site conditions on the y-axis and comparing the site results to a threshold of scour (Annandale, 1995 & 2006). WSDOT presents this phase diagram without data in Figure 1. The diagonal line that divides the plot is the threshold of scour. Project conditions that plot above the line are likely to result in scour, while those that plot below the line are likely to resist scour. The black, double-ended arrows relate only to the x-axis and represent the typical EI values for earth materials, or the relative effort needed to excavate the material.

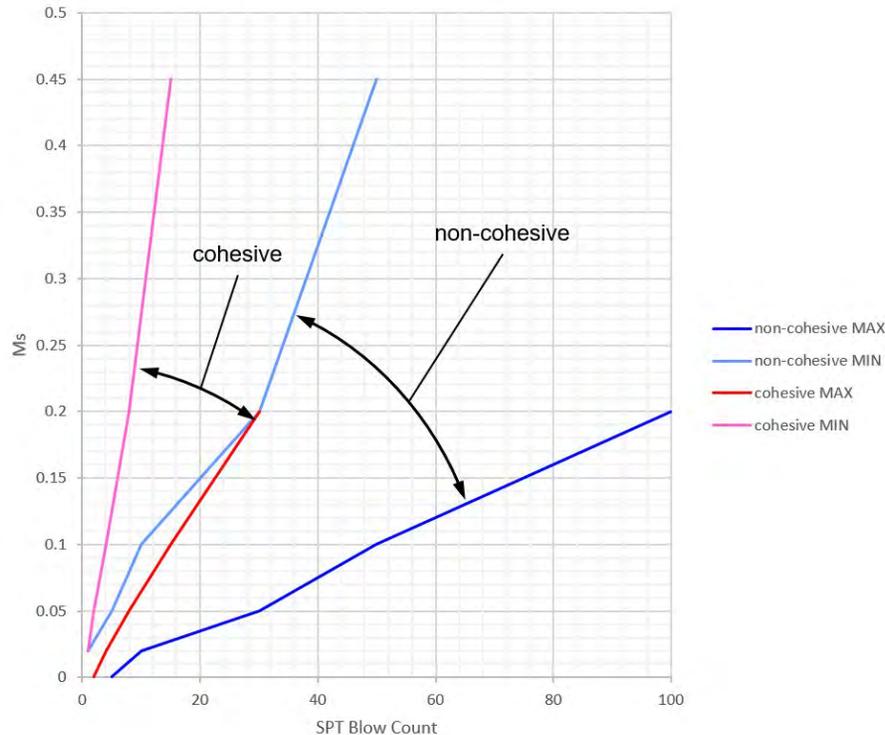
Annadale (2006) says that non-cohesive particles at the surface should have a default Ms value of 0.02, but for subsurface cohesive and non-cohesive materials, Ms can empirically correlated to the n-value from a standard penetration test (SPT). Figure 2 present the relation between n-values and Ms, which can also be found in Tables 52-2 and 52-3 (NRCS 2001).

**Figure 2 – n-values vs. Ms number for cohesive and non-cohesive materials.**

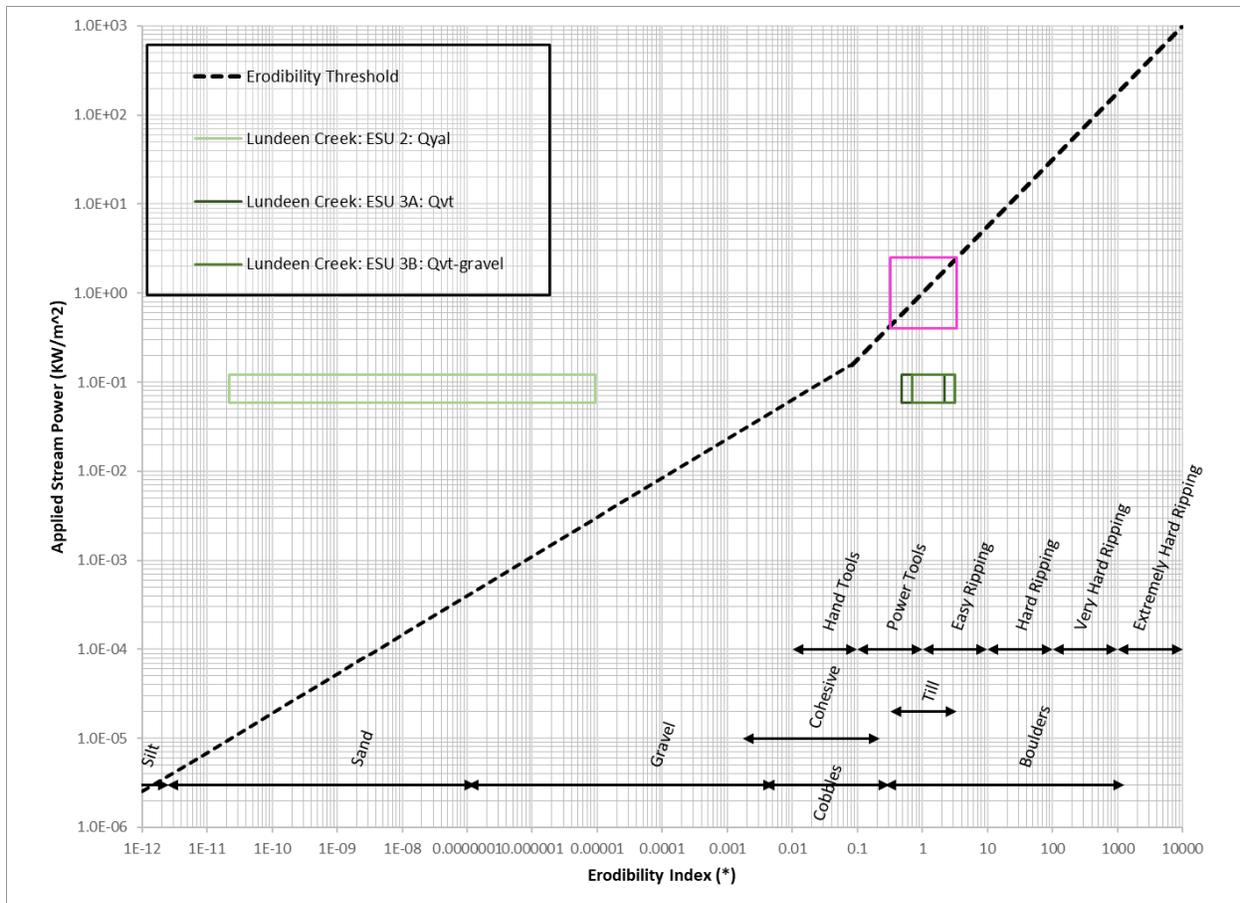
The results of the EIM assessment at Lundeen Creek (Figure 3) show that the alluvial deposits (ESU 2) are likely to scour during the modeled discharges, but that both the Till units (ESU 3a and 3b) are likely to resist scour.

**Figure 3 – EIM results for Lundeen Creek crossing.**

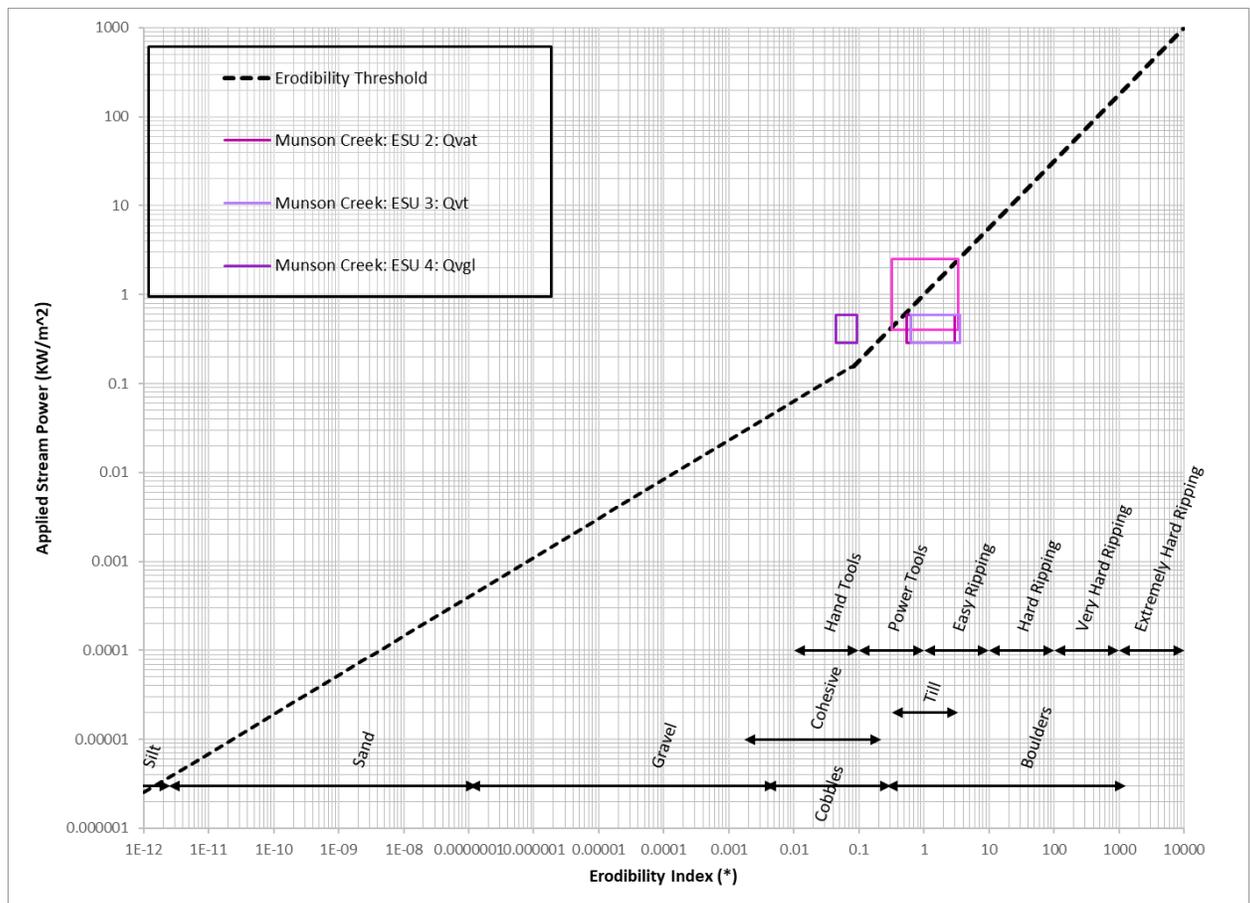
The results of the EIM assessment at Munson Creek (Figure 4) show that ESU 2, the ablation Till is unlikely to scour, as is glacial till of ESU 3, but glaciolacustrine sediment of ESU 4 is likely scour. Because the uncertainty range of ESU 2 and 3 is close to the threshold of scour, and because ESU 4 represents a more easily erodible unit at depth, further assessment is warranted (Figure 4).

**Figure 4 – EIM results for Munson Creek crossing.**

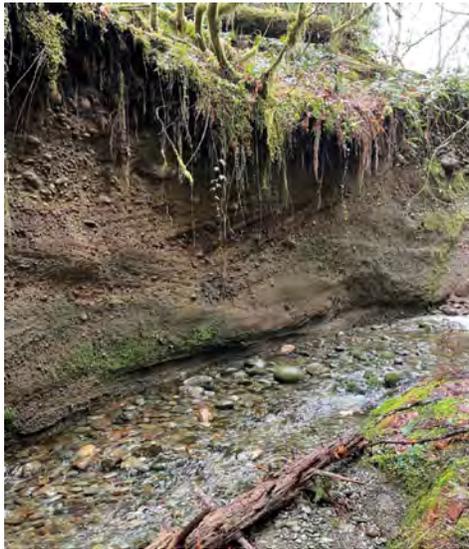
**Figure 5 – Photograph of Till unit at UNT to Lake Cushman.**

The results of the EIM assessment at the UNT to Lake Cushman show that the uncertainty range of the unit lies within the characteristic range for till material and across the threshold of scour (Figure 6). The photograph in Figure 5 shows the vertical riverbank of the channel where scour process has cut into the Till unit. The scoured bank qualitatively confirms the result of the EIM.

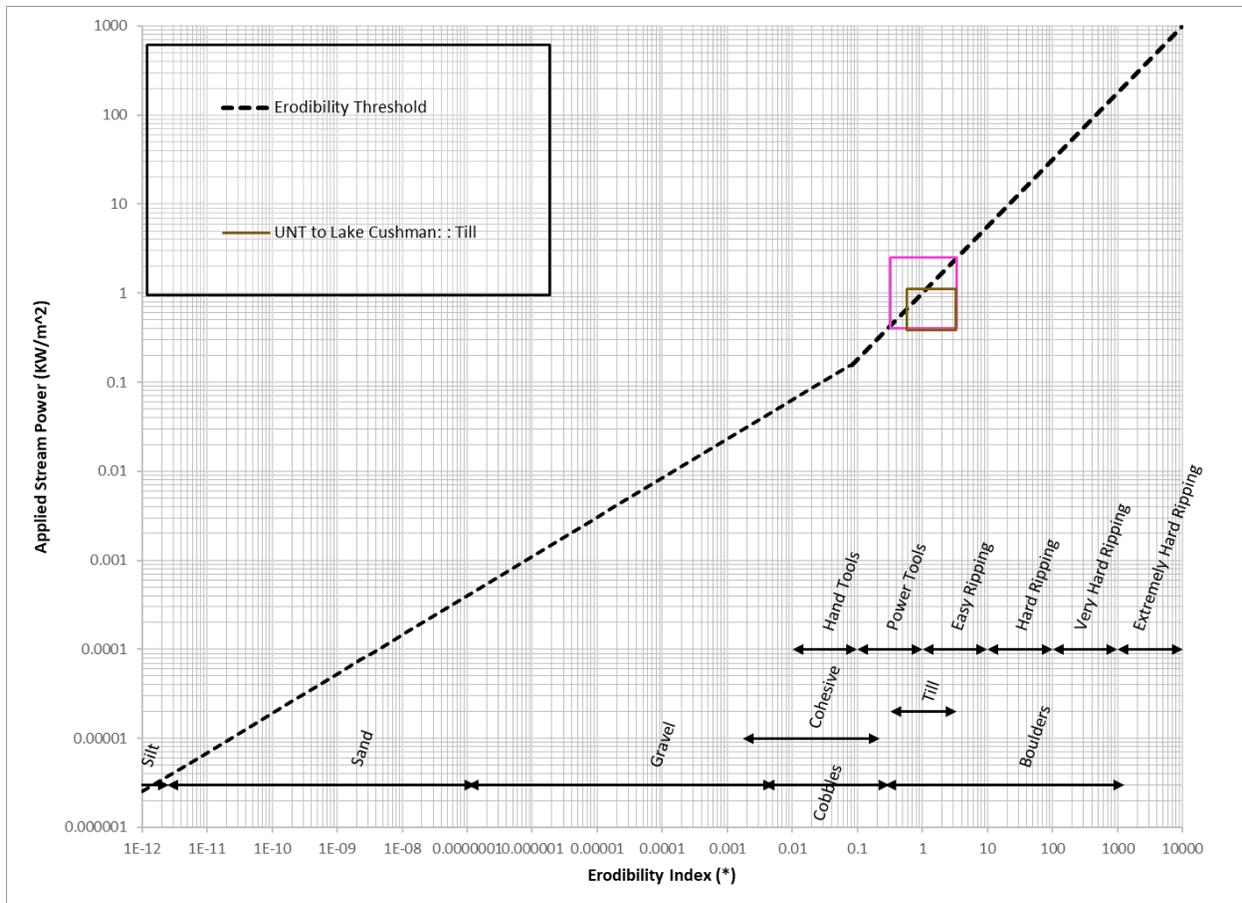
**Figure 6 – EIM results for UNT to Lake Cushman crossing.**

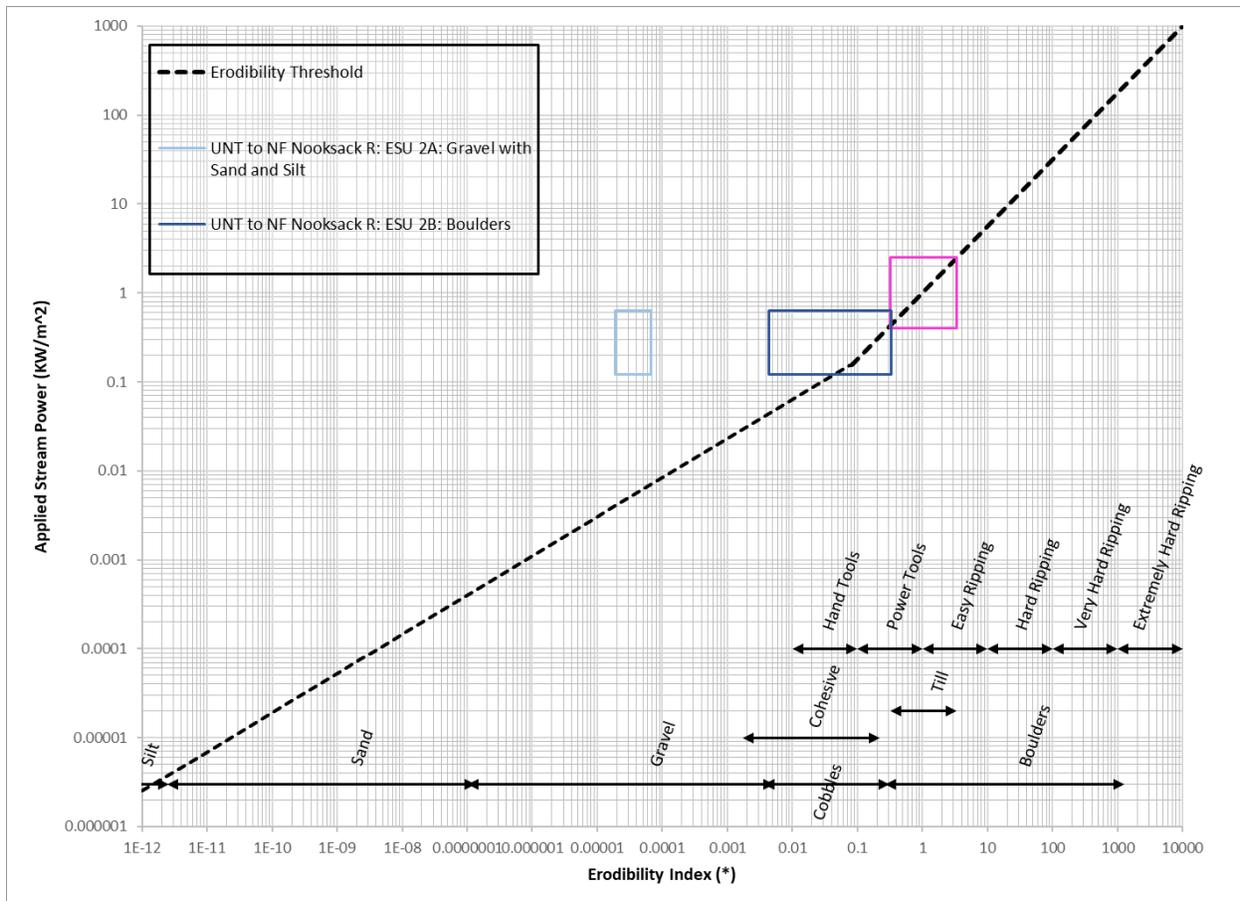
The results of the EIM assessment for the UNT to Lake Cushman (Figure 7) show that both units ESU 2a and 2b both have the potential to scour under the proposed conditions.

**Figure 7 – EIM results for the NF of the Nooksack River crossing.**

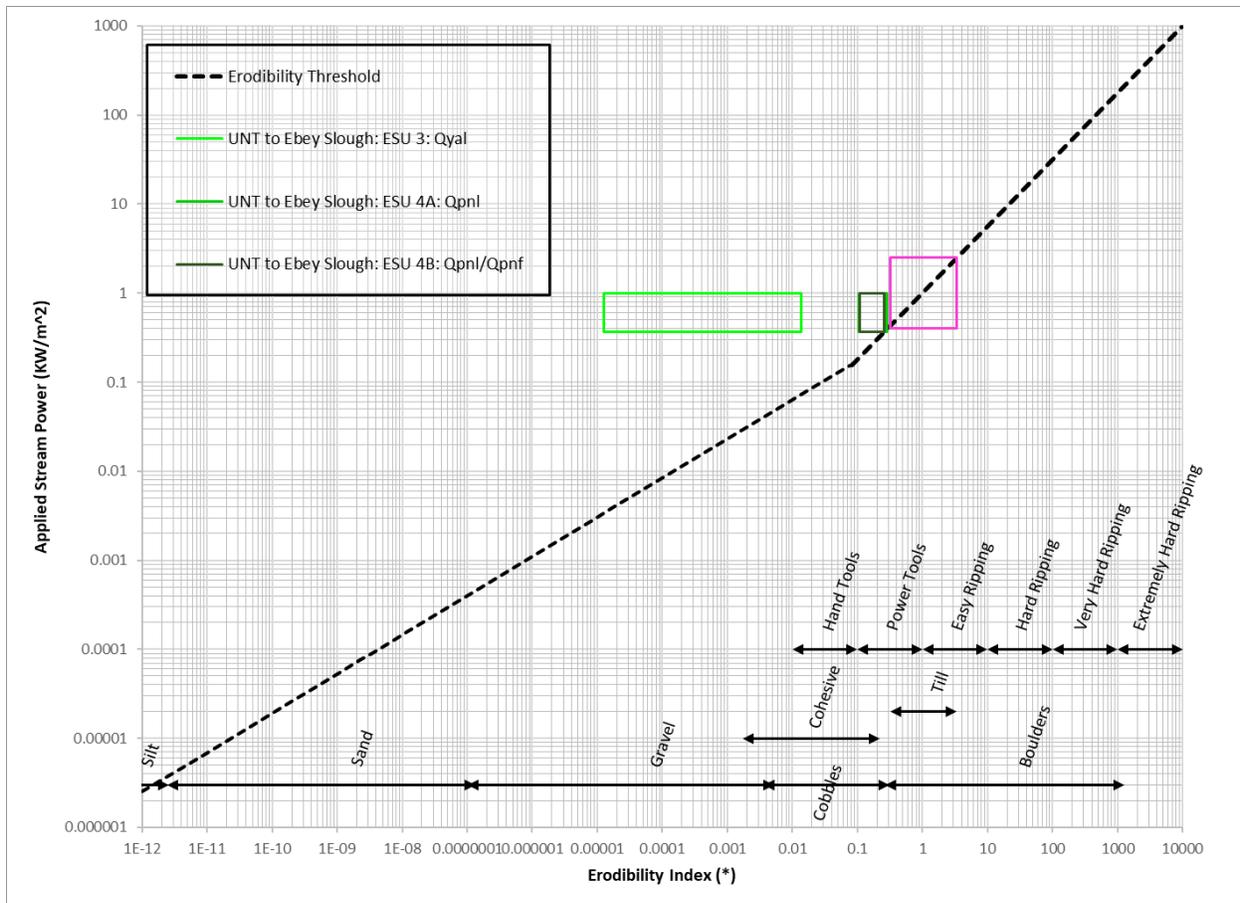
The results of the EIM at UNT to Ebey Slough show that all the assessed ESUs are likely to scour at the proposed conditions (Figure 8).

**Figure 8 – EIM results for UNT to Ebey Slough crossing.**

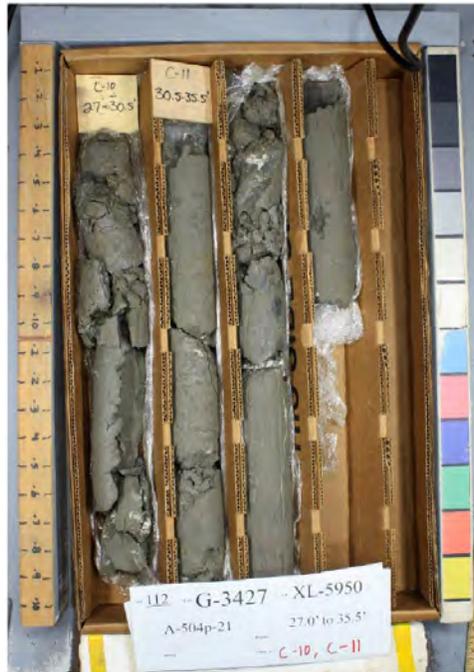
**Figure 9 –Siltstone rock core on left and profile on right.**

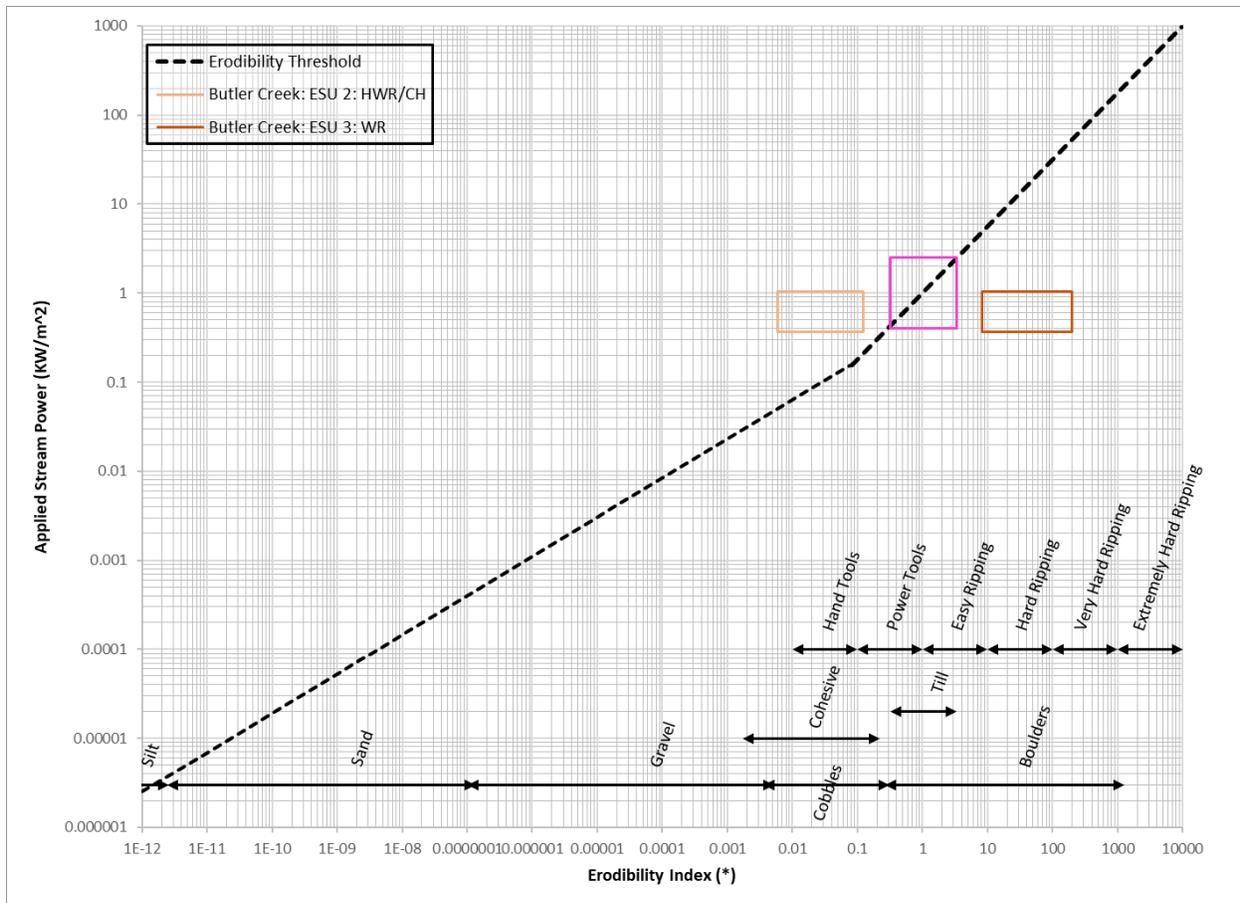
The results of the EIM assessment at Butler Creek show that ESU 2 is likely to scour, and that ESU 3 is likely to resist scour (Figure 10).

**Figure 10 – EIM results for Butler Creek crossing.**

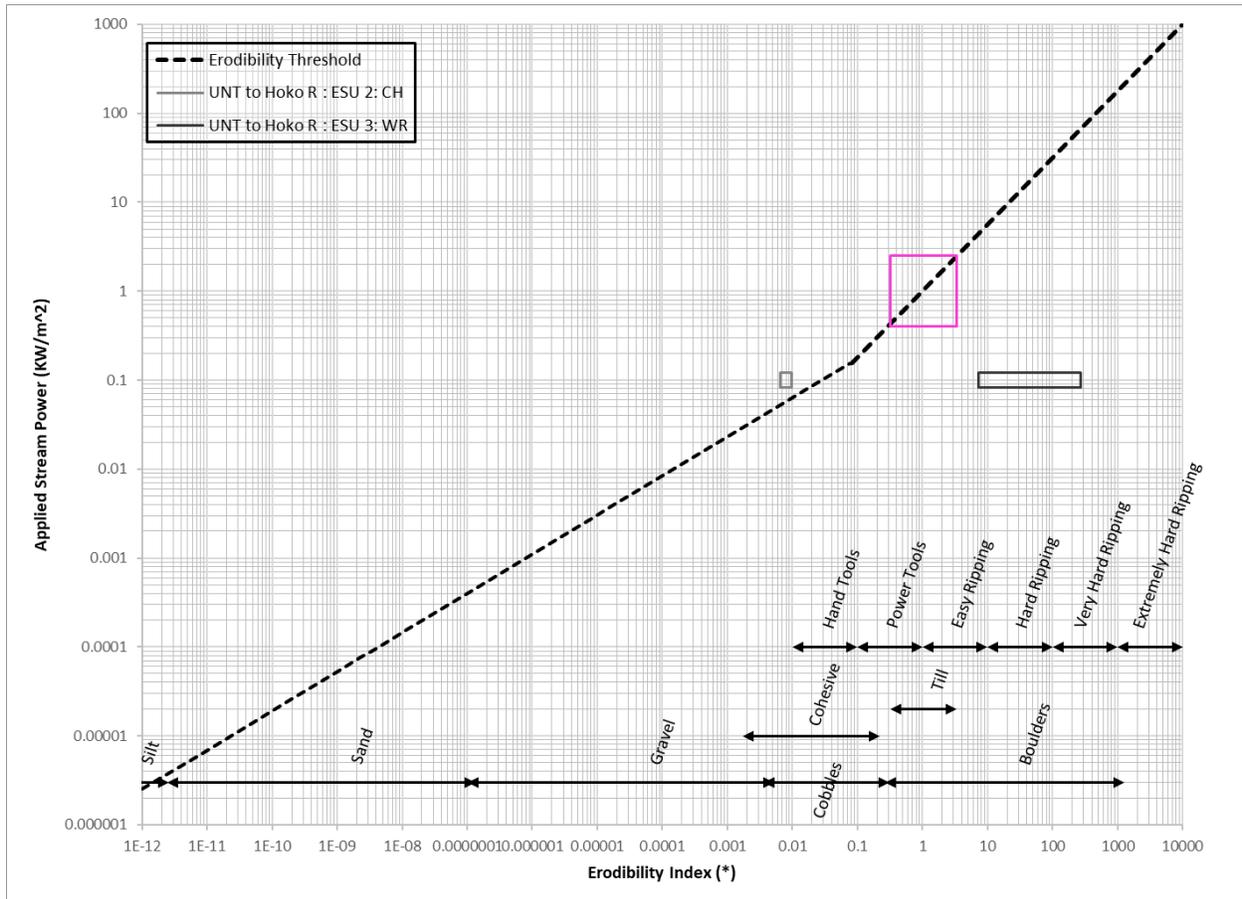
The results of the EIM at UNT to Hoko River show that ESU 2, the glacial drift and lacustrine deposit, is likely to scour, but that ESU 3 the Siltstone bedrock is unlikely to scour (Figure 11).

**Figure 11 – EIM results for UNT to Hoko River crossing.**

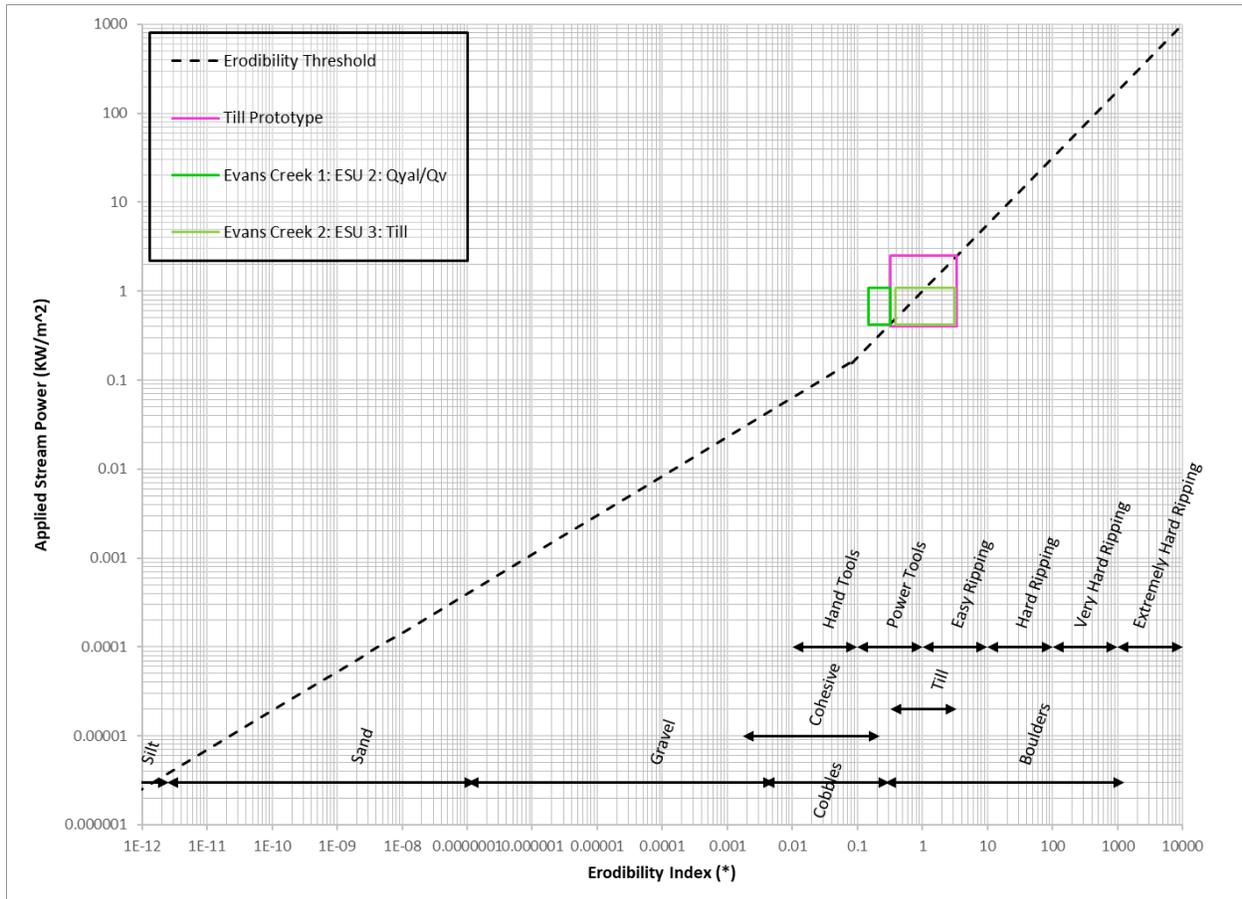
The results of the EIM at UNT to Evans Creek show that scour of the alluvial and glacial clastic material (ESU 2) is likely and that scour of the Till (ESU 3) is less likely, but still possible and that further investigation is called for (Figure 12).

**Figure 12 – EIM results for Evans Creek crossing.**

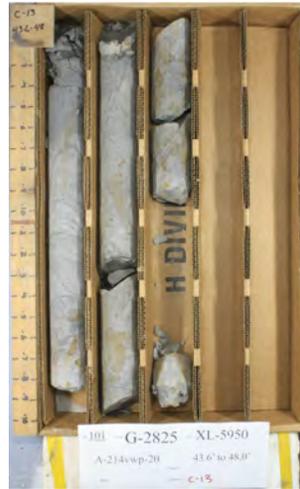
**Figure 13 –Siltstone rock core.**

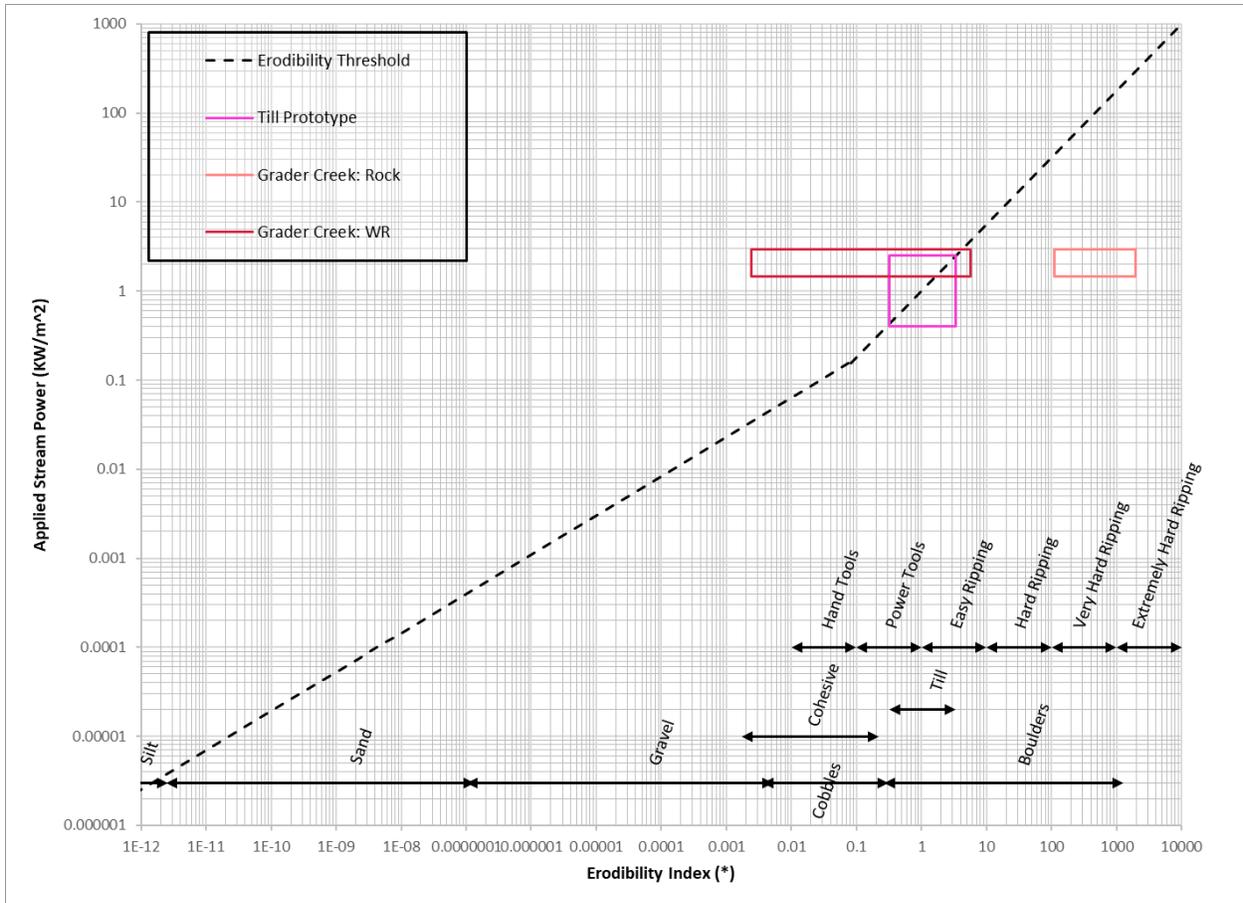
The results of the EIM at Grader Creek show that the weather rock is likely to erode, but that the un-weathered rock is not likely to scour under the project conditions (Figure 14).

**Figure 14 – EIM results for Grader Creek crossing.**
