# 72<sup>nd</sup> Highway Geology Symposium

## 2023 PROCEEDINGS

August 14-17, 2023 • Hotel Murano • Tacoma, Washington

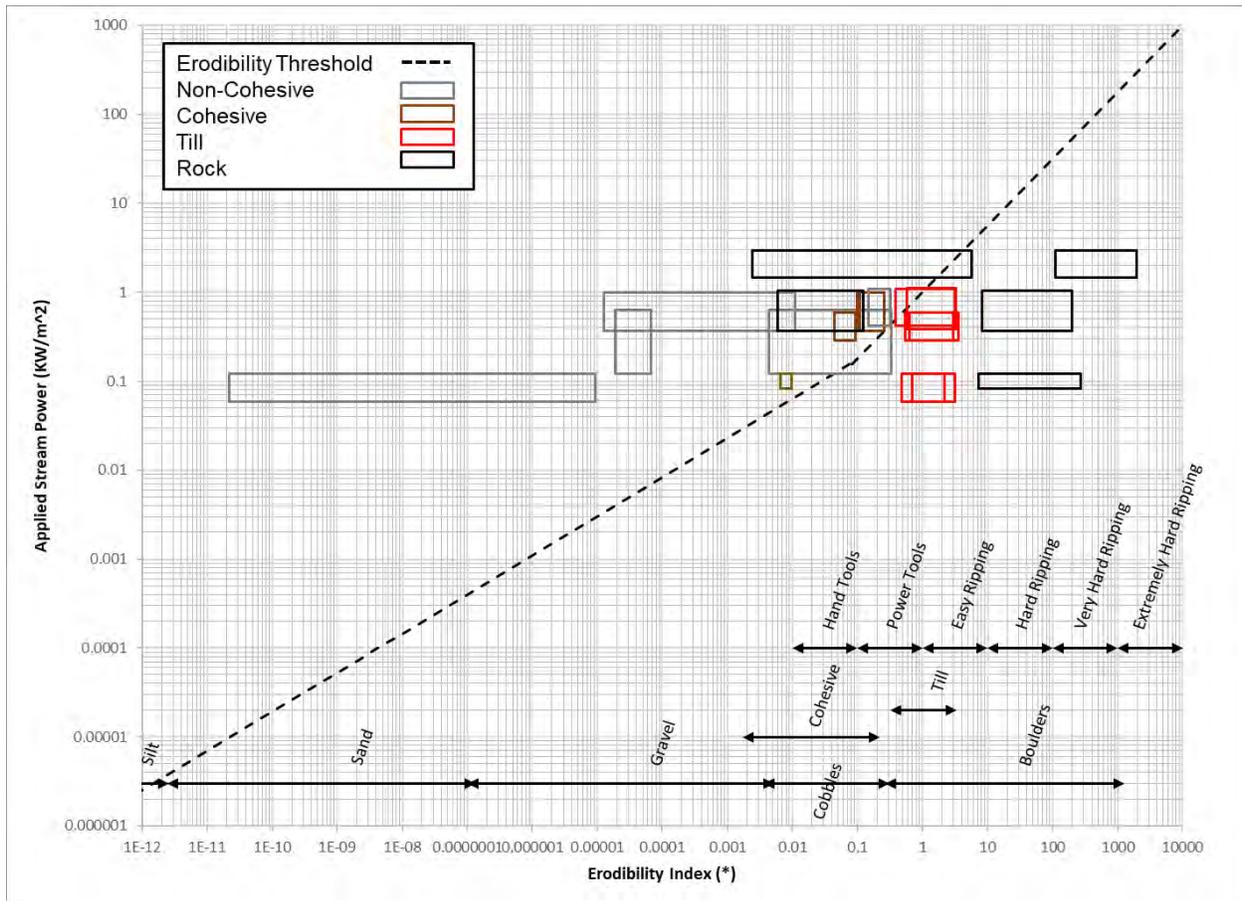
In Table 2 and Figure 15, WSDOT presents the hydraulic and geotechnical input data needed for, and the results of the EIM assessment for the 20 ESUs in the nine case study sites presented above. In Figure 15, the 4 material types have been color coded to illustrate their range of susceptibility to erosion.

Figure 15 – EIM results for Grader Creek crossing.

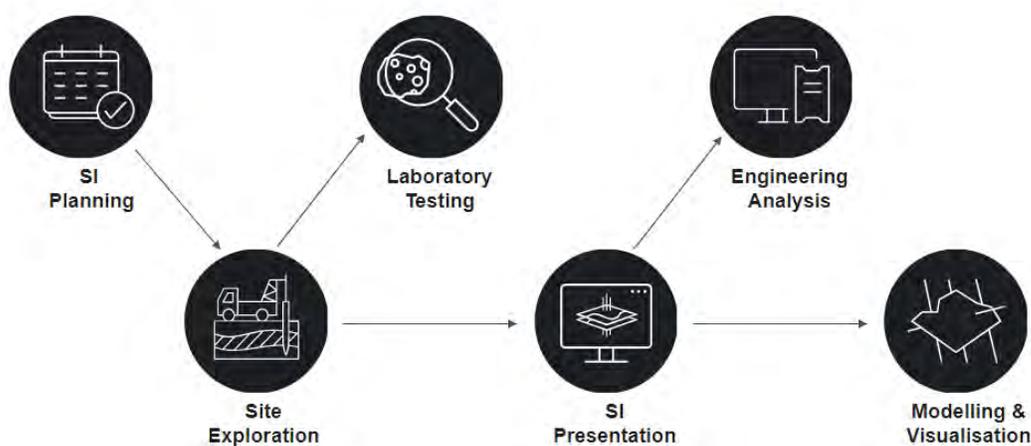
**Figure 1: Disconnected geotechnical workflow**

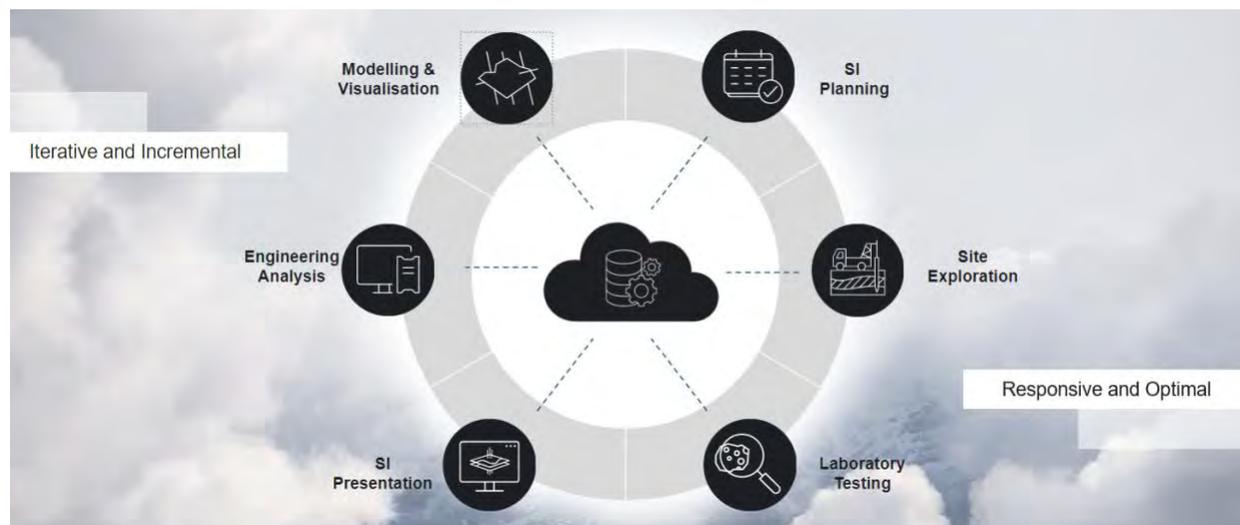
The figure below shows a single database for six primary workflows in a connected data environment. Data is not being imported or exported. Rather, tools external to the database call

the data and the geo professional can work with, evaluate, and understand the data using standard tools for design, modeling, and evaluation.

**Figure 2: Connected Workflow with a common data environment**

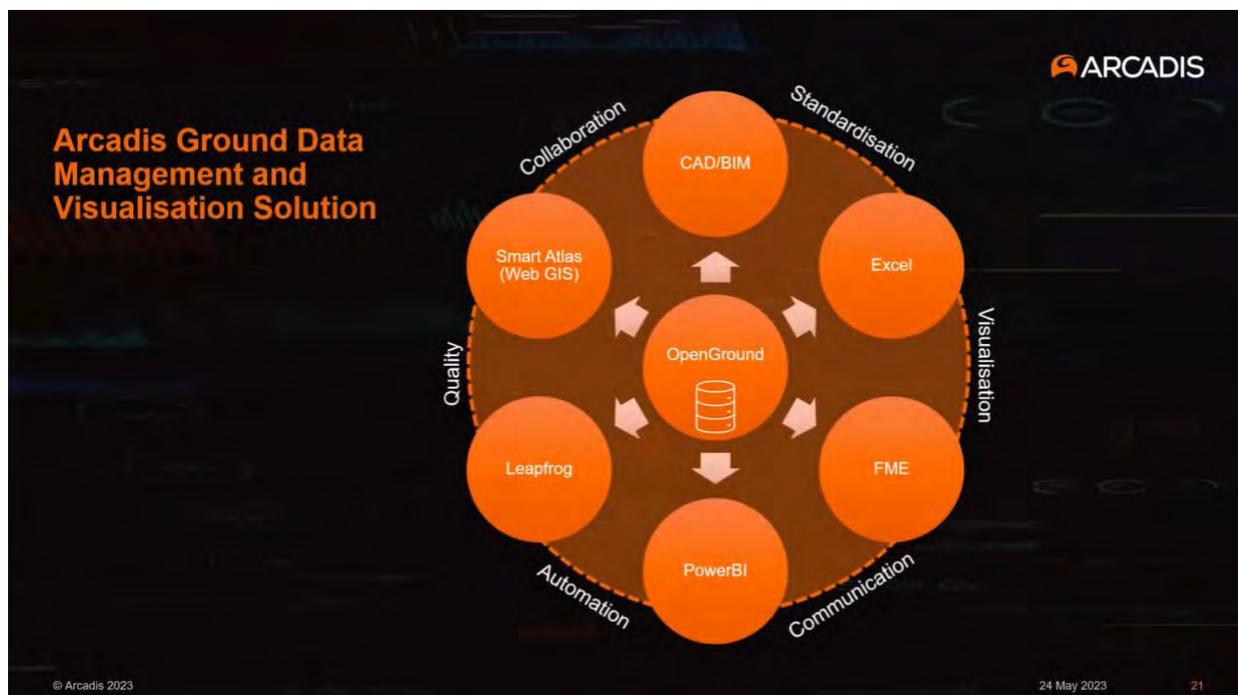
**Figure 3: Arcadis Ground Data Management Visualization Solution**

Standardization enabled collaboration, visualization, communication across groups on a large-scale project with personnel external to Arcadis, as well as internally. Standardization enabled automation of complicated processes across large data sets including QA, evaluation, and modeling. In the diagram above, the standardization allowed the use of standard OpenGround tools and bespoke processes to create connected data workflows. By centralizing to a single, standard database Arcadis was able to efficiently turn around thousands of data points from site investigations from many contractors to contractors and engineers waiting on data to take the next steps in design and construction. Arcadis is confident in the quality of the data presented to others for use in the project thanks to the automation of QA. Internally they could use the data from OpenGround with other applications. The image below shows a model which combines data from OpenGround (boreholes), a Leapfrog geological model that used geotechnical information from OpenGround, and the Building Information Model (BIM).

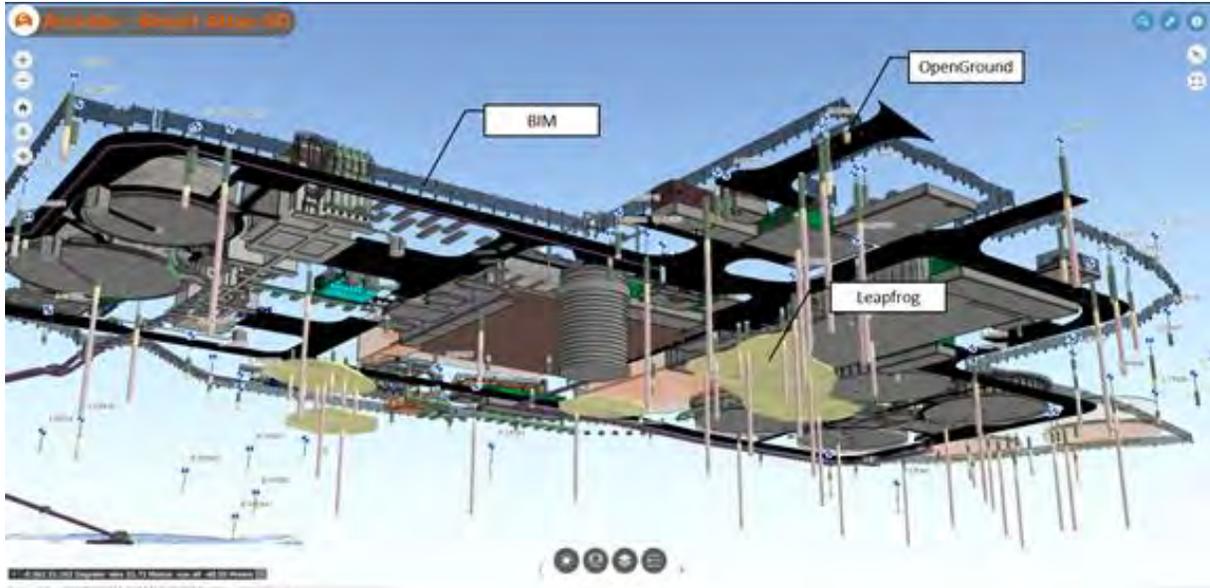
Without a standardized database with API capabilities a model such as shown would prove an enormous undertaking: from QA of data entered manually, time to enter data, and even time to create the model in a single system vs using tools fit for purpose and integrating results. Using the standard database being accessed via the API makes it a matter of a few clicks. It is work to program and build the program using the API, but once built it is a simple, repeatable, scalable by project process for end users.

**Figure 4: A comprehensive model with as built and geotechnical data**

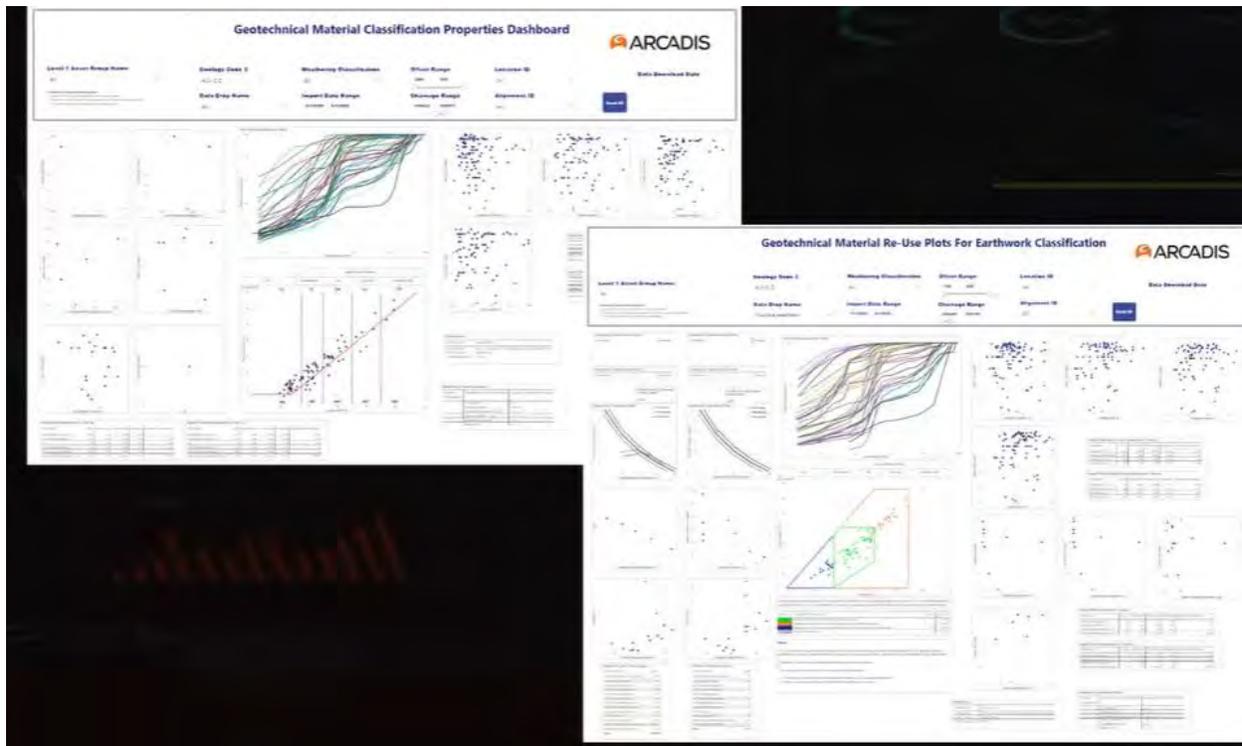
**Figure 5: A dashboard using Power BI to evaluate geotechnical materials.**

Dashboards built by Arcadis in Power BI enabled advanced review and analysis of materials across sites. Arcadis engineers and geologists could be reasonably comfortable with materials present and making recommendations for design. The image below is two Power BI dashboard Arcadis used to evaluate materials across a site. In a project with large amounts of data, a manual evaluation for the data would take days. The Power BI dashboard, once built, is a

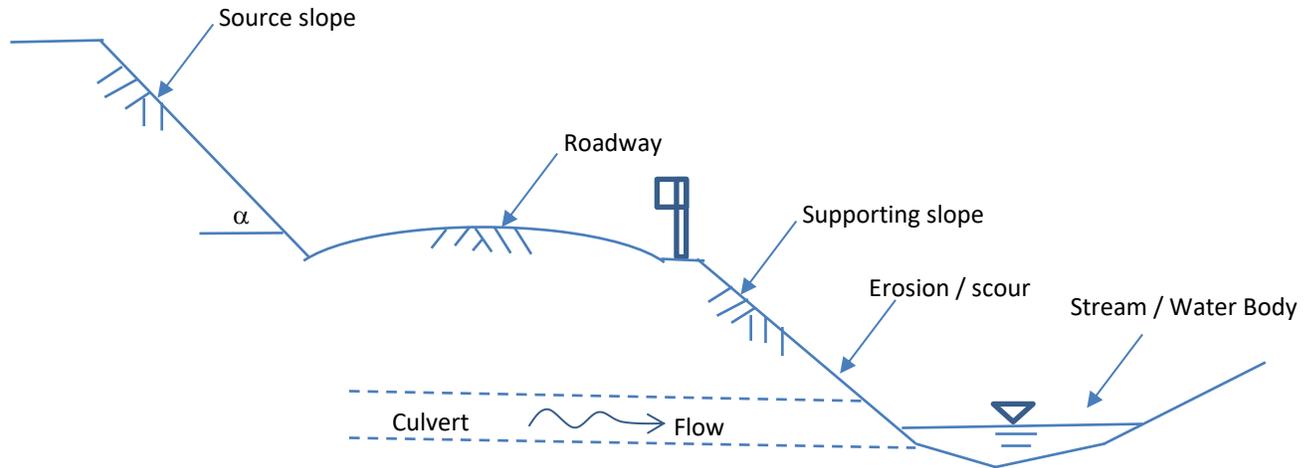
**Figure 2 – Simplified Schematic of Slope Model**

Figure 2 presents a simple schematic of the road-side slopes for this study. We grouped slopes into two main categories: source slopes and support slopes, which are defined by their relative elevation to the nearest roadway segment. GZA adopted an analytical concept “analogous” to the Response Surface method widely adopted by USACE and FEMA for their coastal storm surge flood studies (e.g., Resio et al., and USACE 2015).

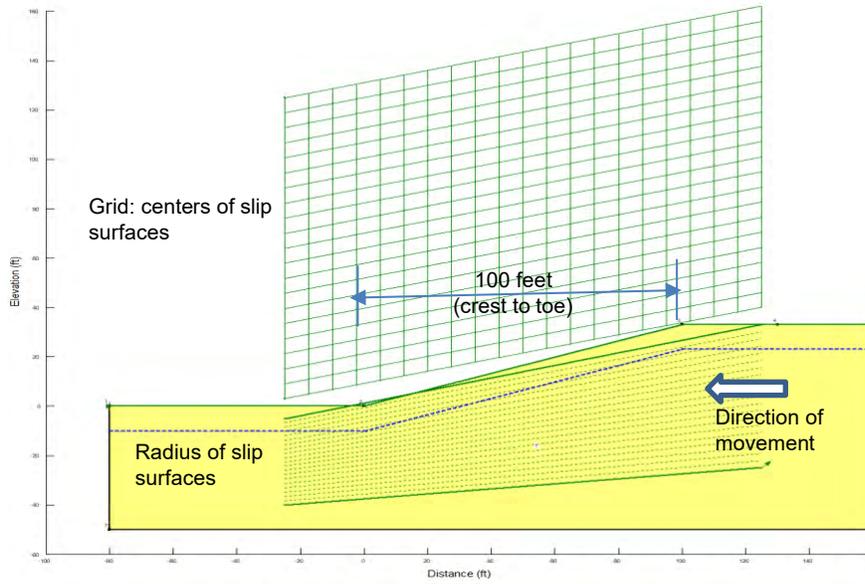
Note: Example shows a 3H:1V slope with one uniform material. Grid and radius method used for Grid and radius for circular slip surfaces.

**Figure 3 – SLOPE/W Model – Example**

SLOPE/W (submodule of GeoStudio v.2018), a widely used commercial slope stability software program for analyzing soil slopes, was used. SLOPE/W can effectively analyze both simple and complex problems for a variety of slip surface shapes, pore-water pressure conditions, soil properties, and loading conditions. Figure 2 presents a simple schematic of the geometry modeled in SLOPE/W. GZA used the Morgenstern-Price (M-P) method with half-Sine side function (SLOPE/W default).

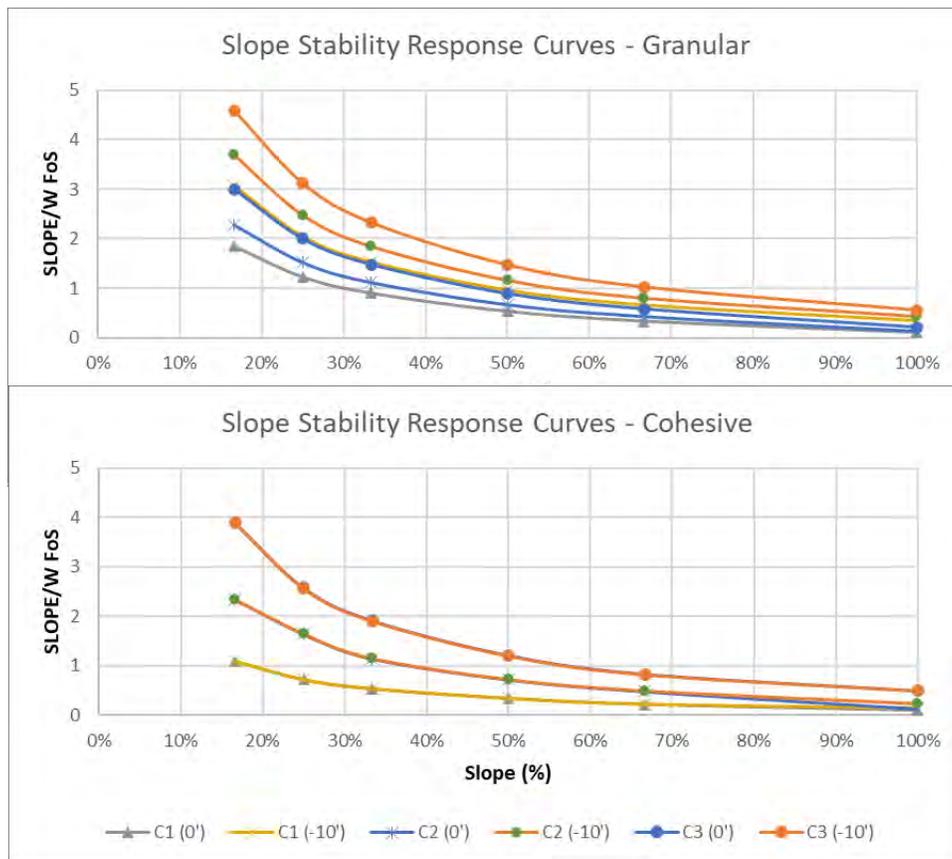
**Figure 4: SLOPE/W-calculated Factors of Safety**

In general, a shallower groundwater table tends to lower the FoS in granular soil slopes, whereas the difference is less noticeable in cohesive soils. FoS values are positively correlated with increasing soil strength parameters. Figure 4 presents the SLOPE/W simulation results for the granular and cohesive soils. These curves can be viewed as discrete slices from a 4-dimensional (response) surface, with the response being the factor of safety and the variables being the slope angle, material type and groundwater conditions. Based on the SLOPE/W modeling results, FoS values for all slope angles (from 0 to 120%) can be determined using 1-dimensional spline interpolation and the interpolated FoS dataset (Figure 5) was used for calculations in GIS.

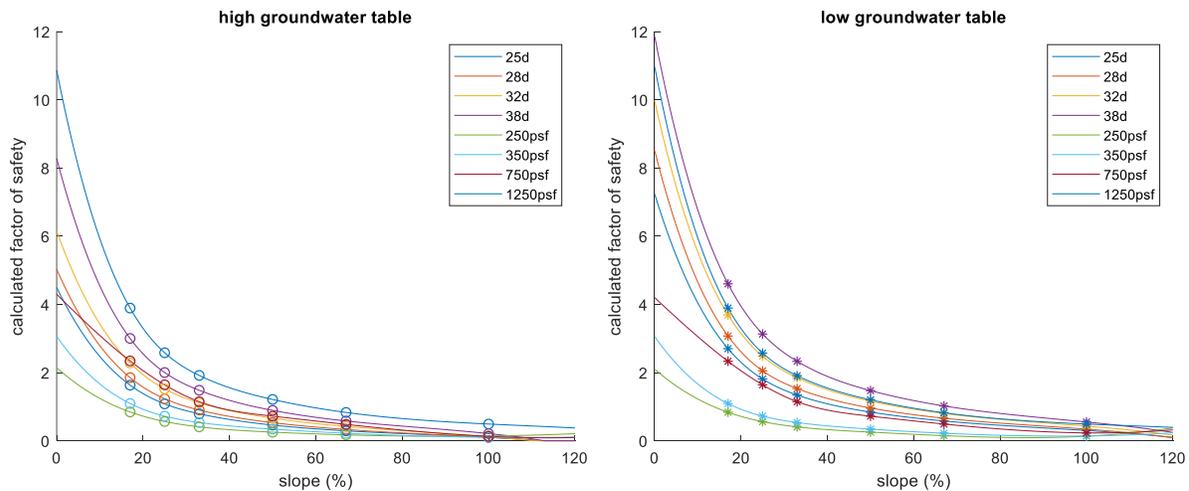
**Figure 5: Interpolated Factors of Safety**

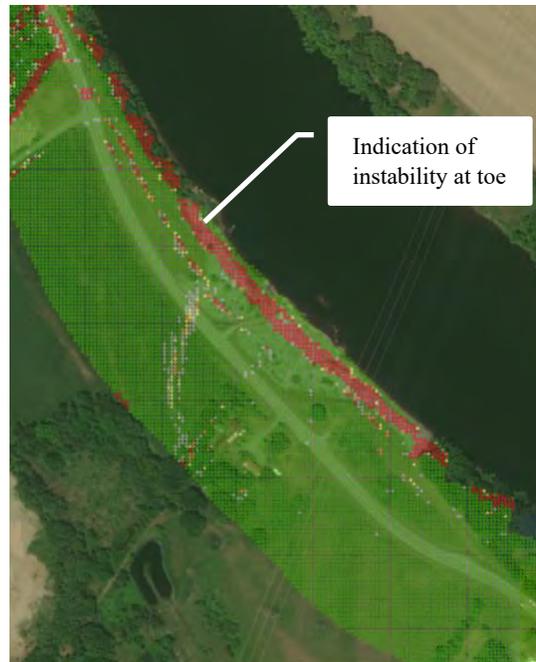
Note: Aerial image more recent than 2010; topography LiDAR from 2009. Failure occurred in Summer 2010.

**Figure 6: Slope Failure Site at Route 136**

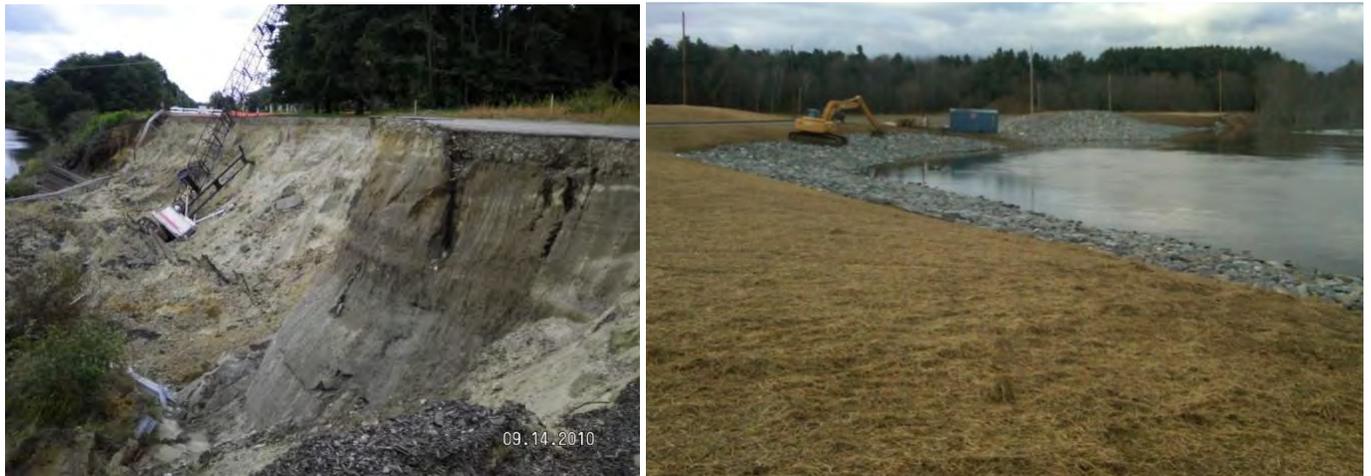
Note: Top image after failure incident in September 2010; bottom image after construction/remediation completed in December 2010.

**Figure 7: Project Photographs for Route 136 Slope Failure**

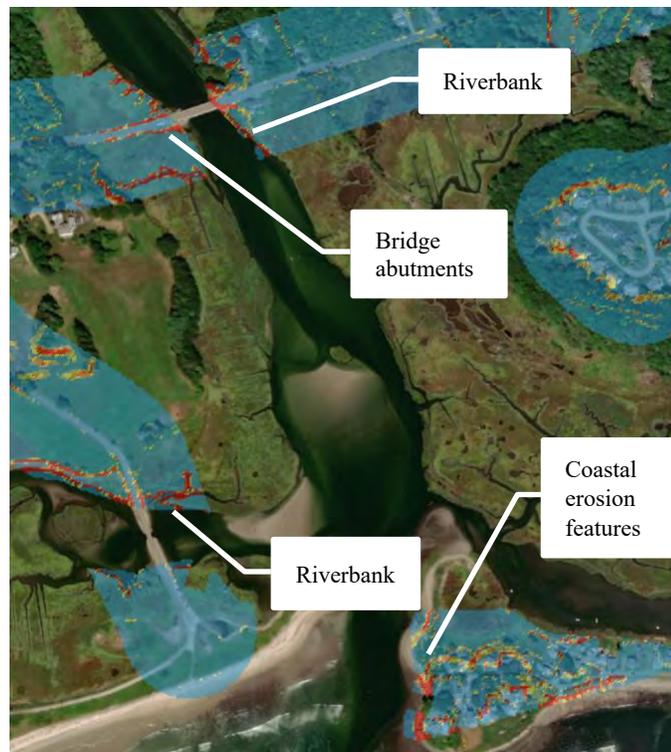
**Figure 8: Coastal Erosion and Instability, Kennebunk, Maine**

GZA converted the MGS map (MGS-b) titled “Landslide Sites and Areas of Landslide Susceptibility, Town of Kennebunk, Maine” in PDF format to a jpeg file and used features such as roads and town lines to georeference the map in GIS so it could be compared to model results.

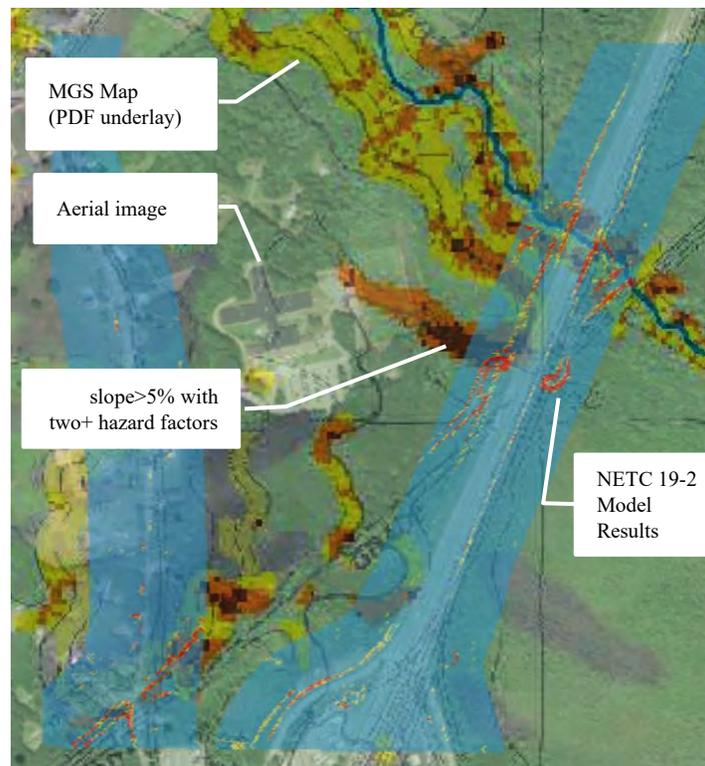
Note: Aerial image and MGS landslide susceptibility map overlaid with NETC 19-2 computed slope stability hazard index.

**Figure 9: Comparison of NETC 19-2 Results and Landslide Susceptibility Map – I-95**

**Figure 9** presents an image where MGS mapping results and NETC 19-2 modeling results are overlaid on top of each other for comparison. Our study results have a focus on existing roadways, whereas MGS results cover the entire land area. There is, overall, agreement between the MGS predictions and NETC 19-2 modeling results, in terms of where high hazard areas are located (darker/warmer colors). It is apparent that the NETC 19-2 modeling results are significantly higher in resolution (green to red scale), compared to the MGS mapped color blocks (yellow to dark brown color scale; refer to MGS map legend). The MGS results appear to have predicted more “high hazard” areas than this study. GZA’s results seems to match the underlying terrain and manmade features more accurately than MGS land-based mapping results, mostly because of the fine resolution (3-meter by 3-meter) and the use of generalized rotational stability analyses as the basis for the current model. **Figure 10** indicates that the NETC 19-2 modeling results are more capable of detecting more detailed potential failure features in general, even if the terrain is generally very gently sloping in the coastal areas.

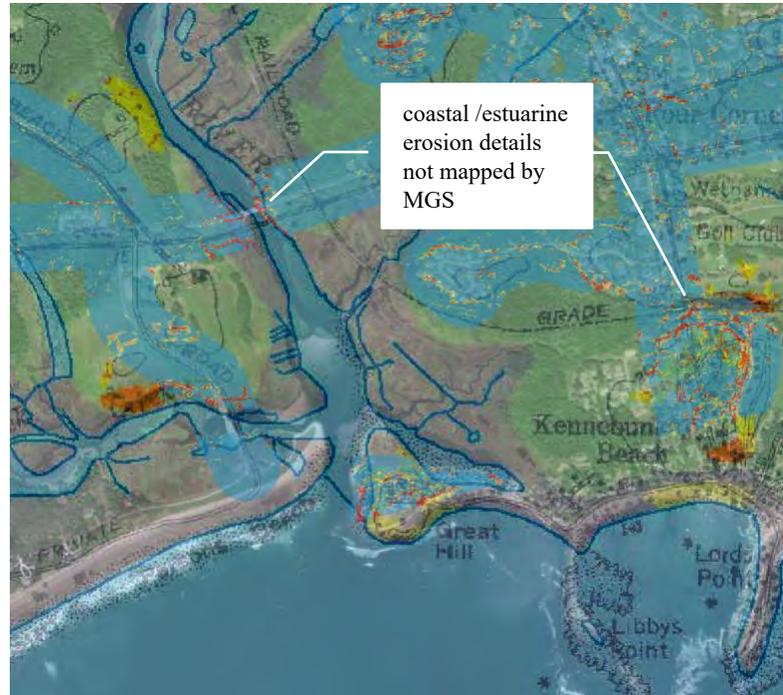
Note: Aerial image and MGS landslide susceptibility map overlaid with GZA computed slope stability hazard index.

**Figure 10: Comparison of NETC 19-2 Results and Landslide Susceptibility Map – Coast**

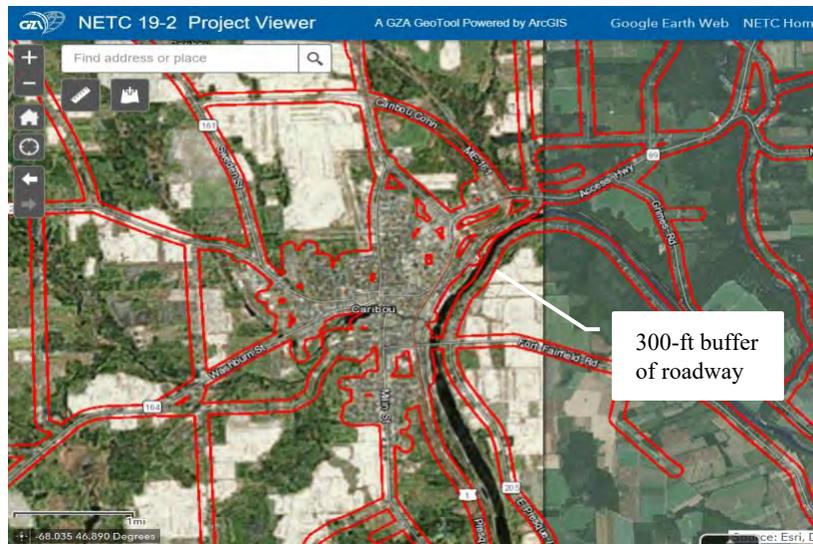
Note: Red outlines represent the study area.

**Figure 11: NETC 19-2 Study Area – 300 feet Buffer along Public Roadways**

Data were processed and saved in raster format. The base geospatial data is the 300-foot buffer zone from the road features contained in the MaineDOT public roads centerline feature class, as shown in Figure 11, based on the assumption that slope instability or erosion beyond 300 feet from the roads has a less significant impact on roadway traffic and safety. Interim layers (also included and presented in the toolkit) served as the necessary input for others. Layers below are presented in the order of our overall workflow.

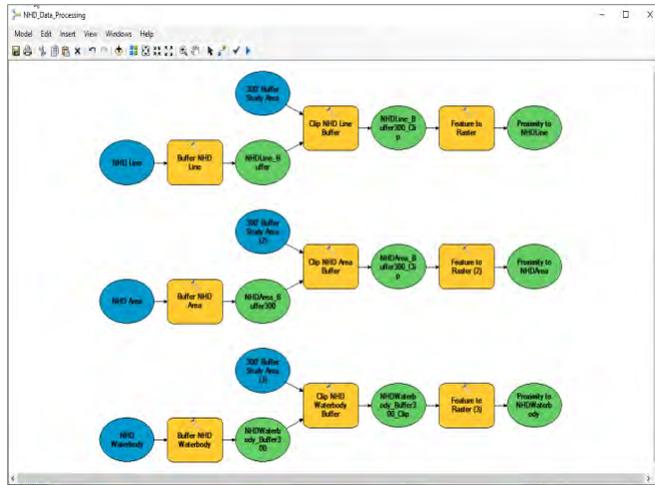
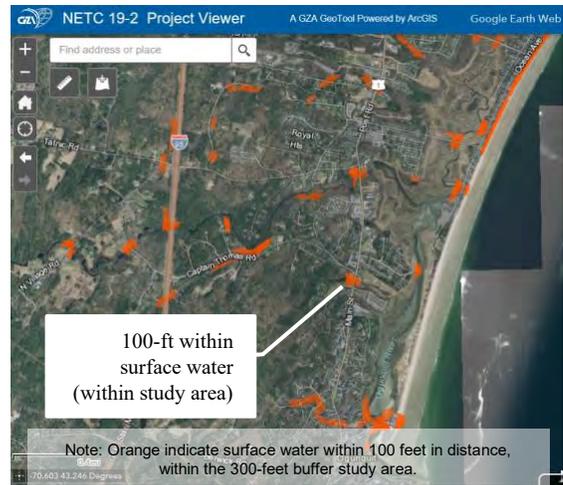
**Figure 12: (a) Model for Processing NHD Data; and (b) Proximity to Surface Water**

An example ModelBuilder is shown in Figure 12(a), which presents the ArcMap ModelBuilder Flow Chart, which highlights the key steps of the geoprocessing model. One-hundred-feet was selected as the screening criteria. As a result, the proximity to surface water layer represents areas that are within 100 feet from water sources (such as perennial streams, ponds, and lakes), as shown in the example image in **Error! Reference source not found.2(b)**.

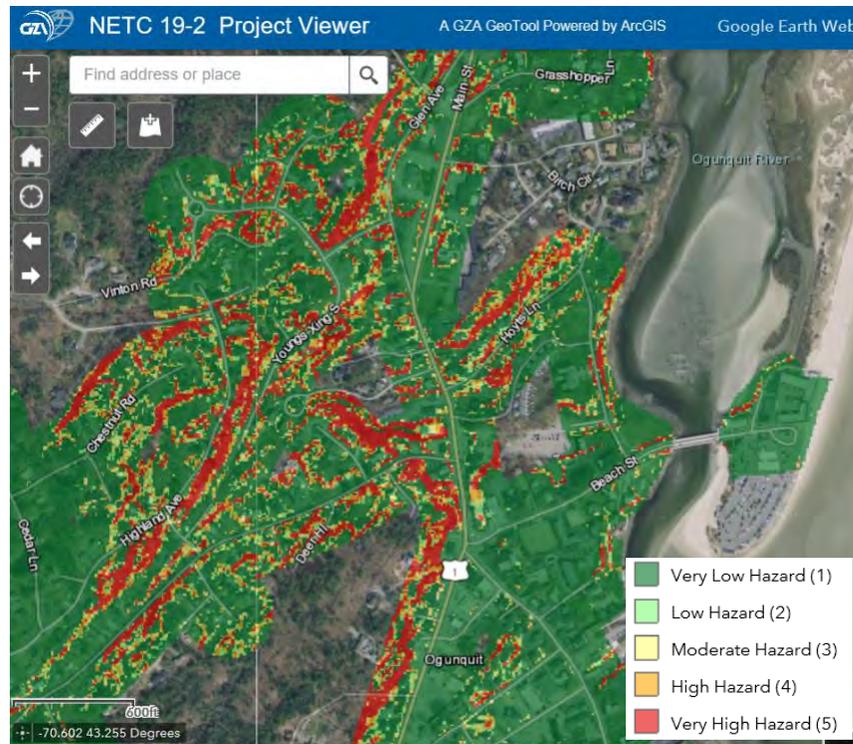
**Figure 13: Example View of Hazard Index**

**Figure 13** presents the results layer in the NETC 19-2 Project Viewer for the final slope stability hazard index layer. Warmer colors indicate a greater likelihood for slope failure (including landslide).

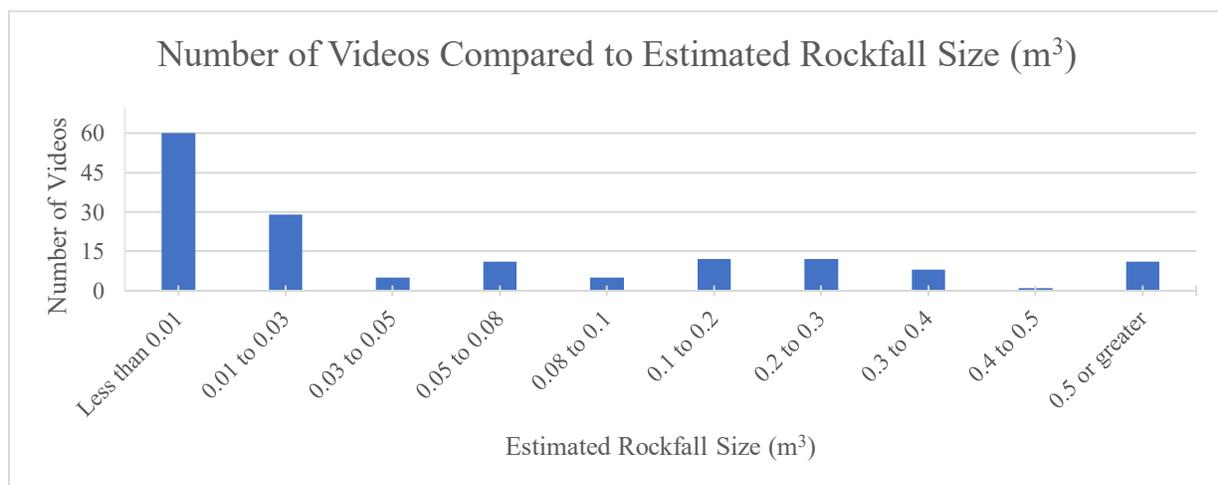
**Figure 1: Number of Videos Compared to Estimated Rockfall Size (m<sup>3</sup>)**

The estimated size of the primary rockfall events assessed is plotted in Figure 1. A traditional data pattern would result in the fewer numbers of each group of rockfalls, as the volume increases. This pattern is not observed in this data. It is hypothesised that two factors are influencing this deviation. There are a large number of rockfall events that occur during a scaling campaign, leading to selective capturing of rockfall events, especially in an informal data collection scenario. It is therefore hypothesized that the number of rockfall videos is not an accurate reflection of the true number and size distribution of rockfalls initiated during a scaling project. Videos taken appear to focus on medium sized rockfalls, resulting in fewer videos of small rockfall events. The under sampling of small rockfalls is also because when there are multiple rockfalls in one video, the rockfall that is best seen or has the most data is tracked by the videographer. Small rockfalls are often more challenging to see, as a result, these events are often not analyzed and added to the database.

Secondly, it is hypothesised that the increase in medium (0.05 to 0.4 m<sup>3</sup>) sized rockfalls in the database is due to the focus of the slope maintenance work. Scaling specifically targets rocks that are identified as a potential hazard, and that can be liberated by scaling methods. Larger blocks are sometimes removed by controlled blasting. To the knowledge of the authors, there is no specific research explaining the effect of slope maintenance on the frequency magnitude curve of a slope, because longer duration maintenance records have not been made available as data sources.

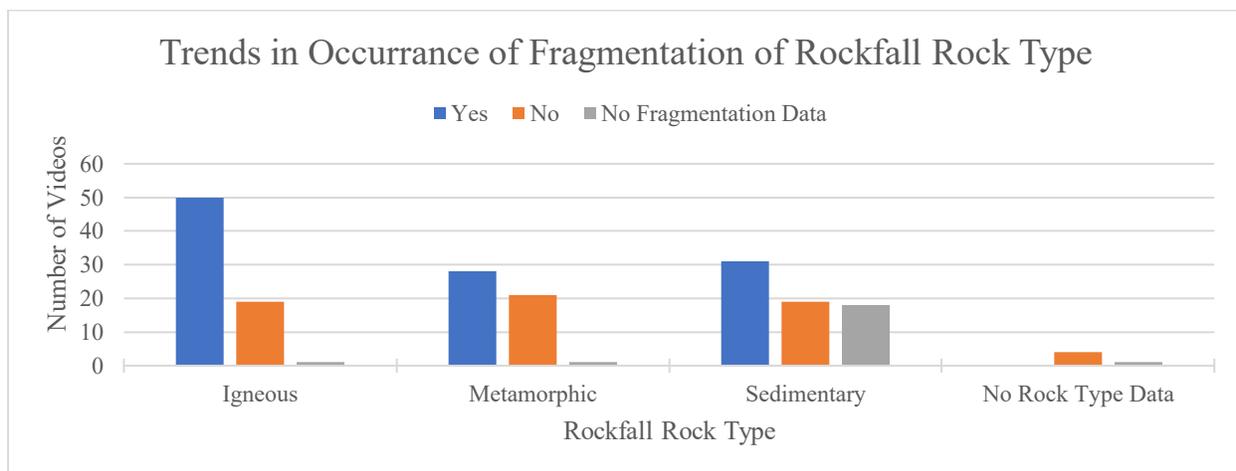
**Figure 2: Trends in Occurrence of Fragmentation of Rockfall Rock Type**

As shown in Figure 2 the analysis of the database at present has yielded an interesting trend on the potential effect of geology on fragmentation. Considering videos where it was possible to determine events with fragmentation and non fragmentation, Igneous rocks fragment more often (72%), followed by Sedimentary (62%) and Metamorphic rocks (57%).

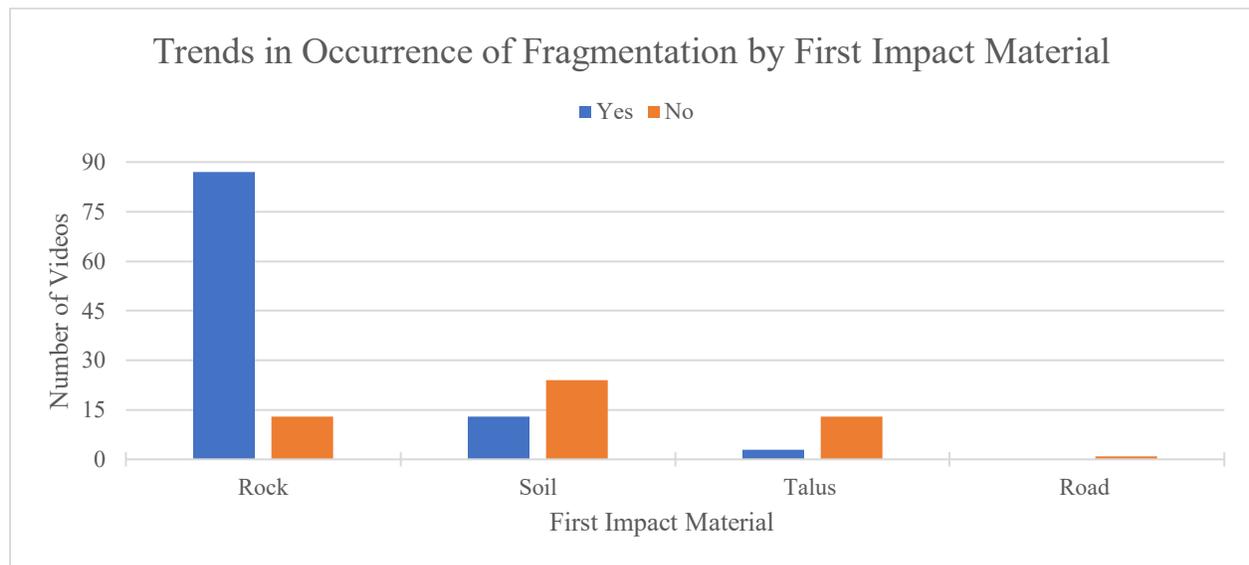
**Figure 3: Trends in Occurrence of Fragmentation by First Impact Material**

propagation resulting in the separation of one section of the rockfall from another (5). Loose material, such as soil and talus, absorbs more energy on impact than bedrock and decreases the amount of energy within the rockfall (19, 21). The likelihood of fragmentation appears to be decreased for rockfall on soil or talus (5). The first impact material is defined as the slope material at the rockfall object's first impact. It can be seen in Figure 3 that most rockfall with a first impact on rock go on to fragment at some point during their fall, and that most fragmental rockfall have a first impact on rock. A total of 80% of videos showing fragmentation have a first impact on rock, with 12% and 3% of fragmental videos having a first impact on soil and talus respectively. Most non-fragmental rockfall have a first impact on soil with 48% of videos, while 26% of non fragmental videos have a first impact on talus and rock each.

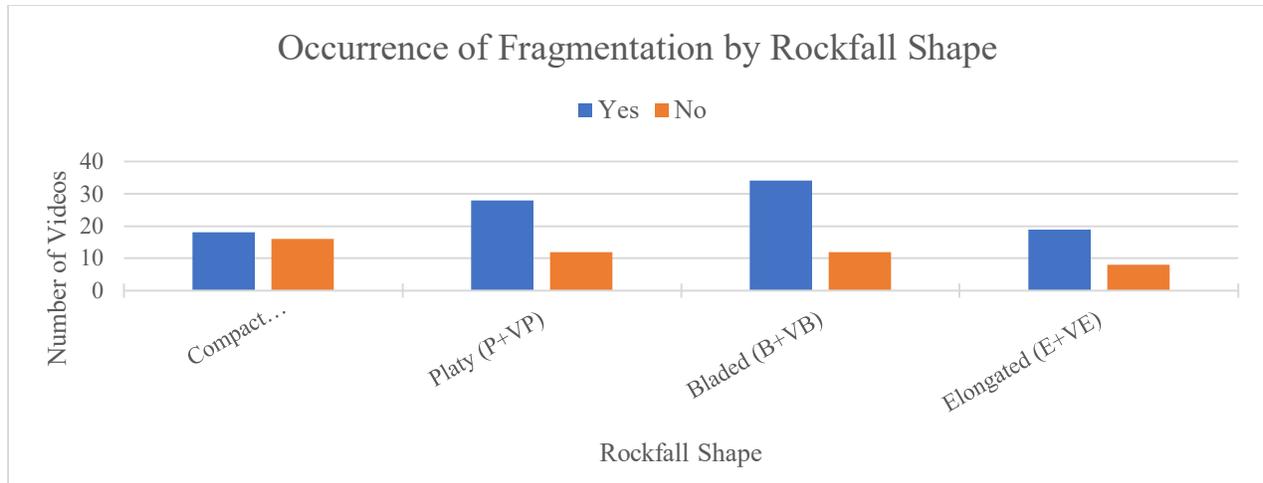
**Figure 4: Occurrence of Fragmentation by Rockfall Shape.**

The shape of the rockfall object is linked to the occurrence of fragmentation in the videos reviewed to date. As seen in Figure 4, bladed rockfalls have the highest rate of fragmentation (74). Compact rockfall fragmented the least (53%). Platy and elongated have a fragmentation rate between bladed and compact shapes, at 70%. Rockfall shape can often be predicted based on the slope structure and resulting block geometry.

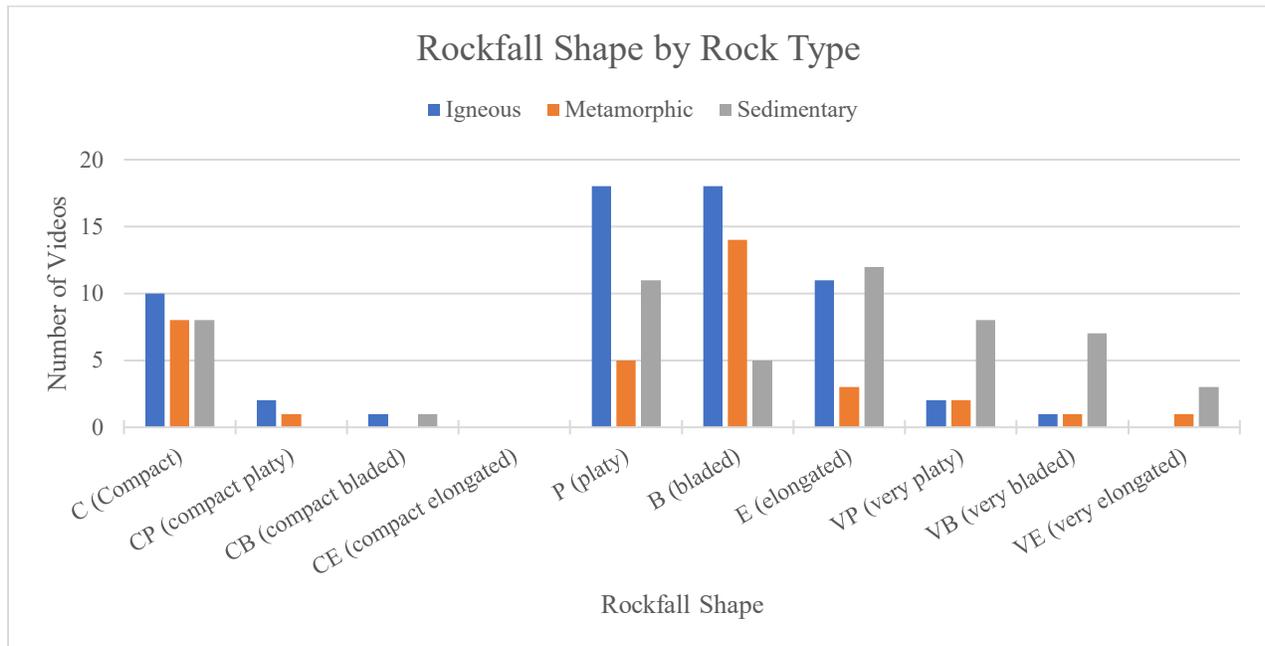
**Figure 5: Rockfall Shape by Rock Type**

The three different rock types produce different rockfall and fragment shape trends, as seen in Figures 5, 6 and 7. Table 1 shows that igneous rockfalls occur more often in platy and bladed shapes with very few videos from the other shape categories. Videos of metamorphic rockfall are more commonly bladed in shape. Sedimentary rock has a less clear trend with respect to rockfall shape, however, have a greater variety of rockfall shapes compared to the other rock types.

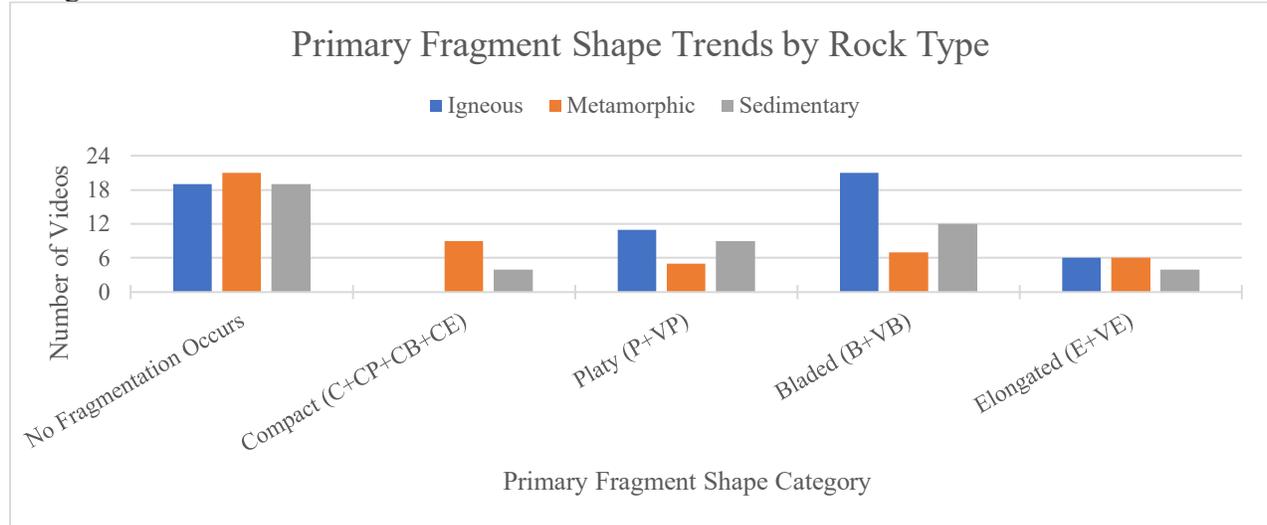
**Figure 6: Primary Fragment Shape Trends by Rock Type.**

The different rockfall rock types have preferred primary fragment shapes as seen in Figure 6. Igneous rockfall produce bladed primary fragments in 21 of the 70 videos of fragmental igneous rockfall. When not fragmenting into bladed primary fragments, igneous rockfall produced platy, compact and elongated primary fragment shapes in 10, 8 and 6 videos respectively with very little representation of any other shape class. Sedimentary and metamorphic rock types have more variety in the primary fragment shapes produced. Metamorphic rockfall most commonly produce compact primary fragment shapes, at 9 videos. Platy, bladed or elongated primary fragment shapes were produced roughly equally where 4 videos have platy primary fragments and 5 videos have bladed and elongated primary fragments for fragmental metamorphic videos. Sedimentary rockfall display a wider array of primary fragment shapes. There is not a single clearly preferred primary fragment shape for sedimentary rockfall within the database and sedimentary rockfall have the most videos with a lack of fragment shape data at 18 of the 49 videos of fragmental sedimentary rockfall. This is because dust clouds obscured the fragment shapes in these videos. The remaining 31 videos that fragment are most commonly bladed with 7

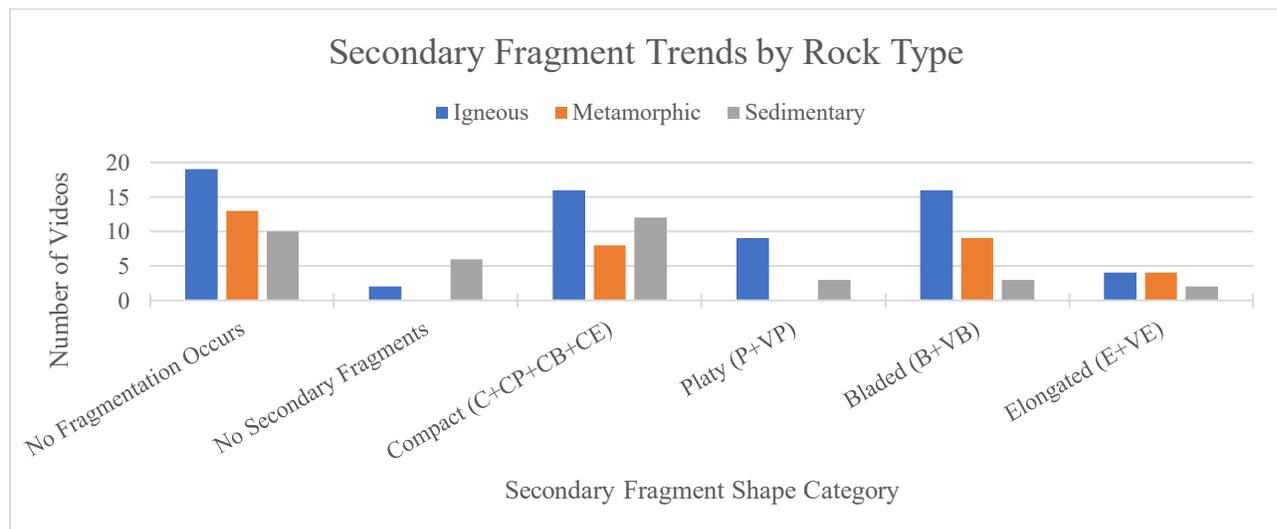
**Figure 7: Secondary Fragment Shape Trends by Rock Type.**

Both primary and secondary fragment trends are important to analyze individually and as a whole to understand the shapes that are being created during fragmentation. As shown in Figure 7, only 18 videos displayed no secondary fragment shape despite fragmentation occurring and a primary fragment shape being discernable. This indicates that in 86 of the fragmental videos with a primary fragment shape, the fragments are represented by more than a single fragment shape. There is an increase in the presence of compact fragment shapes in the secondary category. Sedimentary rockfalls tend to produce the most compact secondary fragments, with 12, more than any other fragment shapes. Igneous rockfalls produced an equal amount of compact and bladed secondary fragments, at 16, and 9 platy fragments. Bladed secondary fragments are the most common from metamorphic rockfall at 9 videos with 8 videos having compact secondary fragments.

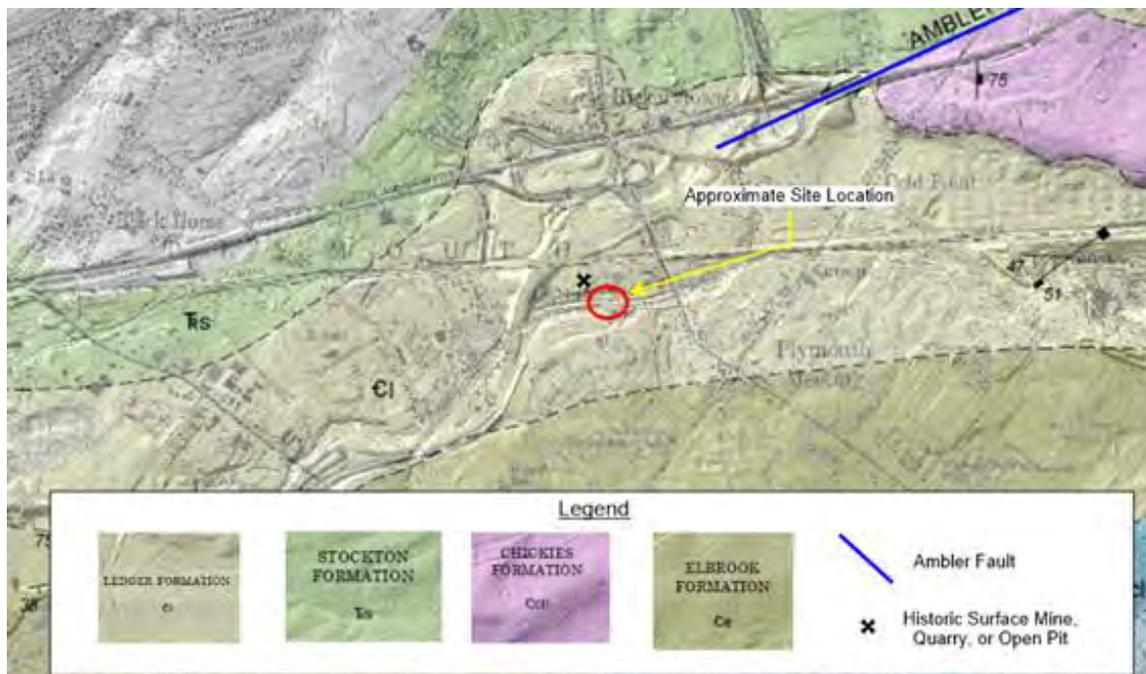
**Figure 2 – Geologic Map Of The Project Area**

The site is located within the Piedmont Lowland Section of the Piedmont Physiographic Province and is underlain by the Cambrian Age rock of the Ledger Formation (C1) (Kochanov 2016). In the surrounding area, the Chickies (Cch), Stockton (C<sup>rs</sup>), and Elbrook (Ce) Formations are mapped and consist of mudstone and siltstone, crystalline quartzite, and dolomite, respectively. Figure 2 includes the approximate site location overlain on a bedrock geologic map.

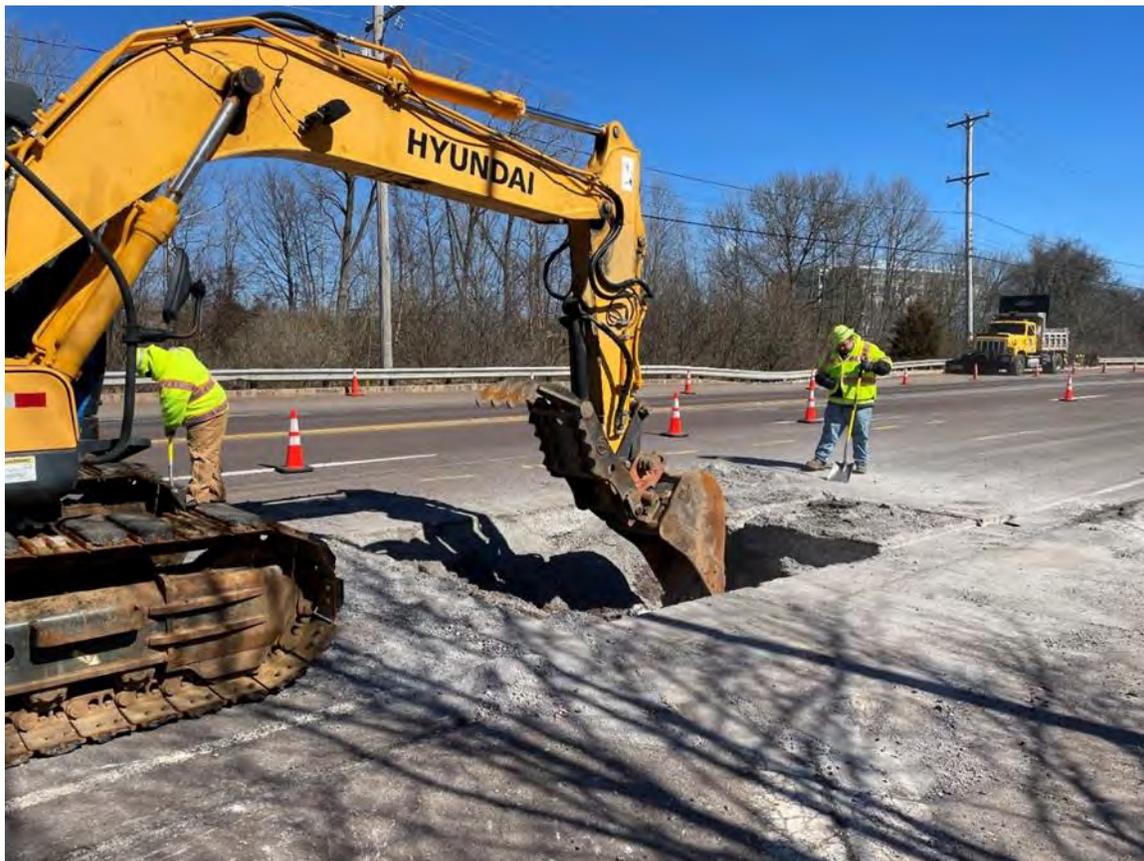
**Figure 3 – Sinkhole Repair on I-476 Off-ramp with Chemical Road  
Southbound Lane Closed Prior to Closure of Chemical Road**

On February 28, 2021, a new sinkhole event in the outside northbound lane (across the roadway from the subsided area in the southbound lane) caused the NB I-476 off-ramp lane to be closed as shown on Figure 3. Due to continued observed subsidence on the roadway, PennDOT initiated the closure of Chemical Road on March 25, 2021, and classified the project as an “emergency” project. PennDOT initiated an emergency geotechnical and geophysical investigation to be conducted, led by Schnabel, to develop sinkhole treatment recommendations.
