# 72<sup>nd</sup> Highway Geology Symposium

## 2023 PROCEEDINGS

August 14-17, 2023 • Hotel Murano • Tacoma, Washington

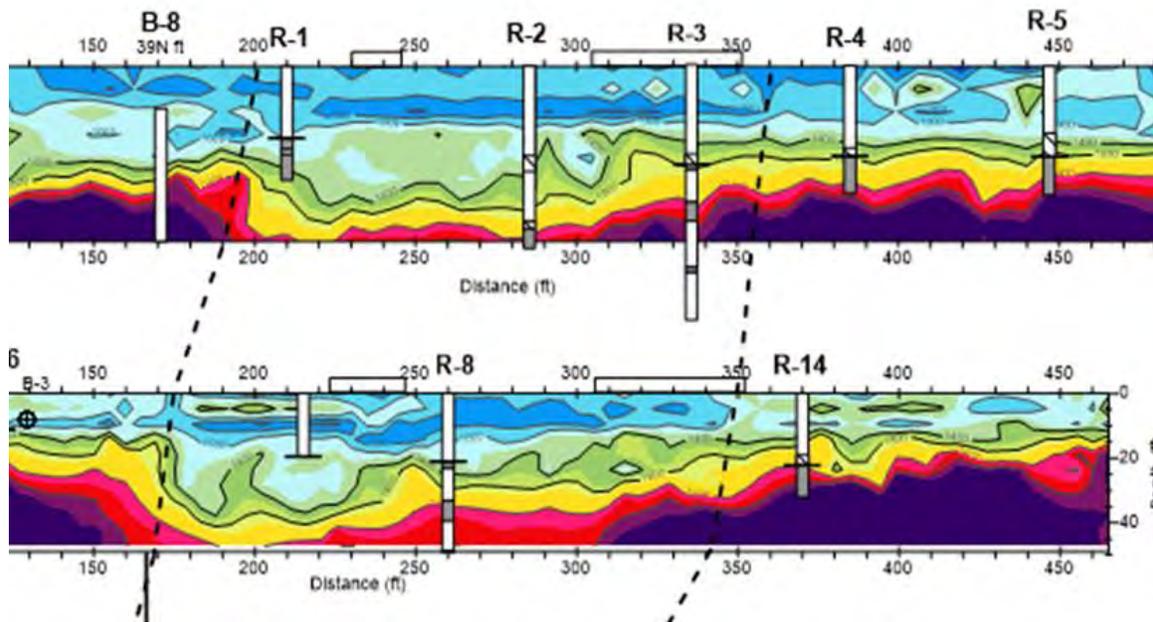
**Figure 4 – Example of Test Borings Plotted on Geophysical Cross-Sections**

To delineate the lateral and vertical extent of the roadway requiring remediation, the team initiated a subsurface investigation. Three geophysical methods were used: Ground Penetrating Radar to evaluate shallow subsidence features, and Electrical Resistivity Imaging and Multichannel Analysis of Surface Waves for assessing deeper karst features. Test boring locations were selected based on the geophysical results. As a result, continuous geophysical cross-sections (see Figure 4) with test boring data superimposed on them were created to interpret the site conditions and delineate the extent of sinkhole treatment.

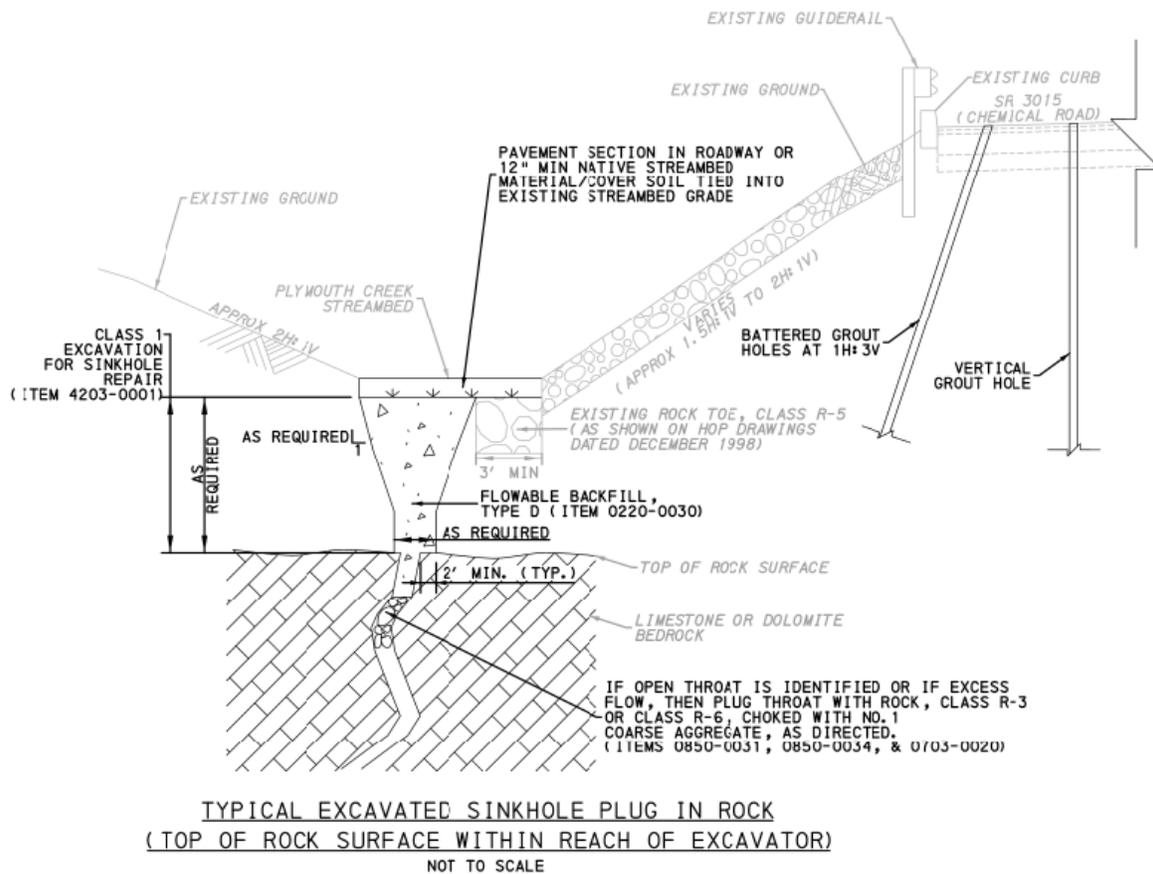
**Figure 5 – Sinkhole Plug Detail**

The scope of work within Plymouth Creek adjacent to the roadway embankment involved excavating loose material from within known/observed sinkholes and backfilling with flowable fill using the detail presented in Figure 5. This process is referred to as “plugging.” The excavated areas encountered rock pinnacles with areas of mixed soil/rock conditions. The visual observation of pinnacles confirmed the geophysical and geotechnical investigations and is typical of high-density sinkhole occurrences in shallow karst. Figure 6 shows the sinkhole plugging in Plymouth Creek.

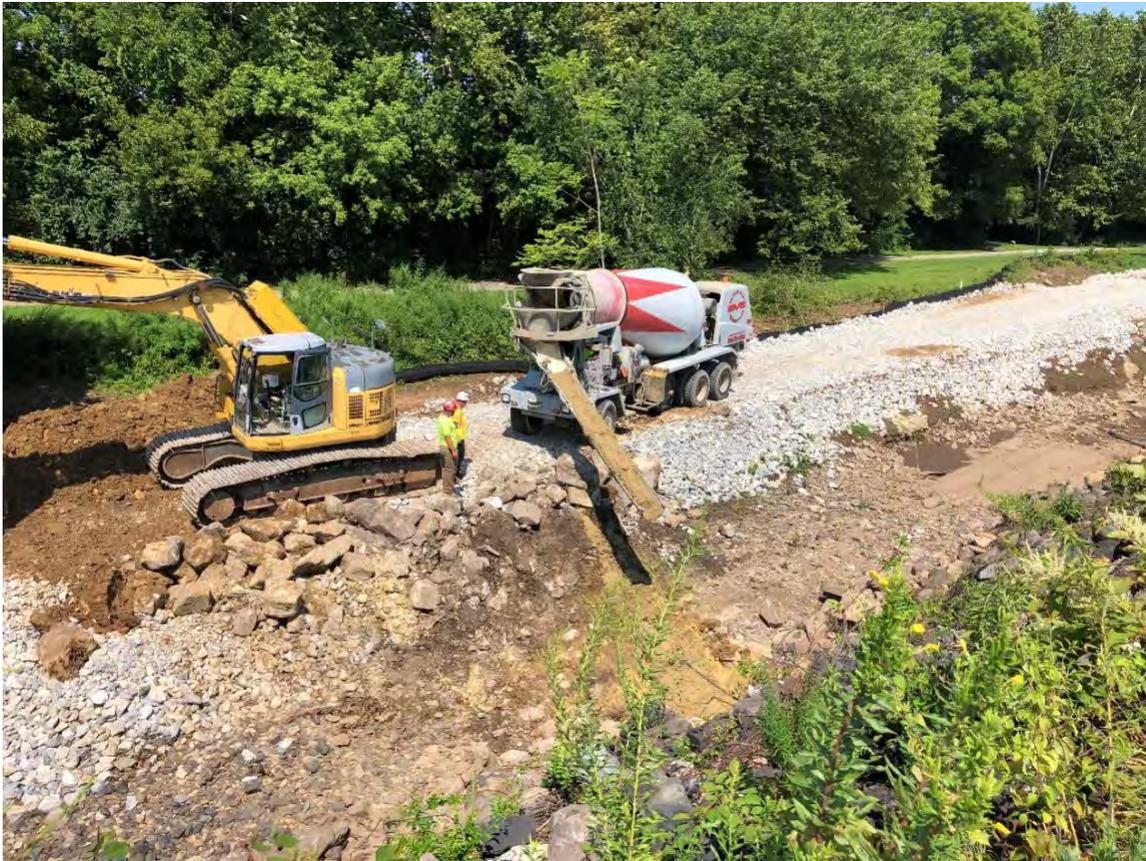
**Figure 6 – Sinkhole Plugging in Plymouth Creek**

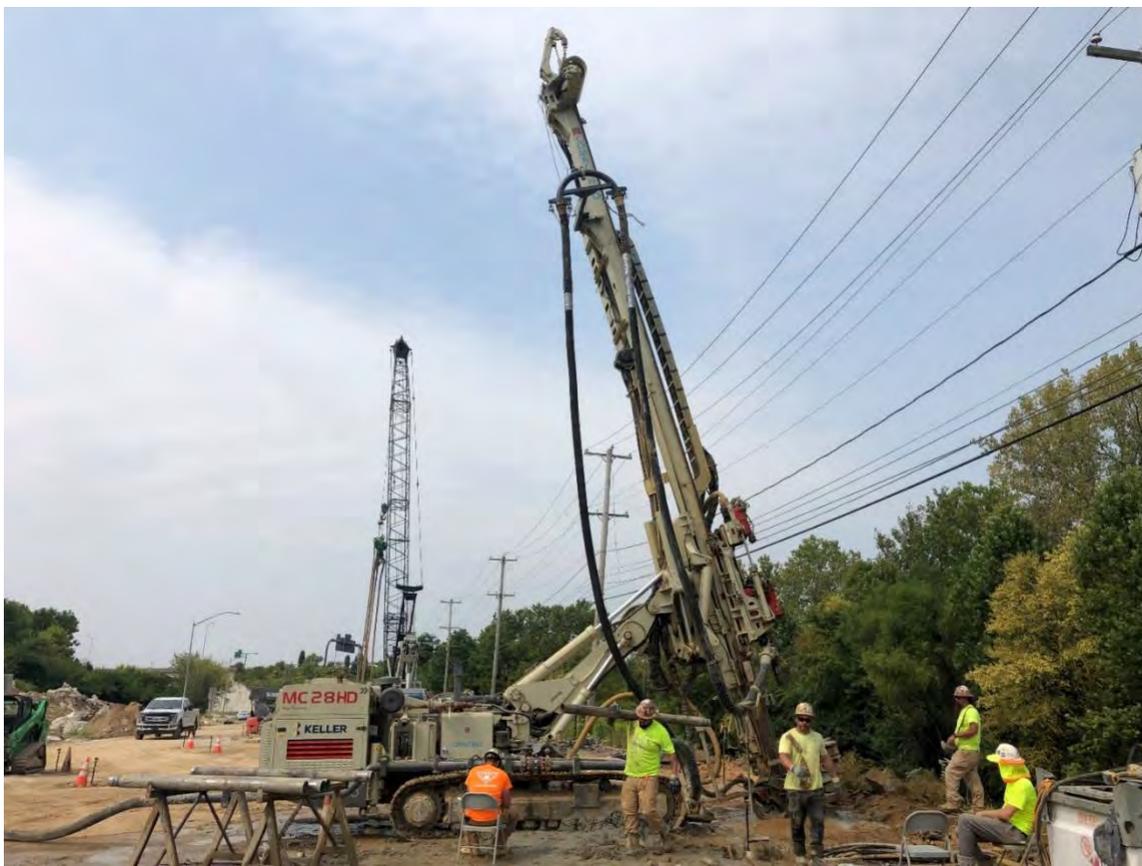
**Figure 7 – Battered Grout Hole Drilling at Embankment Slope Adjacent to Overhead Wires**

Keller used a Maxim Link-Belt LS-138H II crane, Comacchio MC 28 rig, and Klemm Bohrtechnik KR 801-3GS rig for the grouting operations. The MC 28 drilled battered holes as shown on Figure 7.

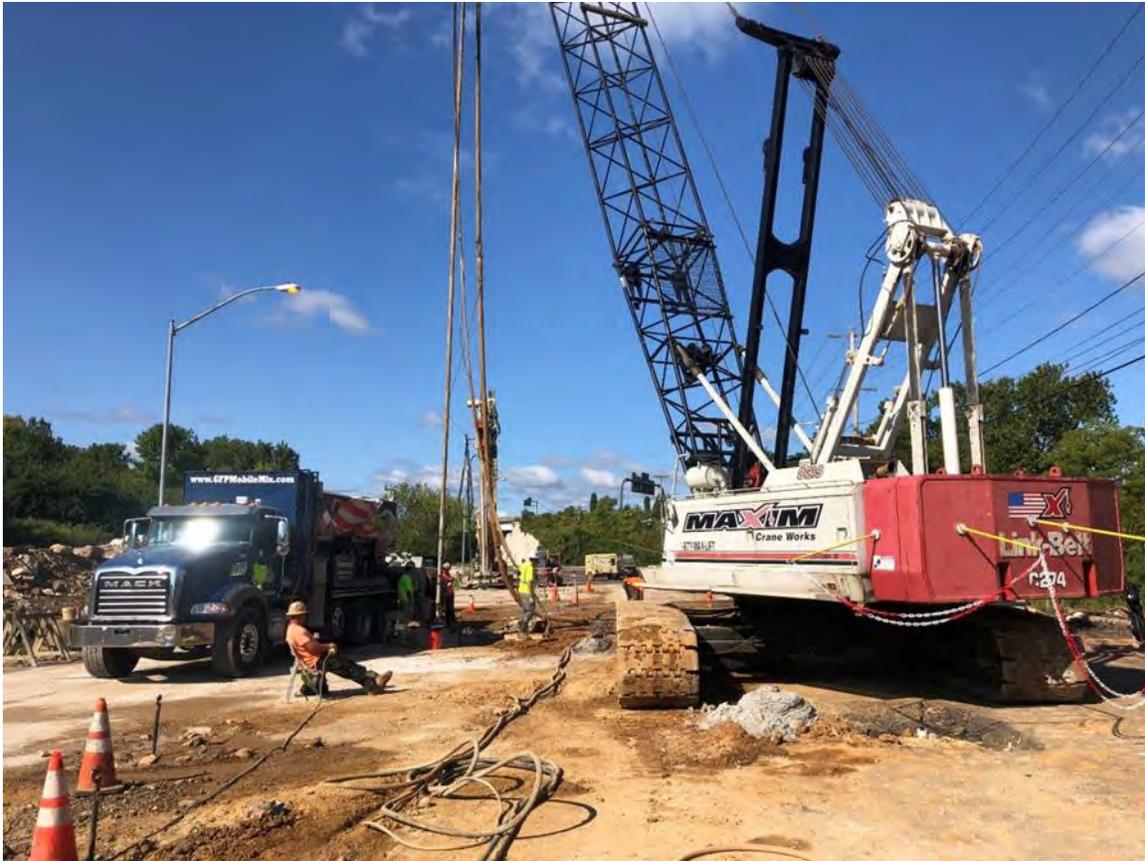
**Figure 8 – Limited Mobility Grouting With Crane Mounted Stinger and Mobile Grout Mix Batch Truck**

At the beginning of the project, Ready-mix grout was provided by JDM Materials Co. of Huntingdon Valley, Pennsylvania. However, due to pumpability issues with the JDM mix, Keller changed the grout supplier to GFP Mobile Mix Supply, LLC of Wilmington, Delaware (GFP Mobile), who batched the grout on site in their mobile-mix concrete truck. The mobile-mix concrete truck (shown in Figure 8) had the ability to mix the grout with specified proportions of cement, aggregate, and water as specified by on-site personnel. The grout was pumped through hoses and risers connected to the crane or rigs and down a 3.38-inch inner diameter flush-joint threaded casing for the two drill rigs, and a 3.5-inch inner diameter for the crane stinger.

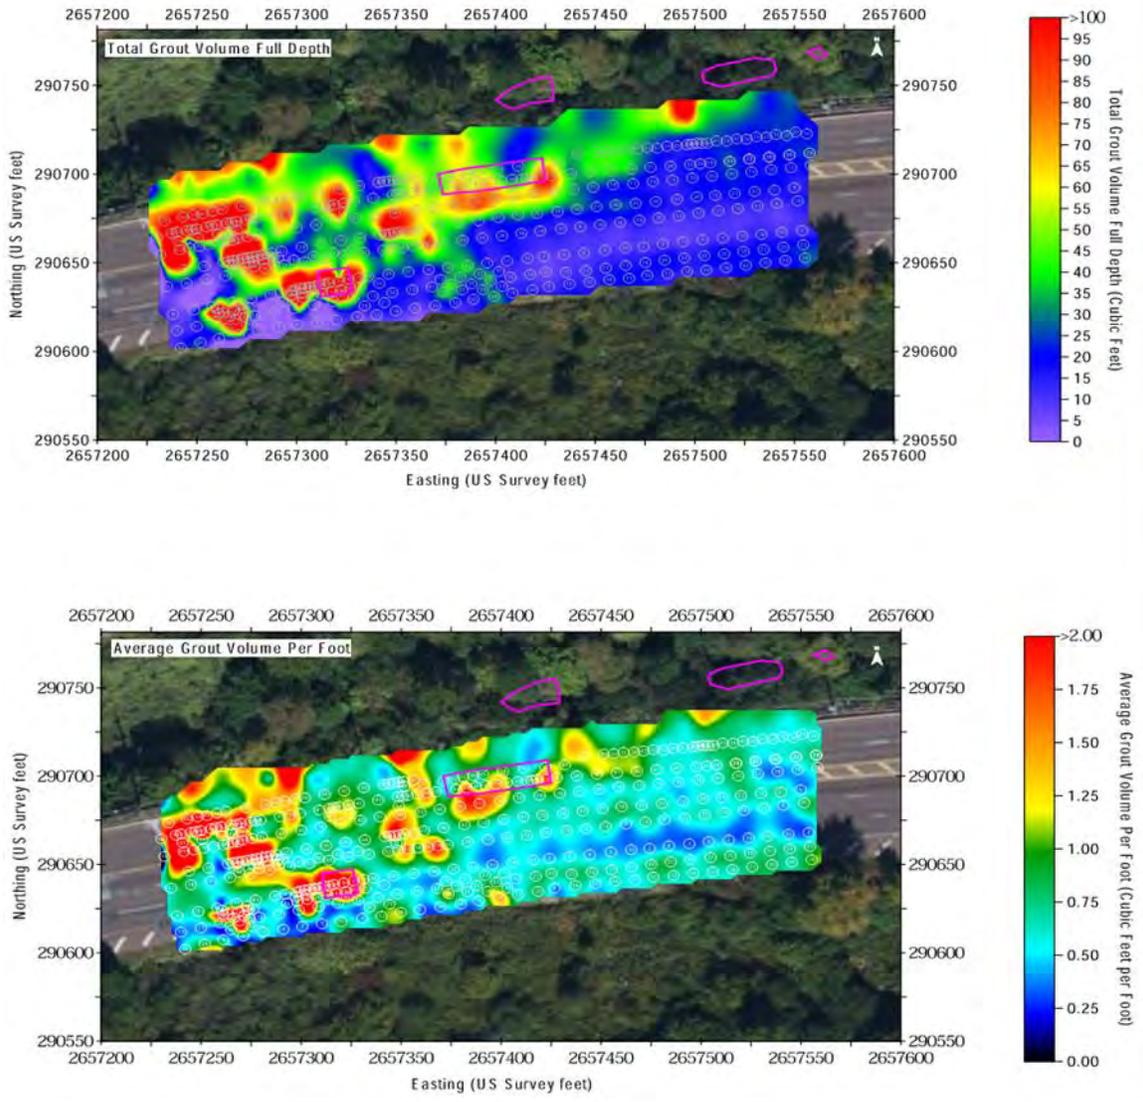
**Figure 9 – Total Grout Volume Full Depth (Top) and Average Grout Volume per Foot Depth (Bottom)**

Grout volumes per hole varied substantially across the site, ranging from 4.0 to 758.5 cf. The site contained areas of shallow rock where lower grout takes per hole were observed. Other areas contained deeper rock and suspected karst features based on drilling observations (rock pinnacles, open voids, soil-filled voids, etc.) where much higher grout takes per hole were recorded. Figure 9 shows a plan view representation of the grout volumes. The top image shows the total grout volume of each hole as a color contour, and the bottom shows the average grout volume per foot for each hole as a color contour. A summary of the average grout volumes per linear foot of drilling depth (cf/ft) is presented in Table 1.

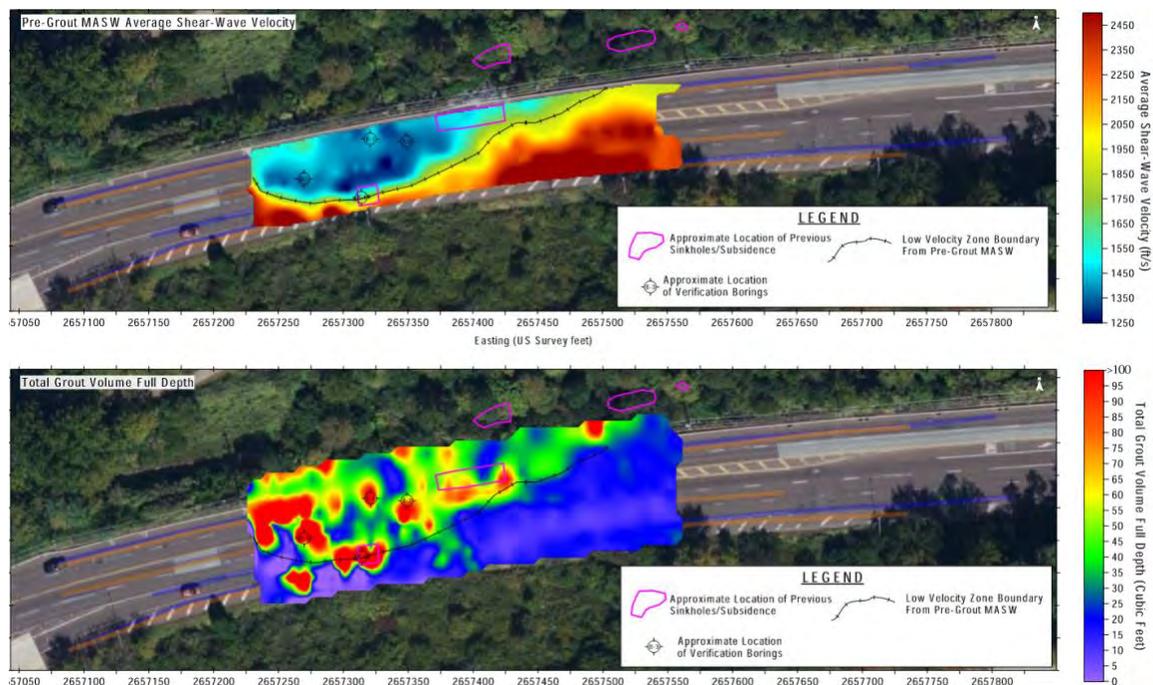
**Figure 10 – Average Shear Wave Velocity Full Depth (Top) and Total Grout Volume Full Depth (Bottom)**

Following grouting, one of the first steps was to compare the pre-grout shear wave velocity to total grout volumes. Figure 10 shows this contoured in plan view, trimmed to include only the areal extent that was grouted. The top image shows the average shear wave velocity among all depths, and the bottom image shows the total grout volume among the full grout hole depth. The total grout volume contours assume the grout injected stayed within the grout hole location, either in vertical holes or battered holes. In reality, it is possible that the grout migrated away from the grout hole in areas with weaker rock and looser, softer soils.

Comparing the two plots on Figure 10, the most notable feature is the correlation between the low velocity zone and the area with higher grout takes. This area is outlined and labeled the “low velocity zone boundary from pre-grout MASW” on the top image of Figure 10 and is based on the MASW results. Without MASW results north of the road, we cannot constrain the shape of this low velocity zone north of the road.

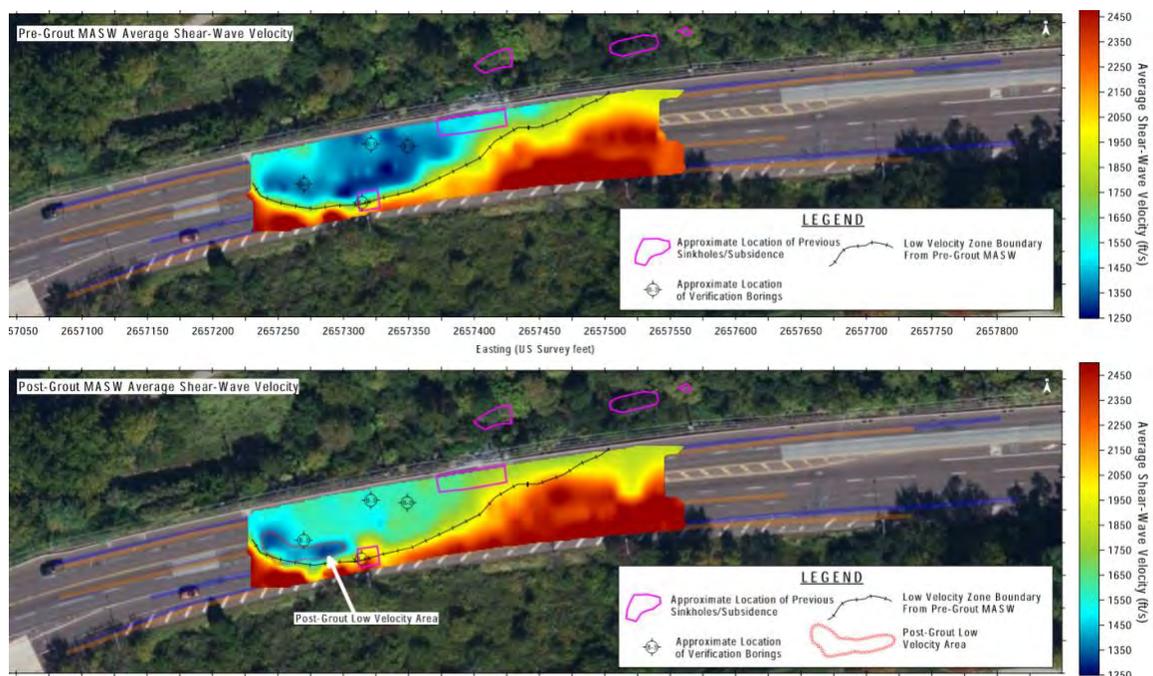
**Figure 11 – Average Shear Wave Velocity Before Grouting (Top) and Shear Wave Velocity After Grouting (Bottom)**

All the MASW lines show an increase in velocity in the area referred to as the “low velocity zone boundary from pre-grout MASW” as shown in Figure 11. These areas also correspond with the greatest amount of grout volumes that were injected; this was interpreted to mean that the grout has increased the velocity, meaning the areas that were grouted were densified compared to before the grouting program.

Figure 11 displays the pre- and post-grout shear wave average velocity in plan view; the top image is the same as that on Figure 10, but the bottom image shows the post-grout MASW average shear wave velocity. Within the low velocity zone from pre-grout MASW, the average shear wave velocity generally increased from about 1,479 ft/sec before grouting to about 1,634 ft/sec after grout injection: a 155 ft/sec change. This increase of about 10% is an indication that the grouting program densified and stiffened the low velocity soil zone that was observed in the pre-grout MASW.

A location to note is in the southwest corner of the low velocity zone, where there is an area where the velocity did not increase after grouting. This area is called out on Figure 11 as the “post-grout low velocity area.” It was observed that this is an area mostly observed on Lines 2 and 3 at a depth of about 25 to 40 ft, and it is a zone where the velocity appears to have not increased in velocity post grout. In these areas, the average velocity is about 1,409 ft/sec, and there was a negligible change. Verification Boring B-3 is located just to the outside of the “Post-Grout Low Velocity Area.” The log of B-3 shows highly variable materials including intermittent soft soils and zones of no recovery, weight-of-hammer (WOH) materials, and thin dolomite layers. The location and specific depths from B-3 do not line up exactly with the post-grout low velocity zone. This is expected because of variations in resolution between test borings and MASW, and the offset of B-3 from the low velocity zone in highly variable subsurface conditions. In this general area, grout drill holes encountered rock at depths of approximately 9 to 16 ft below ground surface. These grout holes were generally terminated 5 ft into rock in accordance with the grouting plan. Based on the grout drill hole data, the “Post-Grout Low Velocity Area” may be situated below a rock ledge; therefore, this low velocity area was likely not grouted because the drilling refusal criteria was achieved prior to encountering it.

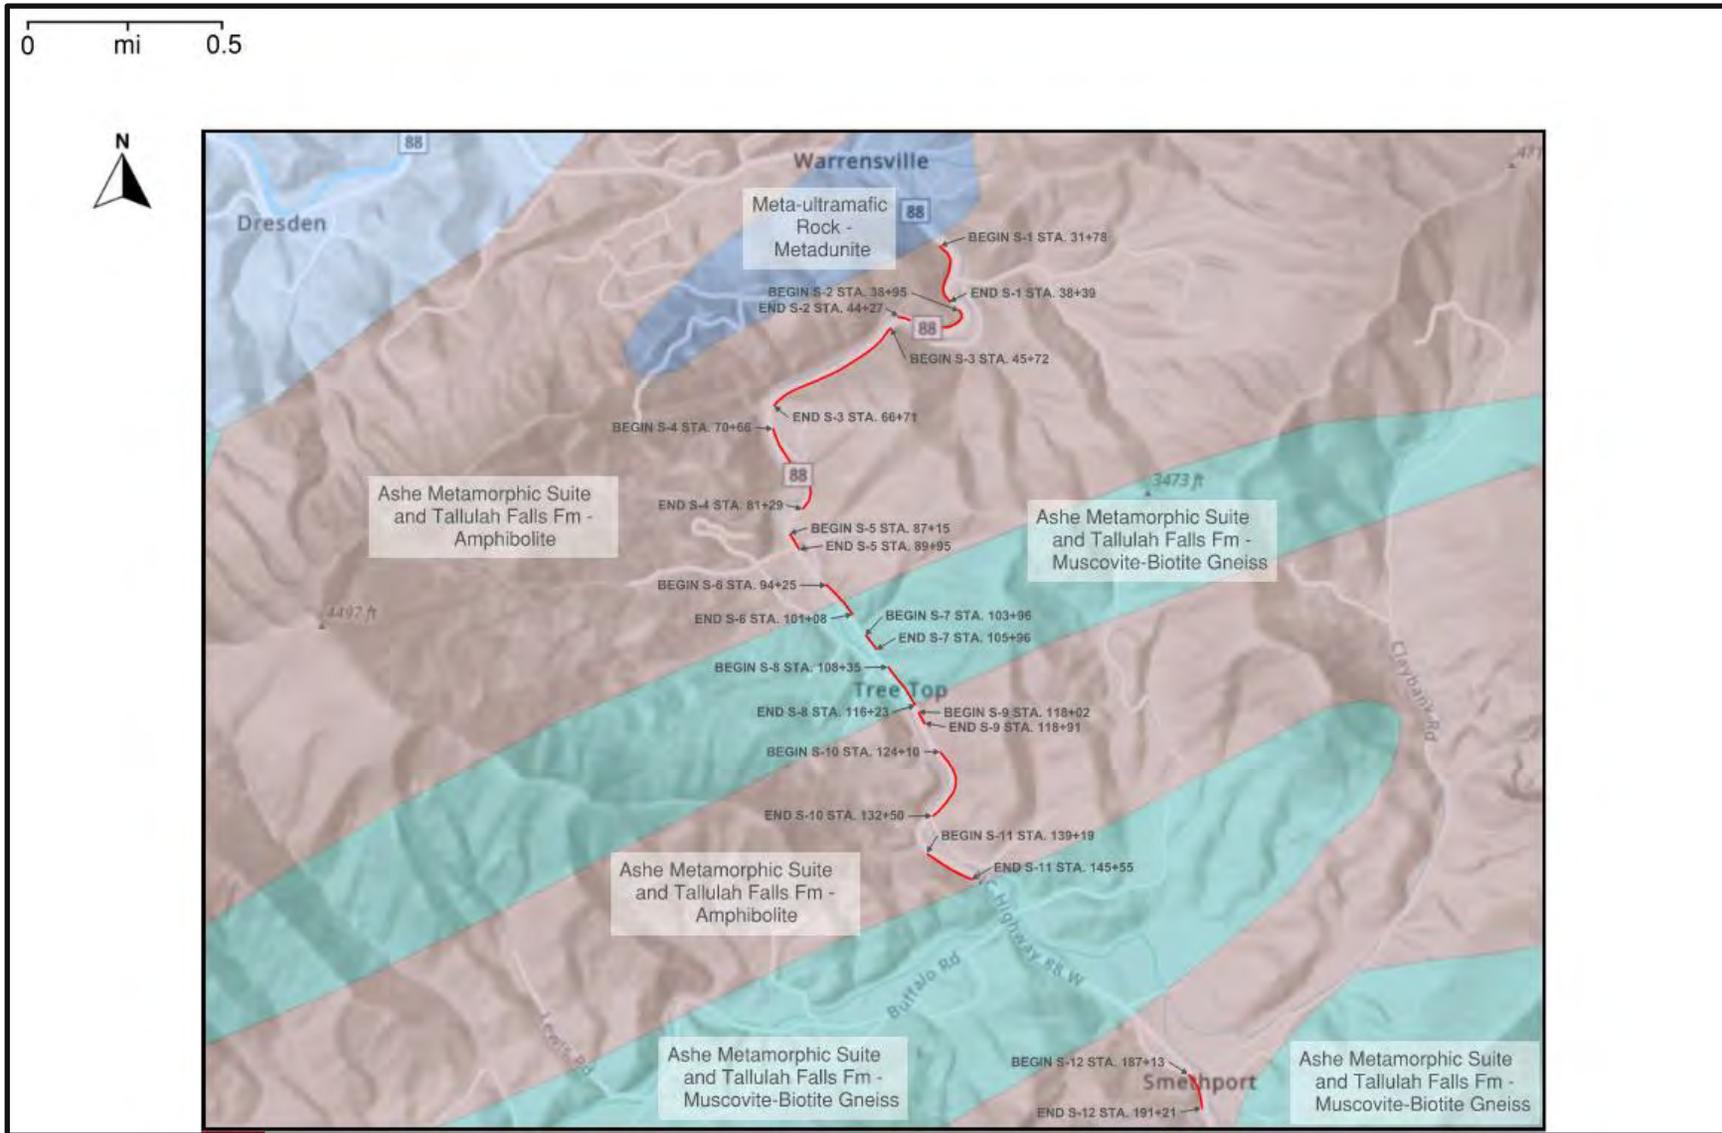
Figure 2 – Geologic Map & Slope Segments along NC-88 Project Corridor

The project alignment is situated in the Blue Ridge Physiographic Province where topographic relief is moderate to high, with massive resistant rocks producing mountain and ridge tops, with subsequent valleys tending to follow weaker rock deposits. The dominant lithology of the slopes is equigranular amphibolite but muscovite-biotite gneiss and schist are also present, all of which belong to the Ashe Metamorphic Suite and Tallulah Falls Formation of the late Proterozoic eon (NCGS, 1985). Figure 2 provides a regional geologic map of the project corridor with associated slope rock cut segments.

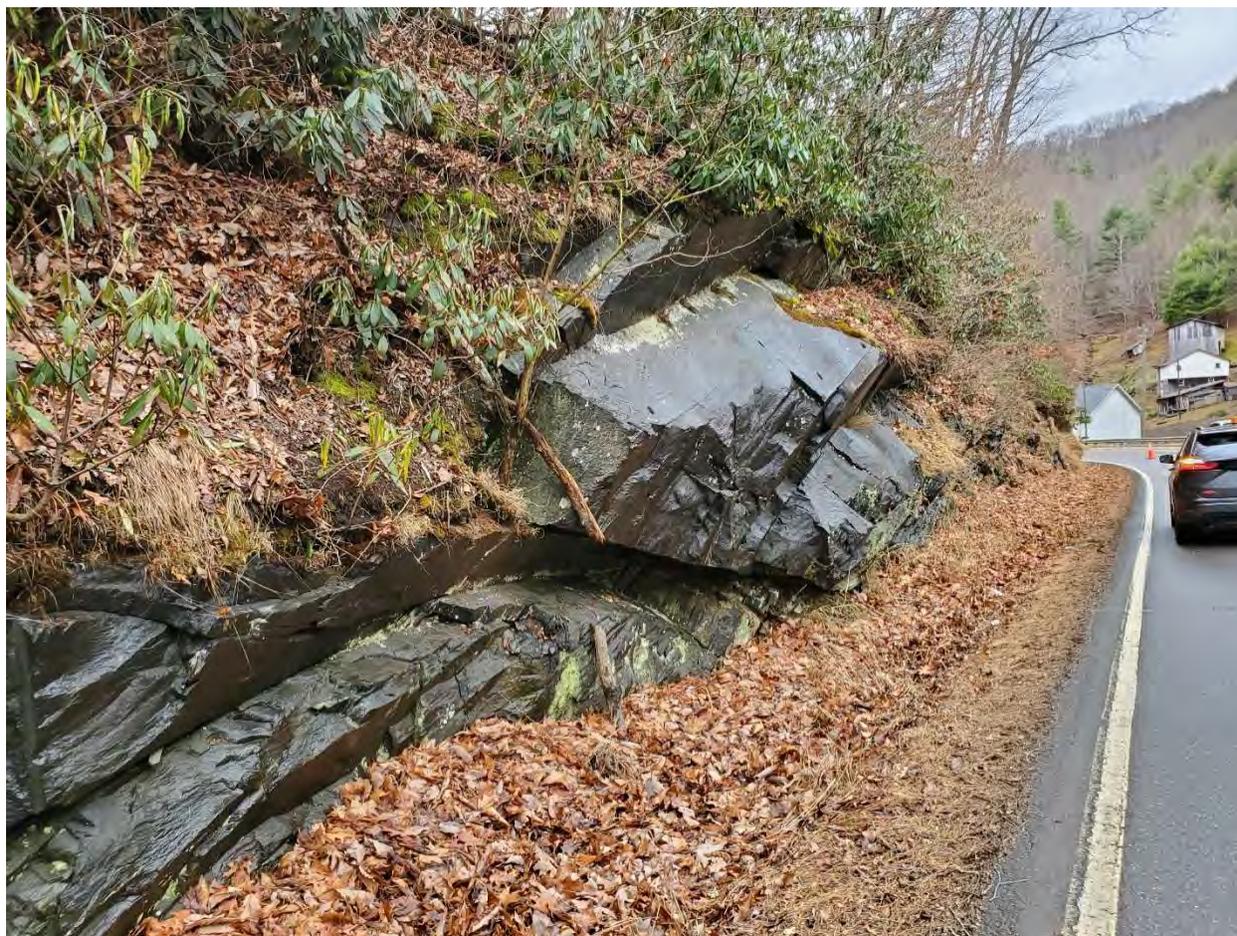
**Photo 1 – Loose Block (Toppling Hazard)**

HDR contacted NCDOT Division personnel regarding rockfall history along the corridor. According to these personnel, to-date only minor activity has been recorded; however, observations of the existing cuts revealed loose overhanging wedge blocks associated with widely-spaced joint and foliation surfaces (Photo 1).

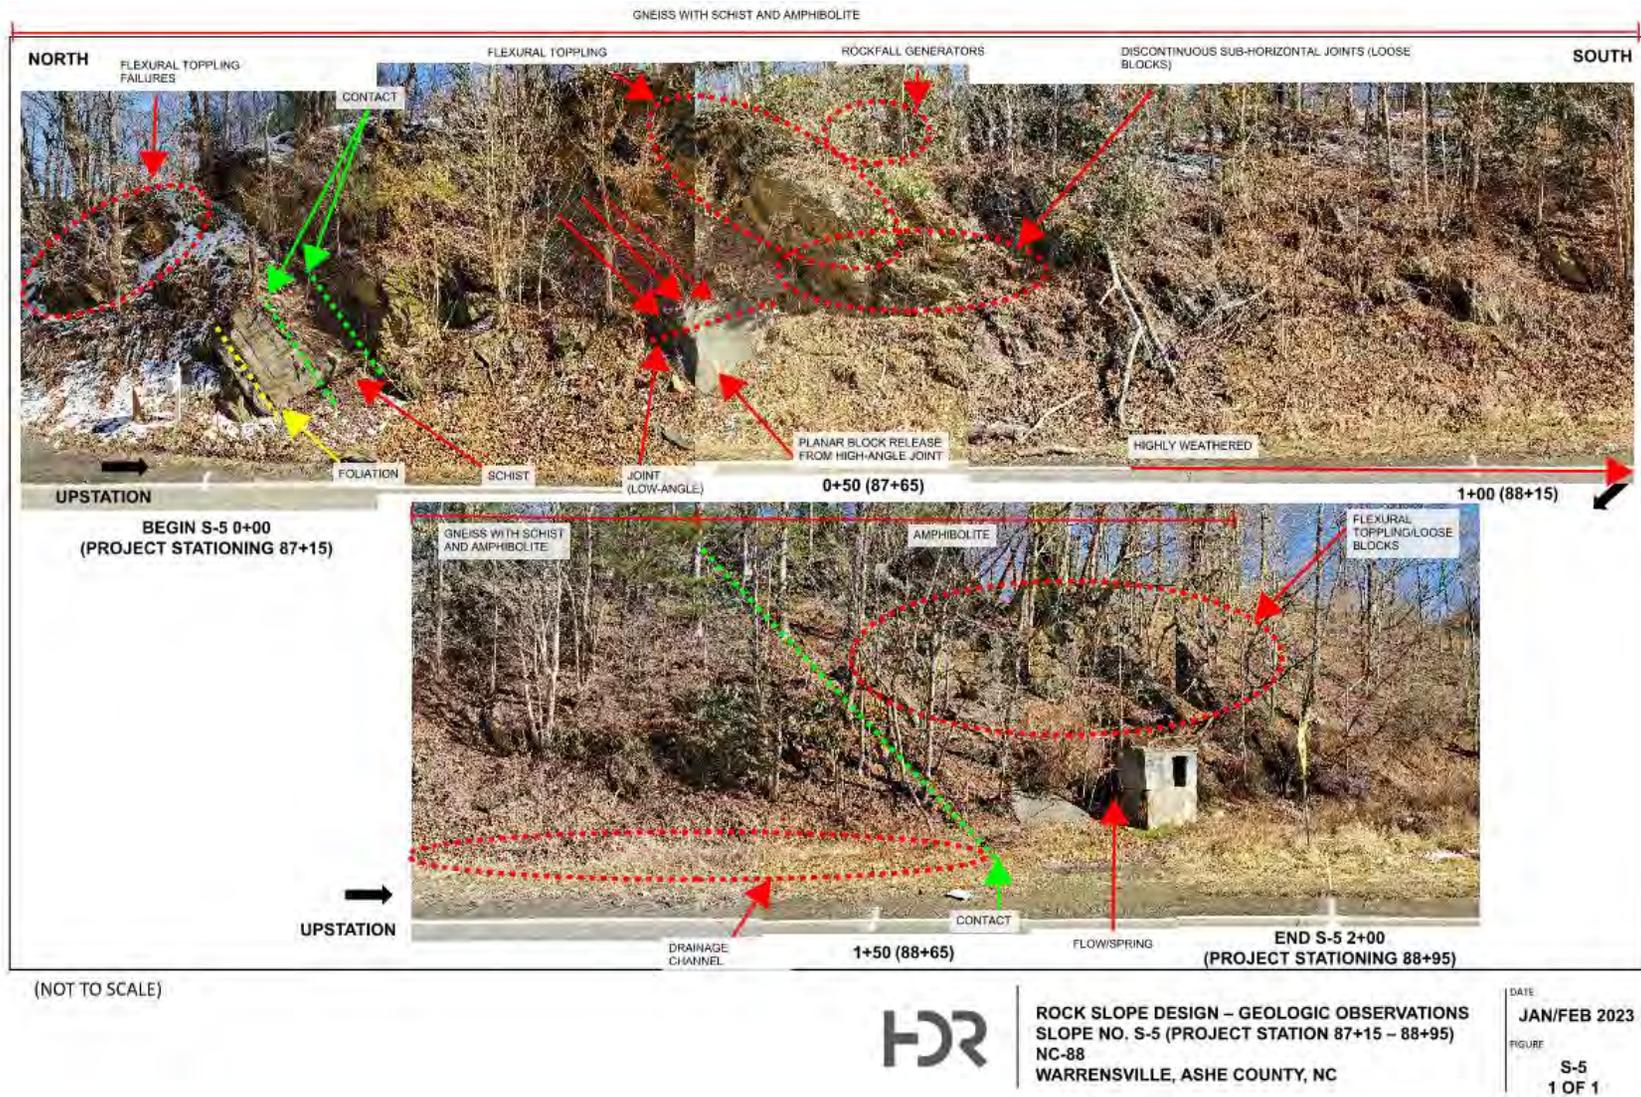
Figure 3 – Photomosaic Sheet for Slope S-5

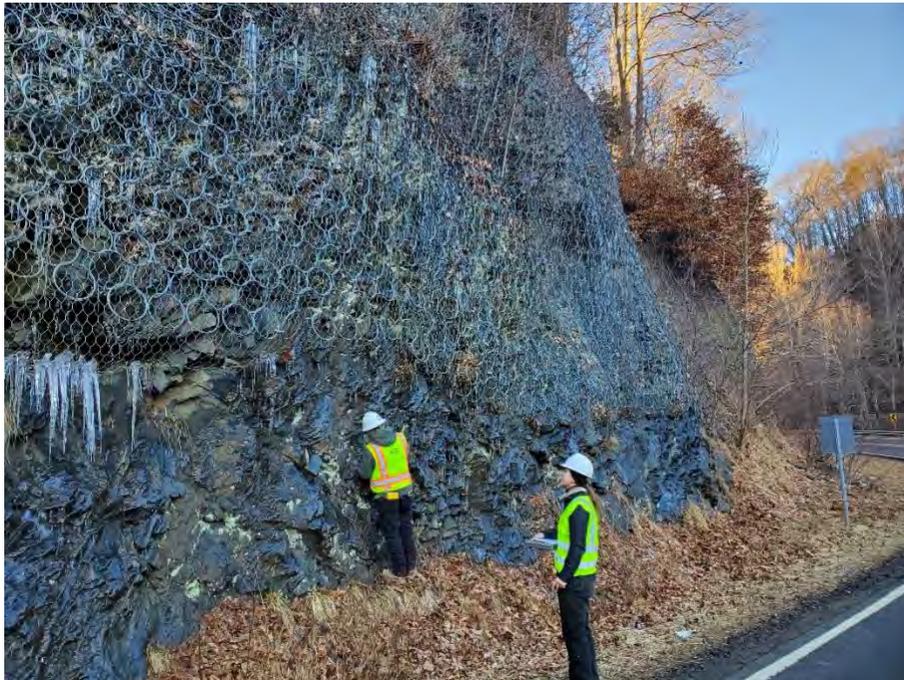
Measurements of discontinuity conditions and orientations were recorded on field data sheets, including approximate station, plane and rock type, dip / dip direction, length / separation / amplitude. Over 1,100 discontinuity measurements were taken on foliations and joint sets along the slopes (Photo 2).

**Photo 2 – Geologic Structure Mapping at slope S-2**

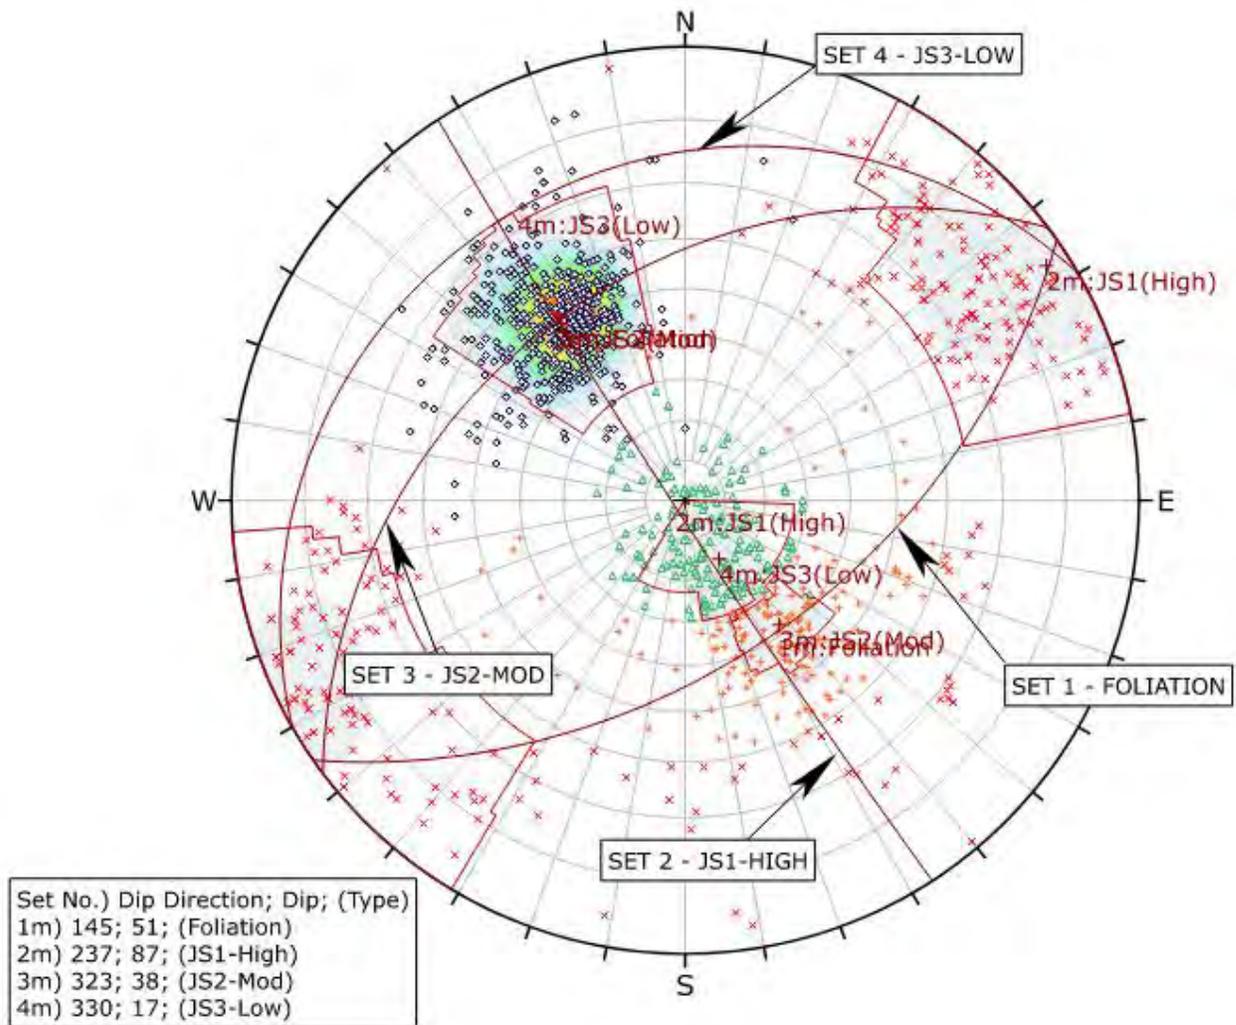
Initially the discontinuity orientations were separated by slope; however, foliation and joint trends at each slope appeared to be relatively similar to each other and were thus combined (Figure 4).

Figure 4 – Stereographic Pole-Plot Projection – All Discontinuities Combined

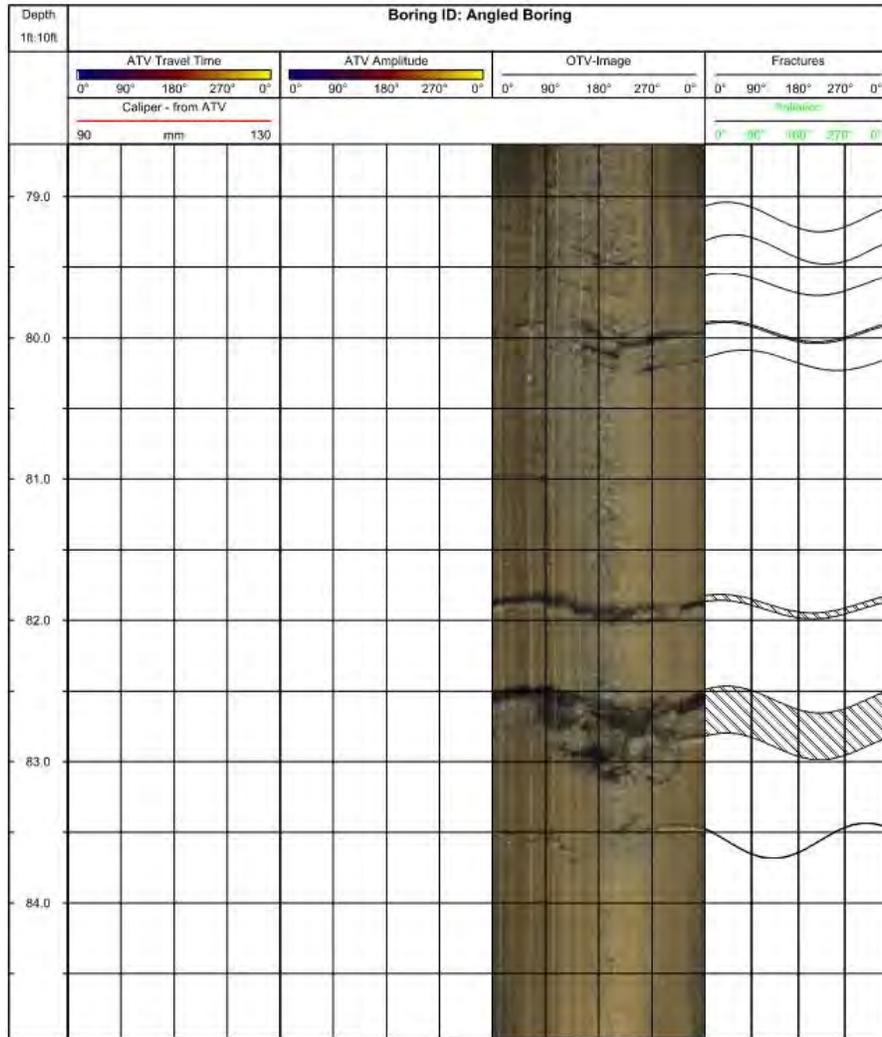
**Photo 4 – Optical Televiewer in Angled Boring**

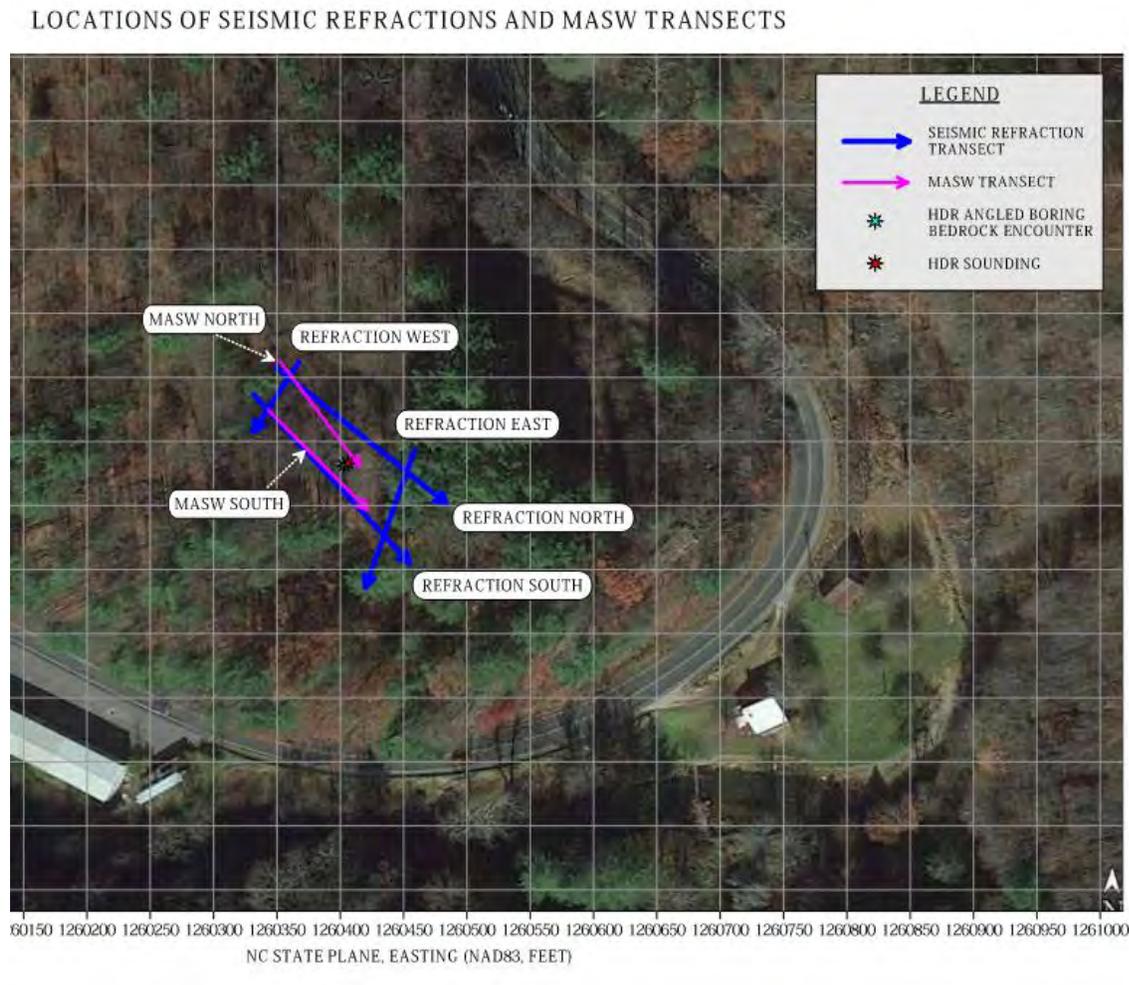
To estimate overburden thicknesses and rockline trends at the proposed mountain cut, four seismic refraction transit lines and two Multi-channel Analysis of Surface Waves (MASW) transit lines were oriented as depicted in Figure 5.

**Figure 5 – Seismic Refraction & MASW Transit Lines**

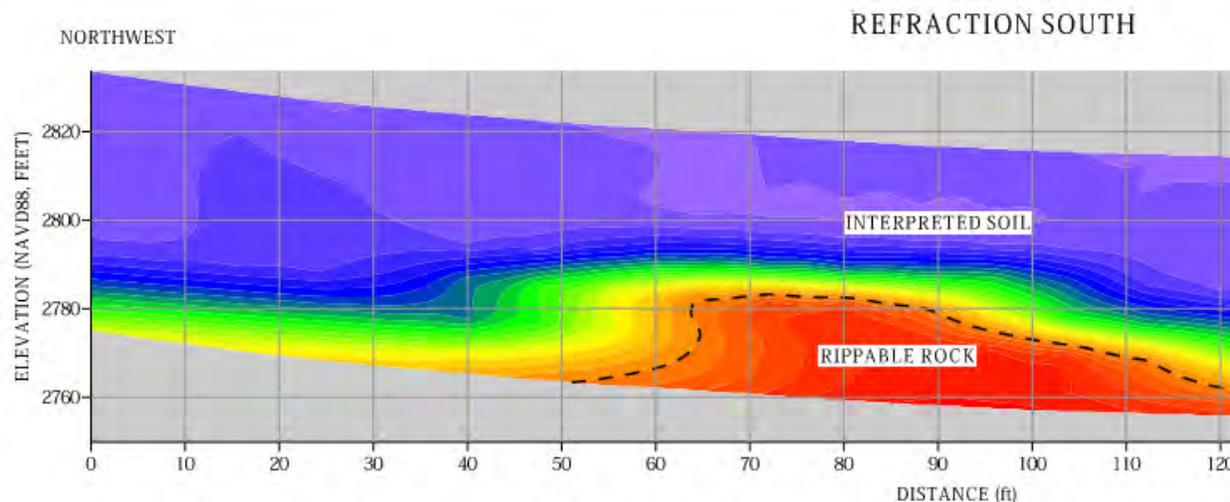
P- and S-wave velocities were mapped at each transit cross section and compared against the Caterpillar Performance Handbook (Edition 48) to correlate seismic wave velocities against rippable (crystalline rock) or non-rippable (residual soil / saprolite).

Results show a significantly thicker level of overburden (greater than 20-ft) than initially anticipated due to the presence of crystalline rock outcrops at the slope crest. Figure 6 presents an example of the southern seismic refraction slope transect.

**Figure 6 – Example of Seismic Refraction South Transect**

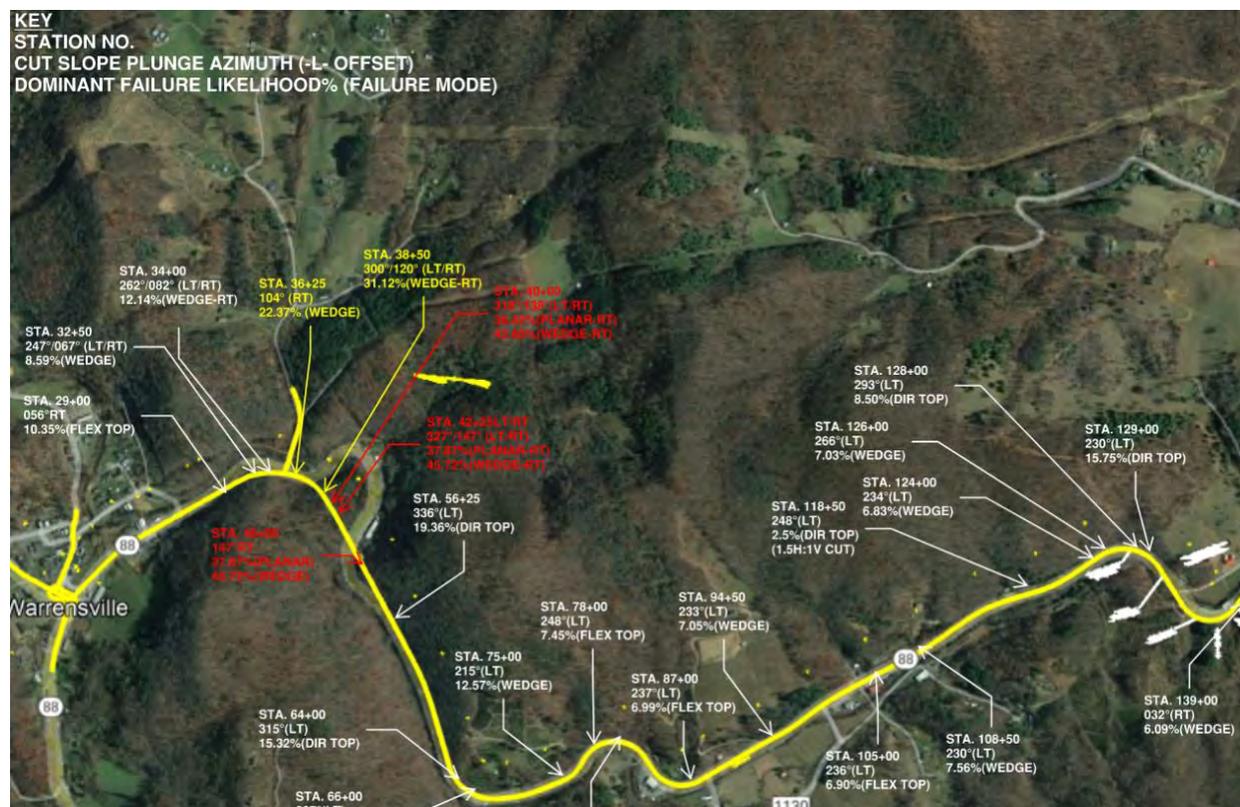
These aggregate trends were used for Kinematic analyses, which assess the potential / likelihood for global rock instabilities caused by bedrock discontinuity orientations relative to an existing or proposed rock cut. Global slope failure conditions are categorized into planar sliding, wedge sliding, and flexural / direct toppling. Thirty-two (32) cut orientations were estimated across the proposed alignment and compared against the aggregate joint and foliation trends with 45° (1:1) and 63° (0.5:1) cuts. Results indicate most rock cuts oriented with a 1:1 cut show a low likelihood of failure. However, a 0.5:1 cut angle results in potential daylighting of the predominant foliation discontinuity, which indicates a moderate to high likelihood of planar and wedge sliding failures for cut slopes dipping to the southeast, coinciding with sections of the corridor mountain cut (Figure 7).

Figure 7 – Example of Kinematic Analysis Summary for 0.5:1 Rock Cuts

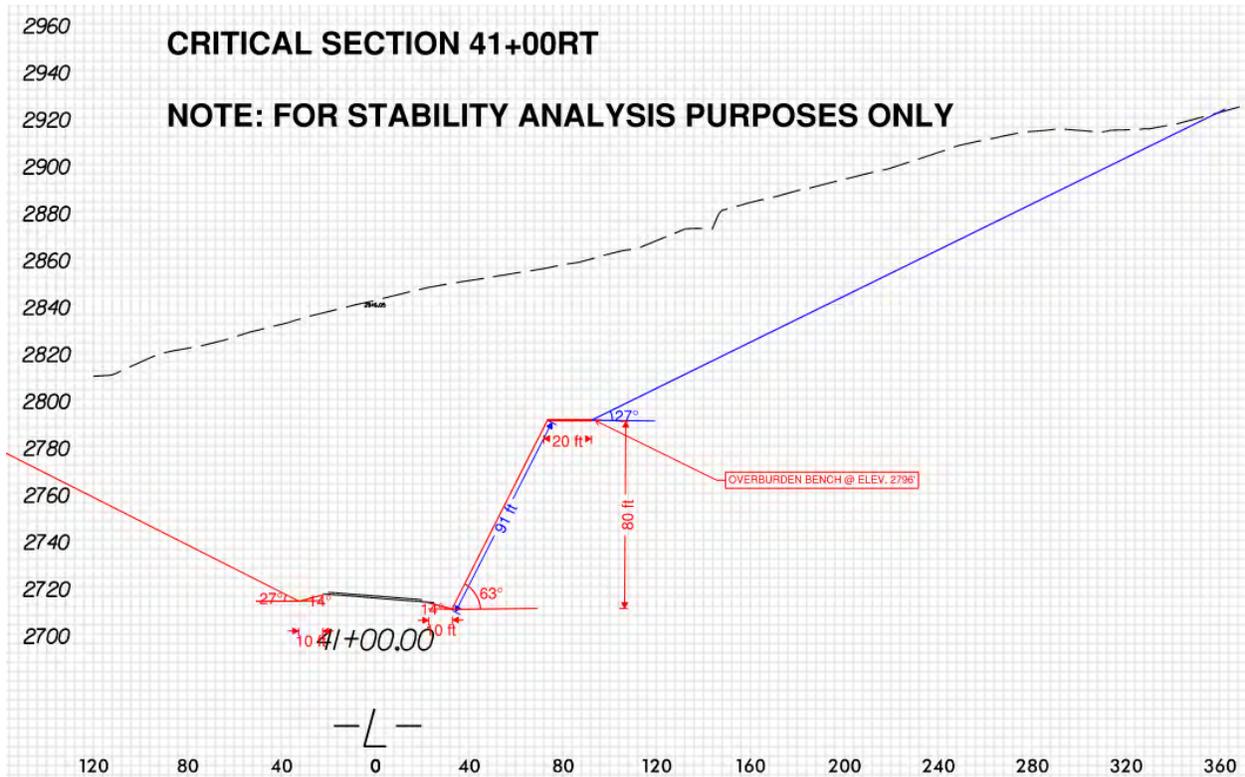
Figure 8 presents the critical section used for stability analyses. A FS  $\geq 1.5$  requires an external force of 128 kips/ft installed perpendicular to the rock cut face (27° down from horizontal) as shown on the 2-D perspective (Figure 9).

Figure 8 – Critical Section used for Planar Stability Analysis

- 1) GEOMETRY
  - a. Slope Height,  $h = 80$  ft. (benched).
  - b. Slope Angle =  $63^\circ$  (0.5:1).
  - c. Failure Plane Angle =  $51^\circ$ .
  - d. Upper Face Angle =  $0^\circ$ . (bench surface with 20 ft width).
- 2) BARTON-BANDIS SHEAR STRENGTH INPUTS (failure on foliation plane in amphibolite with thin interlayers of mica schist and biotite gneiss; assume mean of mica schist UCS estimates).
  - a. Joint Roughness Coefficient (JRC) = 2.7 (based on in situ joint amplitude/lengths)
  - b. Joint Compressive Strength (JCS) =  $850 \text{ kips/ft}^2 / 2.5 = 340 \text{ kips/ft}^2$
  - c. Base (Residual Friction) Angle,  $\phi_{\text{res}} = 23^\circ$  (referenced for mica schist)
  - d. Rock Unit Weight =  $0.172 \text{ kips/ft}^3$
- 3) PLANE WATER PRESSURE
  - a. 40% of slope height filled with Toe Distribution Model.

- a. Force applied to the slope surface to estimate required anchor force (kips/ft – force per foot of width of potential planar block) to provide a factor of safety (FS)  $\geq 1.5$ .
- b. Using these inputs without rock anchor/external force, the FS is 0.29.
