# 72<sup>nd</sup> Highway Geology Symposium

## 2023 PROCEEDINGS

August 14-17, 2023 • Hotel Murano • Tacoma, Washington

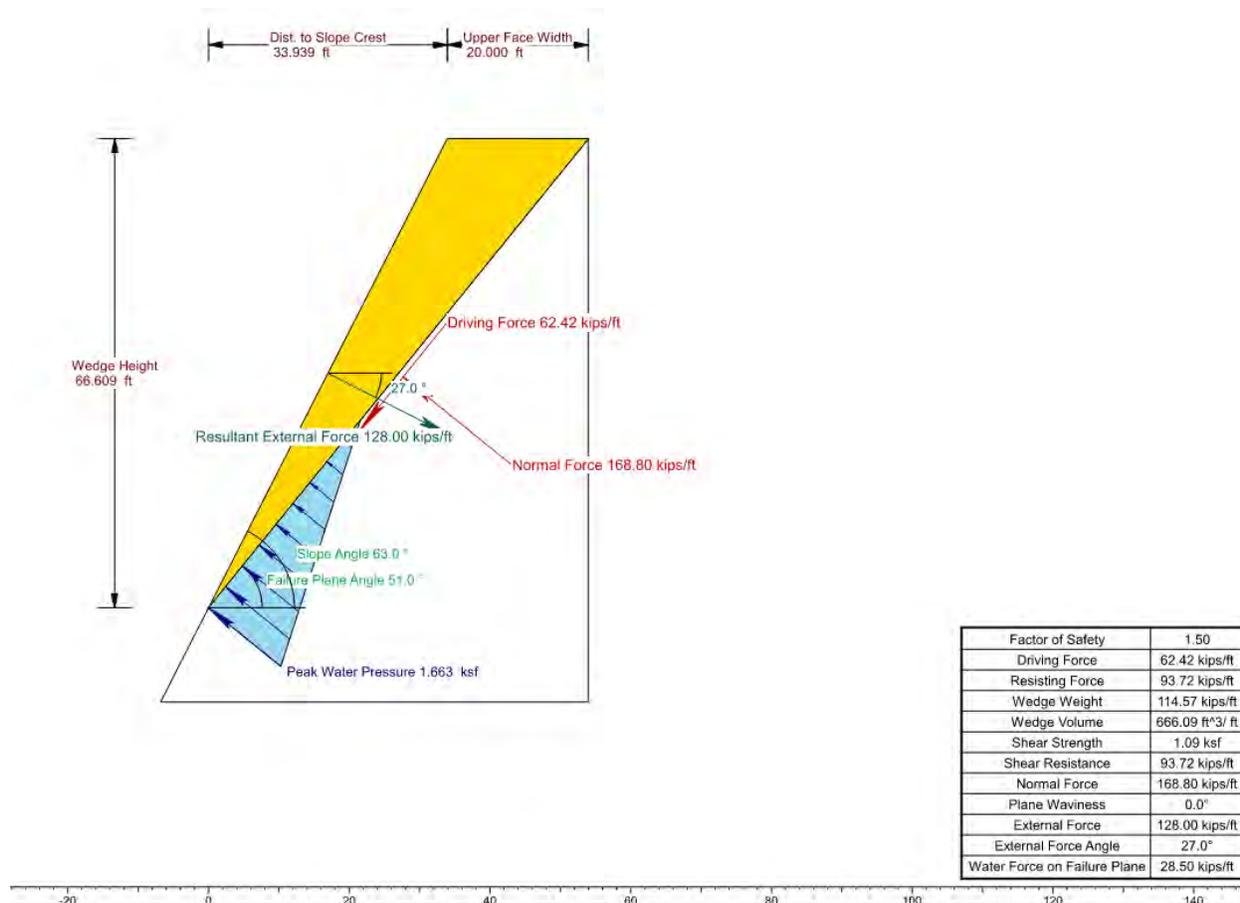
Figure 8 presents the critical section used for stability analyses. A FS  $\geq 1.5$  requires an external force of 128 kips/ft installed perpendicular to the rock cut face (27° down from horizontal) as shown on the 2-D perspective (Figure 9).

**Figure 9 – 2-D Perspective of Planar Feature from Stability Analysis**

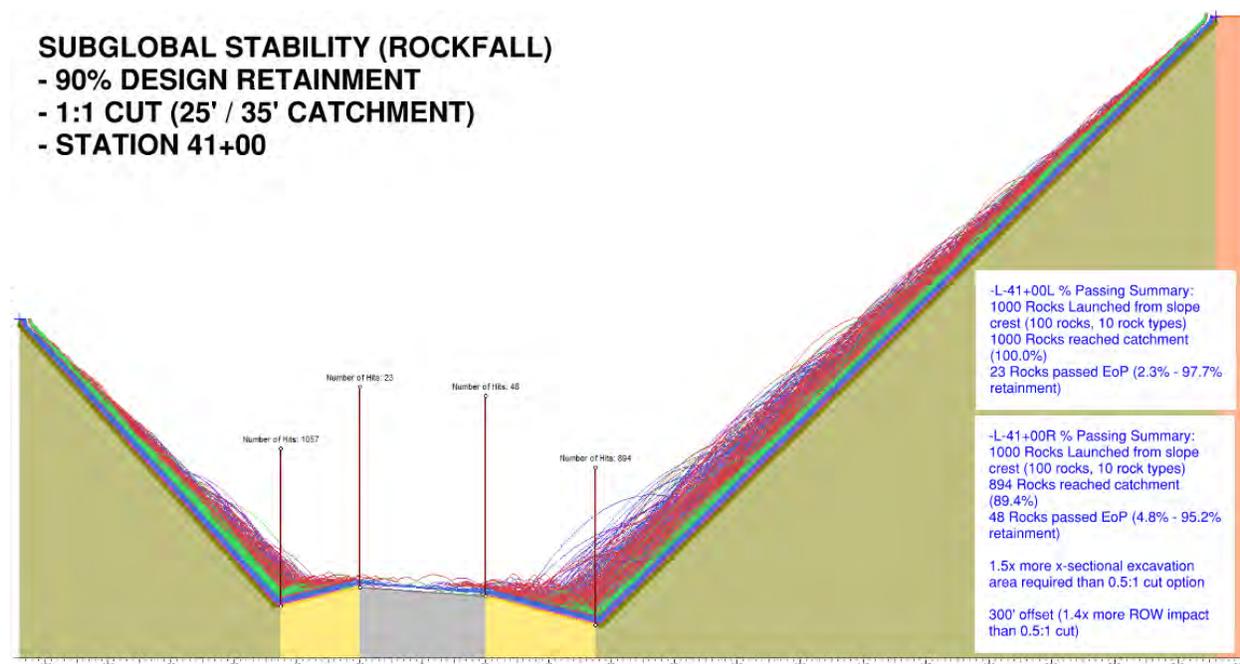
For analysis purposes, rockfall generator (seeder) elevations were defined and characterized based on observable outcrops / exposures, subsurface investigation data (where available), and slope cross-section features. Amphibolite and schistose gneiss with density values of 180 and 175 pcf (respectively) and block sizes of 1'x1', 1'x2', 2'x3', 5'x6', and 6'x6' were simulated as rock seeder projectiles. Horizontal and vertical starting velocities for each seeder of 1 ft/sec were used and 100 rockfall events were modeled for each rock seeder type at each seeder elevation (1,000 total rockfalls per seeder). An example output cross section of a 1:1 cut is provided in Figure 10.

**Figure 10 – 2-D RocFall Output (1:1 Cut, expanded rockfall catchment, Sta. 41+00)**

The rockfall analysis results regarding percentage of modeled rocks reaching the catchment and passing over the edge of pavement were summarized and tabulated for NCDOT. Outputs also included average and maximum bounce heights and total kinetic energies, which were used to develop rockfall protection systems, where needed.

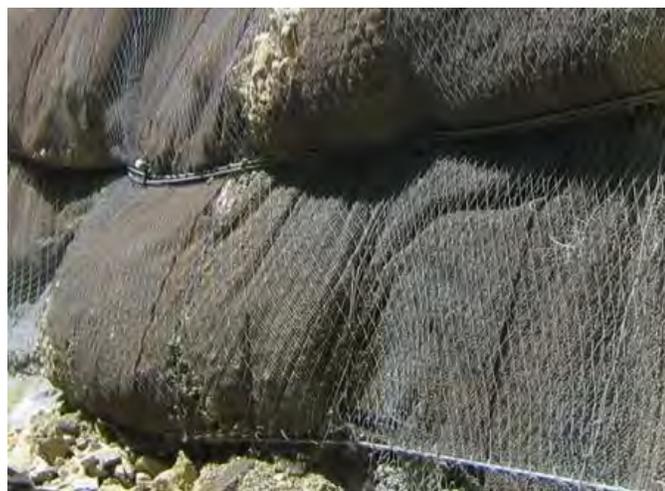
**Figure 1: Large Punch Displacement of Flexible Structural Facing Loaded by the Soil as the Cables Reduce Mesh Displacement**

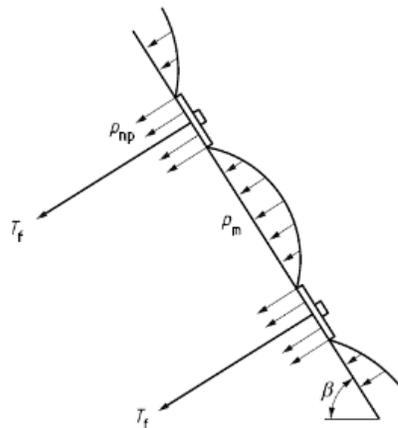
As per the British Standard 8006-2, Flexible Structural Facing, for soil nailing application, may be used to provide long-term stability of the face by supporting the soil between nail locations and transmitting the load from the soil to the soil nails via the nail heads. Flexible facing may be used to provide support through the mobilization of tensile forces within them, and therefore some deformation is required for a component of these forces to act normal to the face. Flexible facings are not normally recommended for permanent slopes in excess of 60° to 70°.

**Figure 2: Flexible Structural Facing (BS 8006-2)**

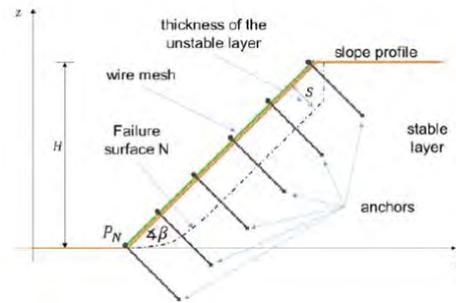
With reference to the simplified two-dimensional model for the reinforcement of the surficial unstable layer of a soil slope shown in Figure 3, a sub-structuring approach is used to study the stability of the surficial soil mass separately from other structural components.

**Figure 3: Model of An Unstable Soil Slope Reinforced with a Passive Anchored Wire Mesh**

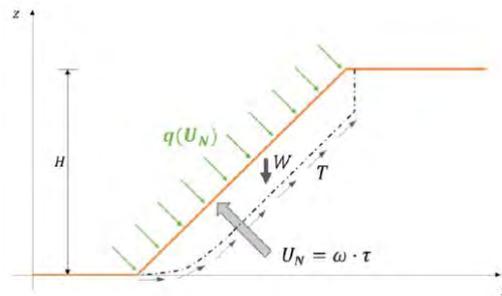
**Figure 4: Forces Involved in the Model of An Unstable Soil Slope Reinforced with a Passive Anchored Wire Mesh**

The soil mass is subject to the self-weight,  $W$ , to the shear force,  $T$ , mobilized along its failure surface, and to the stabilizing contact pressure,  $q$ , arising between the mesh and the slope profile (Figure 4). In general, no initial pre-stressing action is imposed to the anchors, as passive intervention systems are only considered, and the contact pressure,  $q$ , is only mobilized upon the activation of a local normal displacement,  $U_N$ , of the soil. As a result, a relationship,  $q = q(U_N)$ , is introduced. From a structural point of view, the anchored steel wire mesh is then subjected to a displacement-controlled loading process governed by the normal component,  $U_N$ , of the underlying soil displacement profile.

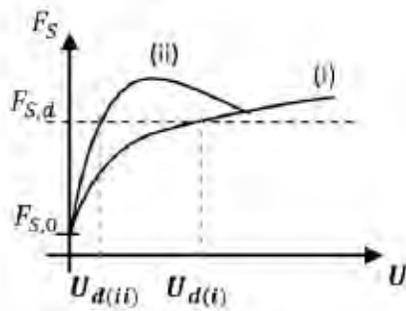
Equation (3), in fact, conceptually introduces a relationship between the safety level (generally expressed as  $FS$ ) and the soil displacement field, as sketched in Figure 5. Starting from the initial pre-intervention value of the safety factor,  $FS = 0$ , the designer can explicitly relate the chosen design value,  $FS_{d}$ , of the safety factor to the corresponding soil displacement amplitude, and to the working condition of the mesh.

**Figure 5: Relationship Between the Slope Safety Factor,  $FS$ , and the Soil Displacement for: (i) Ductile and (ii) Fragile Stabilizing Systems**

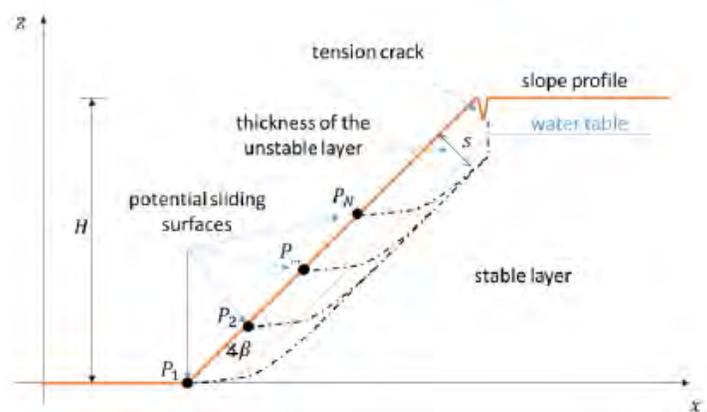
A sketch of the adopted slope profile is presented in Figure 6. In particular, a slope of total height,  $H$ , constituted by a homogeneous layer of granular material with uniform thickness,  $s$ , and slope angle inclination,  $\beta$ , along a stable deep layer, is considered. A water table at a uniform depth along the slope is present, and, depending on the mechanical properties of the unstable layer, tension cracks at the top of the slope may be considered.

**Figure 6: Slope Cross Section Model**

In this approach the stability analysis is run by approximating the sliding surfaces sketched in Figure 6 by means of a two-block failure mechanism along the slope, as shown in Figure 11. Each failure mechanism is composed by a layer of thickness,  $s$ , and length,  $L$ , sliding along the inclined plane according to a translational displacement field,  $U$ . The toe of the failure mechanism is instead composed of a rigid triangular block (points  $P'-P''-Q$ ), sliding along its base failure plane of a quantity,  $U_T$ , corresponding to a normal displacement component,  $U_N$ , with respect to the slope over a length,  $L_a$  (between points  $P'$  and  $P''$ ). In presence of the wire mesh, this length,  $L_a$ , represents the “active” length of the stabilizing system, i.e. the zone of the slope where the stabilizing contact pressure,  $q$ , is mobilized between the mesh and the slope.

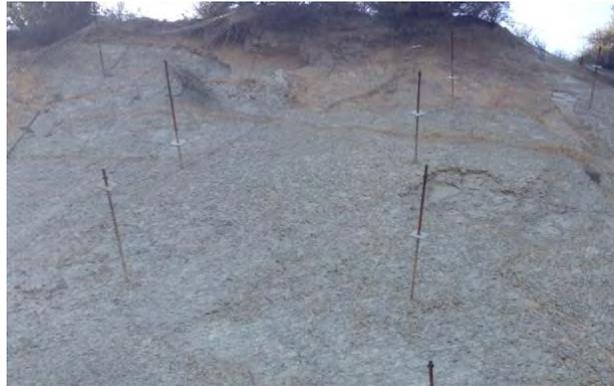
It is interesting to underline that this tool is quite unique, because it takes into consideration the failure mechanism along the entire slope; while other mesh-design software are based on the behavior of the mesh only between a pattern of nails, considering an undefined slope. Field investigations have shown that this innovative assumption is fundamental for the design of the steel wire mesh and nails, as shown in Figure 7.

**Figure 7: Example of a Soil Nail Slope Where the Soil Has Slid Underneath the Mesh, and the Foundation of the Nail Drastically Reduced**

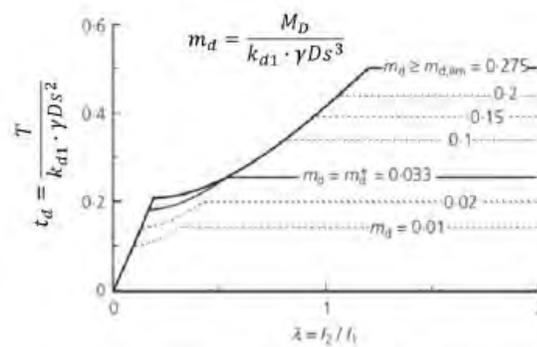
All six solutions are summarized in the non-dimensional abacus of Figure 8 (Di Laora et al.; 2017), where the dimensionless value,  $t_d$ , of the stabilizing action is plotted for increasing values of the dimensionless length,  $\lambda$ , of the anchor.

The dimensionless value,  $t_d$ , corresponds to a force,  $T$ , provided by an anchor of diameter,  $d$ , grouted in a hole of diameter,  $D$  (generally coinciding with the ideal diameter of the grouted section), in a soil layer of unit weight,  $\gamma$ , and thickness,  $s$ . The,  $\lambda$ , parameter expresses the ratio between the anchor length,  $l_2$ , beyond the sliding plane and the thickness of the unstable layer,  $l_1=s$ ).

**Figure 8: Values of the Dimensionless Stabilizing Action,  $t_d$ , Provided by One Single Anchor (Di Laora et al., 2017)**

The values of,  $t_d$ , are strictly influenced by the activation of the plastic hinges in the anchor, and, consequently, different curves are plotted in the abacus, depending on the value of the dimensionless bending strength,  $m_d$  (function of the yielding bending moment,  $M_d$ , of the anchor section). It is worth noting that the value,  $M_d$ , does not necessarily correspond with the ultimate strength,  $M_y$ , of the anchor in pure bending test, but, through the well-known  $M-N$  interaction domain for the anchor section (usually, a steel rod), it depends on the value,  $N_d$ , of the tensile action,  $N$ , as shown in Figure 9, where  $N_y$  represents the ultimate strength in pure tensile tests mobilized in the anchor by the pressure,  $q$ , developed over each single span of the mesh at the soil-mesh interface.

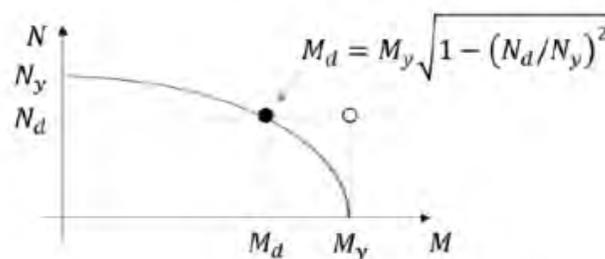
**Figure 9: M-N Interaction Diagram for an Anchor Steel Section**

Consequently, the actual stabilizing action,  $T$ , provided by each anchor along the sliding plane can be evaluated only by means of a coupled analysis, accounting for both the bending and the tensile response of the anchor. In other words, the working condition of the mesh also influences the anchor resistance against transverse soil sliding. At each run, the code solves this coupled problem by numerically determining the couple of values  $(M_d, N_d)$  laying on the boundary of the  $M-N$  interaction domain. Such condition also represents the safety check for the anchor, at least for the section where a plastic hinge is activated, since a maximum value in the bending moment diagram is expected with a nil value of the shear force.

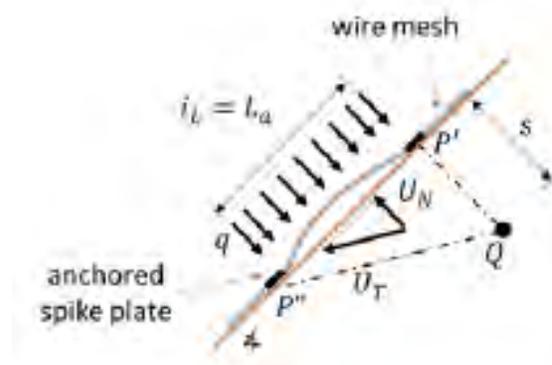
In Figure 10, the ideal case of an active block,  $P'-P''-Q$ , interacting with a single span of an anchored wire mesh is sketched, with the underlying hypothesis that the active length,  $L_a$ , of the failure mechanism coincides with the longitudinal spacing,  $i_L$ , of the anchored spike plates along the slope (a specific reduction factor is then introduced on the characteristic curve for the case  $L_a < i_L$ ).

**Figure 10: Qualitative Deformation of a Span of an Anchored Wire Mesh Subjected to a Soil Displacement,  $U_N$ , and Developing an Average Stabilizing Pressure,  $q$ , Over Its Active Length,  $L_a$**

The characteristic curve conceptually represents the relationship between the average value of the contact pressure,  $q$ , mobilized between the soil and the mesh over a span of the mesh and the corresponding normal displacement of the backfill soil material.

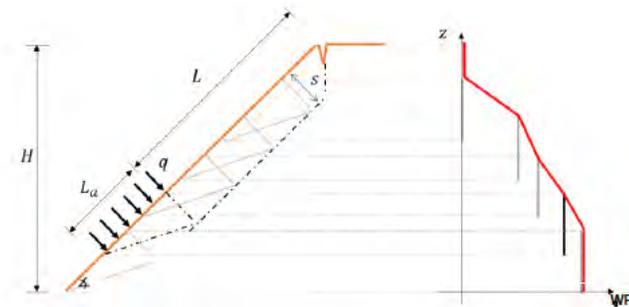
**Figure 13: Envelope of the Required Contact Pressure Distribution Along the Slope**

The results of the stability analyses for a prescribed  $FS$  value is generally expressed as an envelope of the values of the mobilized pressure,  $q$ , along the active length,  $L_a$ , for each considered failure mechanism in the surficial layer and for the two adopted stability analyses. If the values of  $q$  are plotted against the elevation,  $z$ , of each mechanism, the resulting red curve in Figure 13 represents the profile of the computed pressure distribution for a fixed value of safety factor  $FS$ . It is worth noting that the curve in Figure 11 does not represent the expected pressure distribution in service conditions for the stabilizing system, but only the envelope of the possible pressure values corresponding with the imposed  $FS$  value.

The code output also provides the values of the tensile forces developed in the anchors, corresponding with the computed distribution of the pressure,  $q$ , having already checked, as a result of the coupled analysis, the working condition ( $M_d, N_d$ ) in the  $M-N$  interaction domain for the sections where plastic hinges are activated. This pressure,  $q$ , allows then a meaningful working ratio parameter to be introduced in order to easily check the behavior of the mesh. Such output parameter is expressed as a percent (%) and this indicates the maximum ratio under which the mesh performs compared to its capacity. The verification on the mesh is satisfied when the working ratio does not exceed 100%.
