Proceedings of the 19th Annual Highway Geology Symposium

PROCEEDINGS OF THE 19TH ANNUAL
HIGHWAY GEOLOGY SYMPOSIUM

West Virginia University
Morgantown, West Virginia

May 16-17, 1968

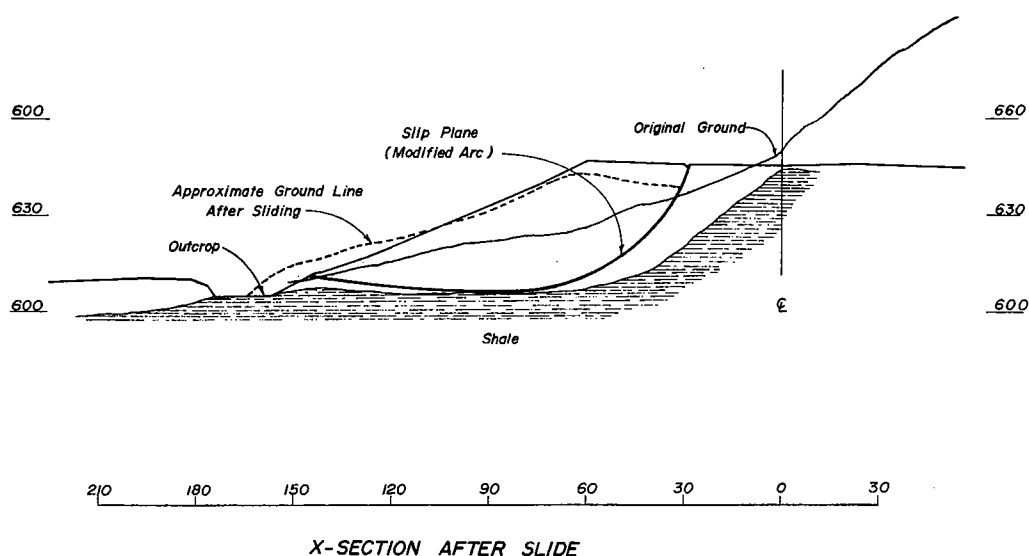
FIG. 4

An example of a failure of a side fill with a maximum height of 20 feet occurred on Interstate Route 77 near Parkersburg, West Virginia (Figure 4). The failure occurred shortly after the embankment reached subgrade elevation. The contractor excavated the slide, fill benches were cut into rock and granular material was used for back fill. This section of roadway has been open to traffic for approximately three years and the correction is performing satisfactorily.

X-SECTION AFTER SLIDE
